# National Transportation Safety Board

ANC22FA047

## COMPUTED TOMOGRAPHY

Location: Clear, Alaska  
Date: June 26, 2022  
Time: 1938 Alaska daylight time  
0338 coordinated universal time (UTC) June 27, 2024  
Helicopter: Bell UH-1B, N9970F

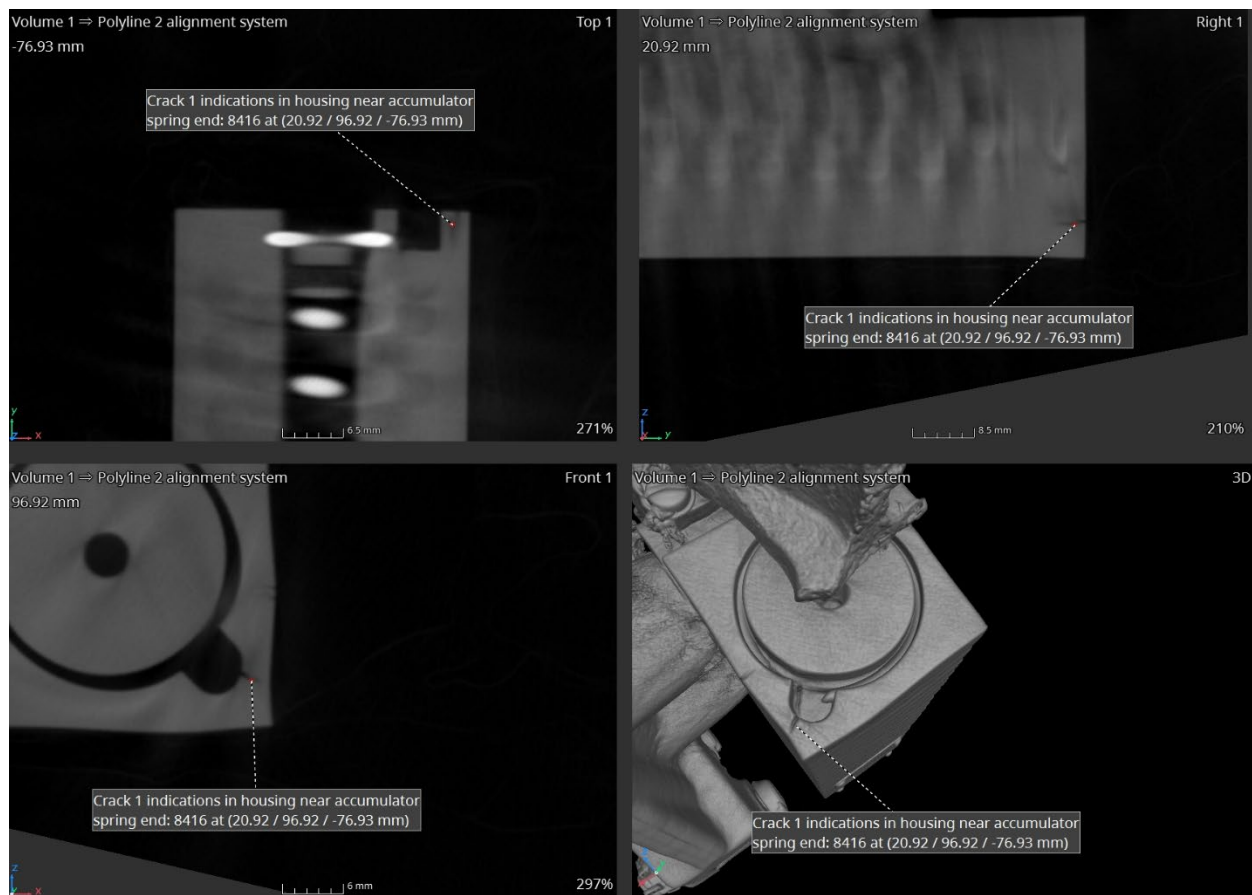
1. There were indications of a bulging cap for the sequence valve of the collective actuator irreversible valve assembly. (Figure 13)
2. There were indications of gaps and distortions in the seals in the collective actuator cylinder assembly and the irreversible valve assembly. (Figures 21, 22, 23, 24, 45, 46, 49, and 50)
3. There were indications of medium density particles and/or material inside the piston rod of the collective actuator cylinder assembly and irreversible valve assembly. (Figures 25 and 53)
4. There were indications of cracks in the irreversible valve housing near the accumulator spring end. (Figures 26 and 27)

**Figure 26.** Collective actuator - irreversible valve - crack 1 indications in housing near accumulator spring end. (450 kV)

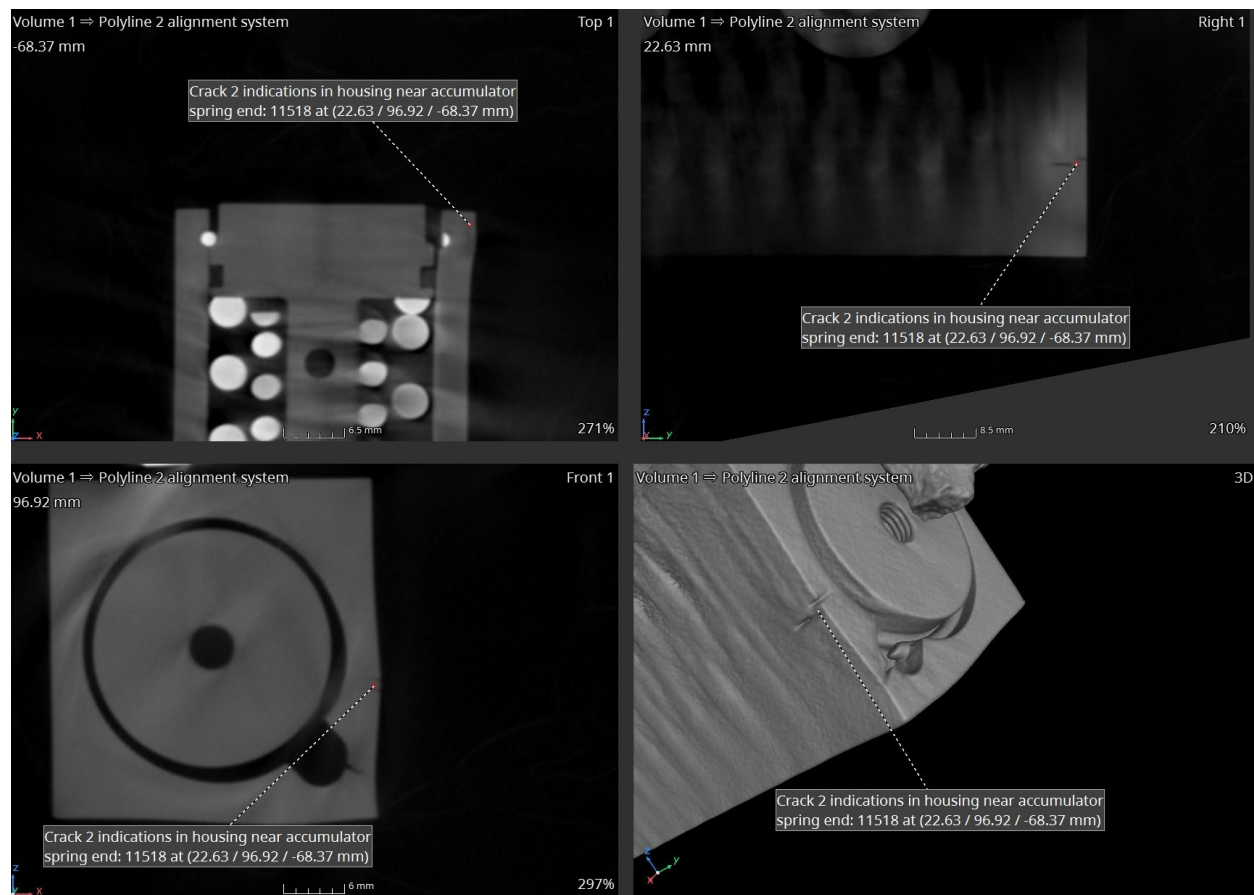
**Figure 27.** Collective actuator - irreversible valve - crack 2 indications in housing near accumulator spring end. (450 kV)

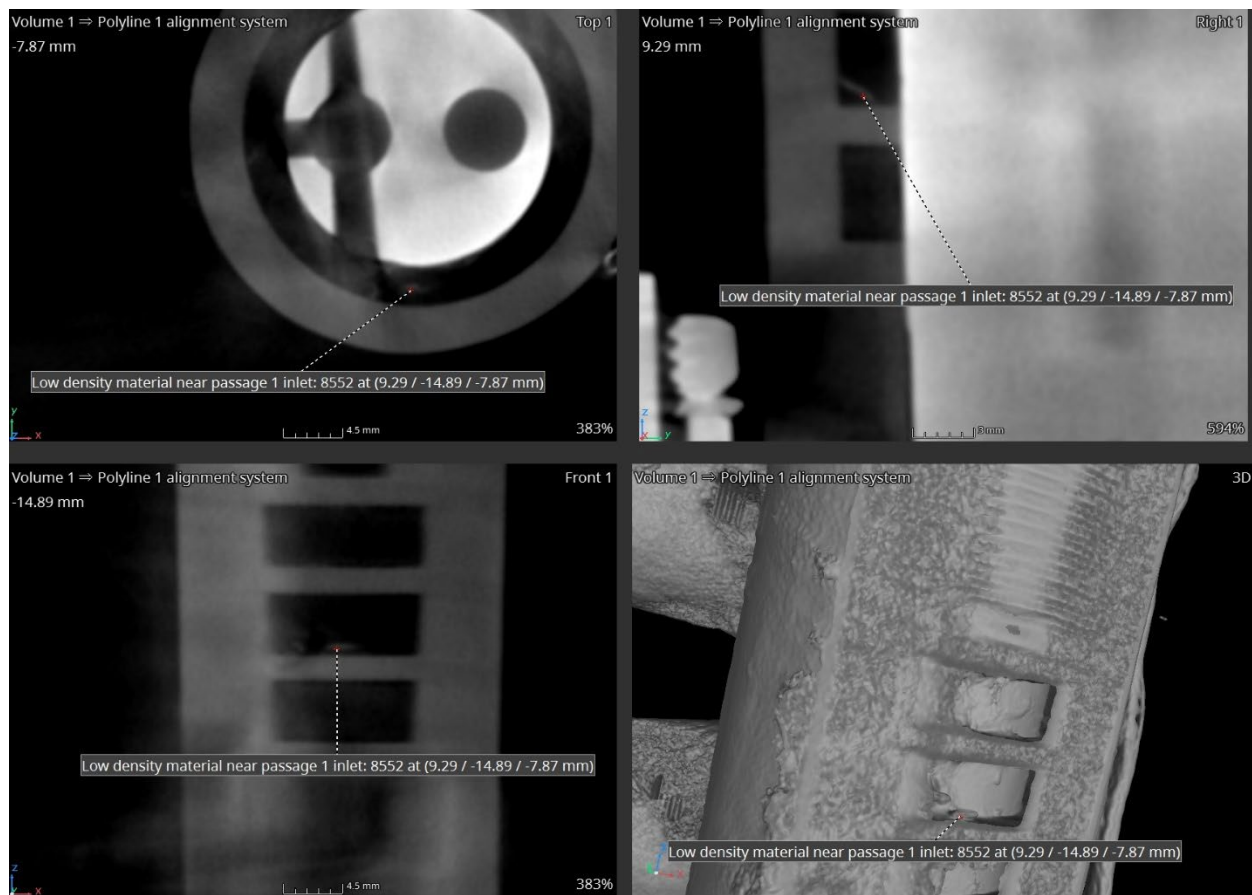
5. There were indications of low density particles and/or material in the hydraulic passage 1 inlet of the collective actuator cylinder assembly. (Figure 36)
6. There were indications of high density particles and/or material in the threads of the piston rod of the collective actuator cylinder assembly. (Figure 40)
7. There were indications of medium density material between the cylinder and ball joint retainer of the collective actuator. (Figure 43)

**Figure 36.** Collective actuator - cylinder assembly - low density material near passage 1 inlet. (450 kV)

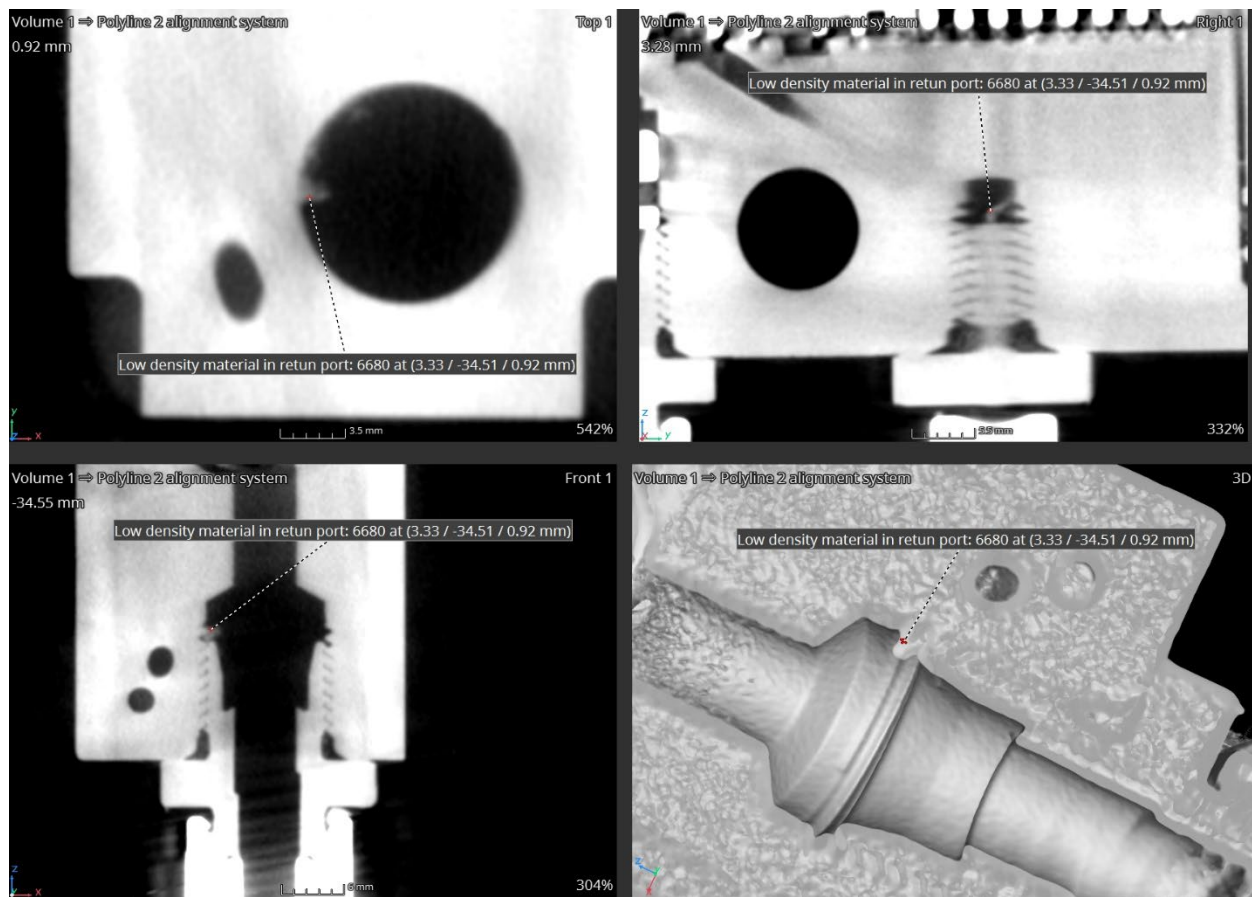
1. There were indications of low density particles and/or material in the return port of the right lateral actuator irreversible valve assembly. (Figure 58)
2. There were indications of a bulging/damaged cap for the sequence valve of the right lateral actuator irreversible valve assembly. (Figures 61 and 62)
3. There were indications of gaps and distortion in the seals in the right lateral actuator cylinder assembly and the irreversible valve assembly. (Figures 70, 71.)
4. There were indications of safety wire between the cylinder housing and the ball joint retainer. (Figure 87)

**Figure 58.** Right lateral actuator - irreversible valve - low density material in return port. (450 kV)

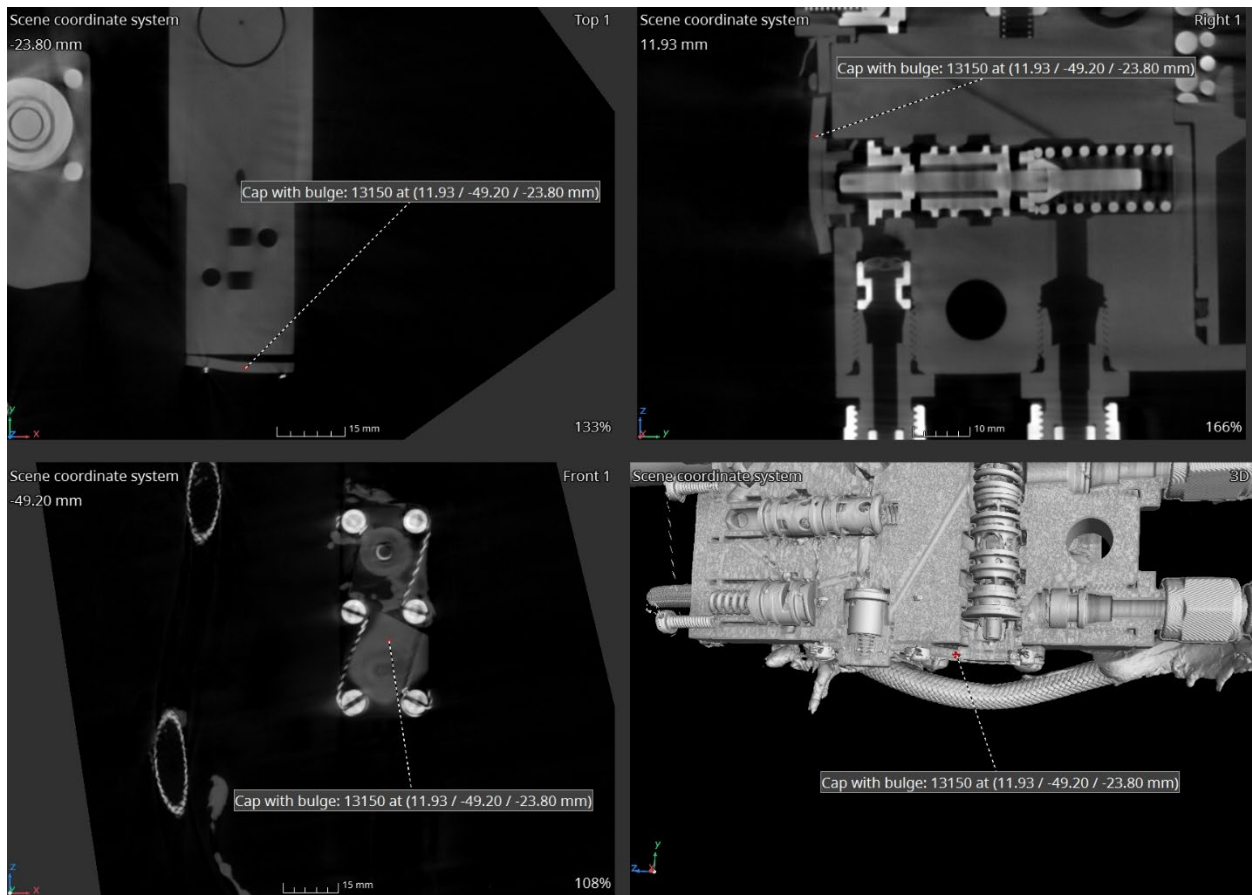
**Figure 61.** Right lateral actuator - irreversible valve - cap with bulge. (450 kV)

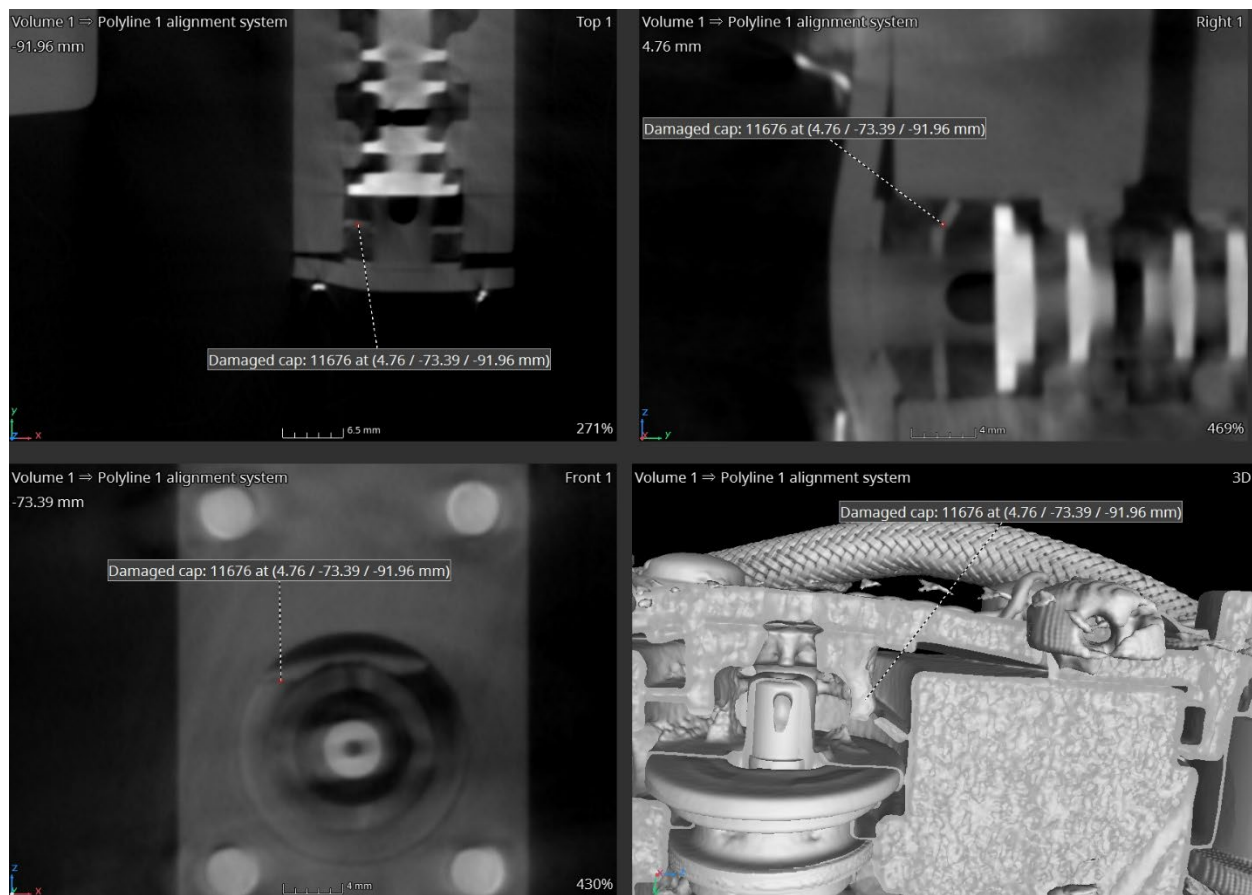
**Figure 62.** Right lateral actuator - irreversible valve - damaged cap. (450 kV)

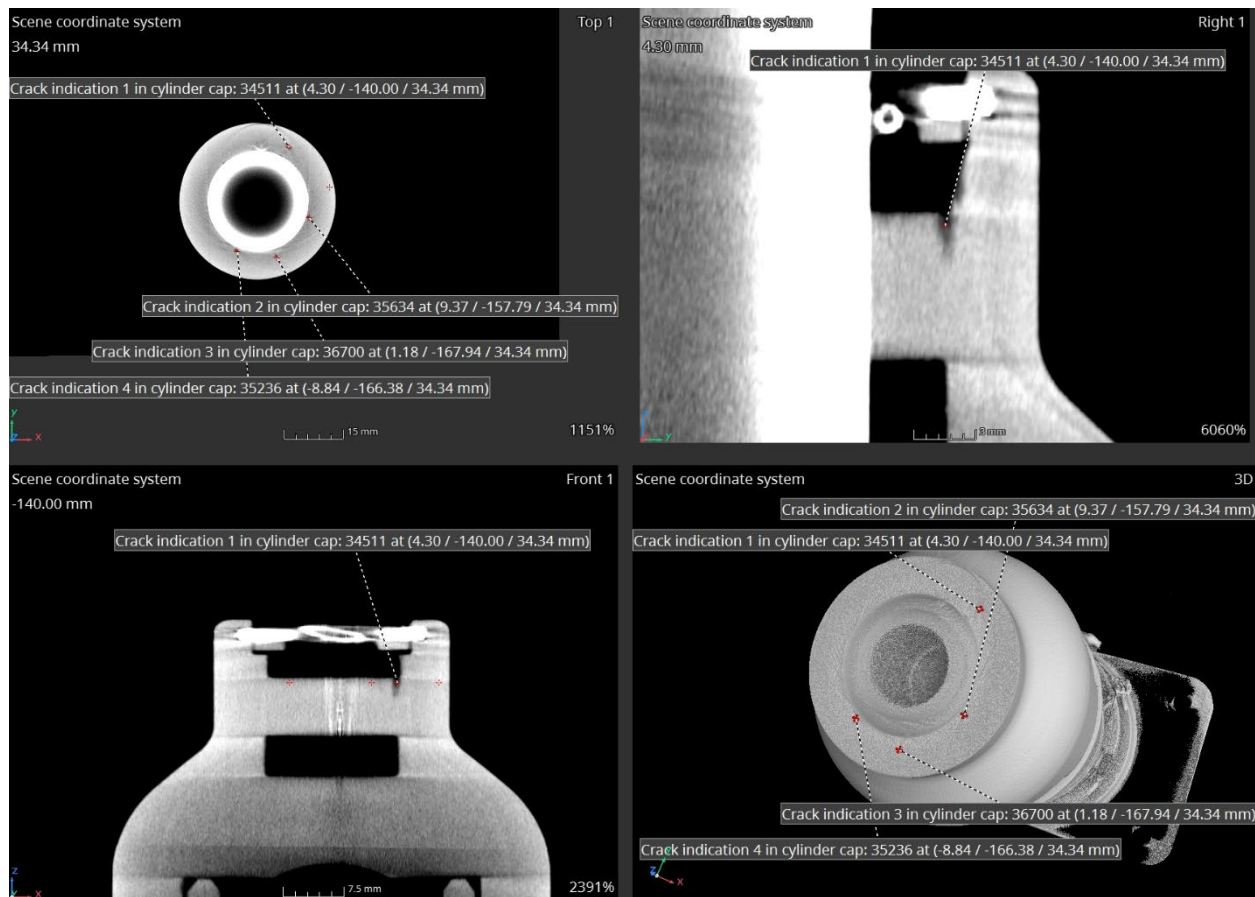
1. There were indications of medium and high density particles and/or material in several locations within the left lateral actuator. (Figures 104, 105, 109, 110, 111, 112, 113, 124, and 125)
2. There were indications of gaps and distortions in the seals in the cylinder cap within the left lateral actuator. (Figures 114, 115, 116, and 117)
3. There were indications of cracks in the cylinder cap. (Figures 120, 121, 122, and 123)

**Figure 120.** Left lateral actuator - cylinder assembly - crack indication 1 in cylinder cap.

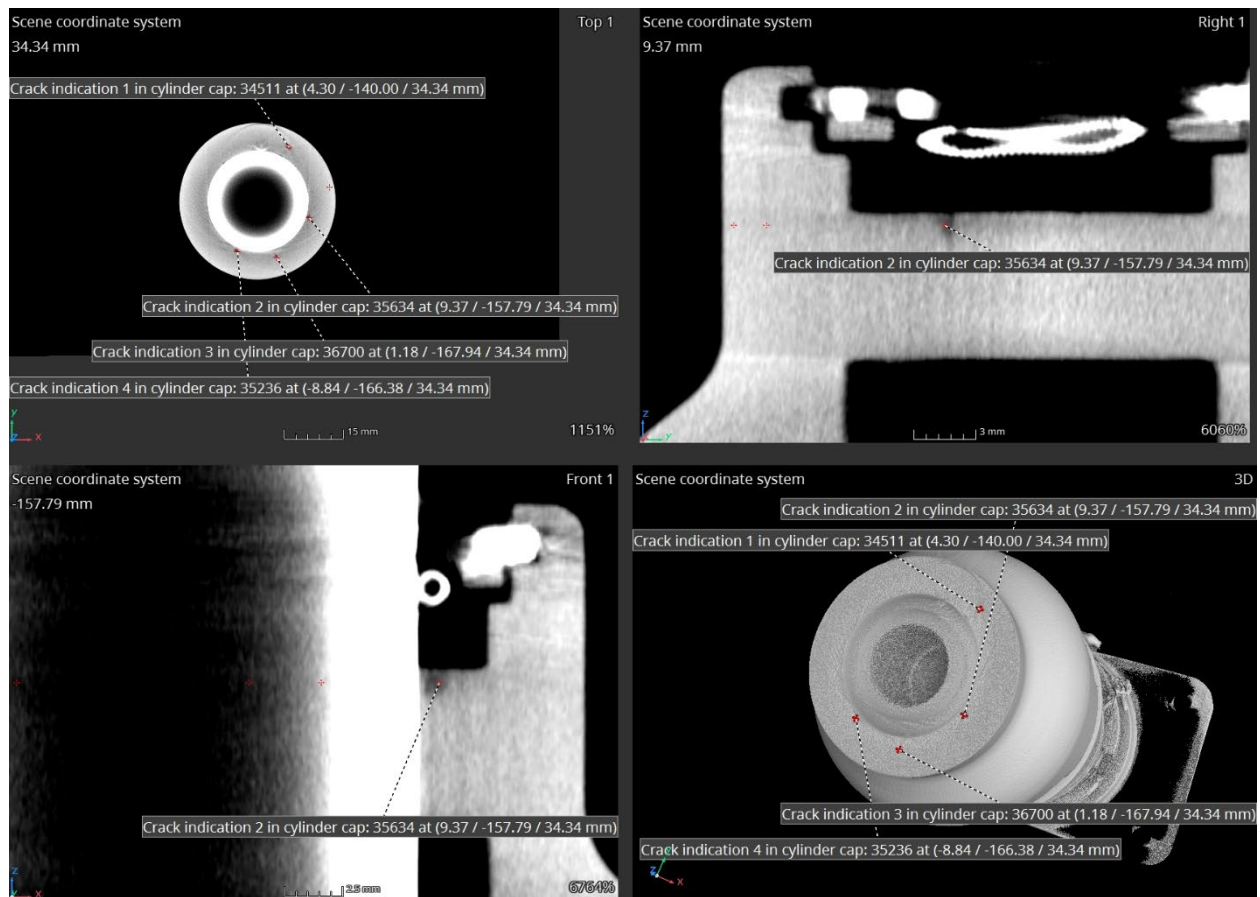
**Figure 121.** Left lateral actuator - cylinder assembly - crack indication 2 in cylinder cap.

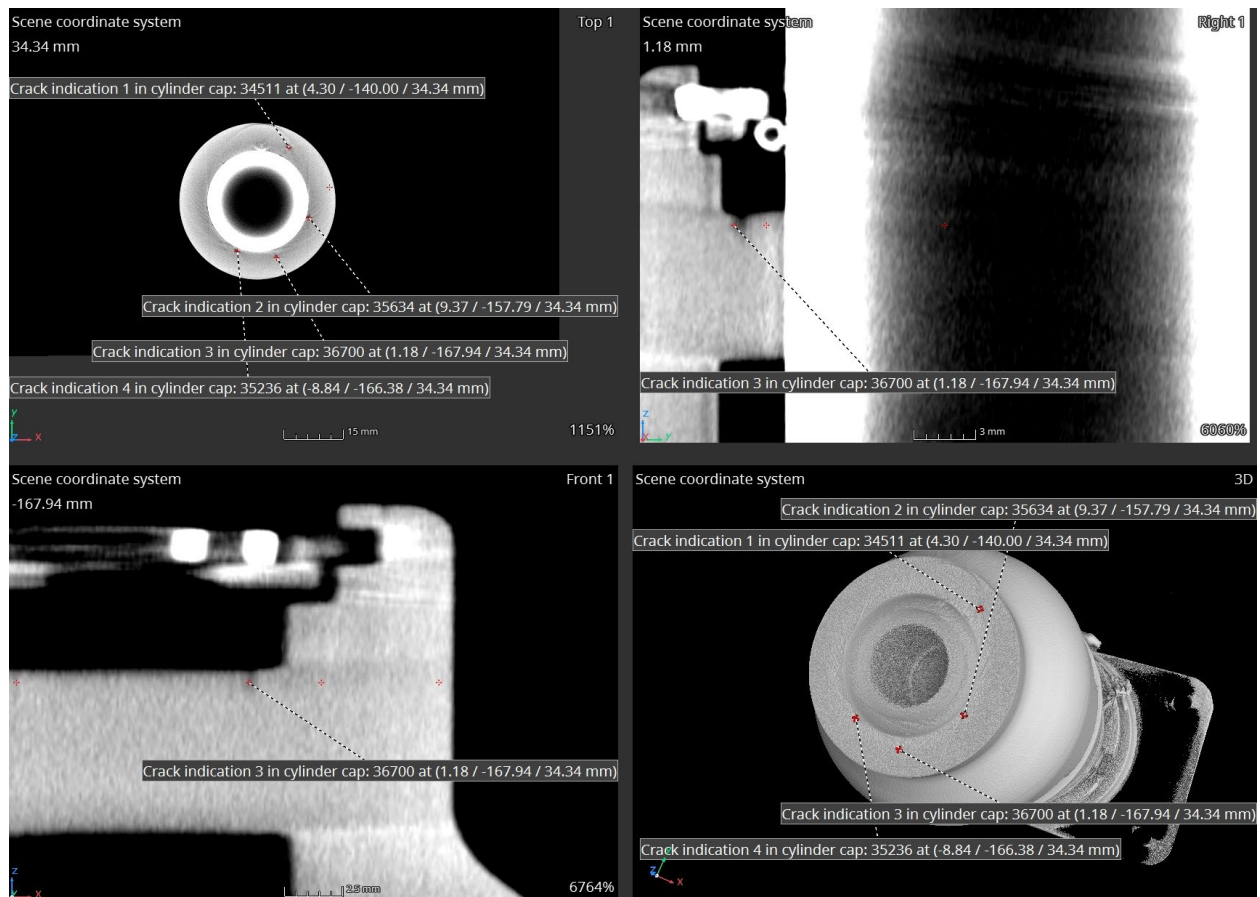
**Figure 122.** Left lateral actuator - cylinder assembly - crack indication 3 in cylinder cap.

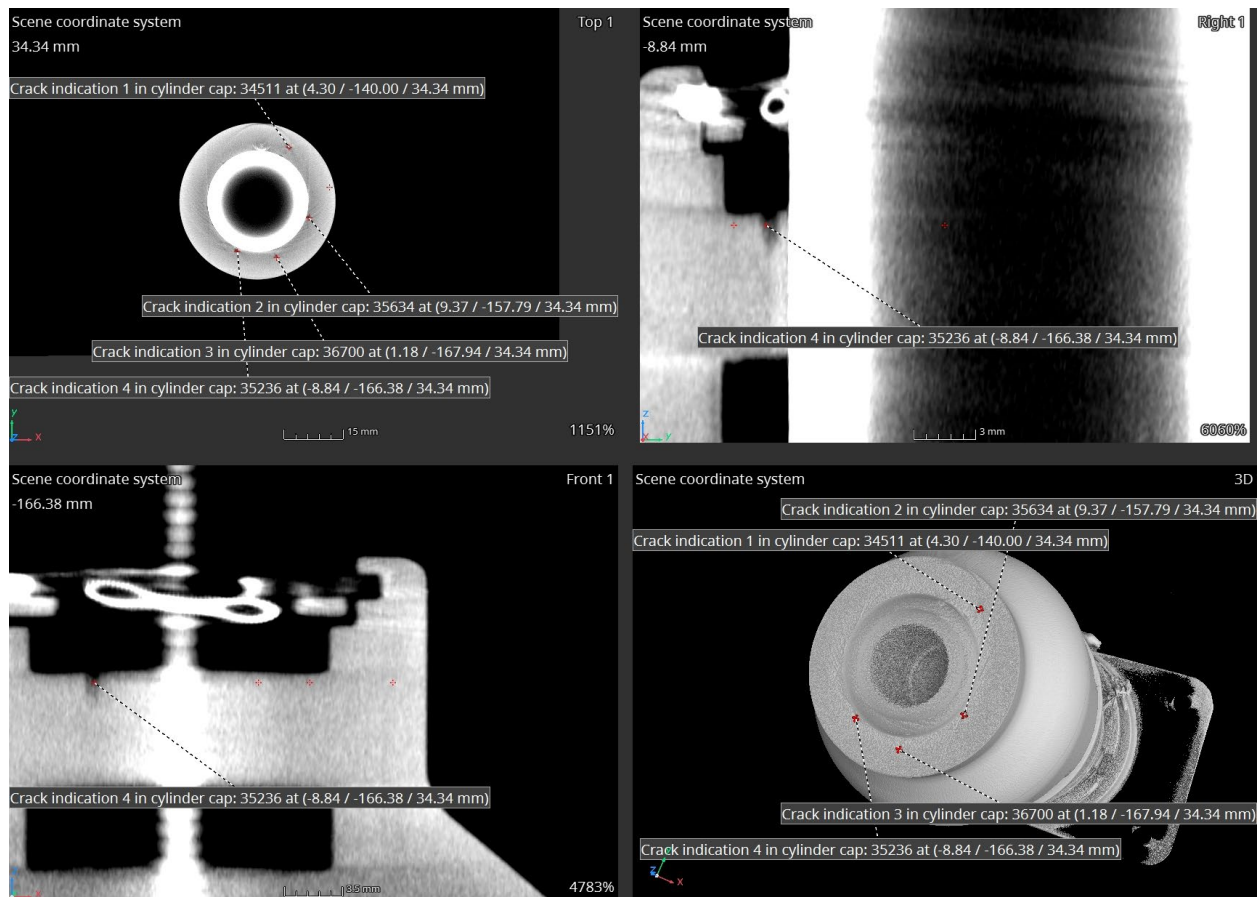
**Figure 123.** Left lateral actuator - cylinder assembly - crack indication 4 in cylinder cap.

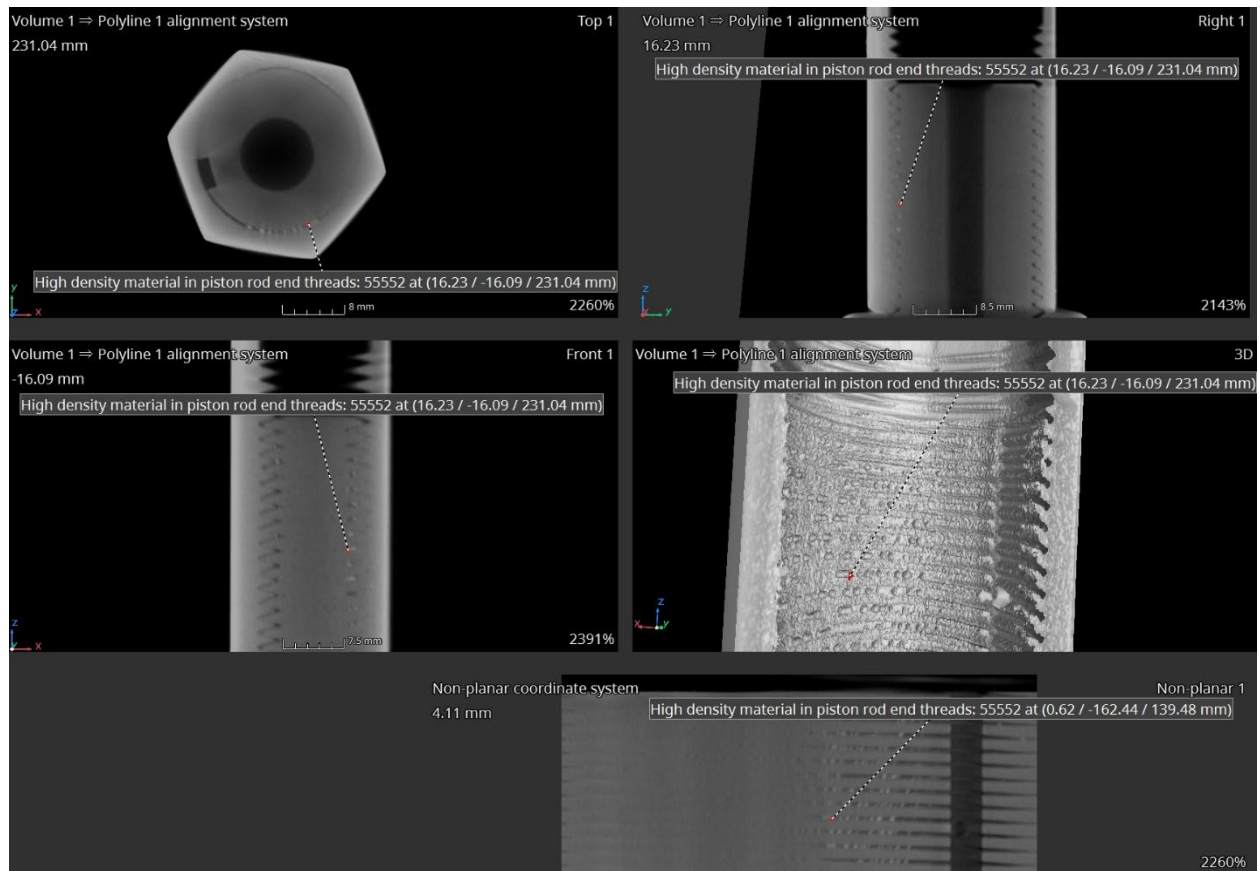
**Figure 124.** Left lateral actuator - cylinder assembly - high density material in the piston rod threads.

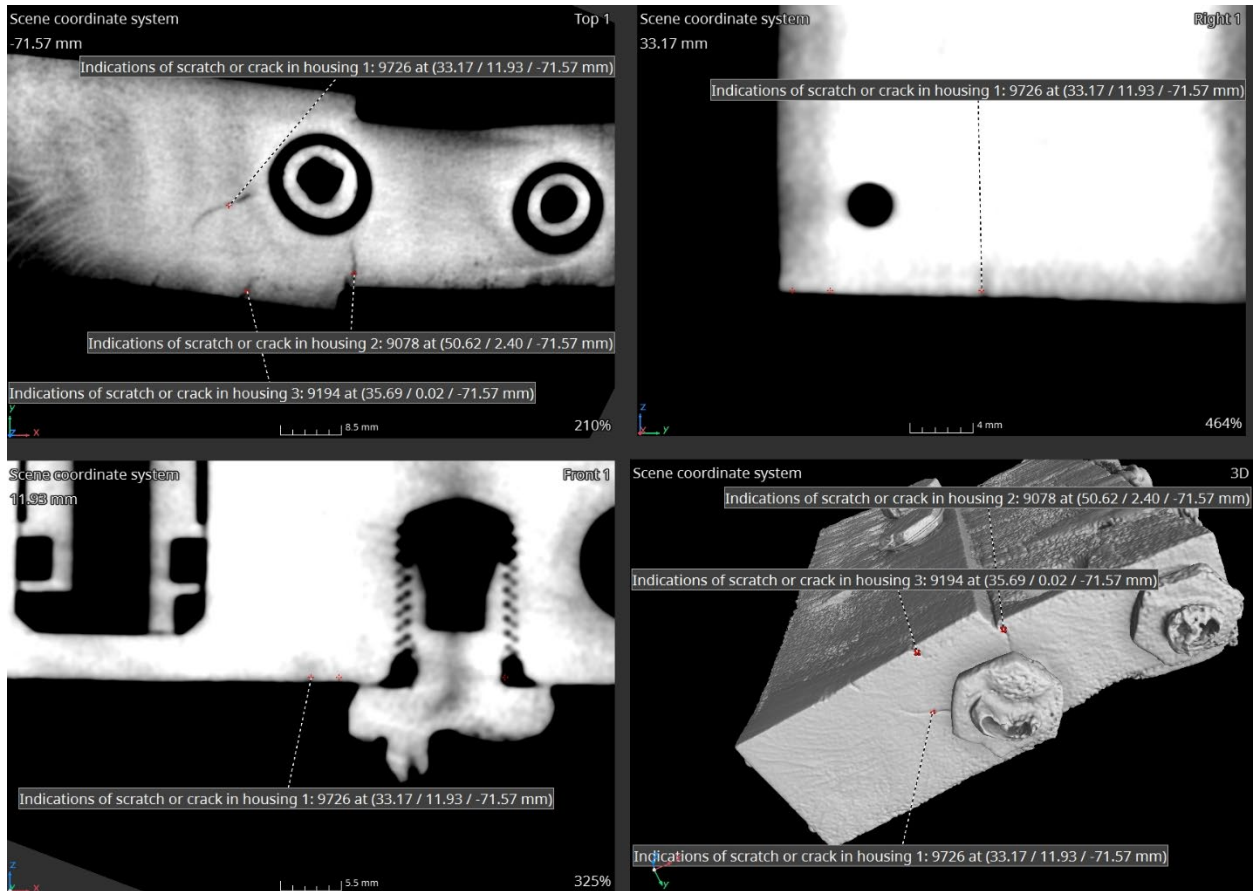
1. The irreversible valve housing was deformed with cracks visible or indications of cracks. (Figures 127, 128, 149, and 151)
2. The pressure and return fittings were crushed and deformed. (Figures 129 and 130)
3. There were indications of low and/or medium density particles and/or material near the sequence valve, near the check valve cap, near the plug between the thermal relief valve and differential pressure relief valve, in the cylinder pressure port, and in the accumulator inlet port. (Figures 133, 134, 138, 144, 146, 155, and 156)

**Figure 128.** Left lateral actuator - irreversible valve - housing - possible cracks. (450 kV)

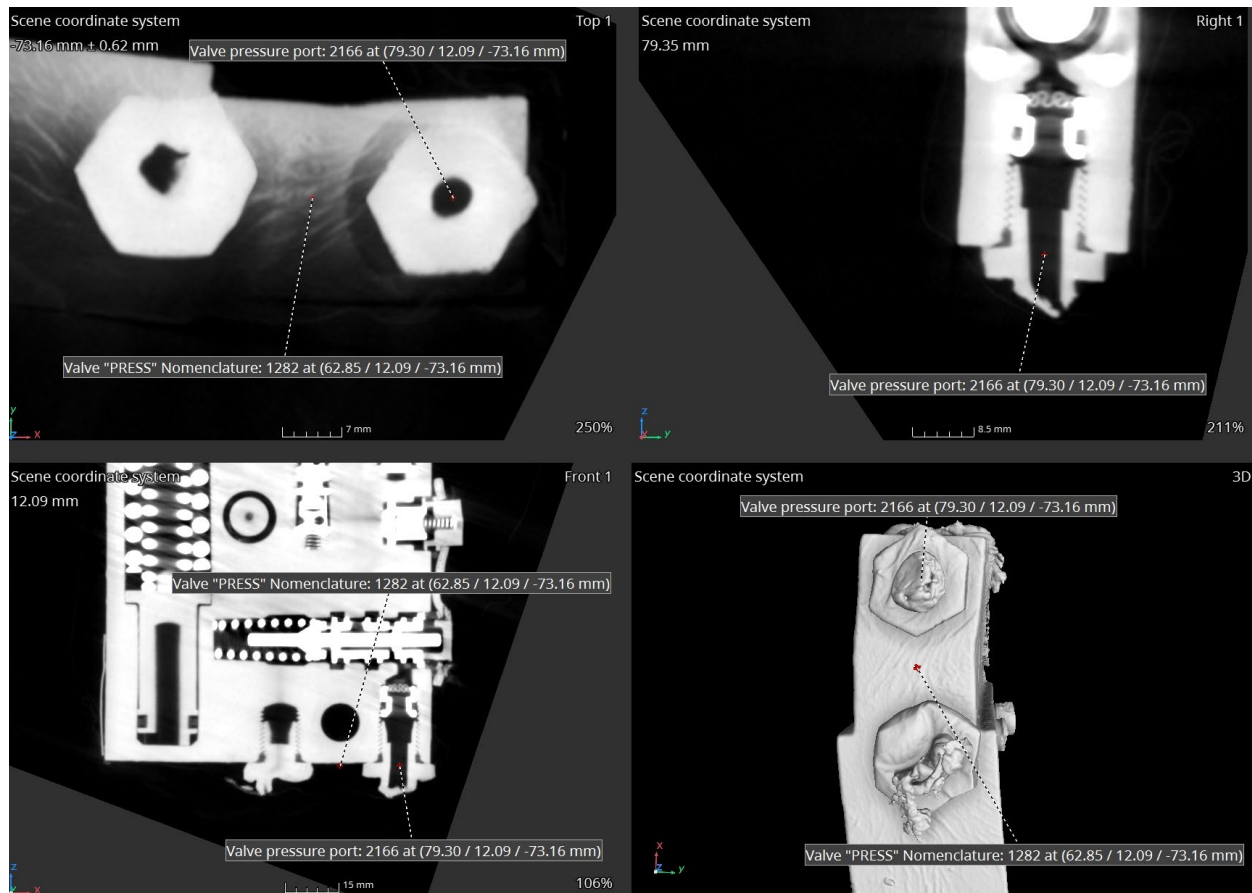
**Figure 129.** Left lateral actuator - irreversible valve - pressure port and nomenclature. (450 kV)

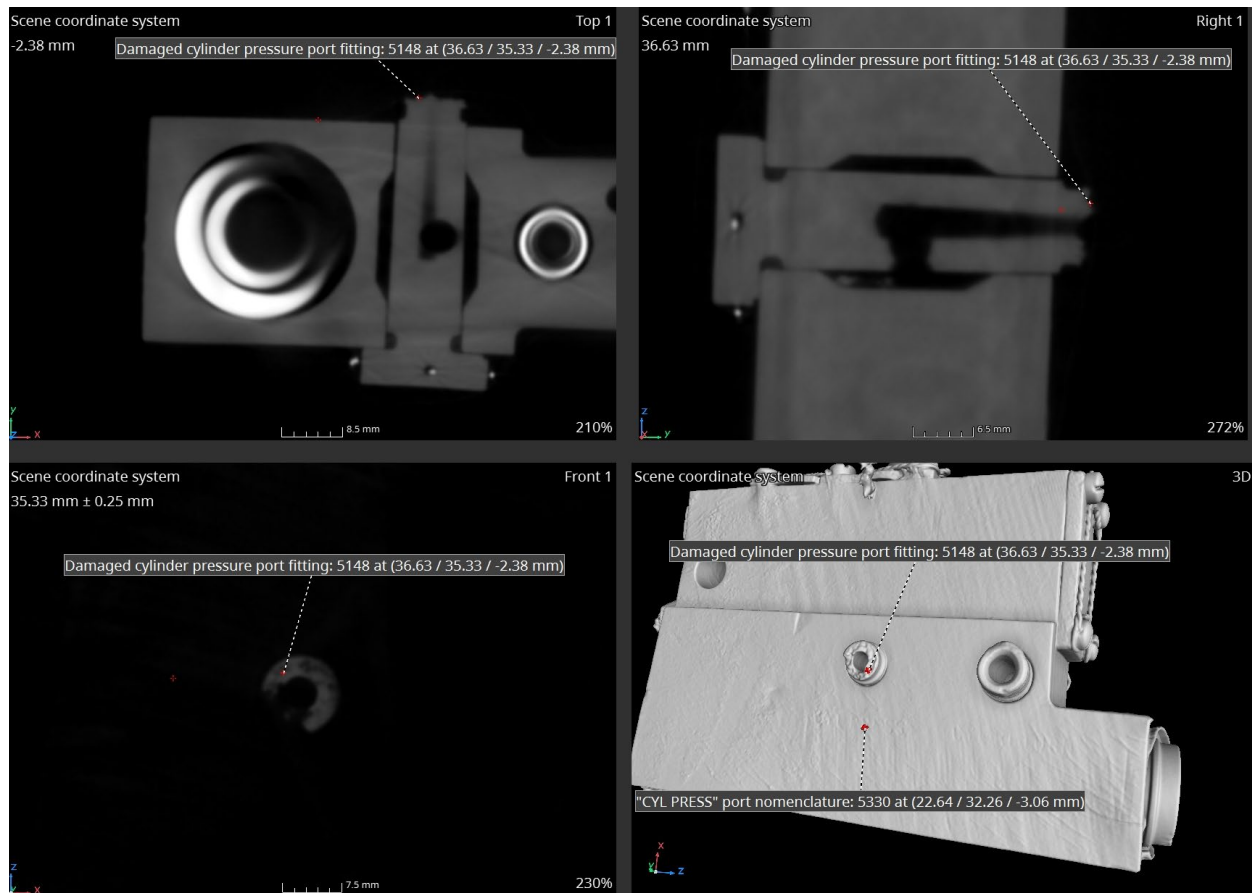
**Figure 147.** Left lateral actuator - irreversible valve - cylinder pressure port damaged fitting. (450 kV)

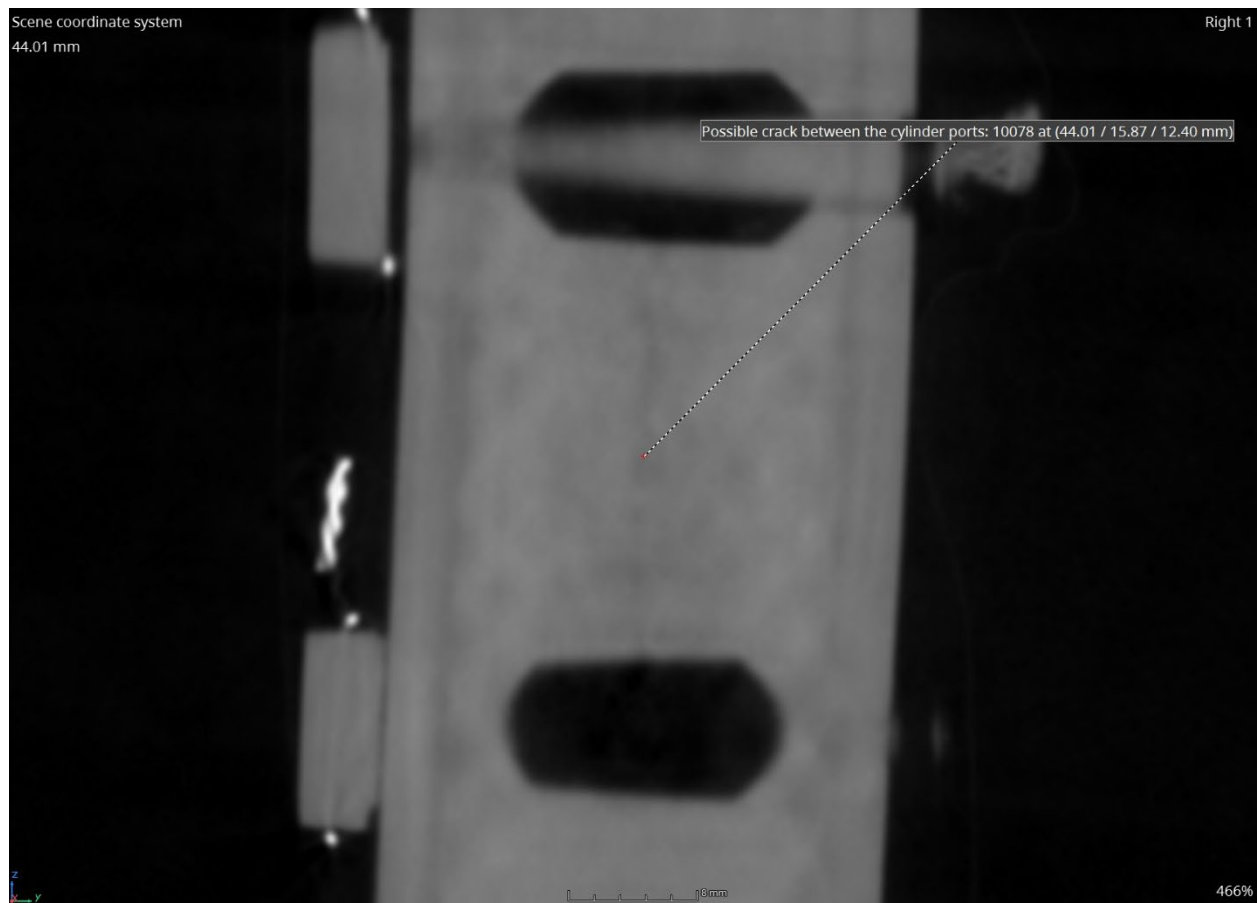
**Figure 149.** Left lateral actuator - irreversible valve - possible crack between cylinder ports. (450 kV)

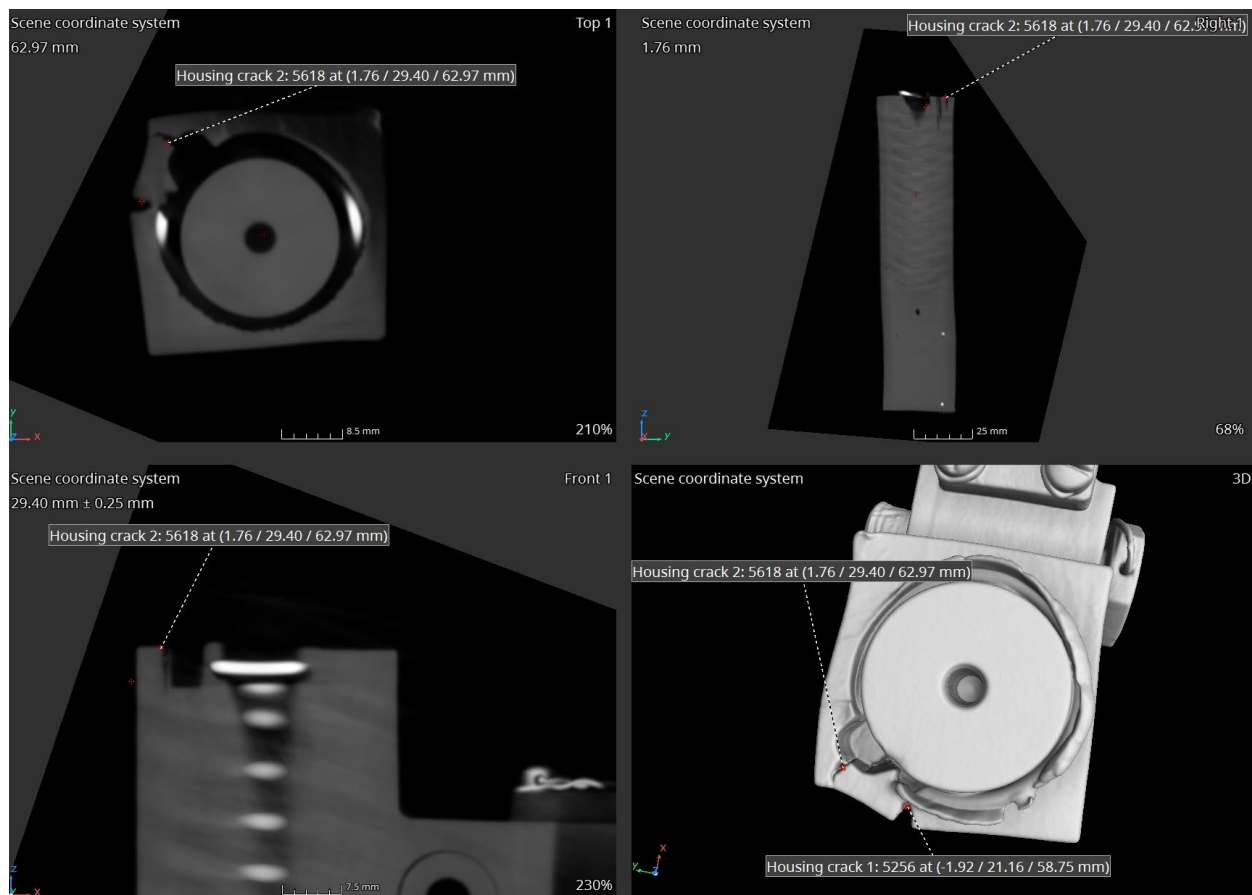
**Figure 151.** Left lateral actuator - irreversible valve - cracks in housing near the accumulator. (450 kV)

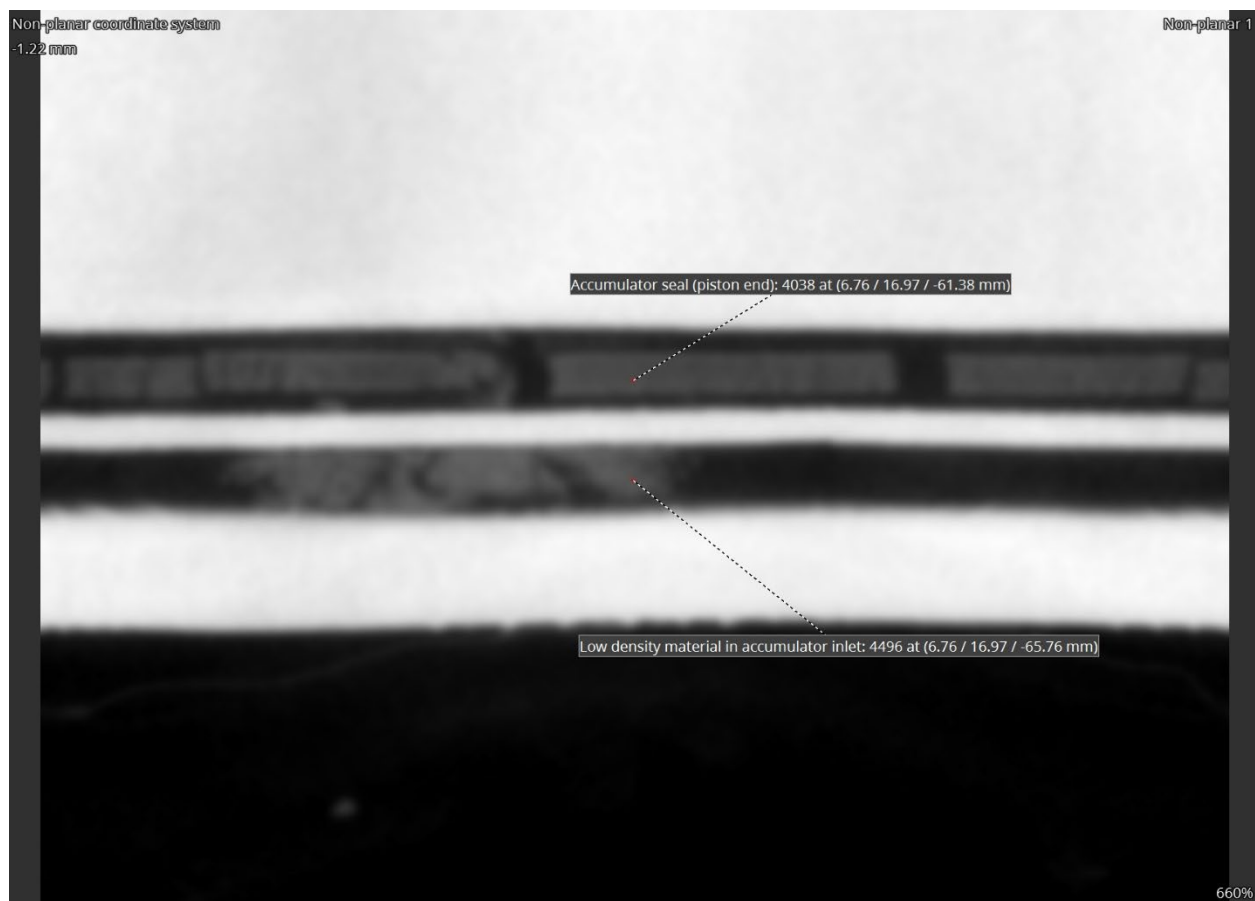
**Figure 156.** Left lateral actuator - irreversible valve - accumulator seal unrolled at piston end. (450 kV)

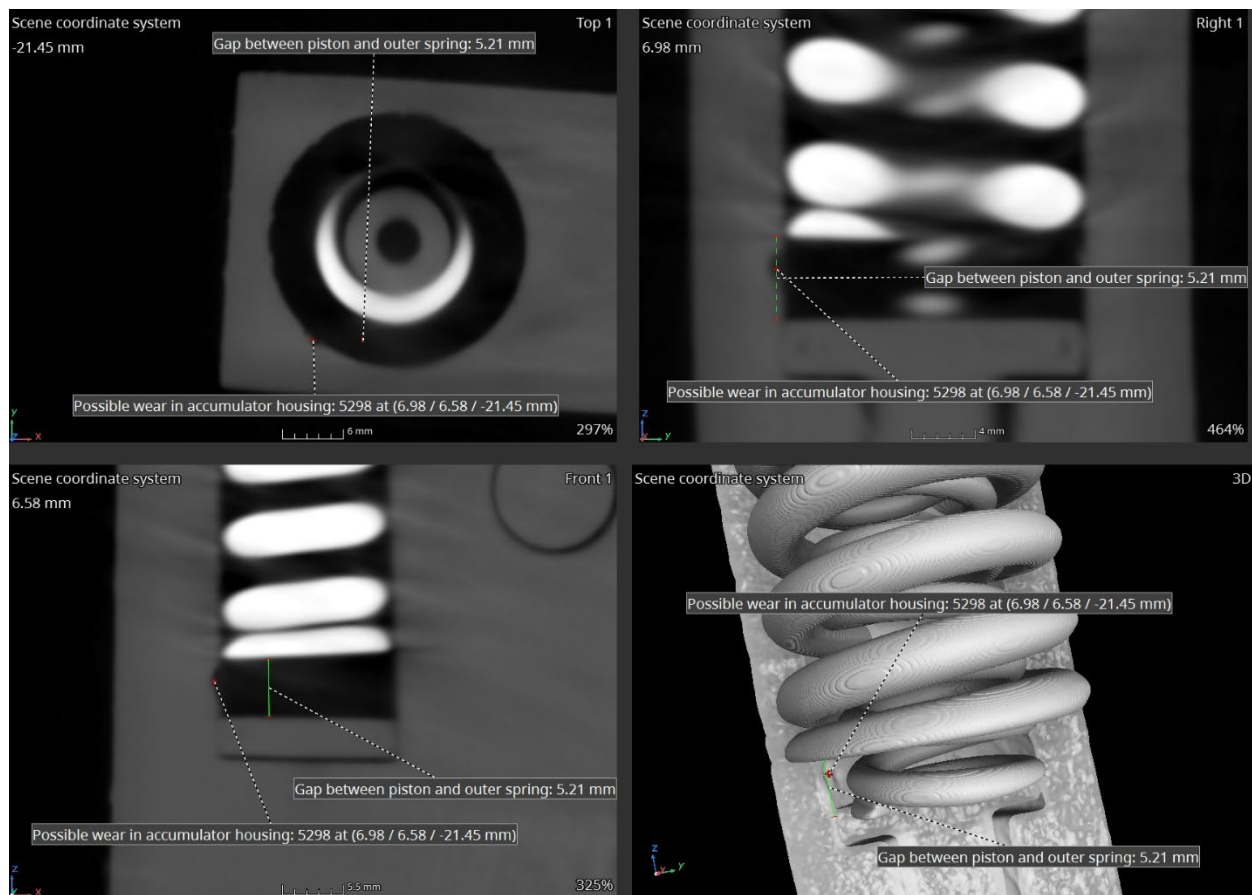
4. There were indications of a bulging cap for the sequence valve and the thermal relief valve of the irreversible valve assembly. (Figures 135 and 140)
5. There were indications of a void in the poppet assembly of the thermal relief valve. (Figure 139)
6. The cylinder pressure port fitting was damaged. (Figure 147)
7. There were indications of cracks in the irreversible valve housing near the accumulator spring end. (Figure 151)
8. The accumulator retainer and retaining ring for the accumulator retainer are out of position. (Figure 152)
9. The seal in the accumulator retainer (spring end) appears to be missing. (Figures 153 and 154)
10. There were indications of cracks in the accumulator piston. (Figure 157)
11. There were indications of wear or damage to the bore of the accumulator and the accumulator springs were not fully extended. (Figures 158, 159 and 160)

**Figure 158.** Left lateral actuator - irreversible valve - showing outer spring is not seated against the piston and possible wear in housing. (450 kV)

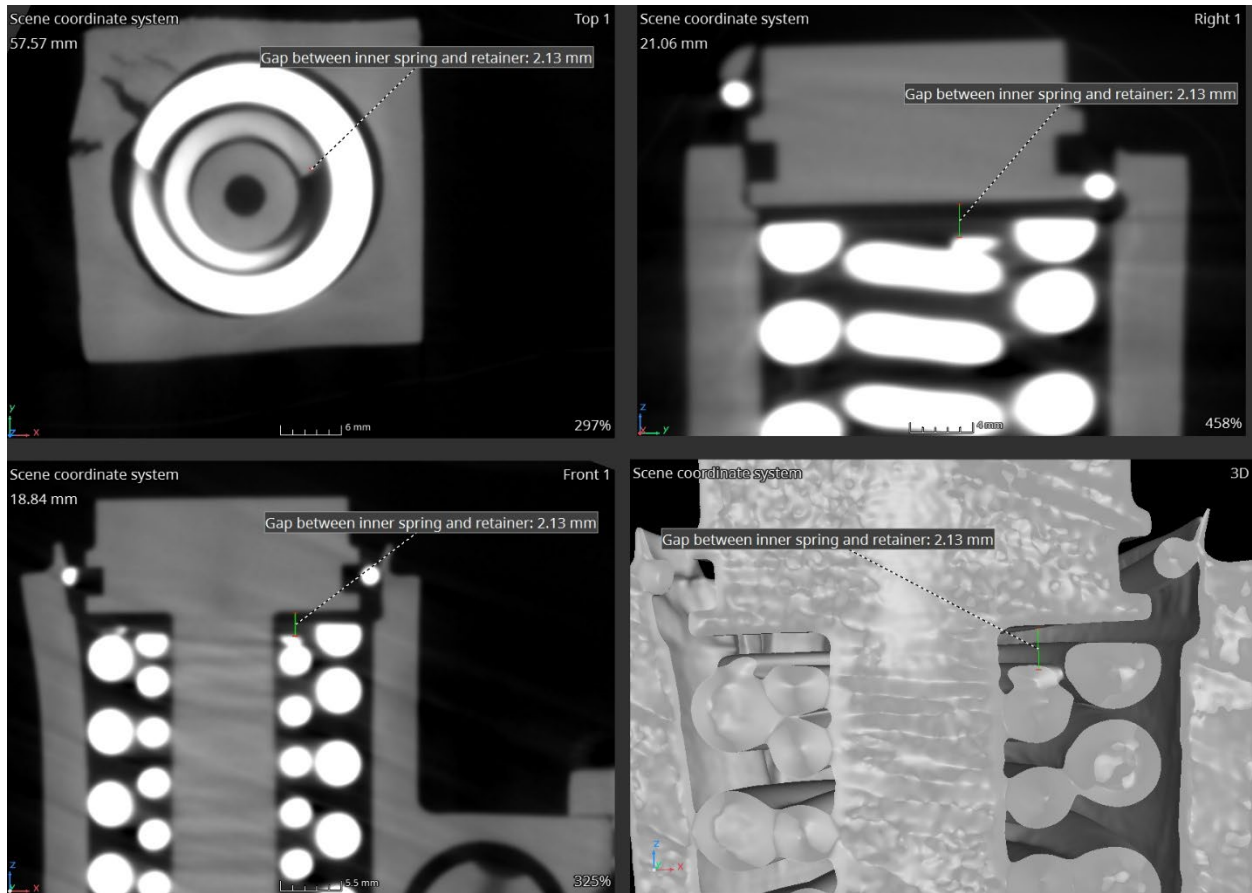
**Figure 159.** Left lateral actuator - irreversible valve - showing inner spring is not seated against the piston spring retainer. (450 kV)
