**Date: June 27, 2022**  
**Person Contacted: Doug Buzga**  
**Location: Telephone**  
**NTSB Accident Number: ANC22FA047**

On June 26, 2022, about 1938 Alaska daylight time, a Bell UH1B helicopter, N9970F was destroyed when it was involved in an accident near Anderson, Alaska. The pilot and sole occupant was fatally injured. The helicopter was operated by Northern Pioneer Helicopters LLC as a Title 14 *Code of Federal Regulations* Part 133 flight.

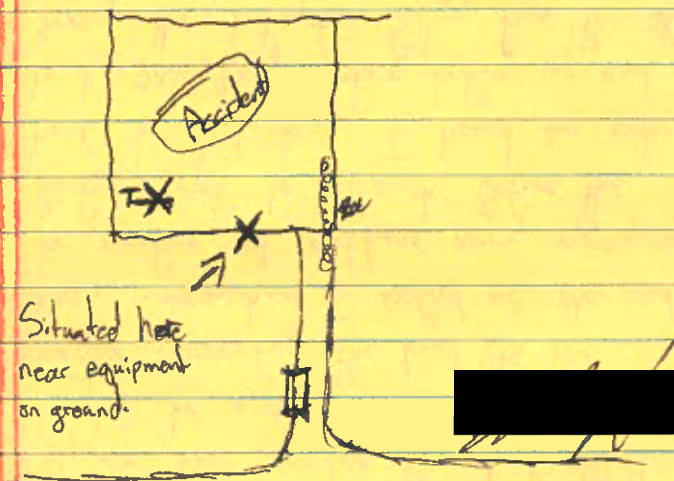
Location of myself and Jesse.
