## **Wreckage Examination Summary**

NTSB ACCIDENT NUMBER: ANC22LA004

AIRCRAFT REGISTRATION/AIRCRAFT TYPE: N368G, Gregg Origer PA-18 Replica  
ACCIDENT LOCATION: Willow, AK

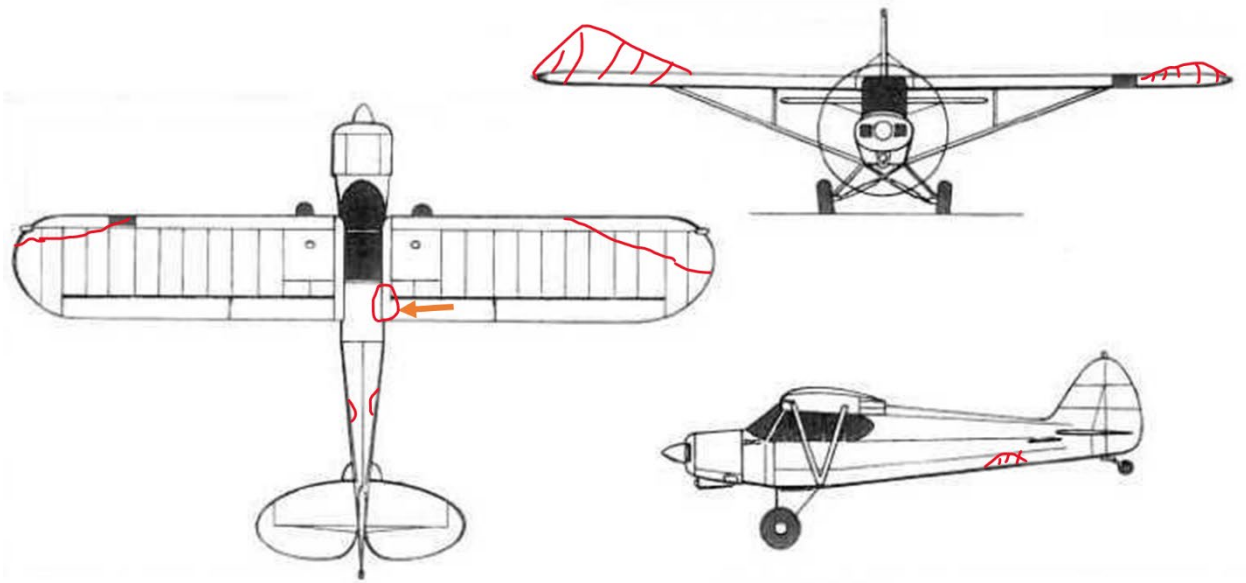
**Cockpit/Fuselage**

- Fuselage Condition / Damage

- Pilot location - Front seat
- Passenger location- Rear seat
- Type of seat belts used- Hooker Harness 4 point

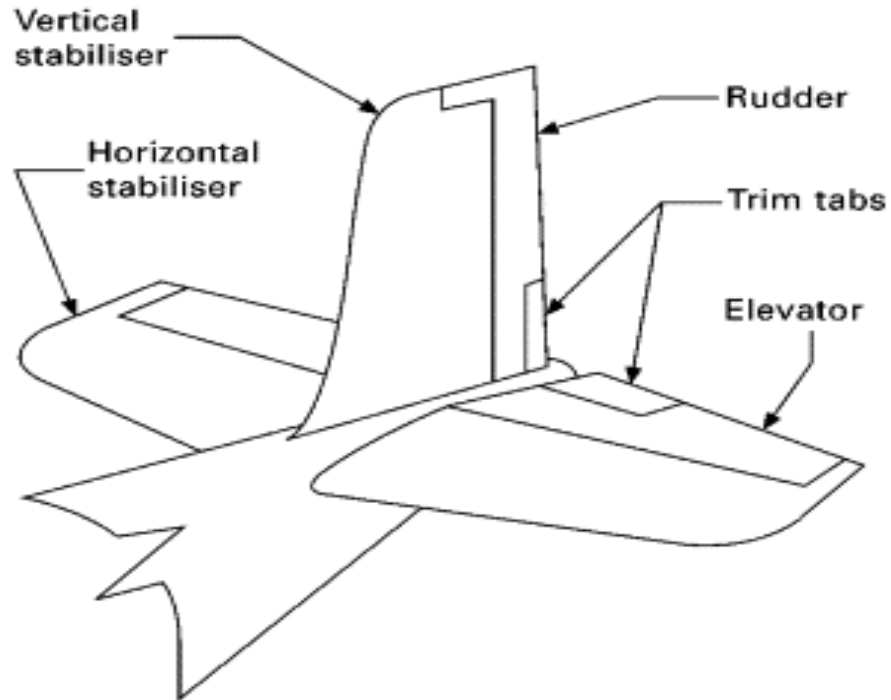
## **Empennage**

- The empennage condition- No damage noted
- The right horizontal stabilator
  - Attached to its respective attach points - Yes
  - Condition/Damage – No damage noted
- The right elevator
  - Attached to its respective attach points - Yes
  - Condition/Damage – No damage noted
- The vertical stabilizer
  - Attached to its respective attach points - Yes
  - Condition/Damage- No damage noted
- The rudder
  - Attached to its respective attach points - Yes
  - Rudder horn – No damage
  - Left and right rudder cables remained attached to their respective attach points - Yes
  - Condition/Damage – No damage noted

- The tail wheel – Matco
  - Attached to its respective attach points - Yes
  - Damage – No damage noted
- The left horizontal stabilator
  - Attached to its respective attach points - Yes
  - Damage – No damage noted
- Left elevator
  - Attached to its respective attach points - Yes
  - Damage – No damage noted

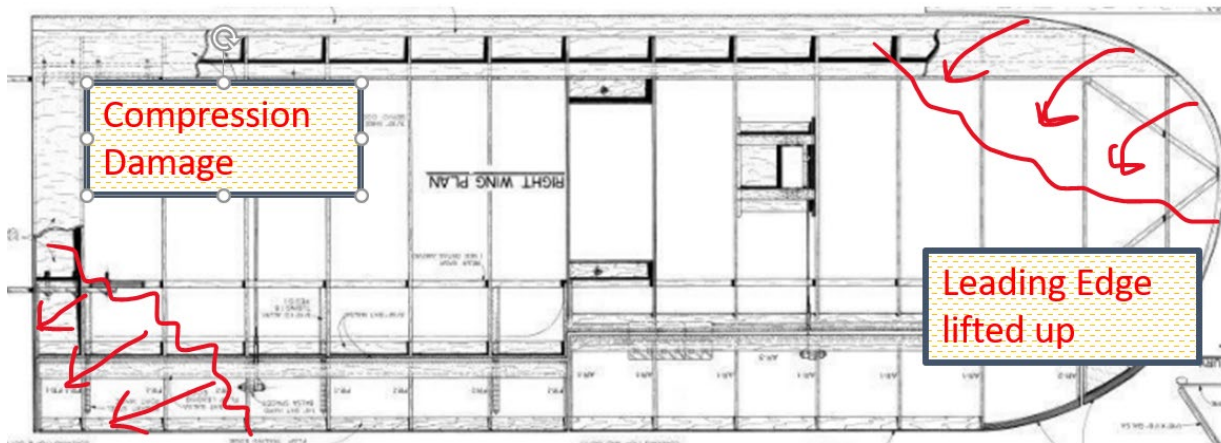
### **Right Wing**

- Overall – Impacted damage to outboard leading edge, inboard trailing edge, and wing struts.
- Leading edge
  - Condition/Damage- Substantial impacted damage from wing tip to about 6 ft inboard.
- The right aileron
  - Attached to its respective attach points - Yes
  - Condition/Damage – Relatively undamaged
- The right flap
  - Attached to its respective attach points - Yes
  - Condition/Damage – Inboard portion pushed into fuselage
- Fuel – Cap on and tight, tank sustained substantial impact damage and was breached. No fuel was observed in the tank.
- Wing attachment to fuselage – Front yes, rear yes; however, rear spar separated about 6 inches from inboard attachment point.

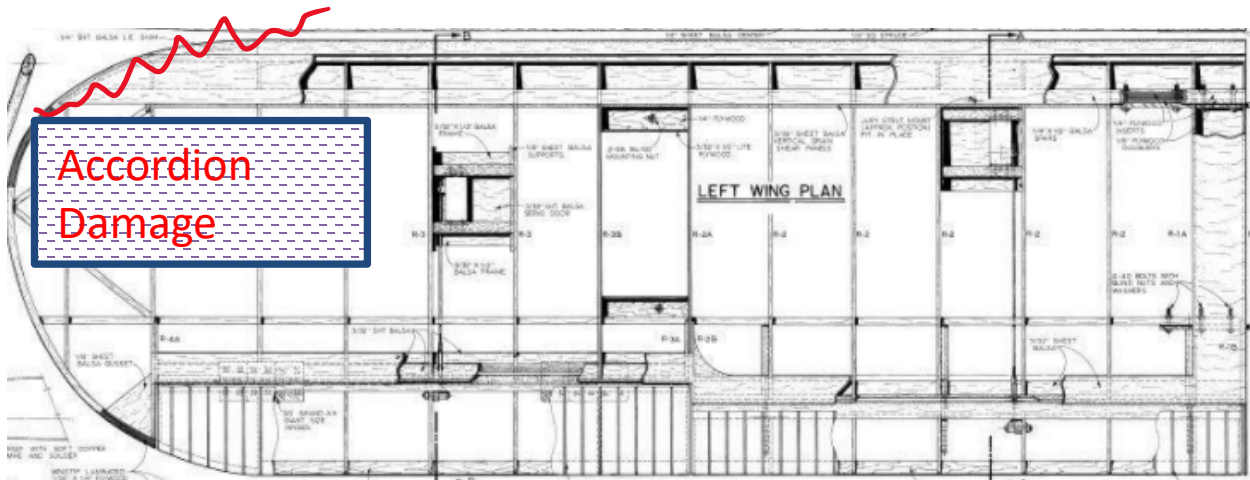
## Left Wing

- Overall
- Leading edge
  - Condition/Damage – Tip to strut attachment, about 6 ft, accordion style impact damage.
- The left aileron
  - Attached to its respective attach points - Yes
  - Condition/Damage – Minimal damage
- The left flap
  - Attached to its respective attach points - Yes
  - Condition/Damage – Minimal damage
- Fuel -Cap on and tight. No fuel observed in tank.
- Wing attachment to fuselage - Yes

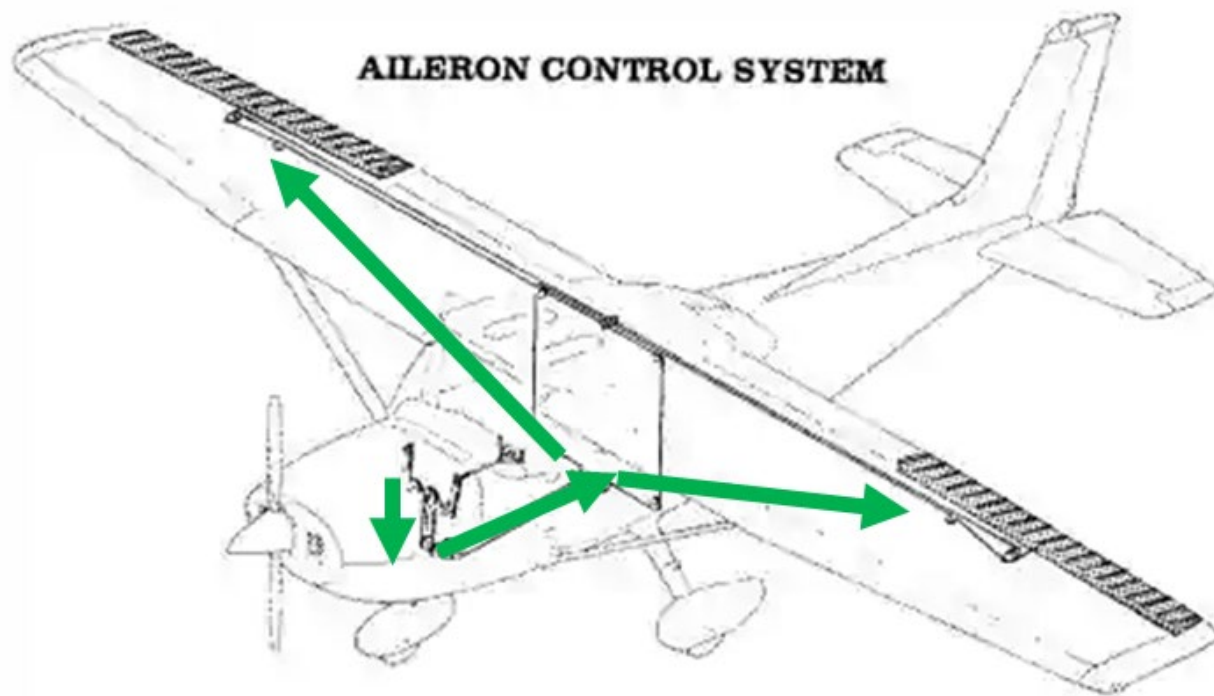
**Flight Controls/Flight Control Cables Remarks:**

- Ailerons – Control continuity was established.
  - In the direct cables from the control column to both the left and right ailerons.
    - Damage – None, no breaks in control cables.
  - Balance cable – Control continuity was established.
    - Damage – None, no breaks in control cable.

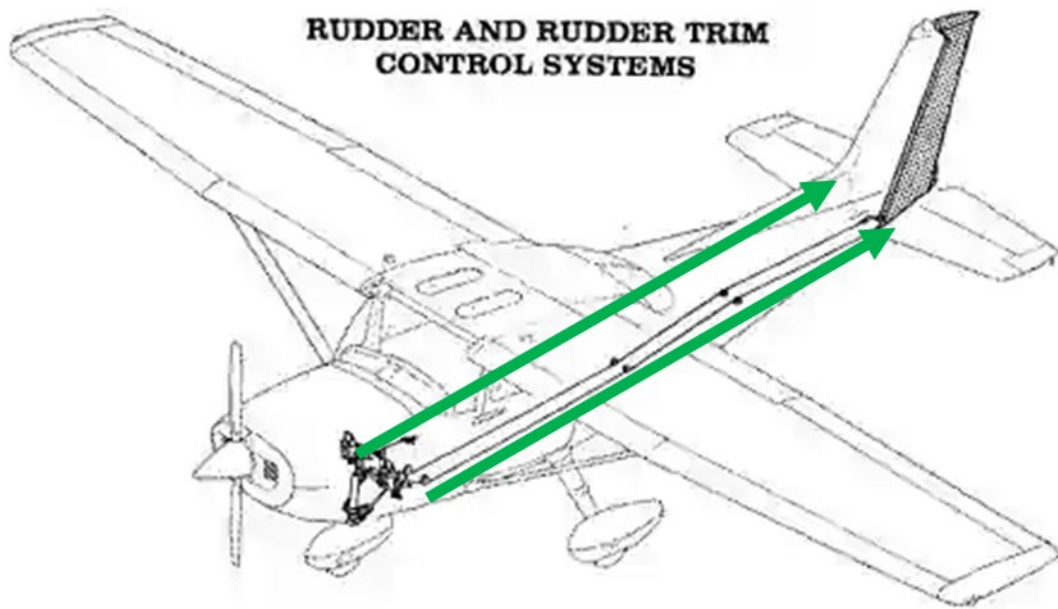
- Rudders- Control continuity was established.
  - From the rudder pedals to the rudder horn - yes
  - Damage, location of disconnect – None, no breaks in control cables.

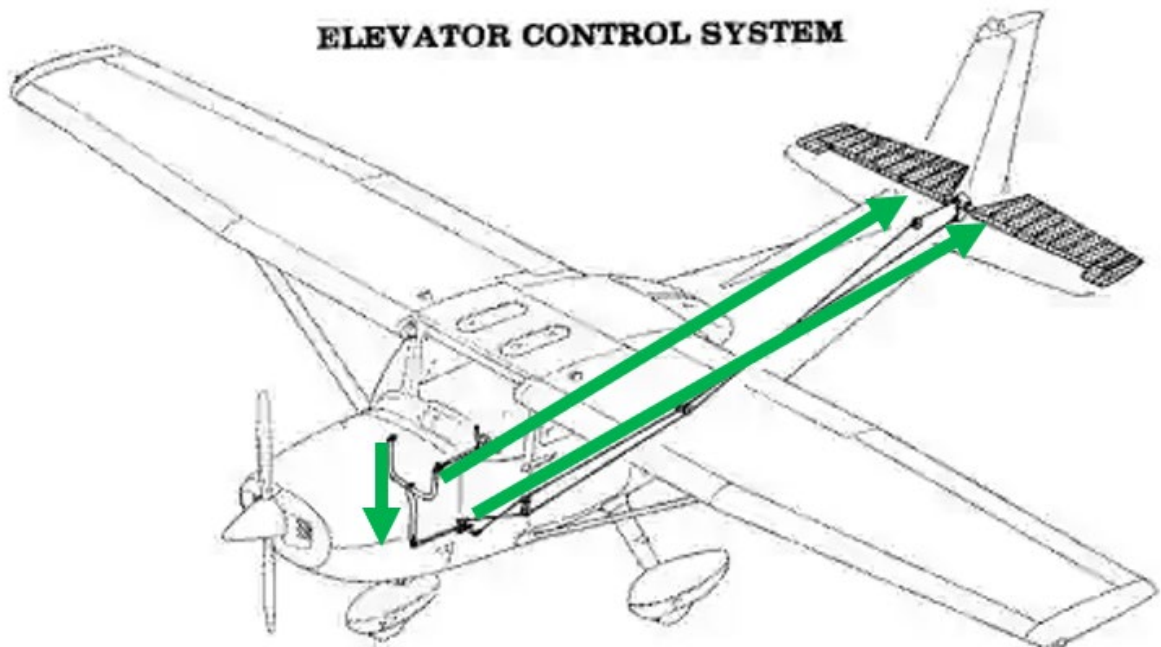
- Elevator – Control continuity was established.
  - In the control cables from the elevators to the elevator bell crank, to the control stick.
  - Damage, location of disconnect – None, no breaks in control cables and/or push/pull tube.

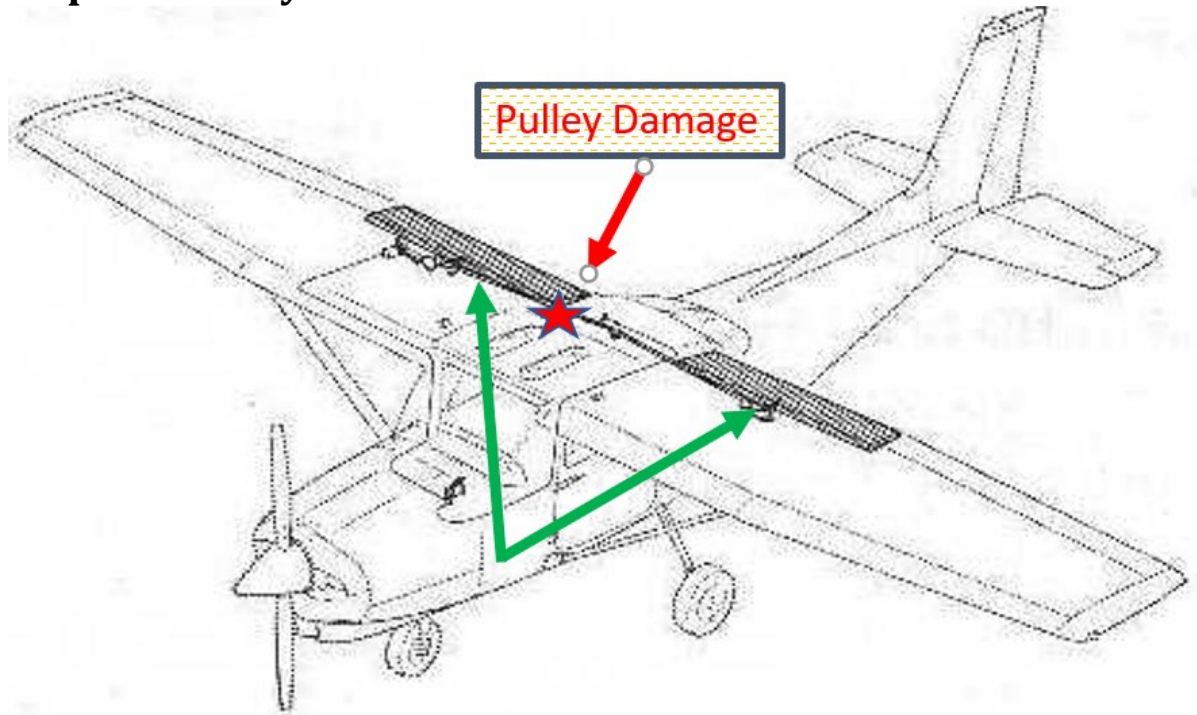
## Flap Control System

- Flaps
  - Flap handle was found in the full up position (flaps full down).
  - Control continuity was established.
    - From the flap handle to the push/pull tube rods in the wings and to the flaps.
    - One pulley attachment separated due to impact damage from wing.
    - Flap handle was in the up and locked position. Unable to release the lock to raise the flaps due to impact damage.

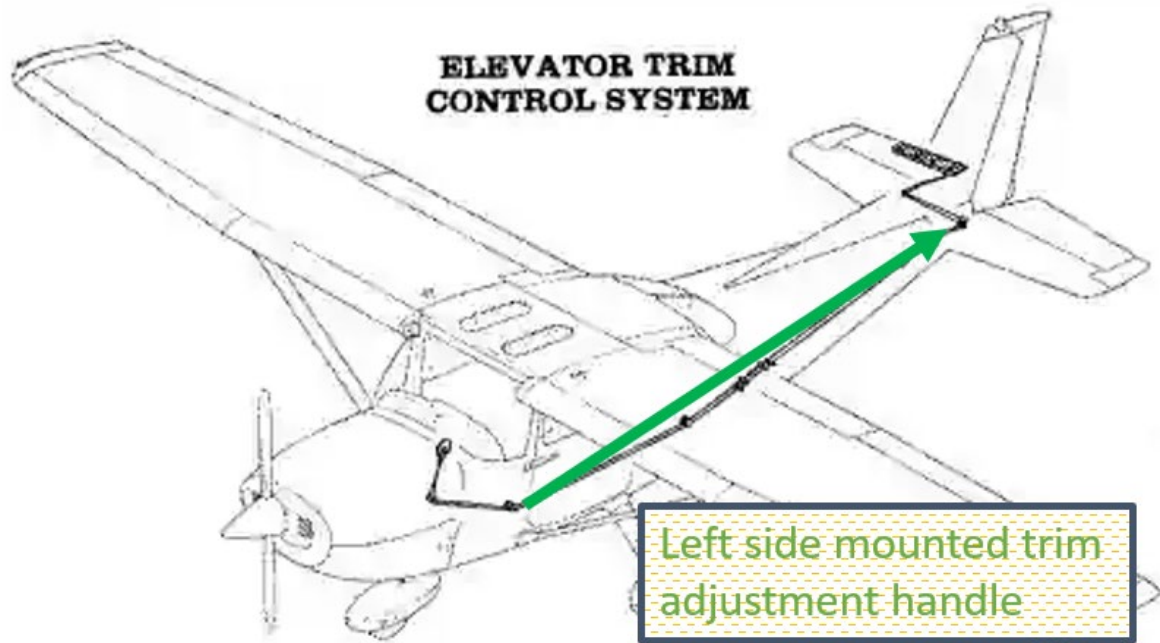
- Elevator trim
  - Control continuity was established.
  - In the control cables from cockpit handle to the stabilator elevator.
  - Damage, location of disconnect – No damage from trim handle to elevator.
