# NATIONAL TRANSPORTATION SAFETY BOARD

## MATERIALS LABORATORY FACTUAL REPORT

Report No. 22-036

Place : Bethel, Alaska  
Date : November 20, 2021  
Vehicle : Cessna 207  
NTSB No. : ANC22LA007  
Investigator : Mark Ward AS-ANC

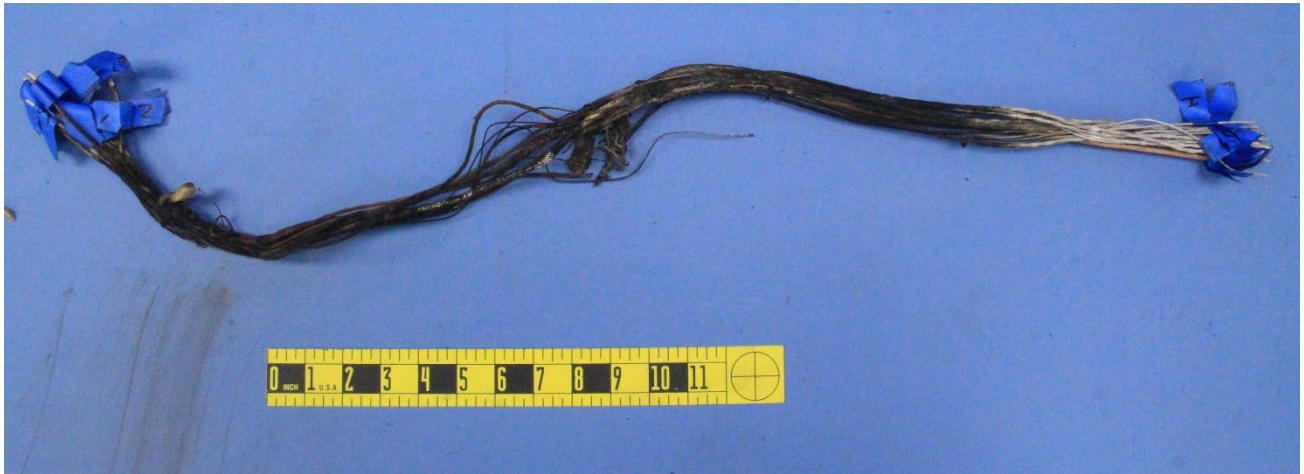
**Figure 1. Wire harness from accident aircraft.**

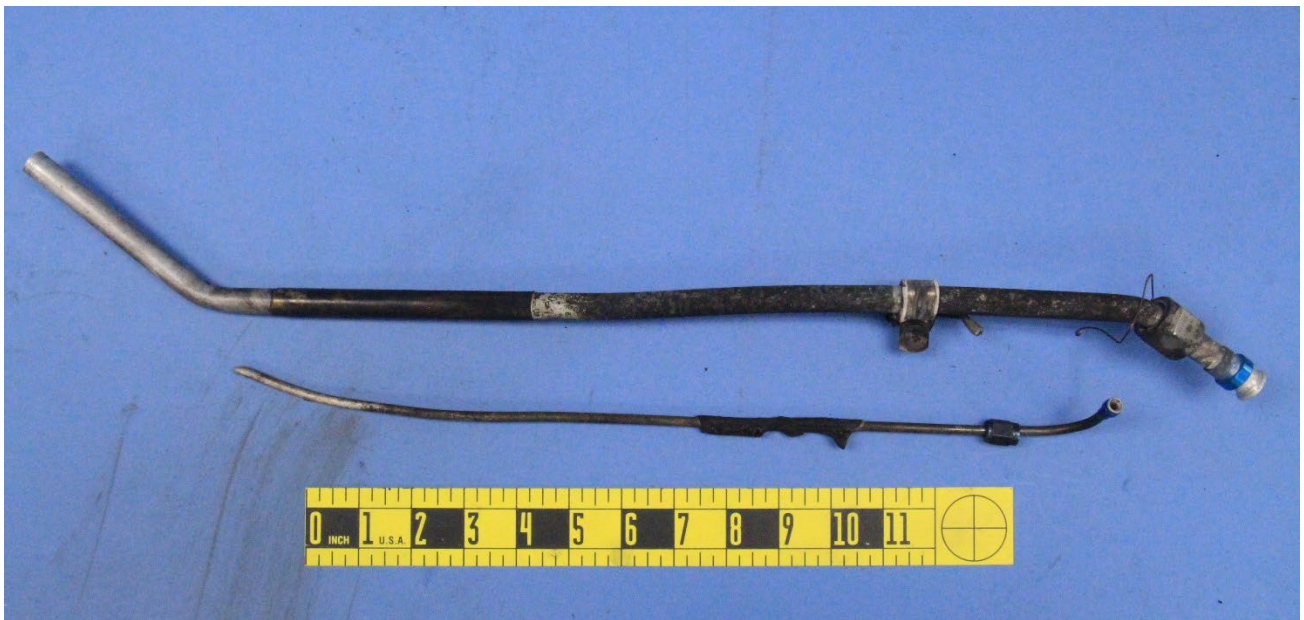
**Figure 2. Brake line and one section of fuel line from accident aircraft.**

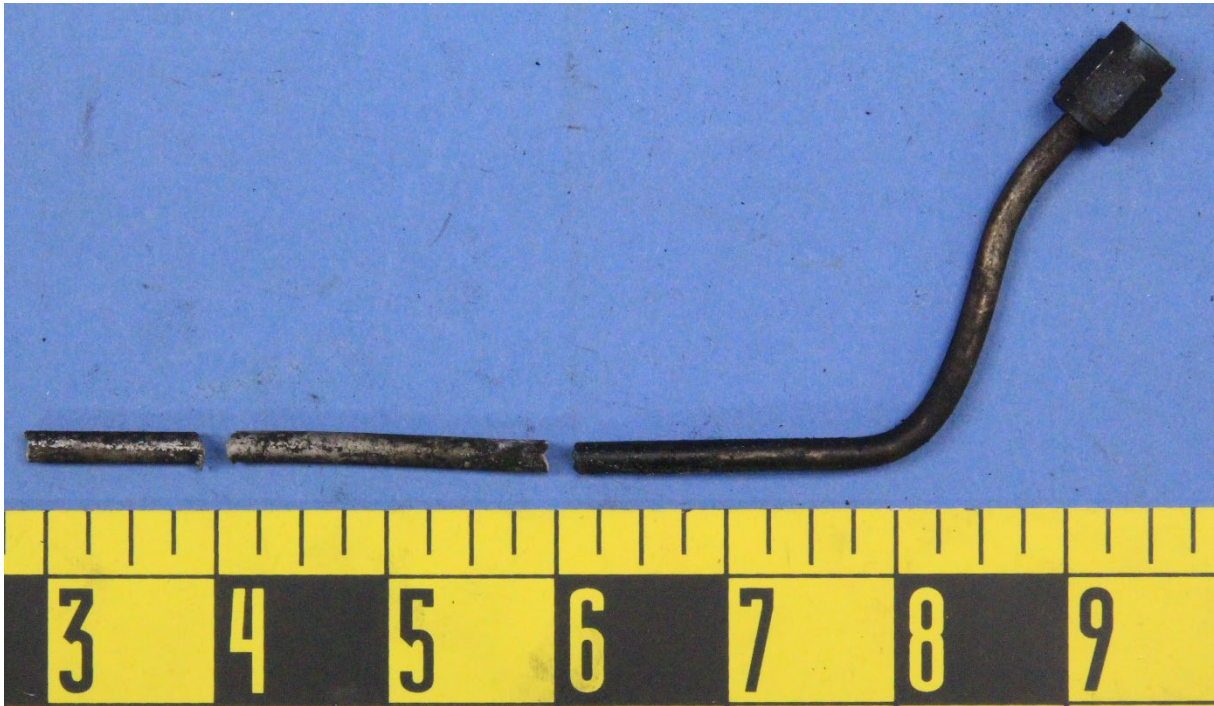
**Figure 3. Second section of fuel line from accident aircraft.**

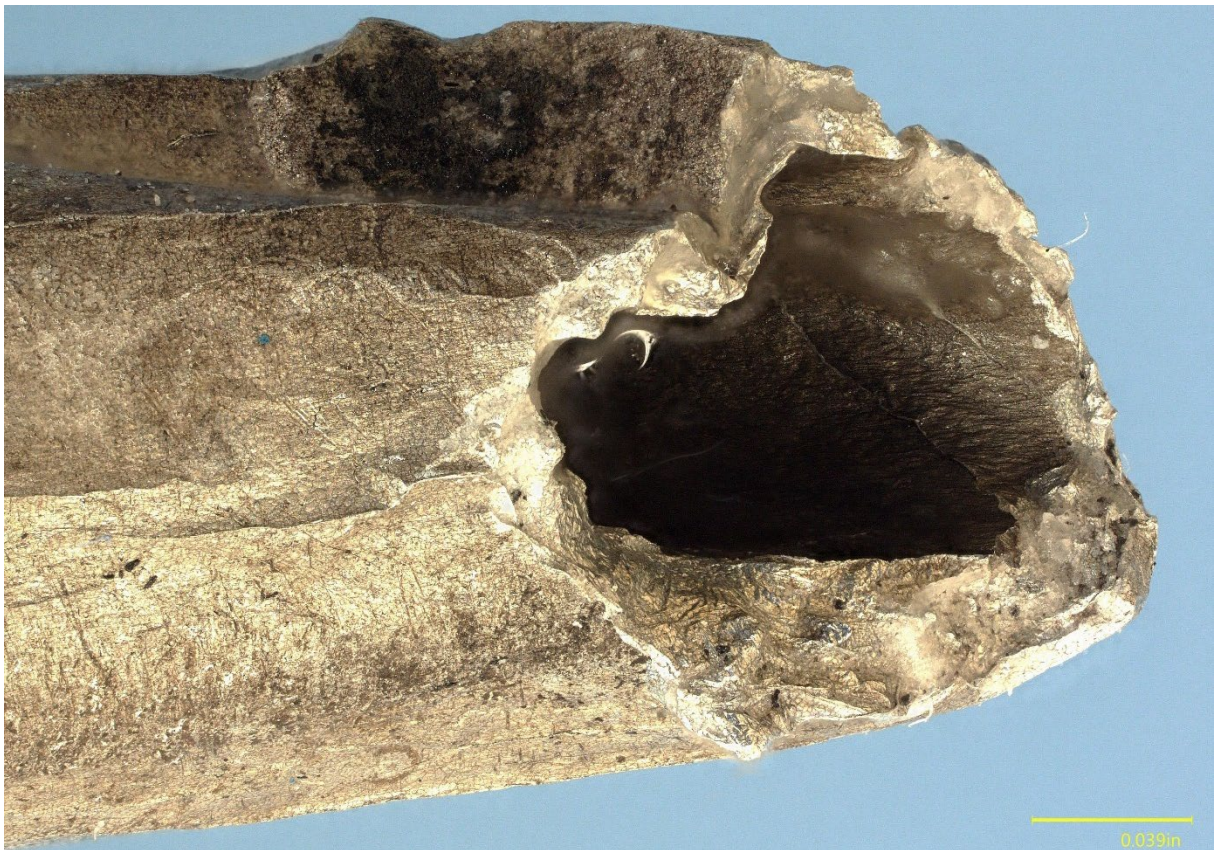
The fuel line was not intact. A section was missing and exhibited melting. The rest of the line also show signs of thermal exposure in the form of thermal fractures and sooting. The fuel line is shown in Figure 4. The damaged (melted) area of the fuel line was examined in a scanning electron microscope using energy-dispersive x-ray spectroscopy to determine if material transfer was present. No foreign material was found on the examined area.

**Figure 4. Closeup of thermal damage to end of fuel line section.**

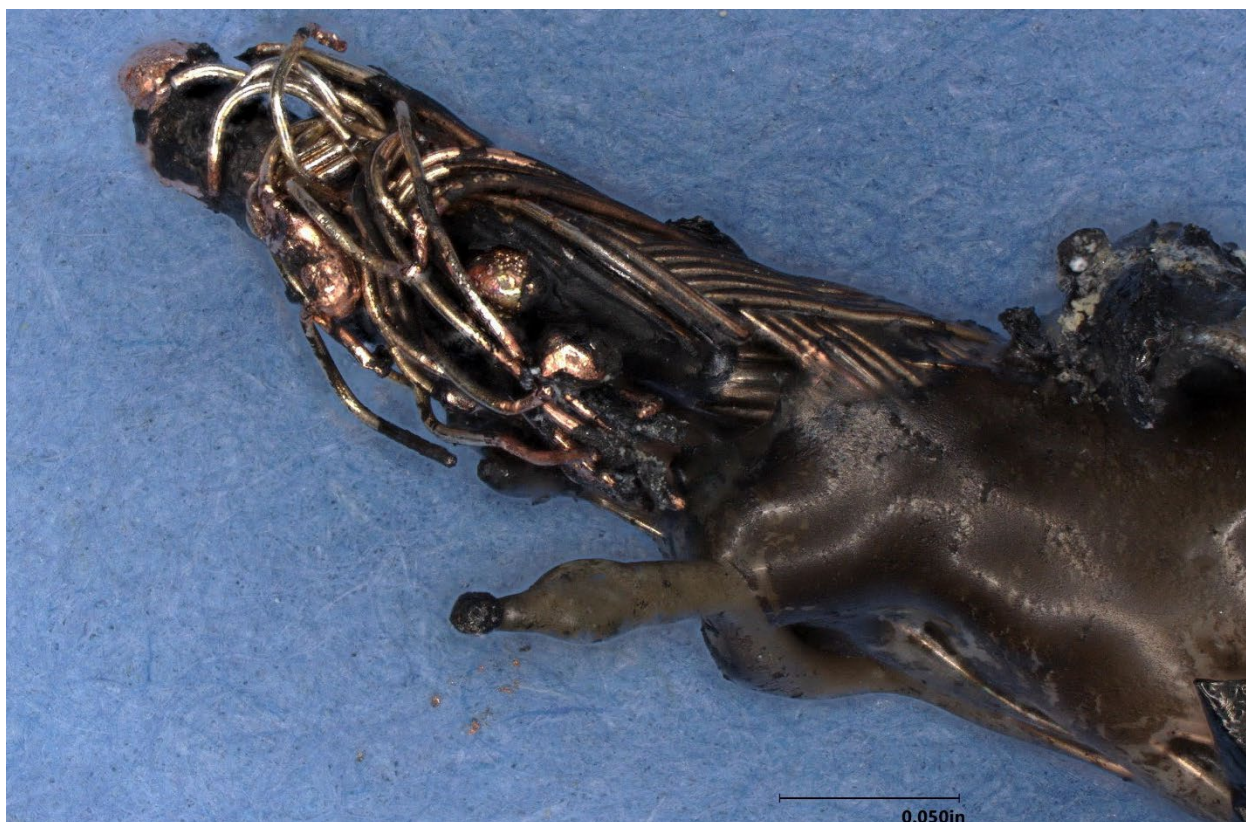
The submitted wire harness section was largely intact with most of the wire insulation in place except for one area near the center of the of the harness where the insulation was missing. The harness exhibited heavy sooting and thermal discoloration to the remaining wire insulation. In the area with the missing insulation, the bare wire conductors exhibited a range of thermal and electrical damage from thermal discoloration and sooting to beading and welding in areas on individual conductors. The electrical damage to several conductors is shown in Figures 5-8. This damage is consistent with the wire being energized at the time the damage occurred.

**Figure 5. Wire conductor with multiple beads on the end.**

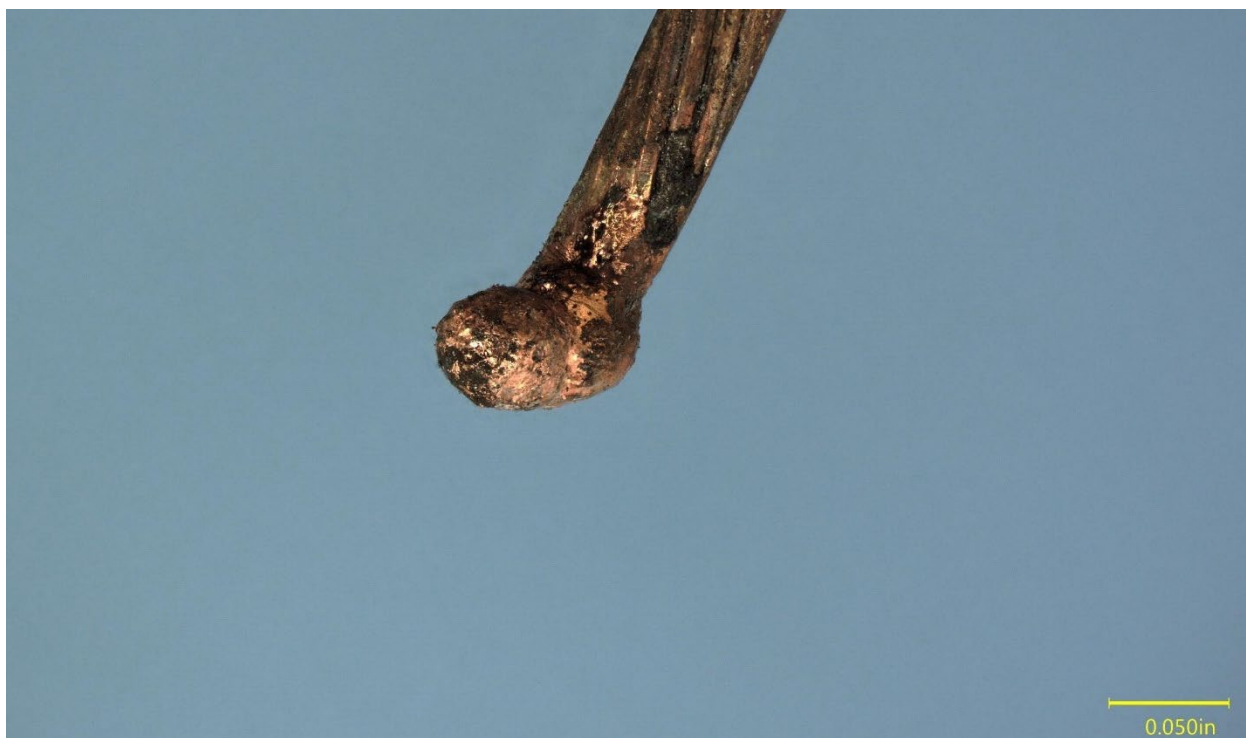
**Figure 6. Wire conductor with beading on the end.**

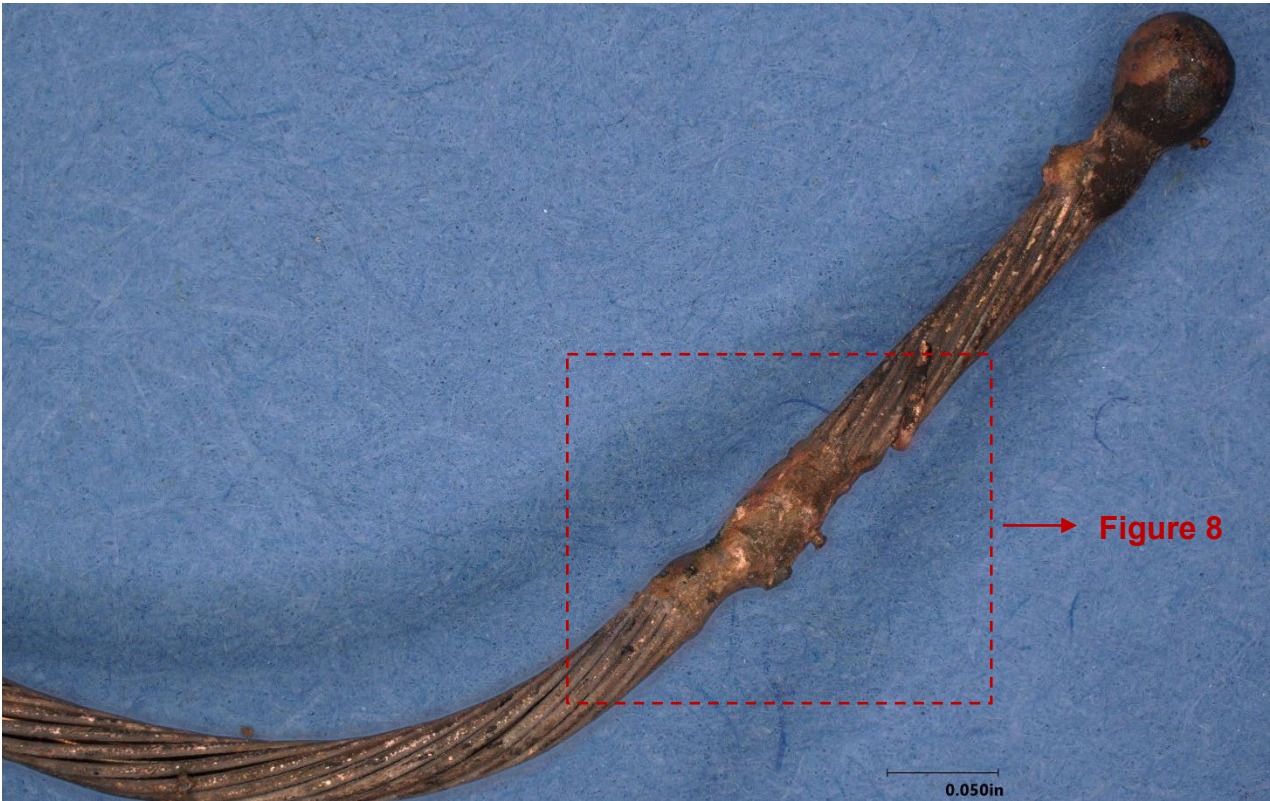
**Figure 7. Wire conductor with arcing, welding, and beading.**

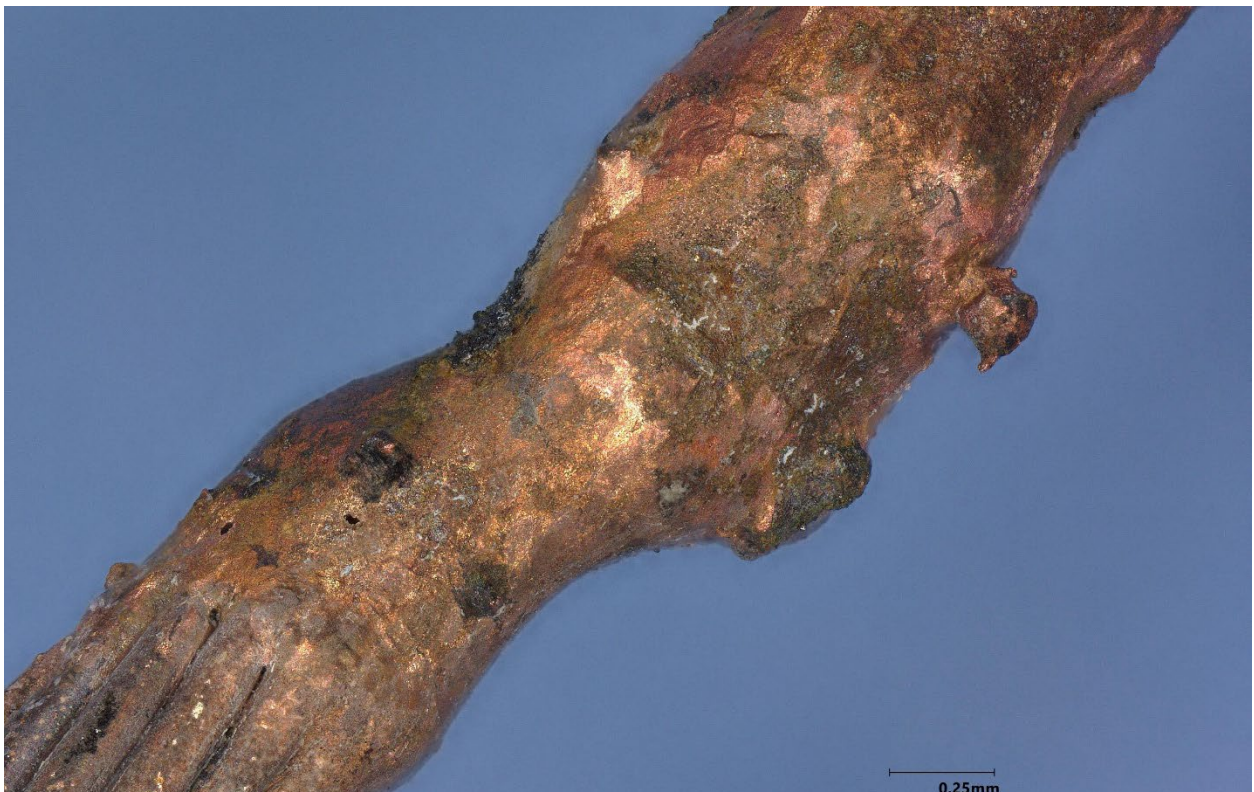
**Figure 8. Closeup of welded area on conductor in Figure 7.**
