U.S. Department  
of Transportation  
**Federal Aviation  
Administration**

**SUBJECT: Notification Letter for Wiring Issue STC2154AK**

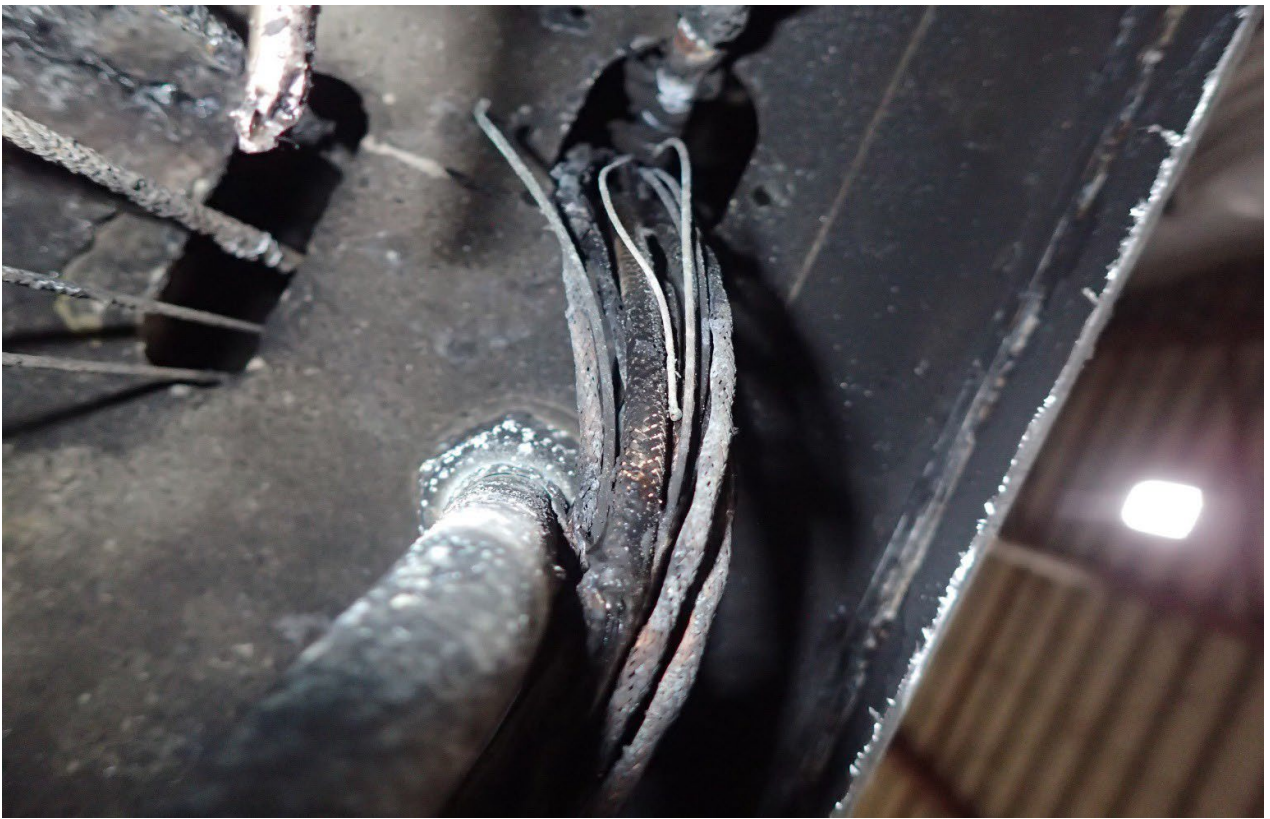
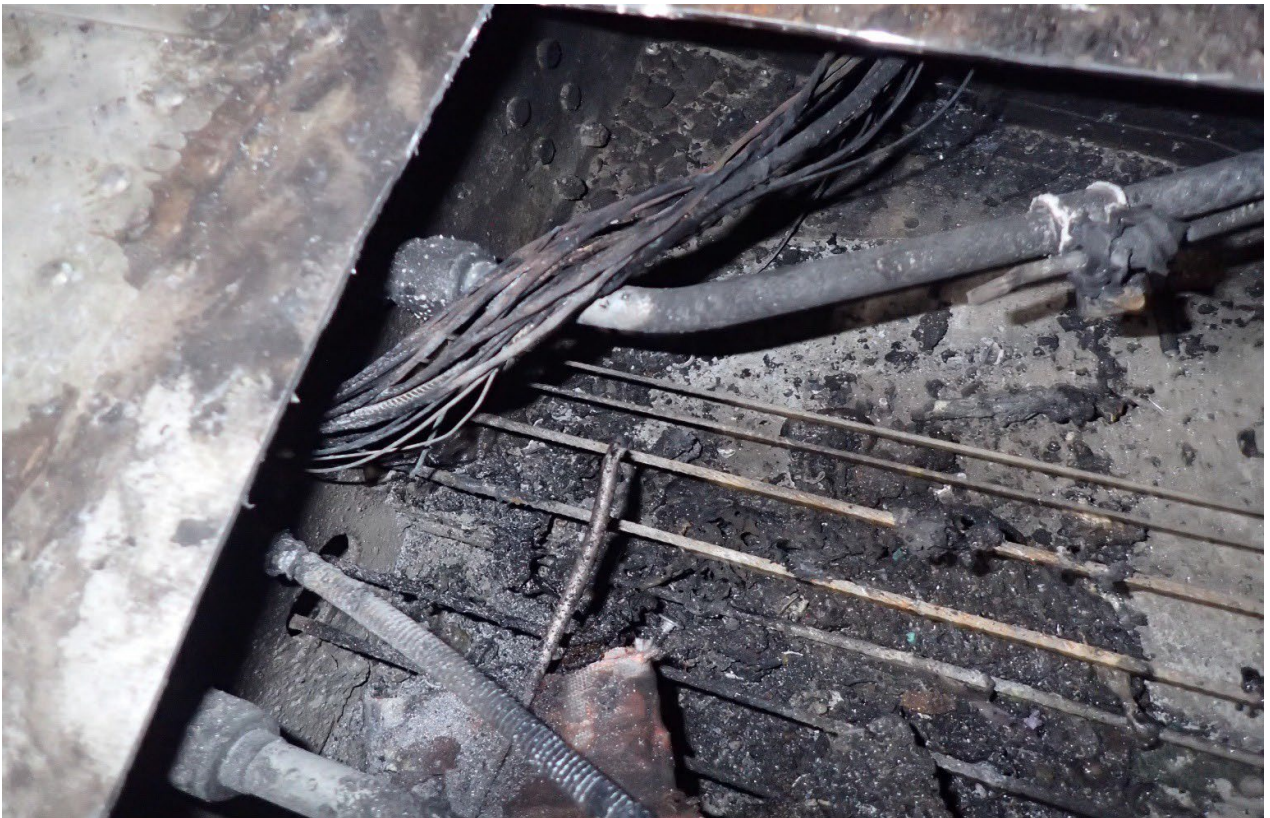
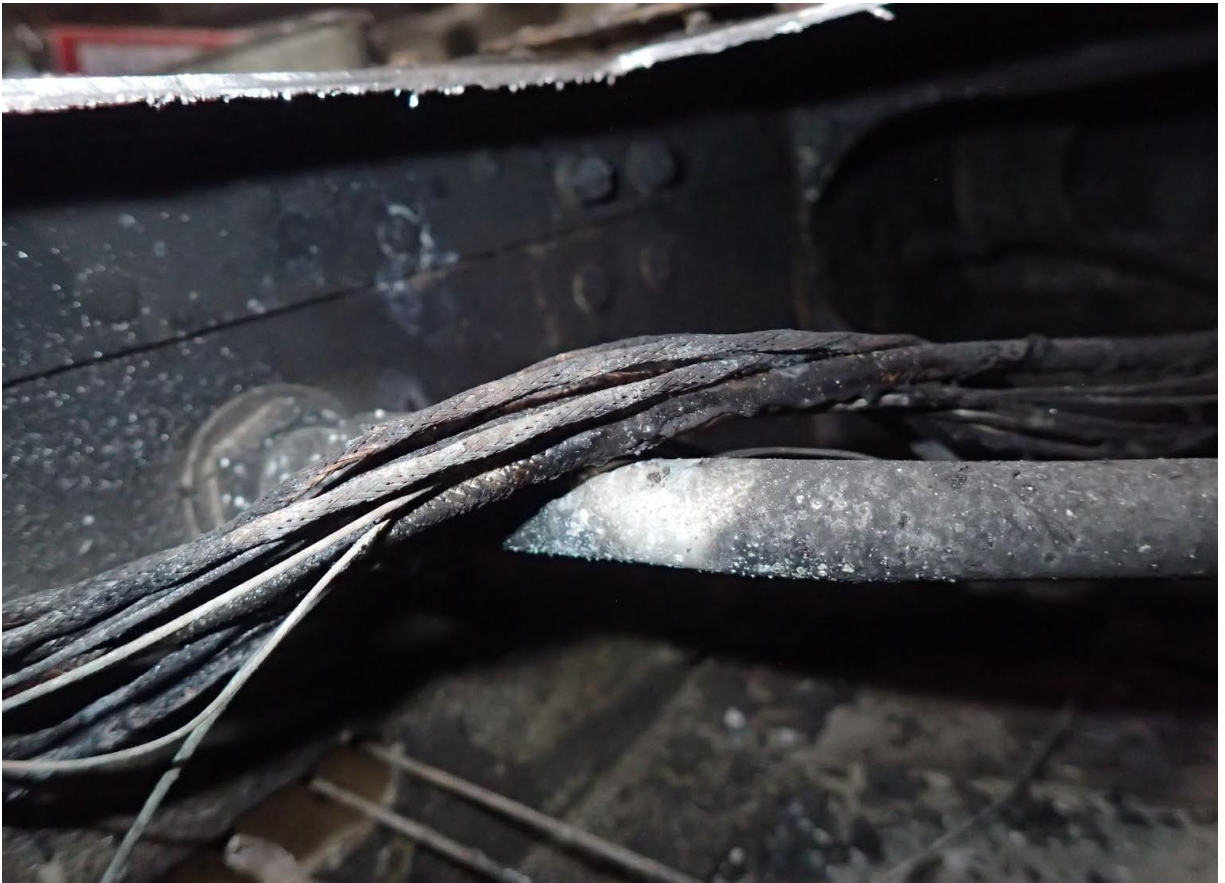
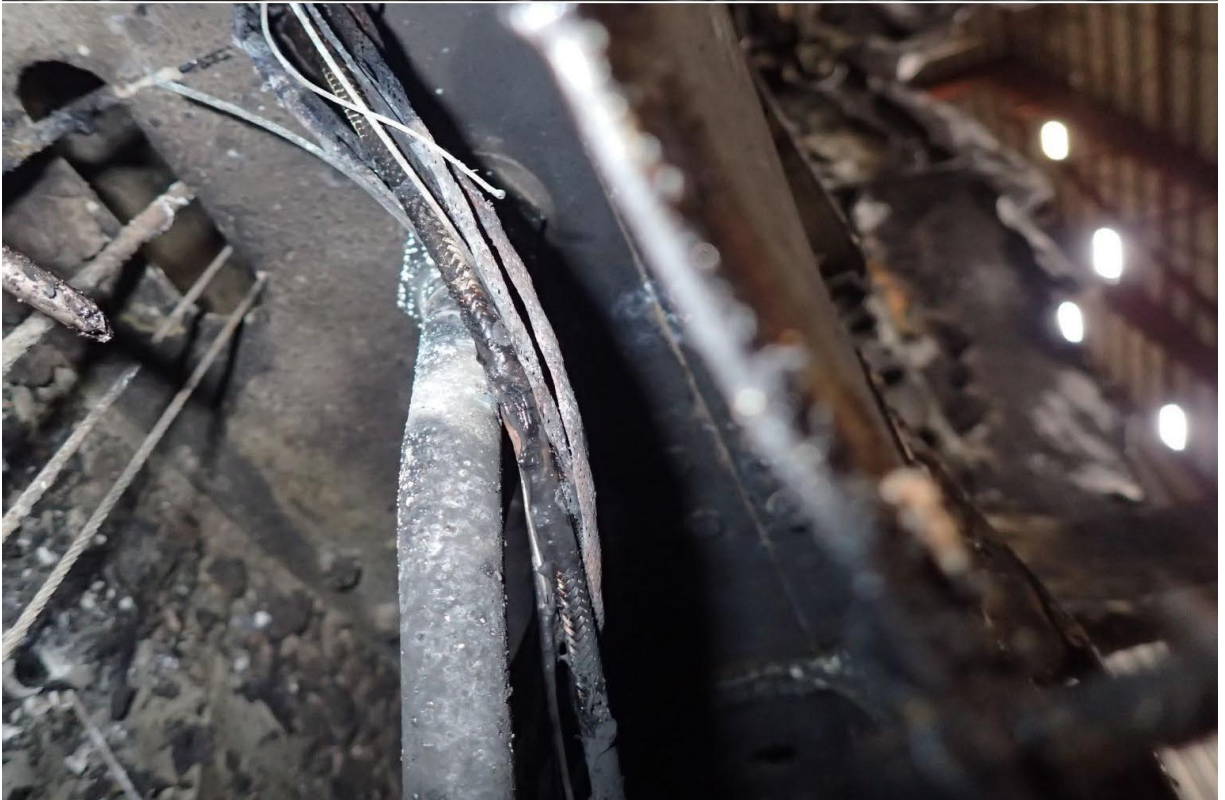
Photos attached below.

The purpose of this letter is to inform registered aircraft owners and operators of the need to inspect the area inside inspection panels from the rear door frame forward under the pilots and passengers floorboards at the next maintenance function, 100 hour, or Annual. Emphasis should be the wires in proximity to the fuel line passing through this area. The accident aircraft had wires secured across the fuel line that appear to have chaffed and caused arcing and a hole in the fuel line.

The accident aircraft that experienced the in-flight fire was a Cessna 207 operated in Alaska. It appears to have been caused by chafing of the CAPSTONE phase 1 equipment wiring due to not being secured correctly in the wire bundle. The investigation is ongoing and the root cause of this situation has not been determined. However, the preliminary information indicated that the fire could have been avoided if good wiring installation practices had been used. The original CAPSTONE equipment had been removed but the wiring remained and was reused for other equipment.
