# National Transportation Safety Board

ANC22LA007

## WRECKAGE EXAMINATION

Airplane: Cessna 207A

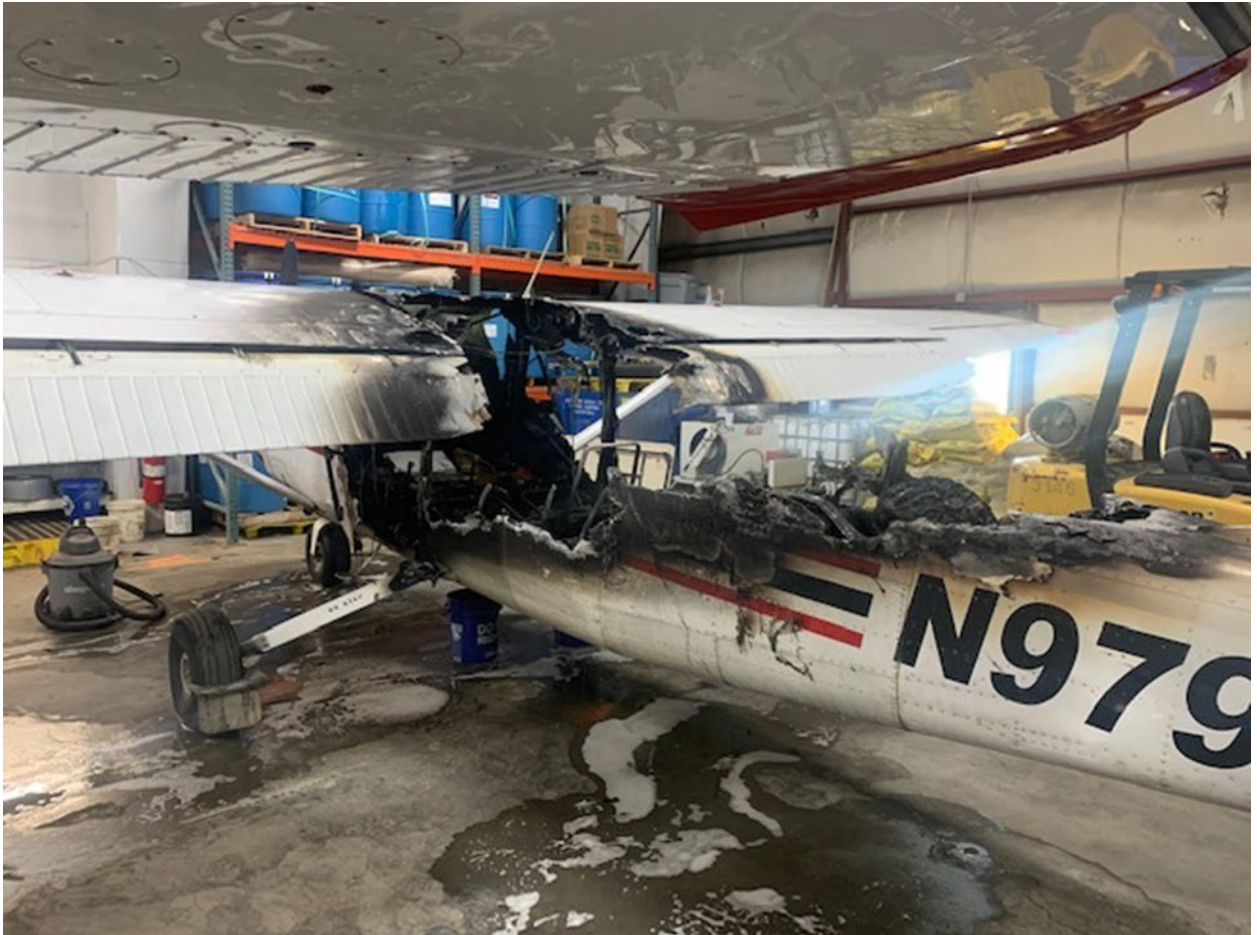
Figure 1View of left side of accident airplane.

- Pilot location - Left.
- Passenger location- all 5 seats occupied.
- Type of seat belts used- 3 point in front, lap in rear.
- Cargo- food, ATV tire and passenger baggage.
- Damage.
  - Extensive fire damage to cabin area. From instrument panel to behind cargo area.

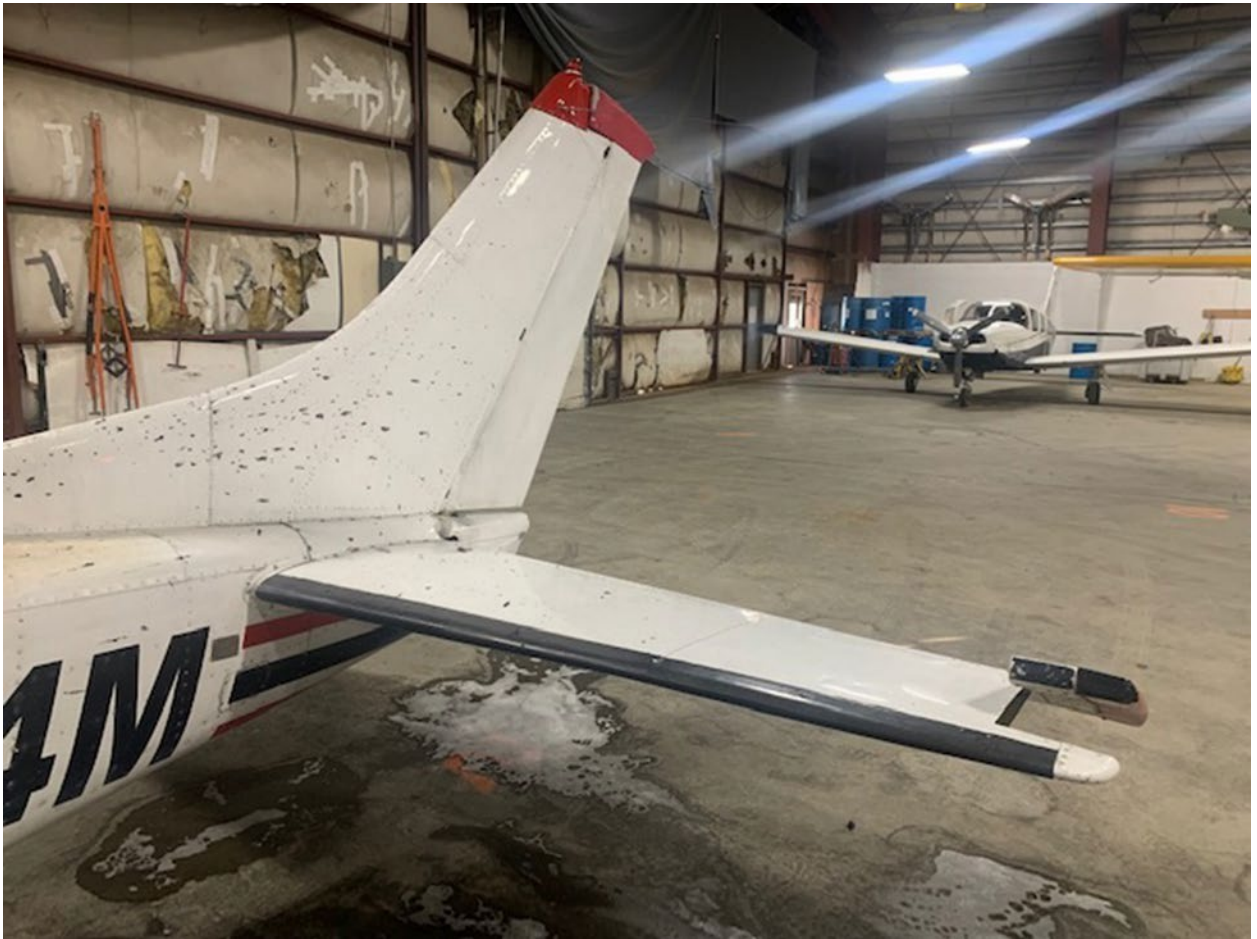
**Figure 2 Empennage of accident airplane.**

- The empennage condition- Undamaged
- The right horizontal stabilator
  - Attached to its respective attach points. Yes
  - Condition/Damage – No damage noted.
- The right elevator
  - Attached to its respective attach points. Yes
  - Condition/Damage – No damage noted.
- The vertical stabilizer.
  - Attached to its respective attach points. Yes
  - Condition/Damage- No Damage noted.
- The rudder
  - Attached to its respective attach points. Yes
  - Condition/Damage – No damage noted.
- The nose wheel –
  - Attached to its respective attach points. Yes

- Damage – No damage noted.
- The left horizontal stabilator
  - Attached to its respective attach points. Yes
  - Damage – No damage noted.
- Left elevator
  - Attached to its respective attach points. Yes
  - Damage – No damage noted.

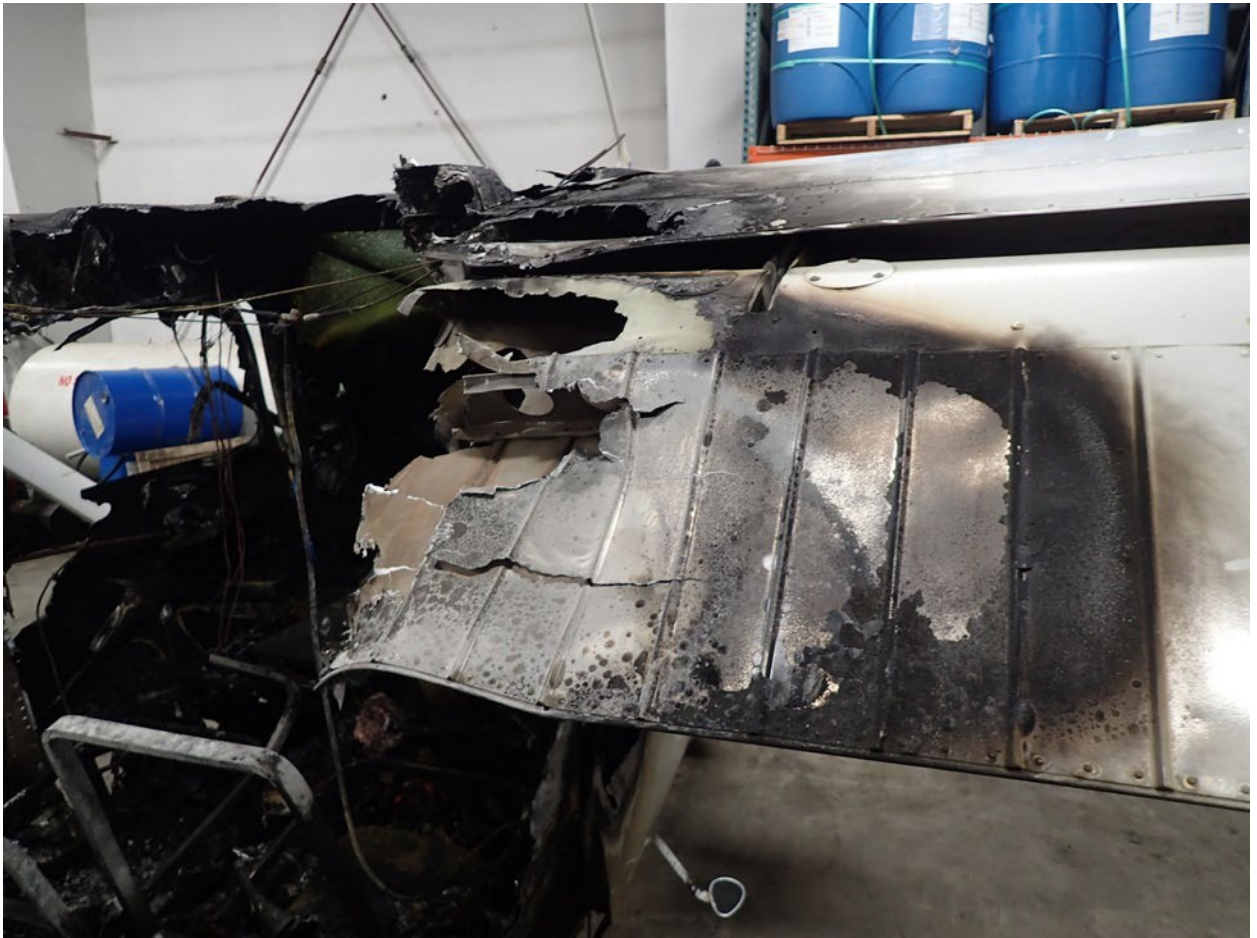
**Figure 3 Right wing root of accident airplane.**

- Overall –Extensive fire damage from inboard to about 30 inches out. Majority of damage at the rear of the wing.
- Leading edge
  - Condition/Damage- No damage noted.
- The right aileron
  - Attached to its respective attach points. Yes

- Condition/Damage – No damage noted.
- The right flap
  - Attached to its respective attach points. Yes
  - Condition/Damage – Extensive fire damage about 30 inches out from the inboard location.
- Fuel – Cap on and tight, Yes
- Wing attachment to fuselage. Yes

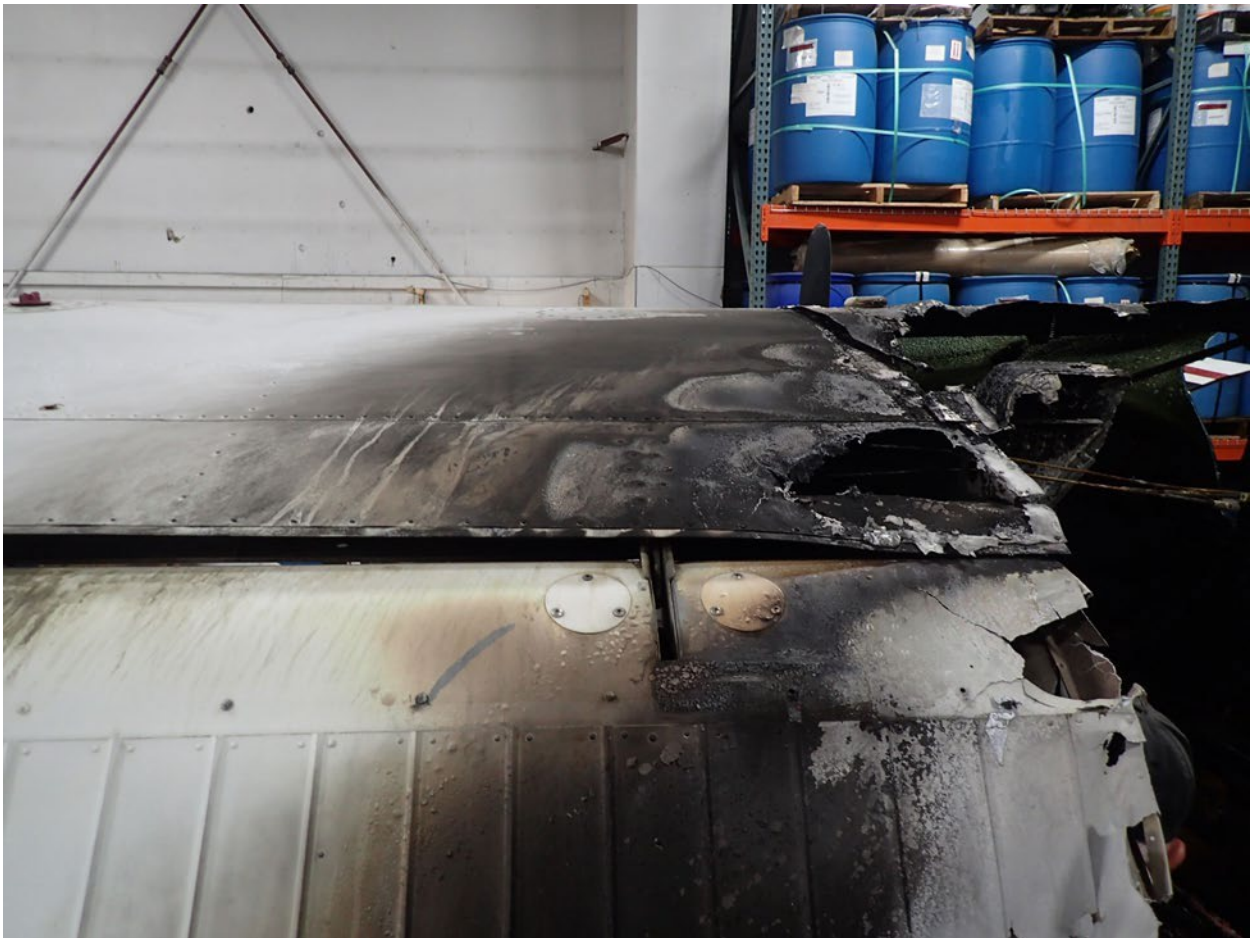
**Figure 4 Left wing root of accident airplane.**

- Overall- Extensive fire damage from inboard to about 30 inches out. Majority of damage at the rear of the wing.
- Leading edge
  - Condition/Damage – No damage noted.
- The left aileron
  - Attached to its respective attach points. Yes
  - Condition/Damage – No damage noted.
- The left flap

- Attached to its respective attach points. Yes
  - Condition/Damage – Extensive fire damage about 30 inches out from the inboard location.
- Fuel -Cap on and tight. Yes
- Wing attachment to fuselage - Yes

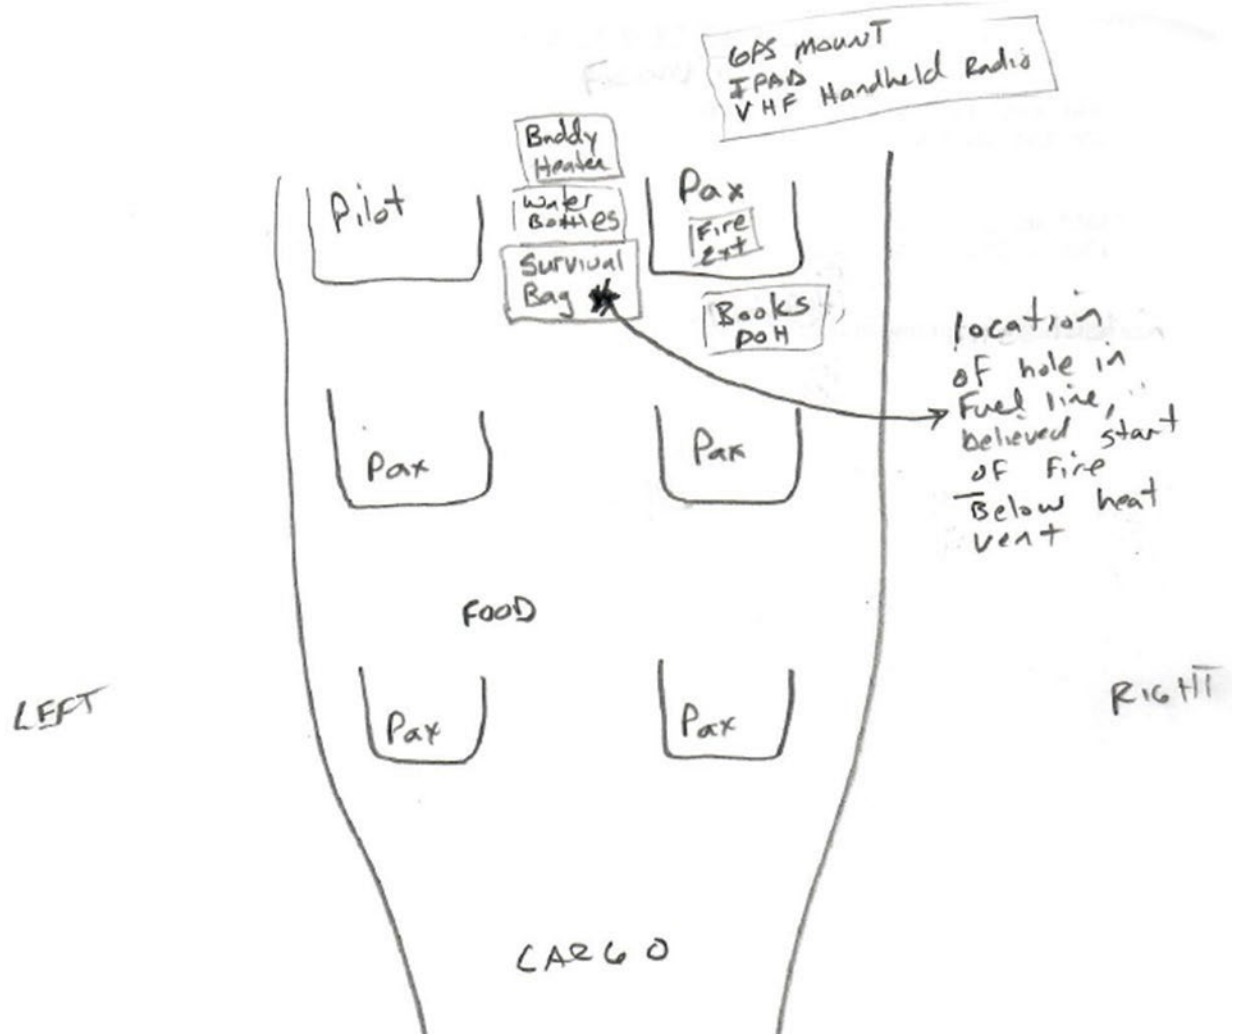
Figure 5 Location of items found in accident airplane.

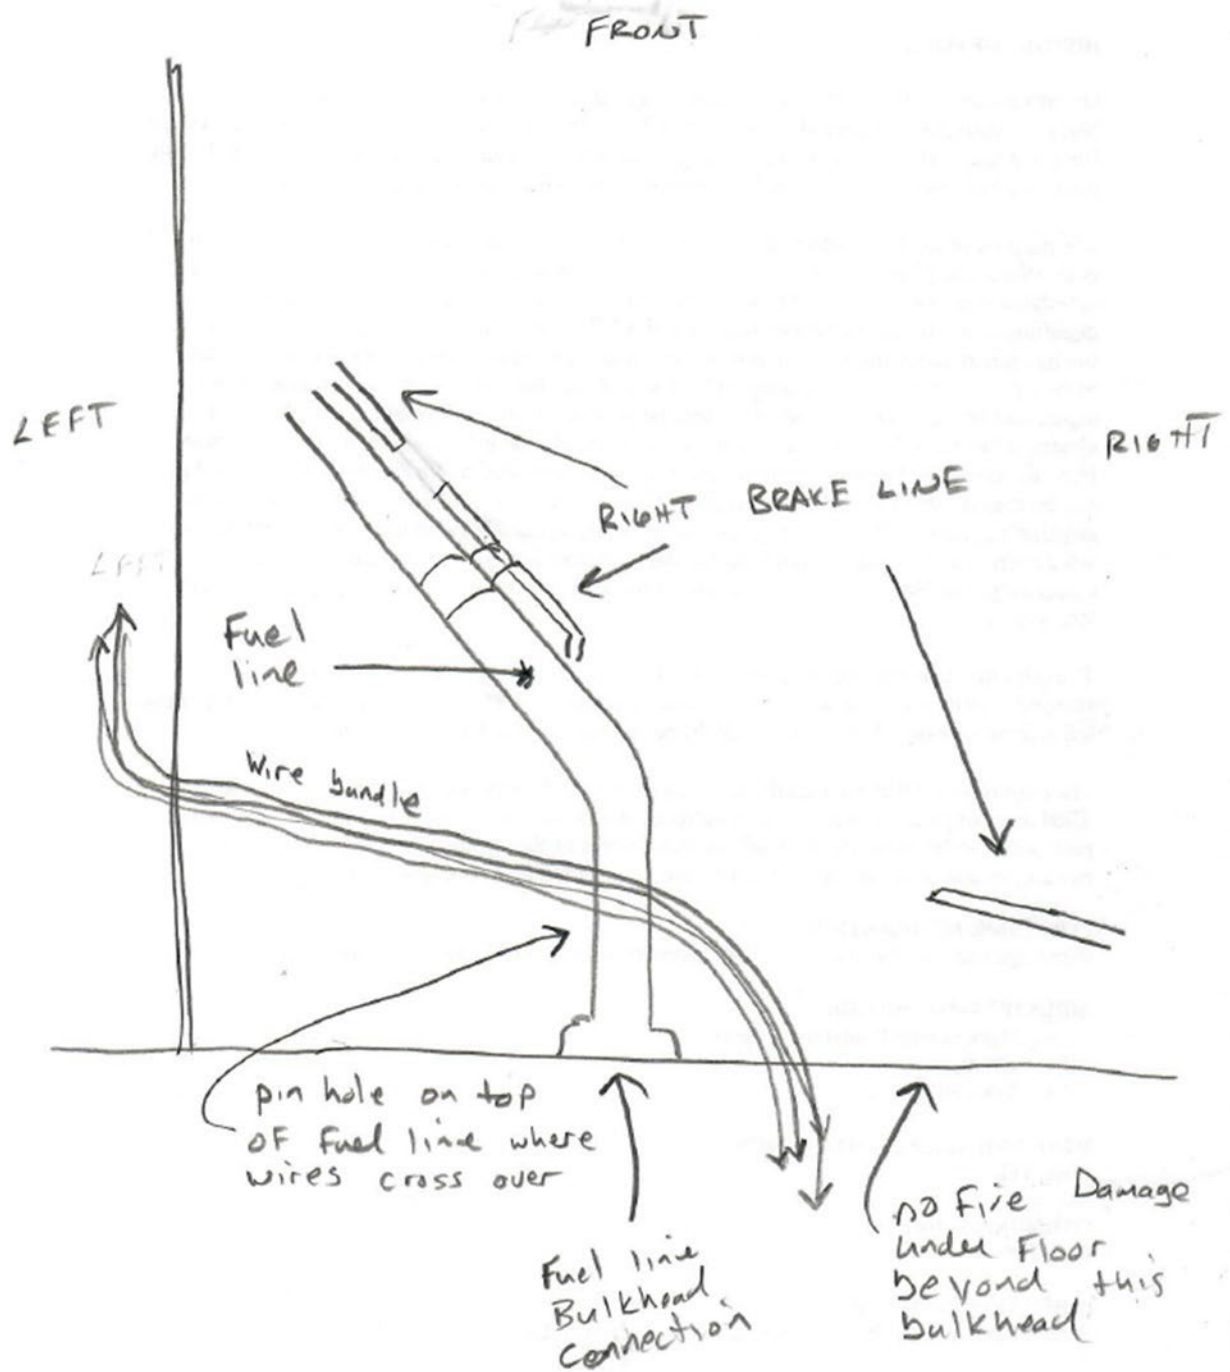
Figure 6 Location of ignition point in accident airplane.

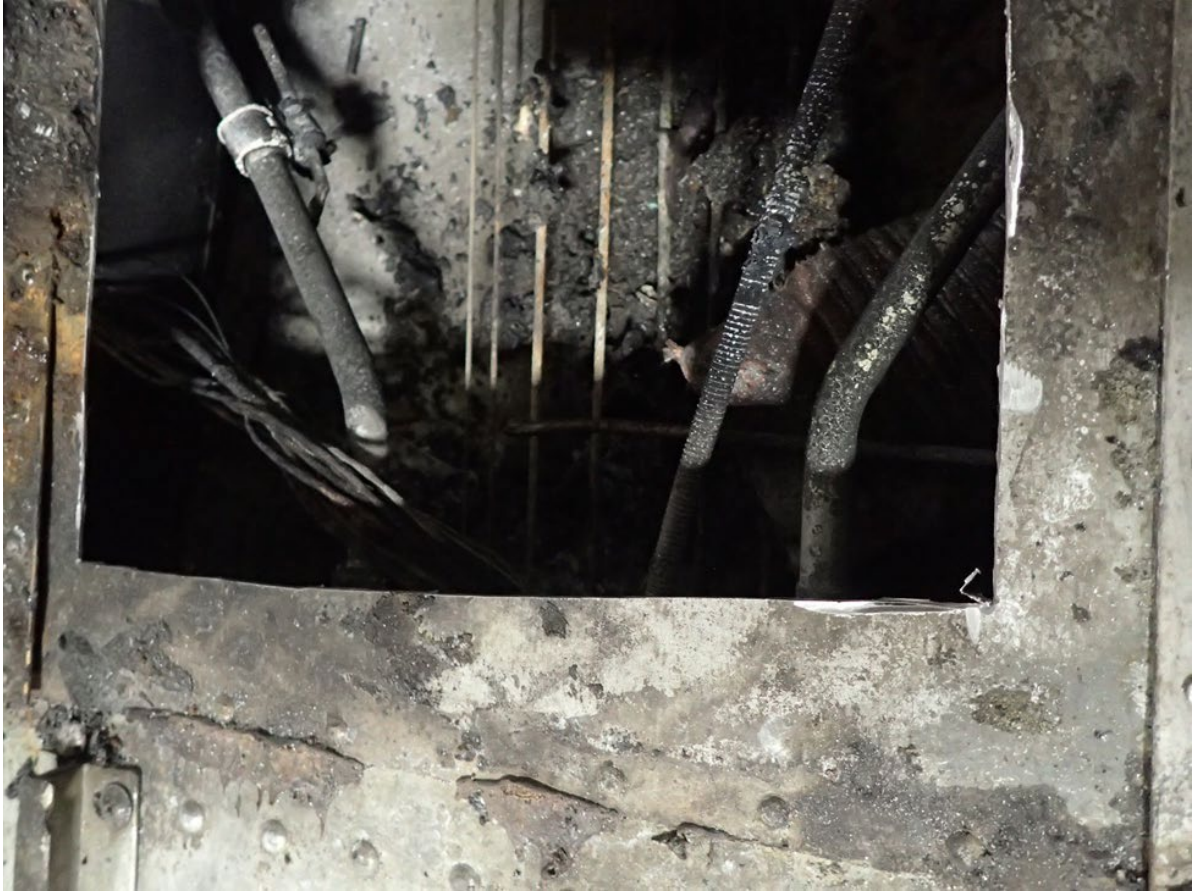
**Figure 7 Overhead view of ignition point in fuselage.**

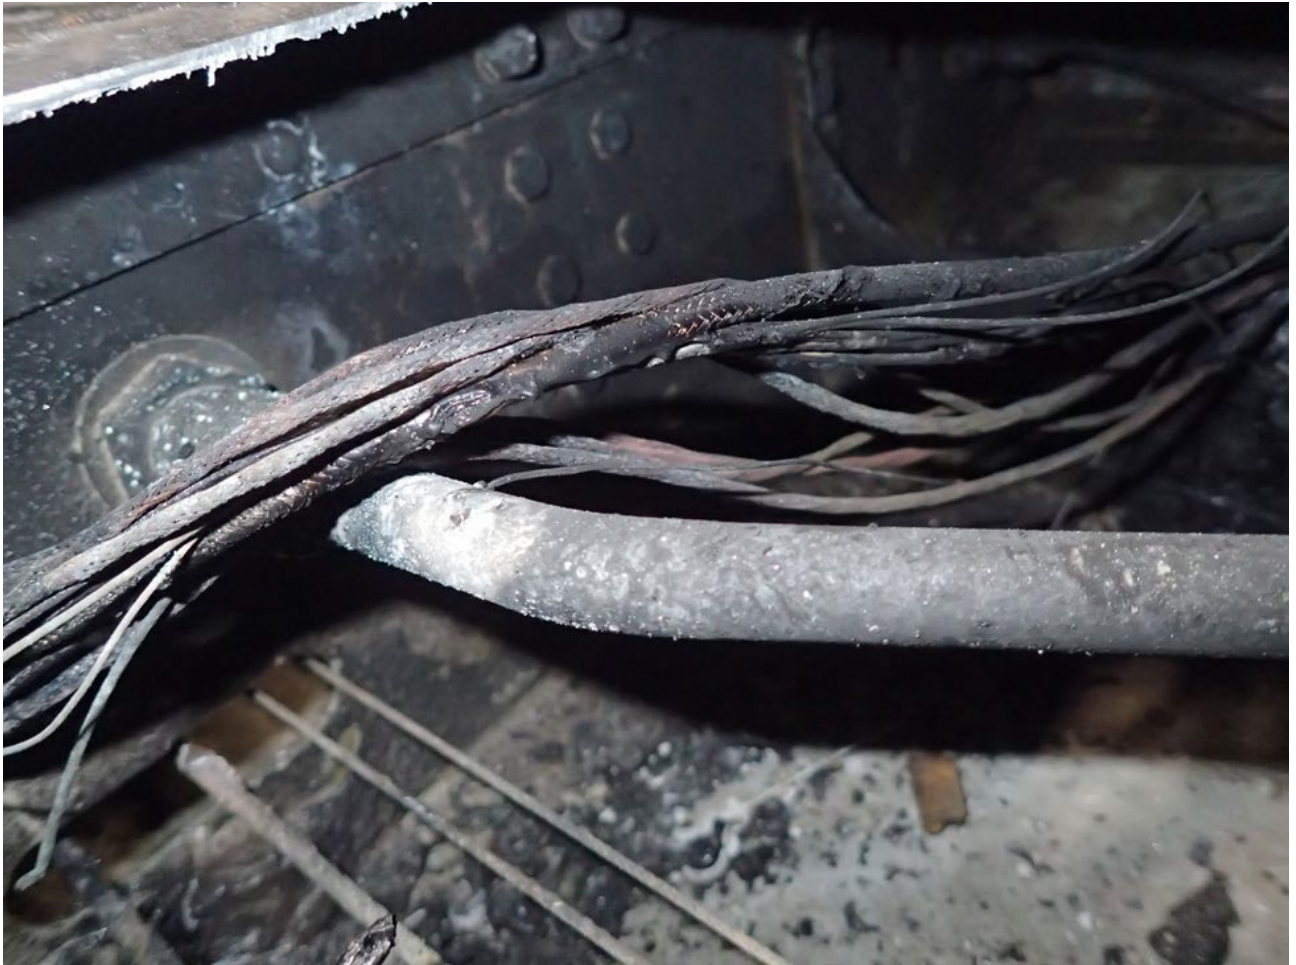
**Figure 8 View of wire bundle crossing over fuel line.**
