## **Examination Summary**

NTSB ACCIDENT NUMBER: ANC22LA020

AIRCRAFT REGISTRATION/AIRCRAFT TYPE: N99640, PA-18-135

### Post-Accident Examination Summary

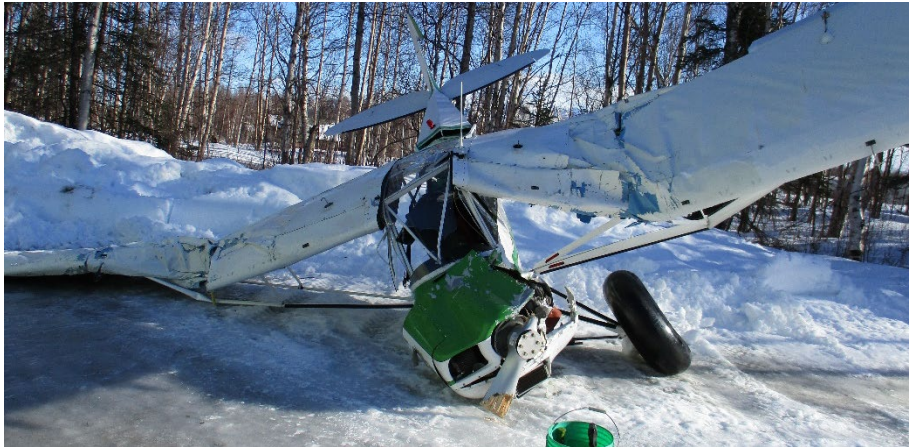
*Photo 1: Airplane*

The wings exhibited extensive impact damage. The fuselage displayed damage at the wing attachment points and was slightly twisted. The empennage was relatively undamaged. Control continuity was established from the cockpit to the rudder and elevator. Control continuity was not established from the cockpit to the ailerons due to impact damage.

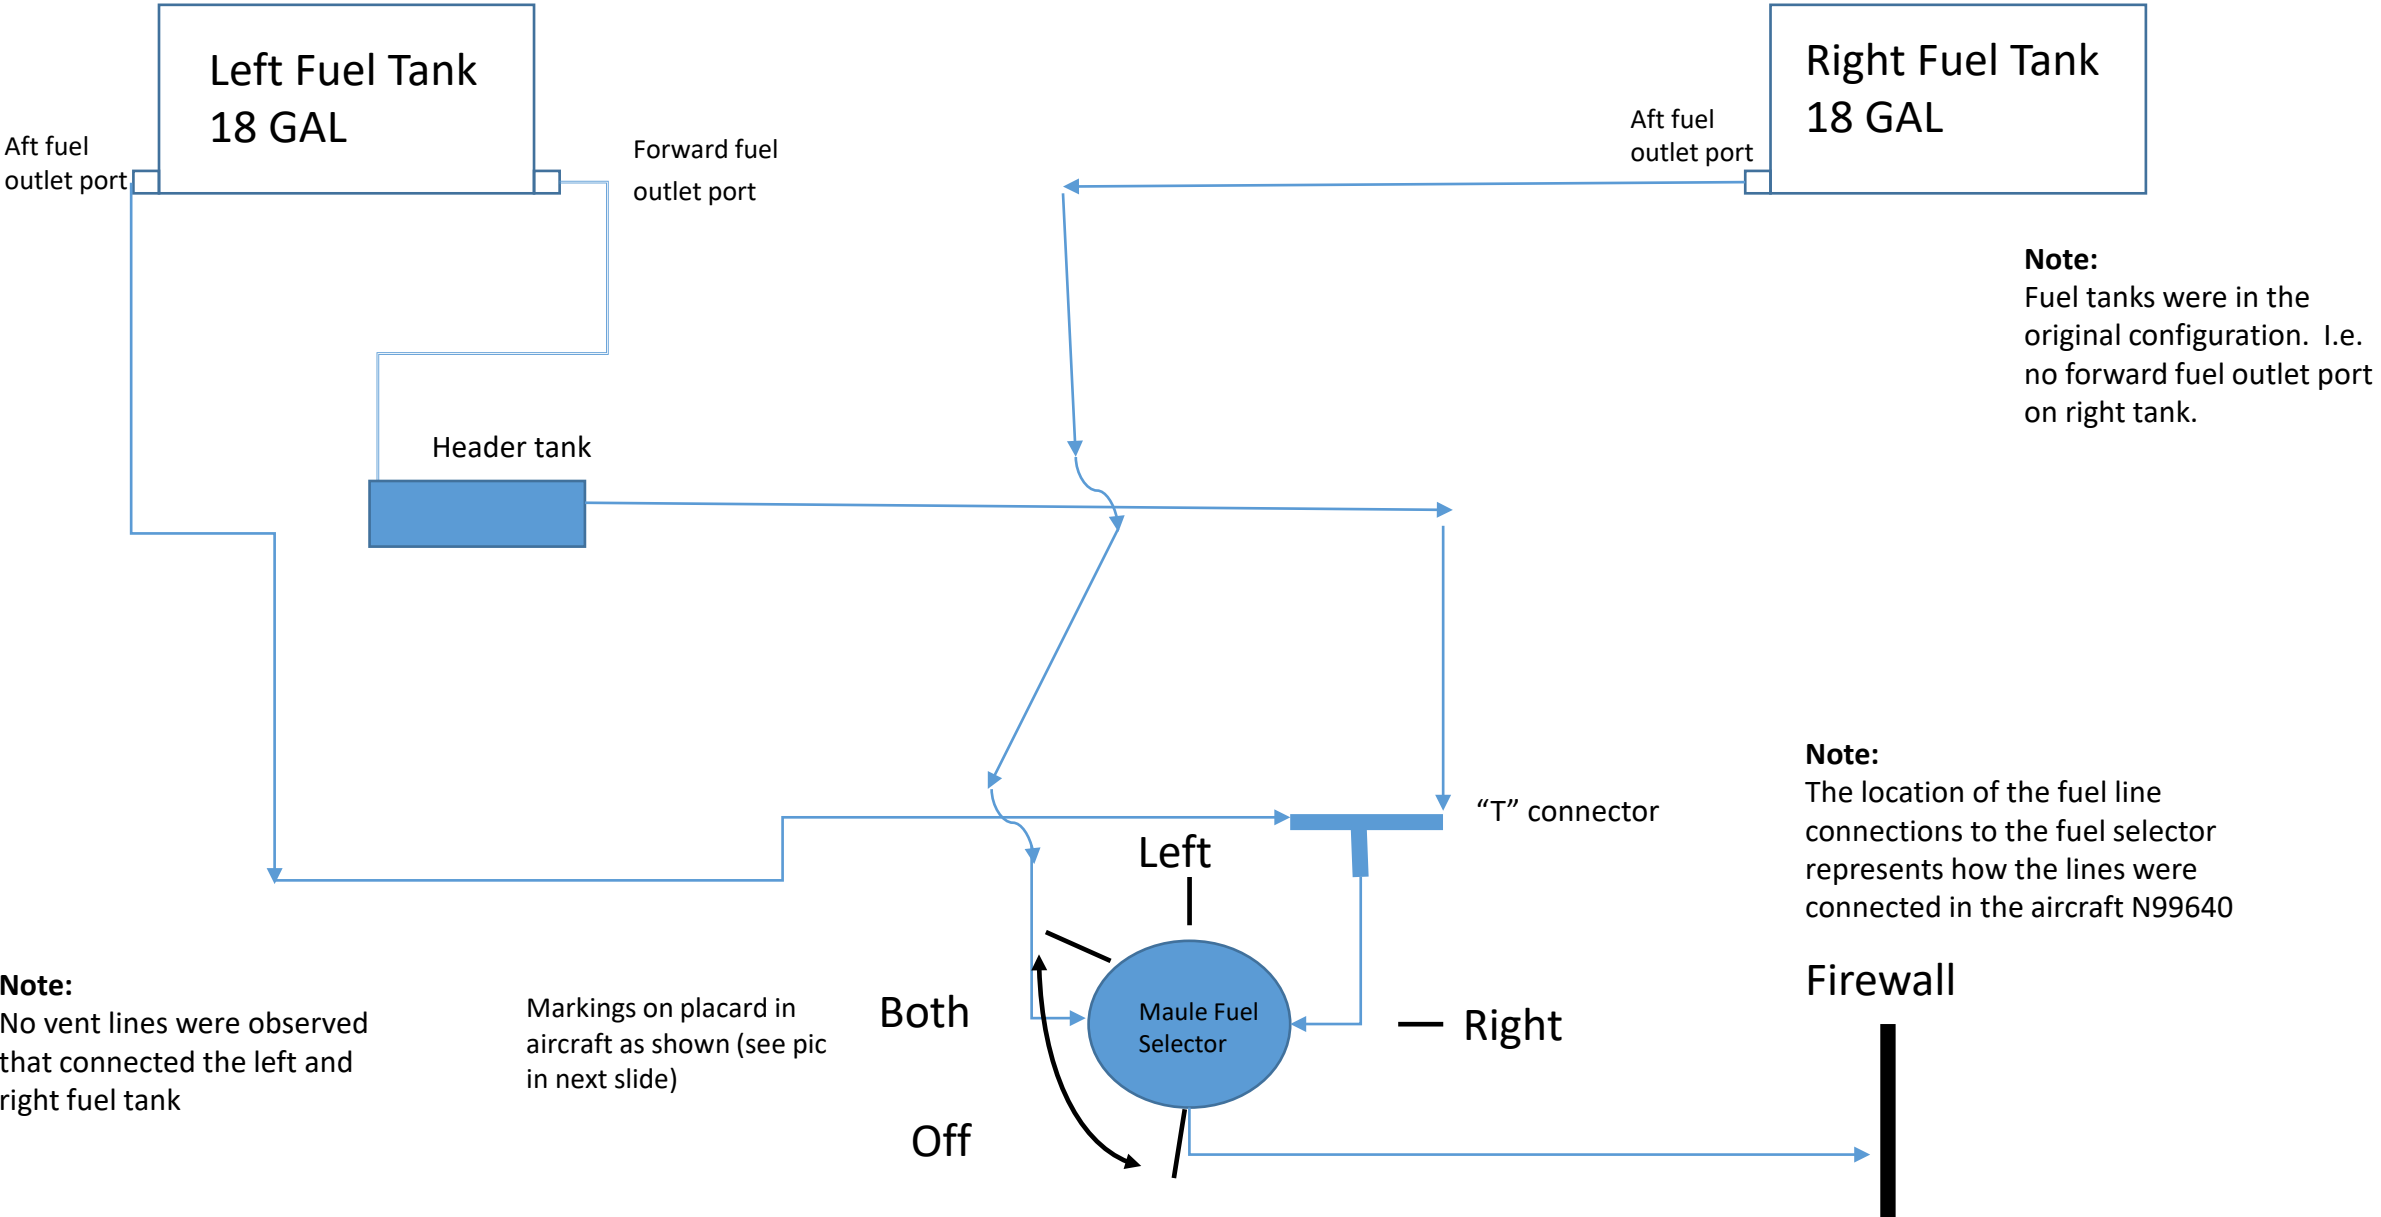
# N99640

According to the pilot the fuel system had been modified. The rear header tank had been removed due to the installation of a 4 position Maule fuel selector. The front header tank remained and was connected to the left fuel system. A very positive "click" was noted as the fuel selector handle was rotated through the various positions. Both the right and left fuel systems were checked for signs of blockage on 03/18/2022. No indications of blockage were noted to include the finger screen in each wing tank.

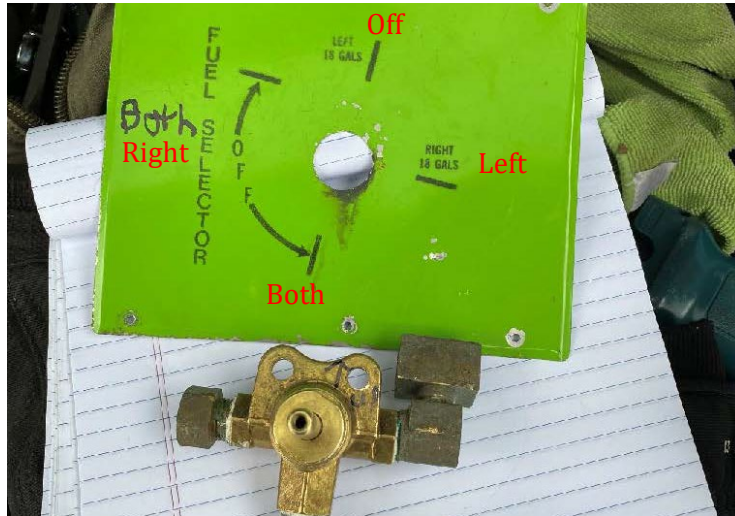
*Photo 2: Fuel Selector Valve*

During an examination of the fuel selector on 03/15/2022 it was determined that the valve worked correctly. However, all placarding for the fuel selector was incorrect. **Placarded "Both" was actually Right, "Left" was actually Off, "Right" was actually Left, and "Off" was actually Both.** Both the right and left fuel systems were checked for signs of blockage on 03/18/2022. No indications of blockage were noted to include the finger screen in each wing tank.

**Red Letters** indicated how the valve was actually installed and should have been placarded.
