# National Transportation Safety Board

ANC22LA035

## **MATERIALS LABORATORY**

Factual Report 23-024 Akutat AK aux spar

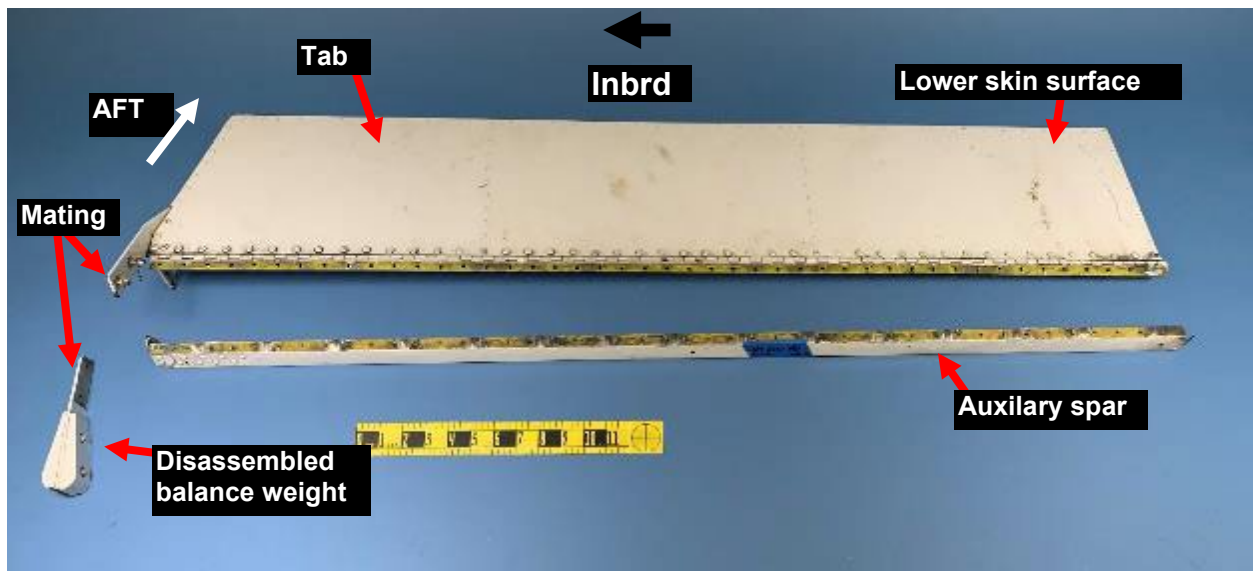
Figure 1. As-received tab assembly; balance weight; and auxiliary spar that were disassembled from the left elevator assembly showing the lower surface.

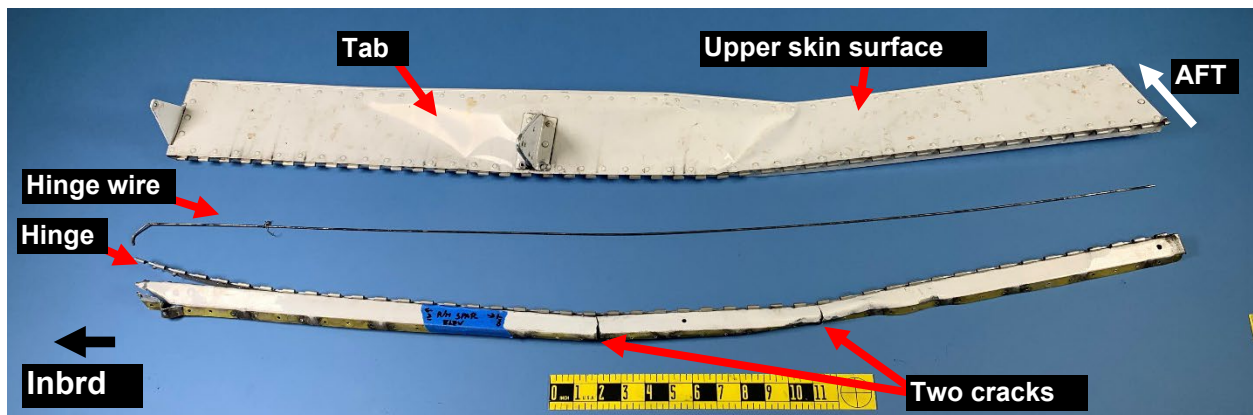
Examination of the right auxiliary spar revealed the forward hinge half which remained attached. The two cracks shown in Figure 2 were found on the right auxiliary spar that extended mostly through the cross section. The cracks were located in the general area of the auxiliary spar that contained severe bending deformation. Bench binocular microscope examination of the fracture faces from the cracks revealed rough texture features on slant planes typical of overstress separation, with no evidence of fatigue cracking.

Figure 2 . As-received tab assembly and auxiliary spar that were disassembled from the right elevator assembly showing the upper surface.

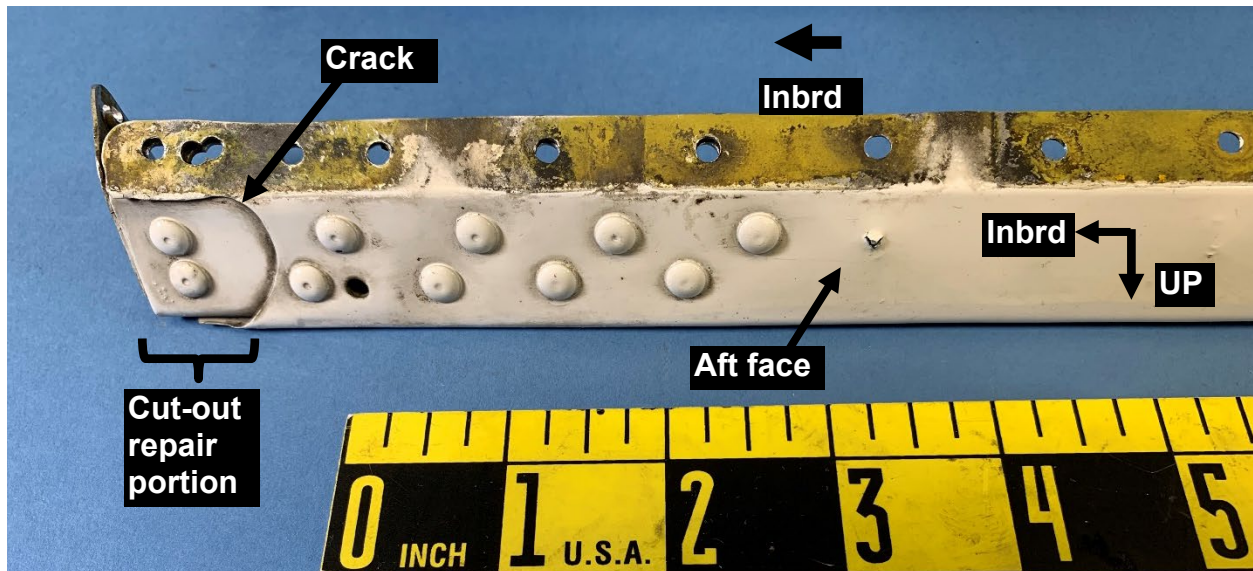
Examination of the left auxiliary spar revealed a 1-inch portion of the inboard end of the auxiliary spar was cut out (see figure 3). A small crack, measuring approximately 0.05 inches in length, extended from the cut radius portion of the auxiliary spar (see figure 4). A saw cut was made between the curved portion of the auxiliary spar and the end of the crack - to expose the fracture face of the crack. Bench binocular microscope examination of the exposed fracture faces revealed evidence of rubbing (mechanical) damage that obliterated the fracture features and the mode of fracture was not determined. A repair doubler (measuring approximately 4.3 inches in length) was attached to the inboard end the auxiliary spar on the forward side at the location where the 1-inch portion of the spar was removed (see figure 5). A repair corner tab was attached to the inboard end of the repair doubler and auxiliary spar.

Figure 3. Inboard end of the auxiliary spar from the left elevator assembly showing the lower cap portion (painted green).

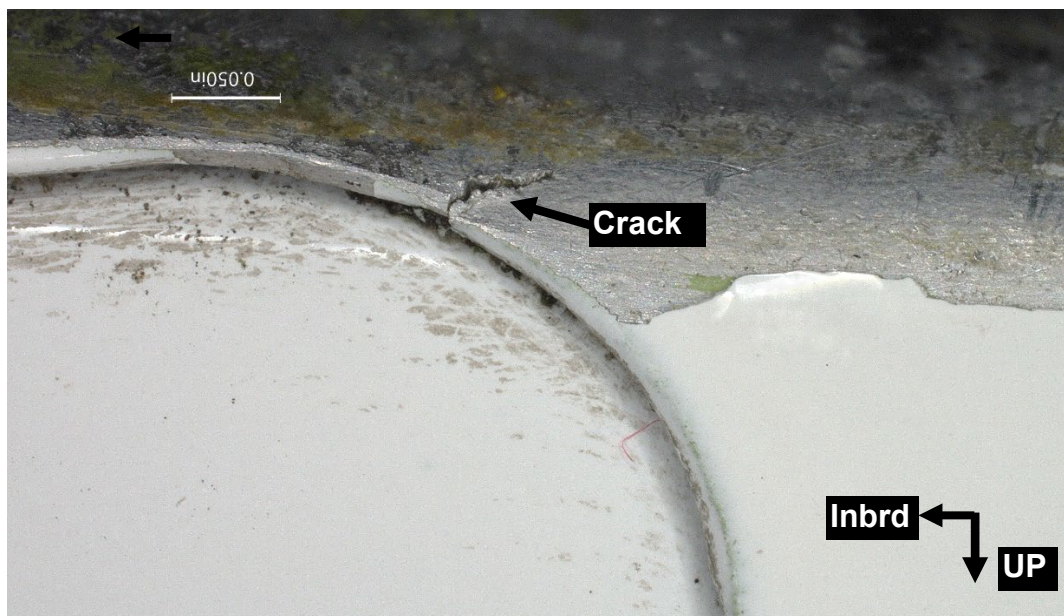
Figure 4. Crack at the cut out lower radius of the auxiliary spar for the left elevator.

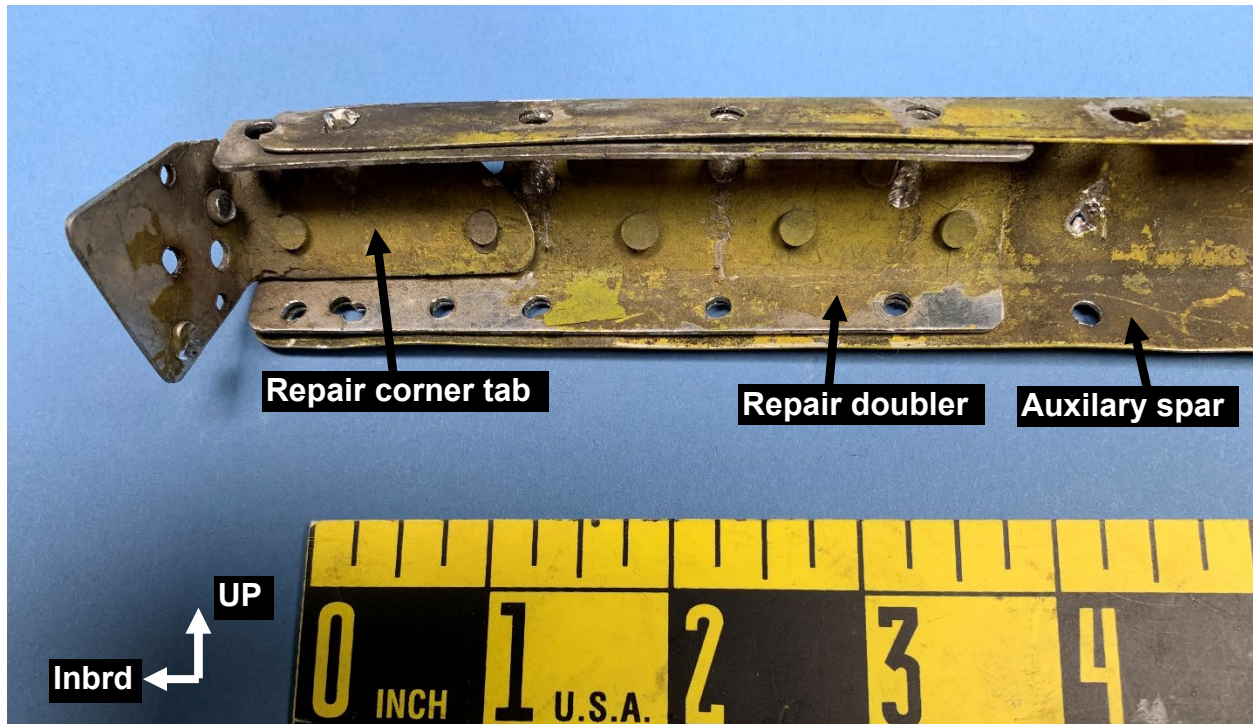
Figure 5. View looking at the inboard forward face of auxiliary spar for the left elevator.
