## **Wreckage Examination Summary**

NTSB ACCIDENT NUMBER: ANC22LA035

AIRCRAFT REGISTRATION/AIRCRAFT TYPE: N703TH, de Havilland DHC-3

ACCIDENT LOCATION: Yakutat, AK

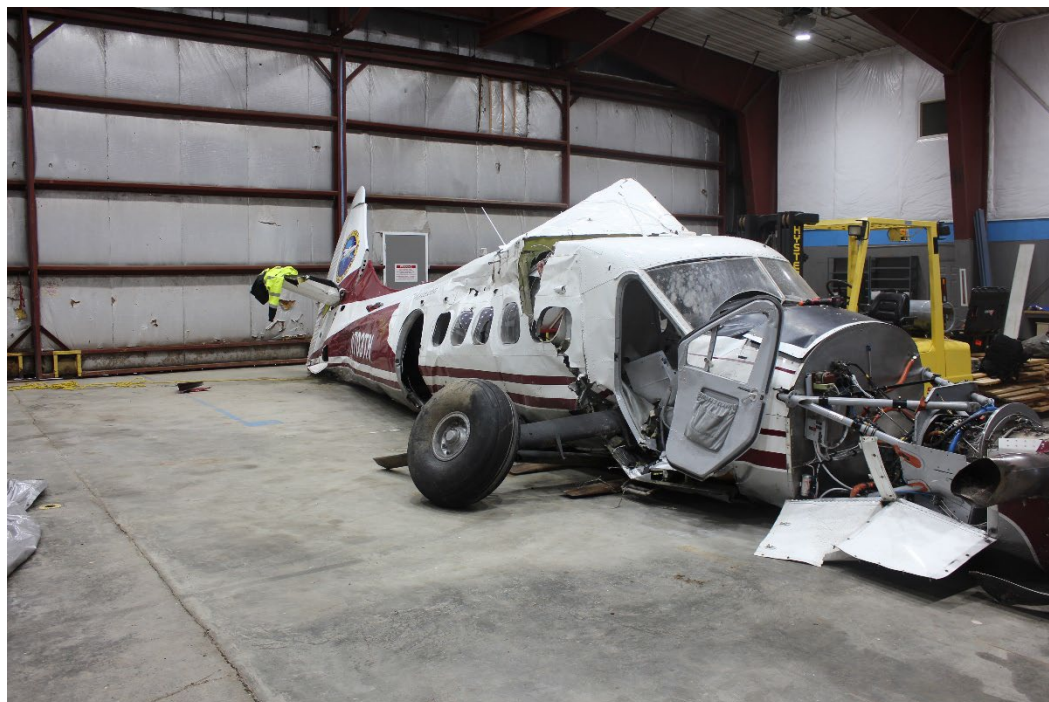
The airplane consequently impacted forested terrain near the approach end of runway 23 at an elevation of about 18 ft, which resulted in substantial damage to the fuselage, wings, and empennage.

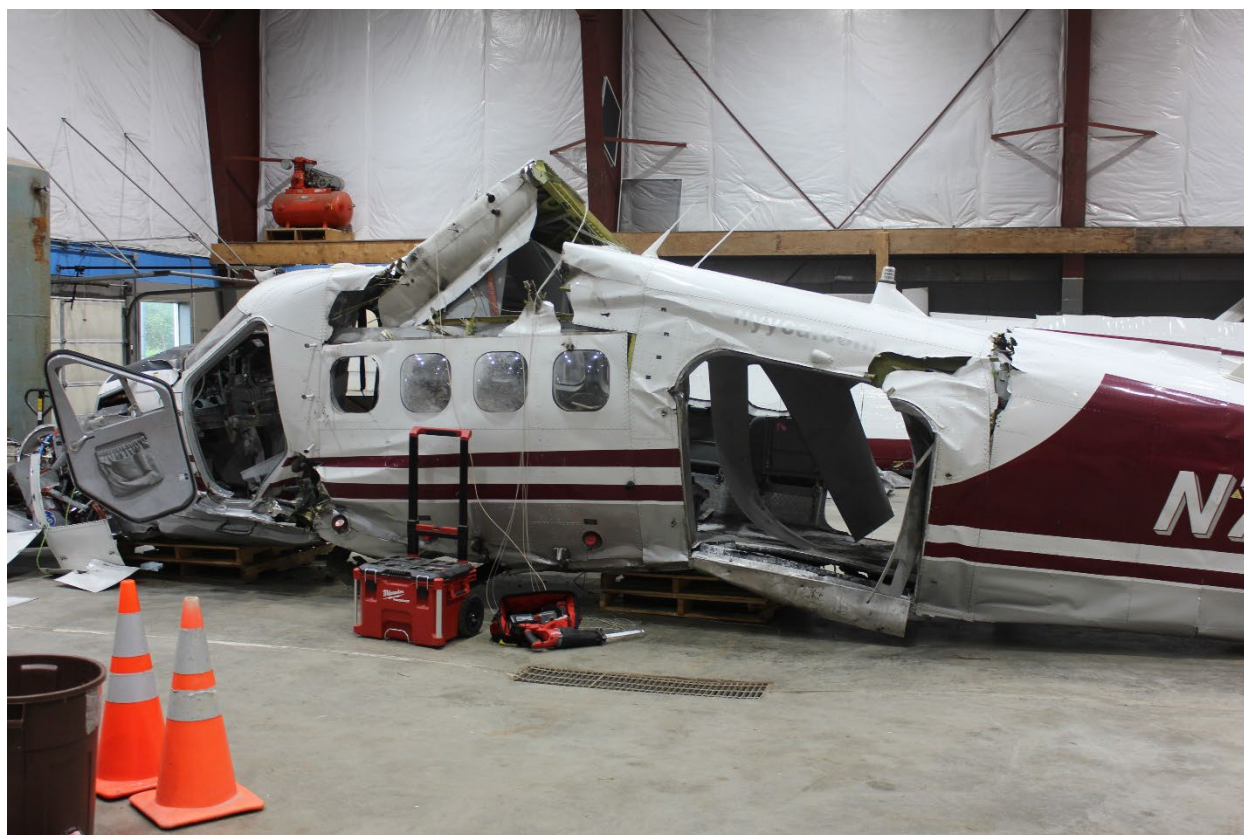
### **Cockpit**

- Cockpit exhibited extensive impact damage to the lower cockpit structure.
- Both main landing gear penetrated the fuselage near the sloping bulkhead. The left main landing gear separated from its attach points. The right main landing gear was partially separated.
- The cockpit floor was buckled.
- Windshields partially separated from windshield frames.
- Both cockpit door frames were broken, and the doors remained attached to the cockpit structure.

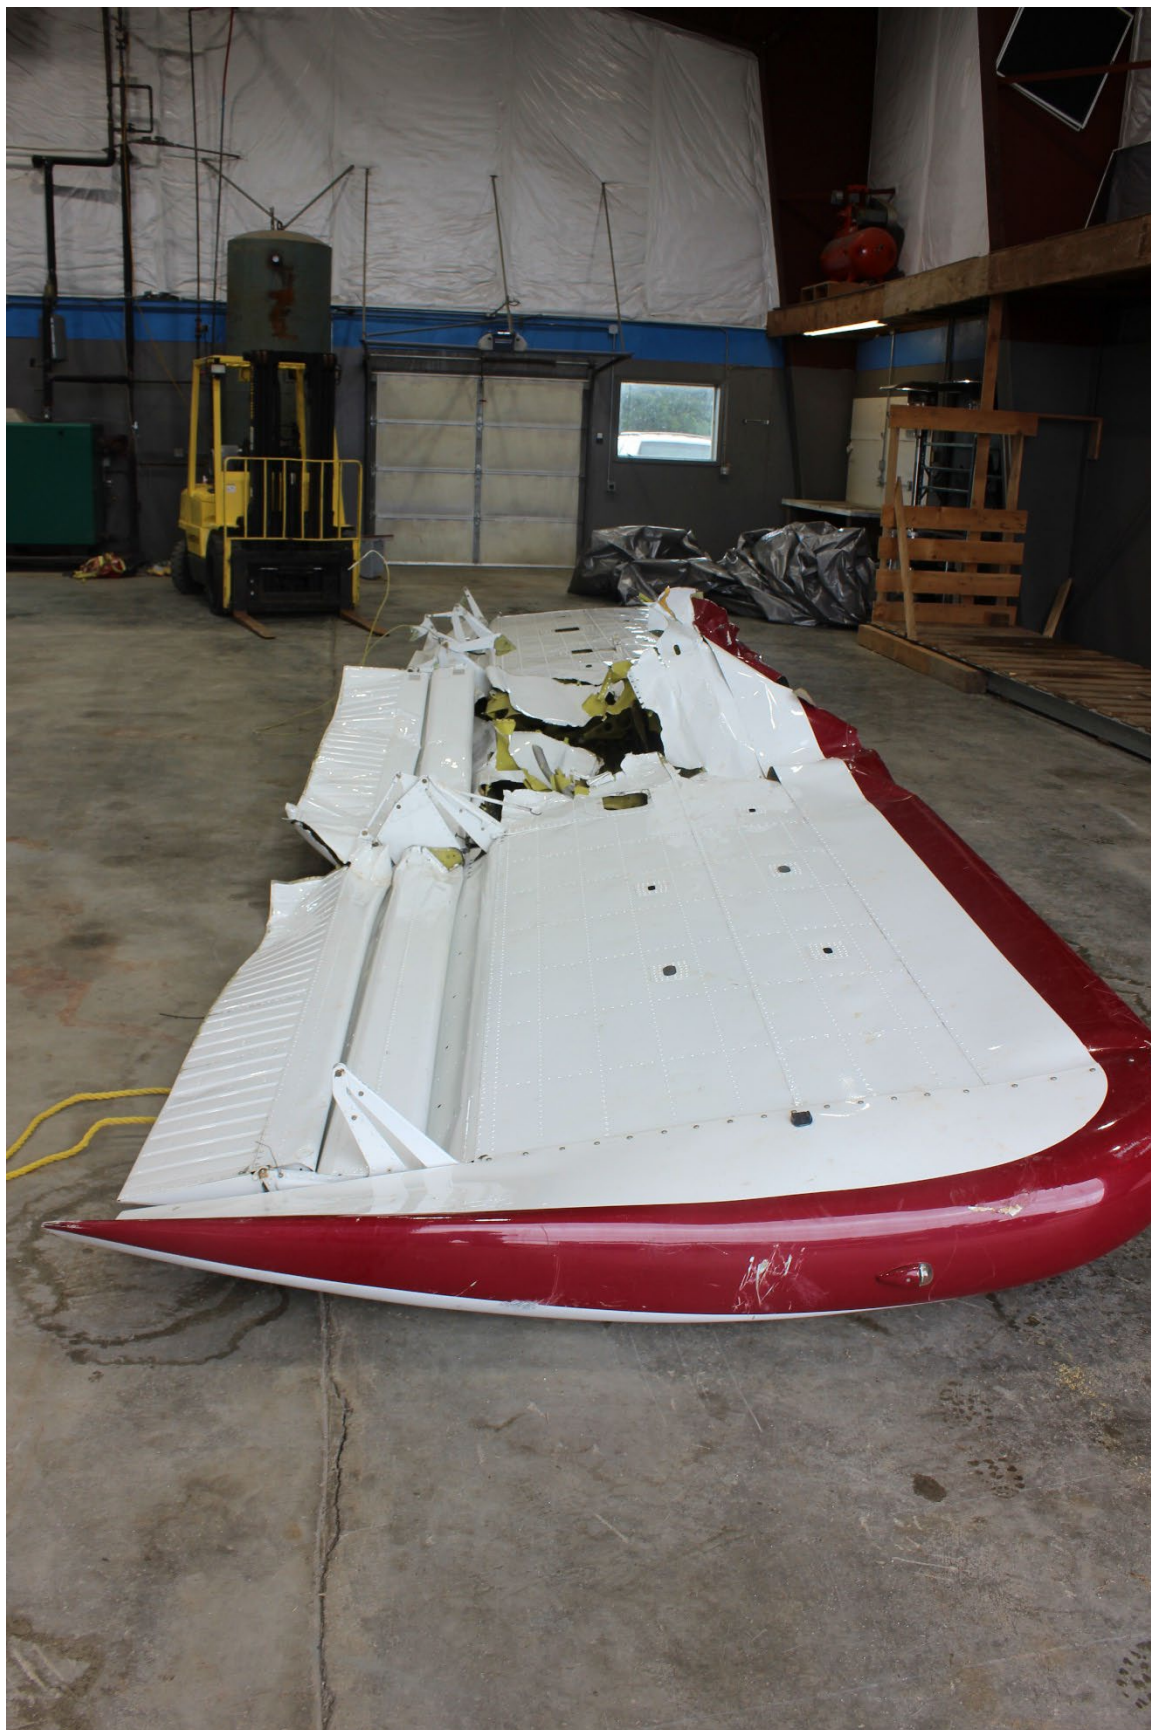
**Right Wing**

- The right wing was intact with leading edge crushing from WS 60 to 135, about 5-7 inches aft.
- Slight leading edge damage was present from WS 135 – 210.

- Leading edge crushing was present from WS 210 – 235.
- Slight leading edge damage was present from WS 235 – 297.
- Leading edge crushing was present from WS 297 – 335.

- The aft portion of the wing tip was separated.
- The root rib was damaged.
- The wing strut remained intact but sustained impact damage. The upper and lower attach bolts and fittings remained intact. The strut was cut by recovery crews.

- The inboard foreflap hinge arm was bent outwards at the wing root.
- The inboard foreflap was bent near the center hinge point.
- The trailing flap was crushed at the root and the flap was bent inboard of the center hinge.

- The outboard foreflap was damaged near the root and the tip.
- The aileron sustained impact damage on the trailing edge skins.
- The inboard and outboard flap actuating rods were intact.
