# National Transportation Safety Board

ANC22LA040

## **MATERIALS LABORATORY**

Factual Report 22-081

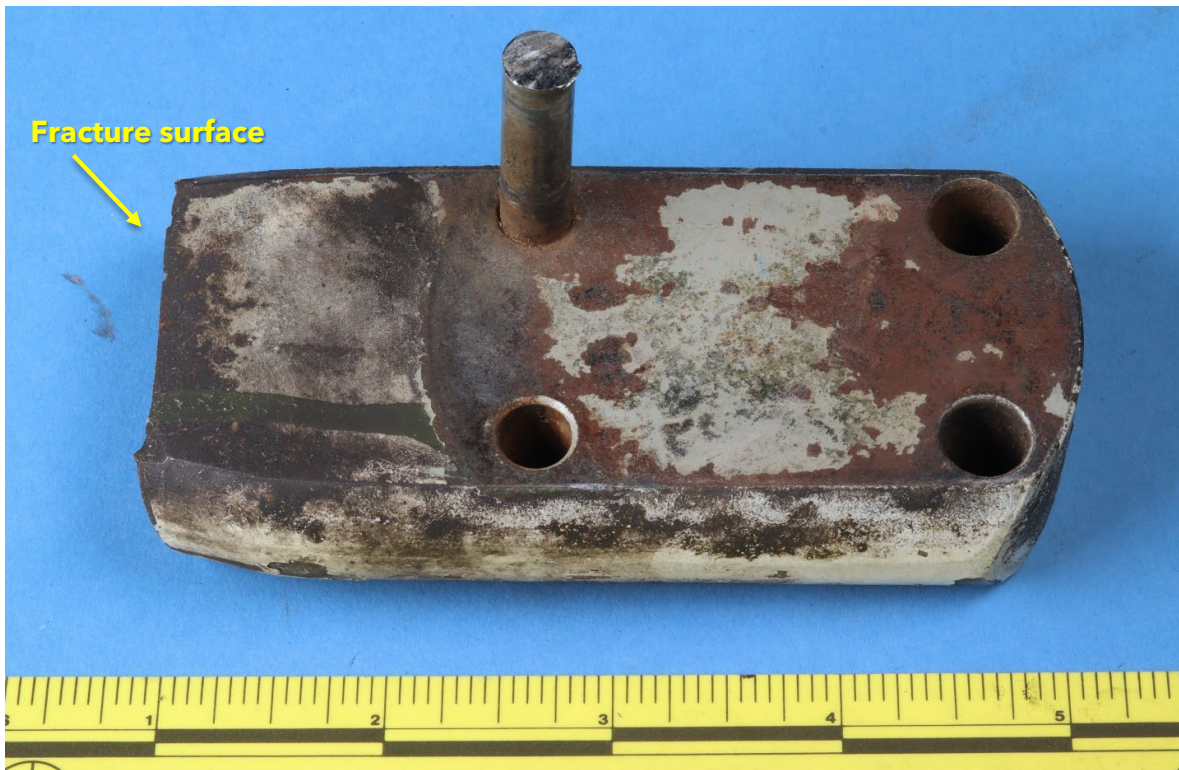
Figure 1 and Figure 2 show the remnant of the landing gear leg, as received. The remnant exhibited four bolt holes, one of which still contained the remnant of a bolt shank. The part had fractured through the cross section, perpendicular to its longitudinal direction. The fracture surface faces towards the left in Figures 1 and 2.

**Figure 1.** View of the main landing gear leg fragment, as received.

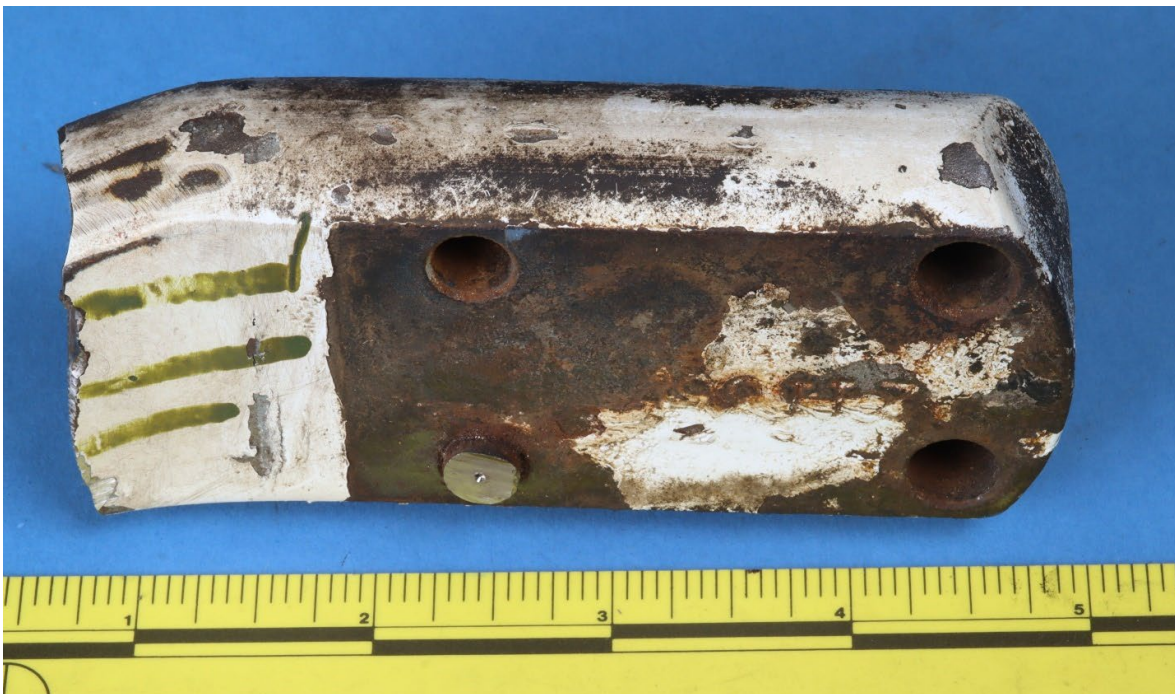
**Figure 2.** Angled view of the leg fragment opposite that of Figure 1, showing a bend towards the fracture surface.

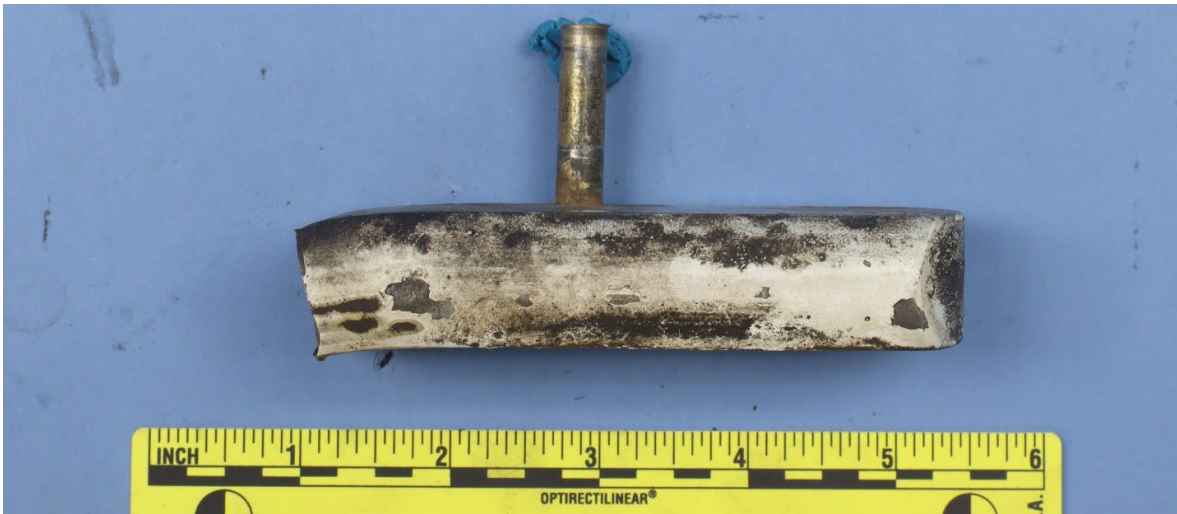
remnant exhibited an angled bend, appearing downward in Figure 3. This bend was approximately 10° from the longitudinal direction of the rest of the remnant.

**Figure 3.** Side view of the leg remnant, showing the geometry of the leg fragment.

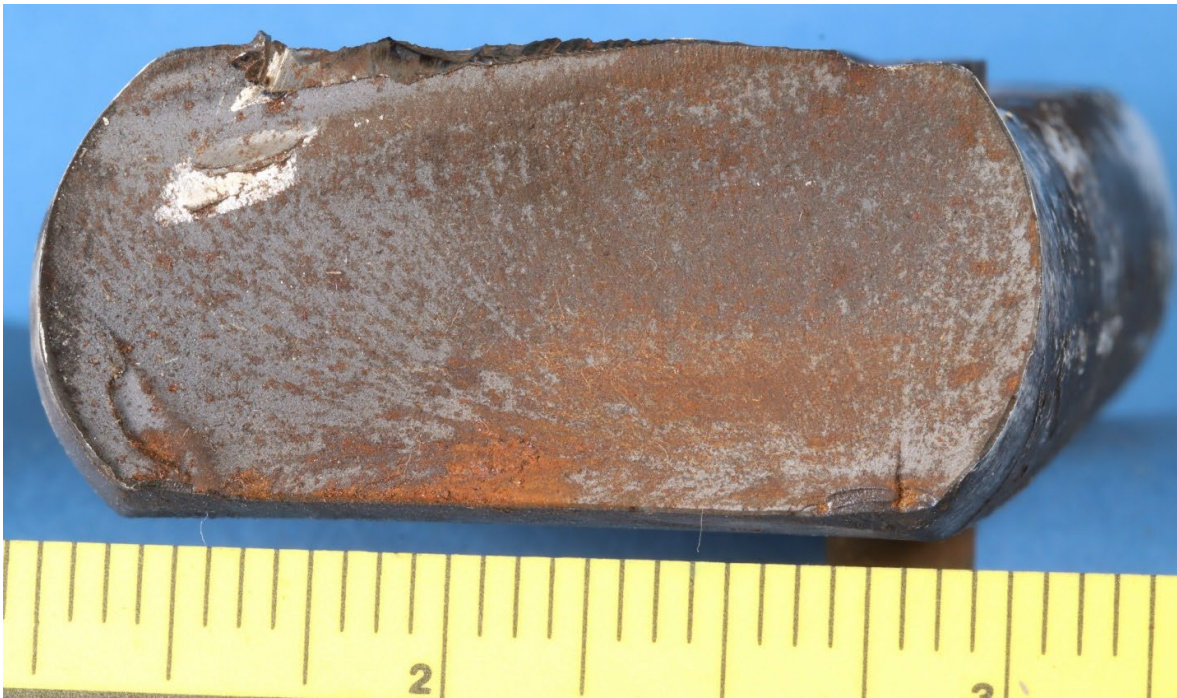
Figure 4 shows the leg remnant fracture surface, as received. The surface was relatively flat, with indications of post-fracture smearing, evidenced by the reflective region in the upper left, and post-fracture corrosion from the presence of rust-colored oxide compounds on the surface. Overall, the fracture surface exhibited a dull luster with a rough texture. The river patterns on the fracture surface emanated from an area in the lower right of Figure 4, consistent with the area of the start of the fracture sequence of the part. This region was located along the edge of the leg, near a corner (shown in Figure 5).

**Figure 4.** View of the leg fragment fracture surface, as received.

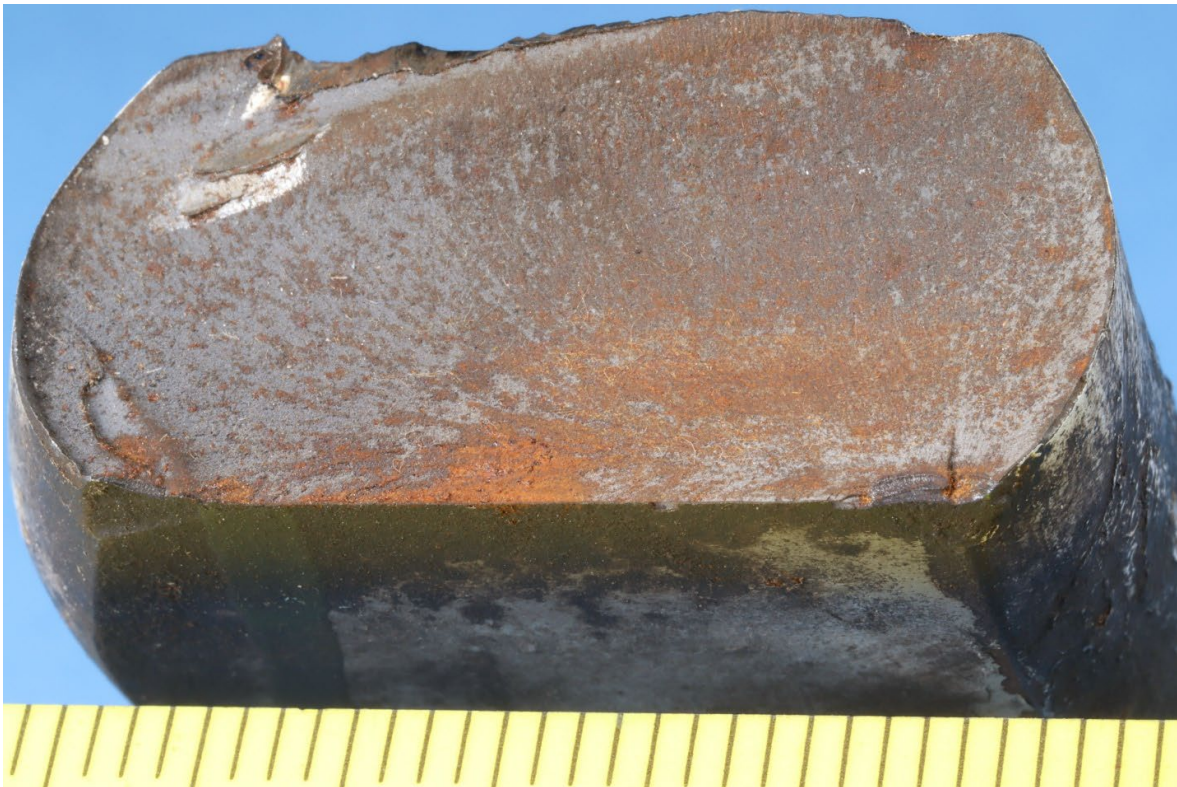
**Figure 5.** Angled view of the fracture surface edge of the leg fragment, showing the fracture initiation region in the lower right.

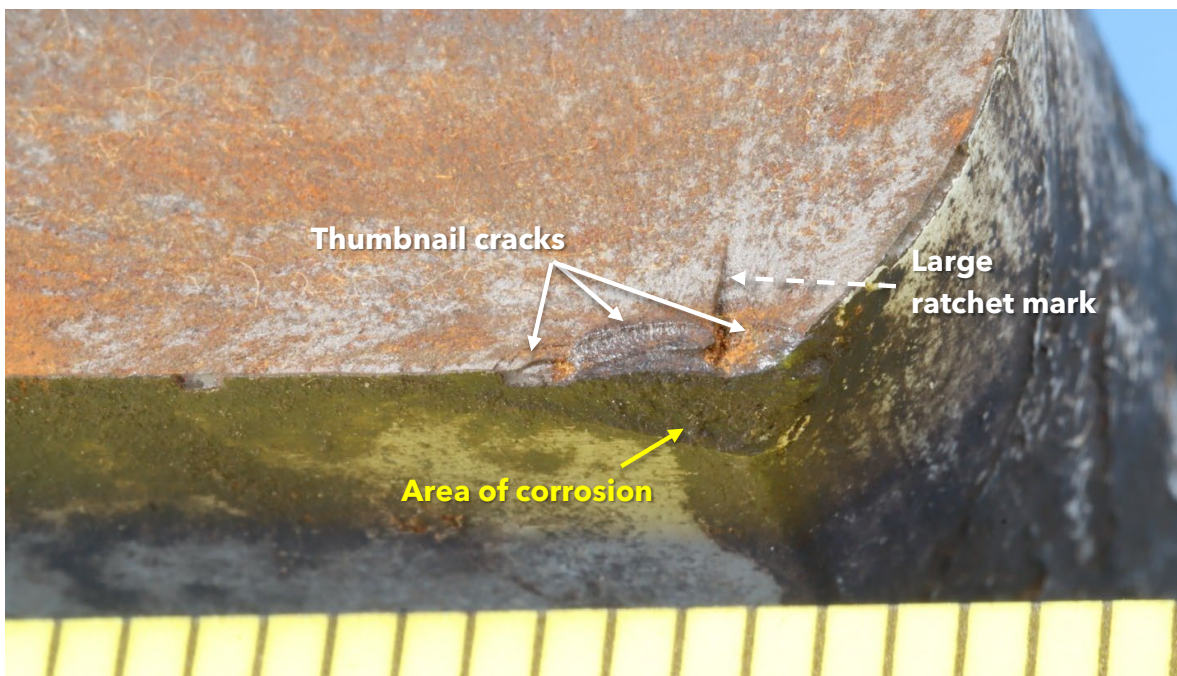
A closer view of the area revealed several thumbnail-shaped cracks, with a large vertically oriented ratchet mark on the fracture surface (see Figure 6). These cracks were also located near an area of corrosion and wear on the outside surface, facing downward in Figure 6. This area was approximately 0.6 inches wide along the fracture surface edge, and it extended approximately 0.3 inches from the fracture surface.

**Figure 6.** Closer view of the thumbnail crack, with various features annotated.

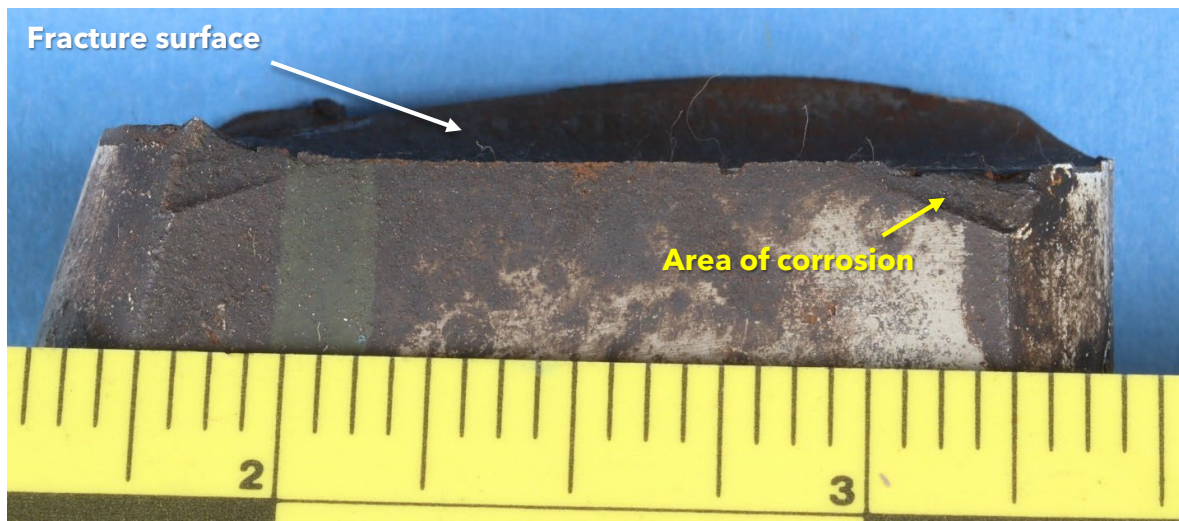
**Figure 7.** View from underneath of the leg, showing the area of corrosion and the fracture surface.

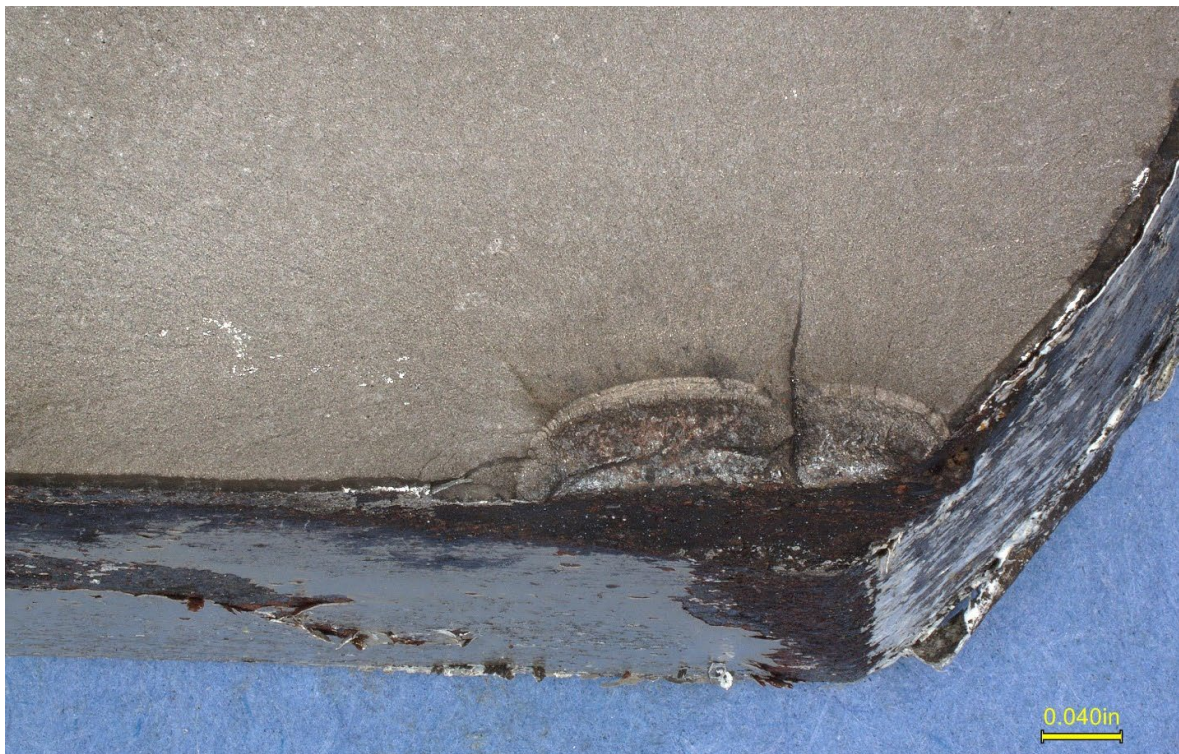
**Figure 8.** Closer view of the thumbnail cracks, after cleaning the fracture surface.

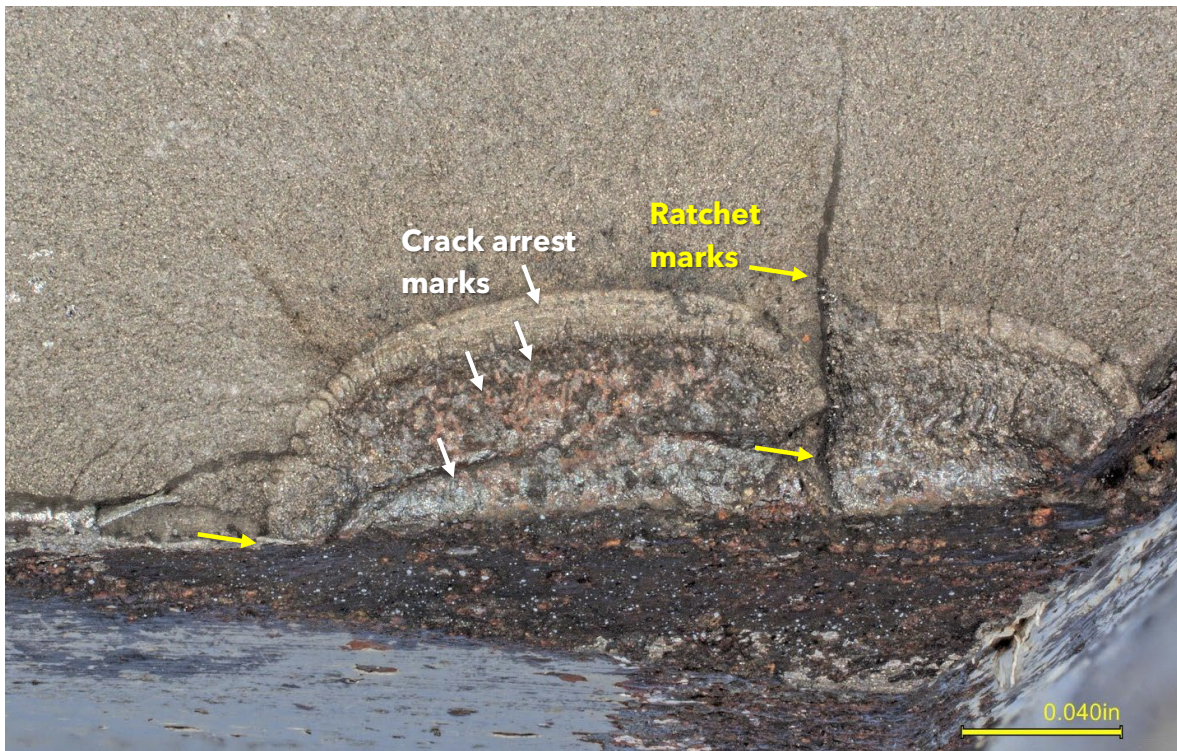
The area near the fracture surface was sectioned with an abrasive saw and then cleaned with an Evapo-rust solution in an ultrasonic bath.<sup>1</sup> Figure 8 shows a closer view of the cleaned fracture surface around the thumbnail cracks. As illustrated in Figure 9, these cracks exhibited crack arrest marks, consistent with crack propagation, and ratchet marks, consistent with multiple crack initiation sites.

**Figure 9.** Closer view of the cracks in Figure 8, showing ratchet marks and crack arrest marks.

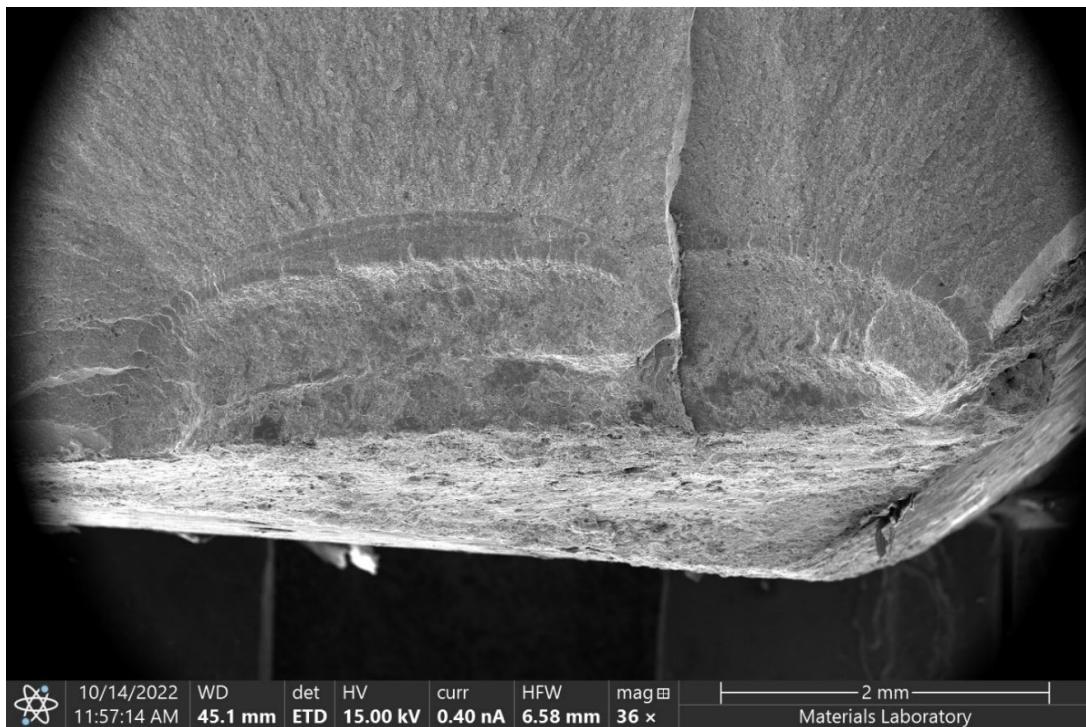
The fracture surface was examined using a field-emission scanning electron microscope (SEM). The thumbnail crack region is shown in Figure 10 and Figure 11. Using the SEM, the cracks were found to measure 5 mm wide by 1.3 mm deep (0.20 inch wide by 0.054 inch deep).

**Figure 10.** Secondary electron (SE) micrograph of the thumbnail cracks in Figure 9.

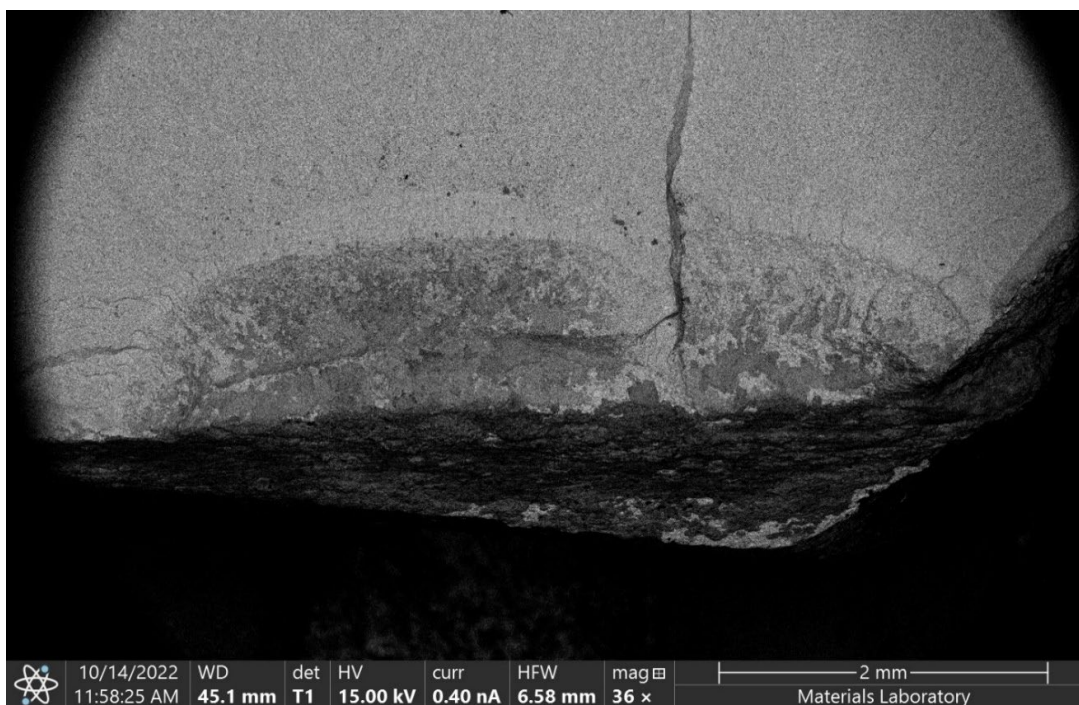
As shown in the backscattered micrograph in Figure 11, the thumbnail cracks exhibited darker contrast material.<sup>2</sup> An examination of this material using energy

dispersive x-ray spectroscopy (EDS) found it to be mainly composed of iron oxides. The oxide also contained minor amounts of copper, with detectable amounts of sodium, magnesium, potassium, sulfur, chlorine, and calcium—these elements were consistent with corrosion products typical of marine environment exposure.

**Figure 11.** Backscattered electron (BE) micrograph of the area in Figure 10.

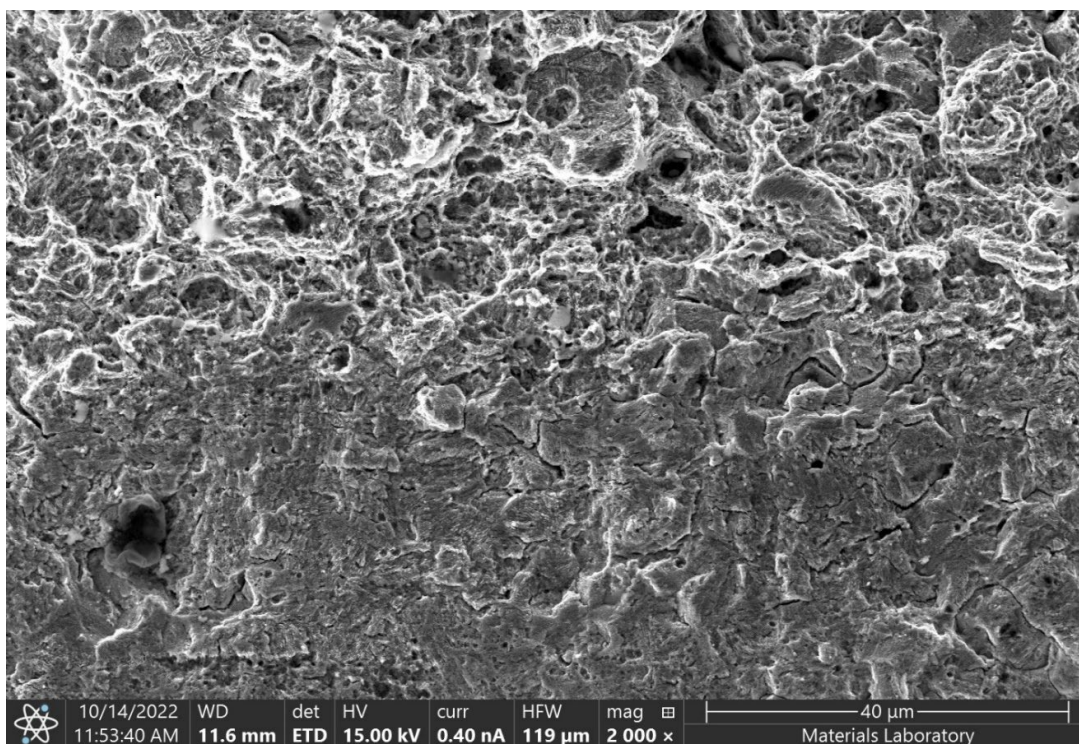
The end of the largest thumbnail crack on the fracture surface is illustrated in Figure 12. The area in the crack exhibited fatigue striations, consistent with fatigue crack propagation (as typified in Figure 13). Outside the fatigue crack terminus, the rest of the fracture surface exhibited dimpled rupture, consistent with overstress fracture, as demonstrated in Figure 14.

**Figure 12.** SE micrograph of the terminus of the thumbnail crack, showing striations and dimpled rupture.

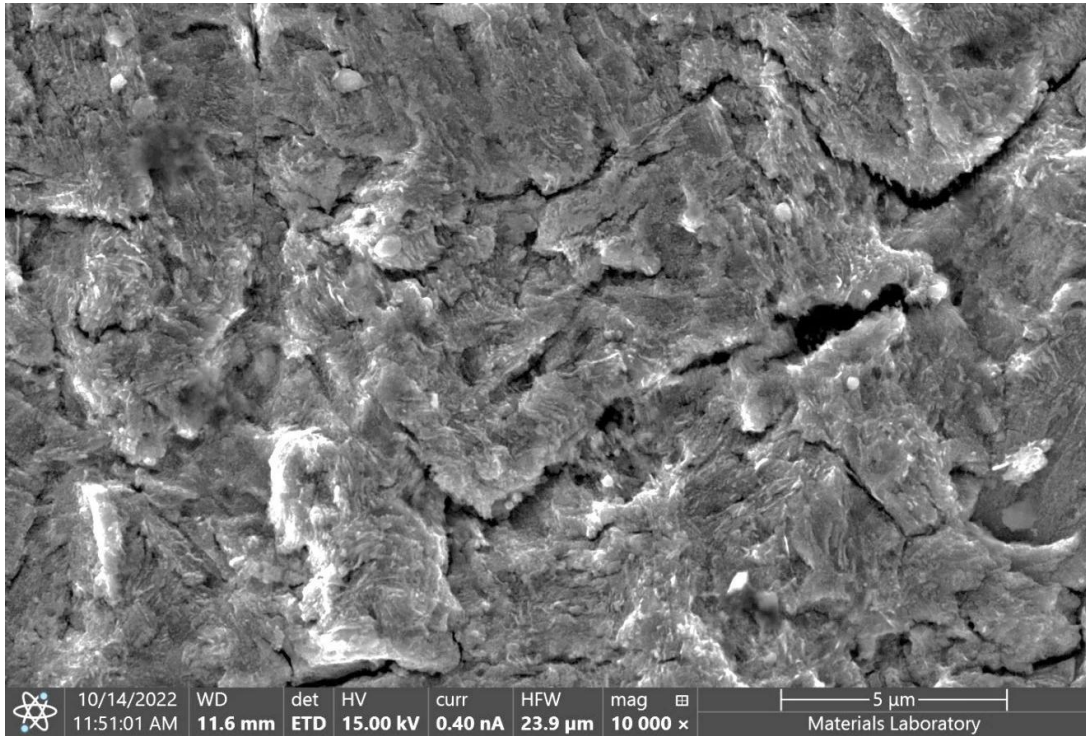
**Figure 13.** SE micrograph of fatigue striations on the thumbnail cracks of the leg remnant.

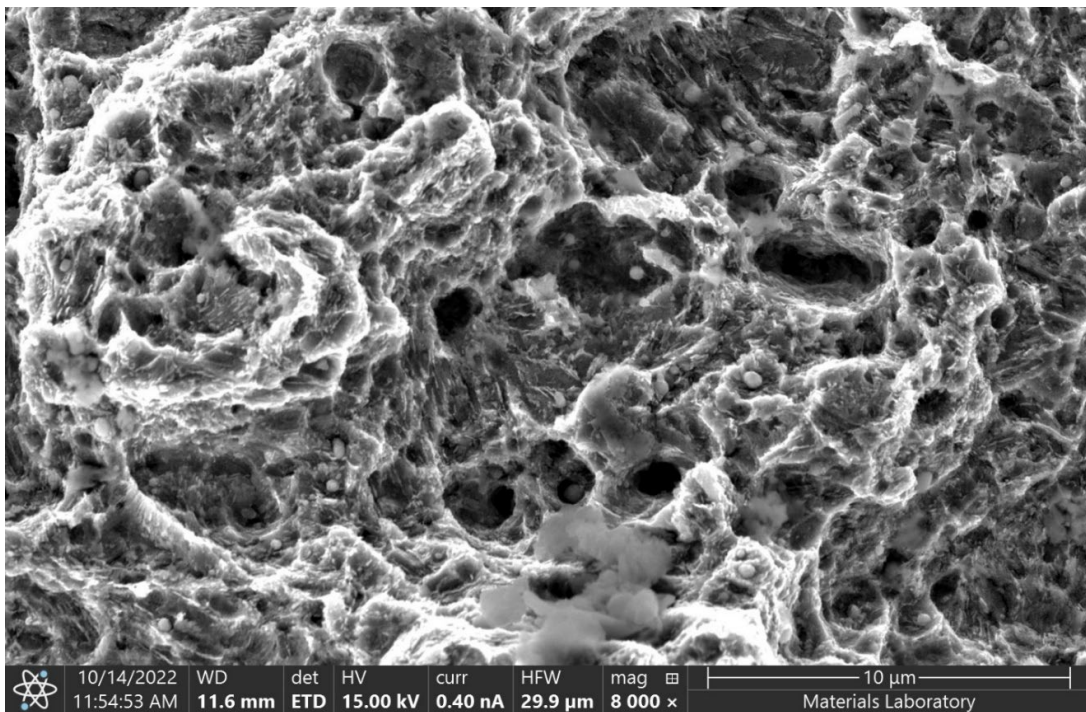
**Figure 14.** SE micrograph of dimpled rupture outside the fatigue crack.

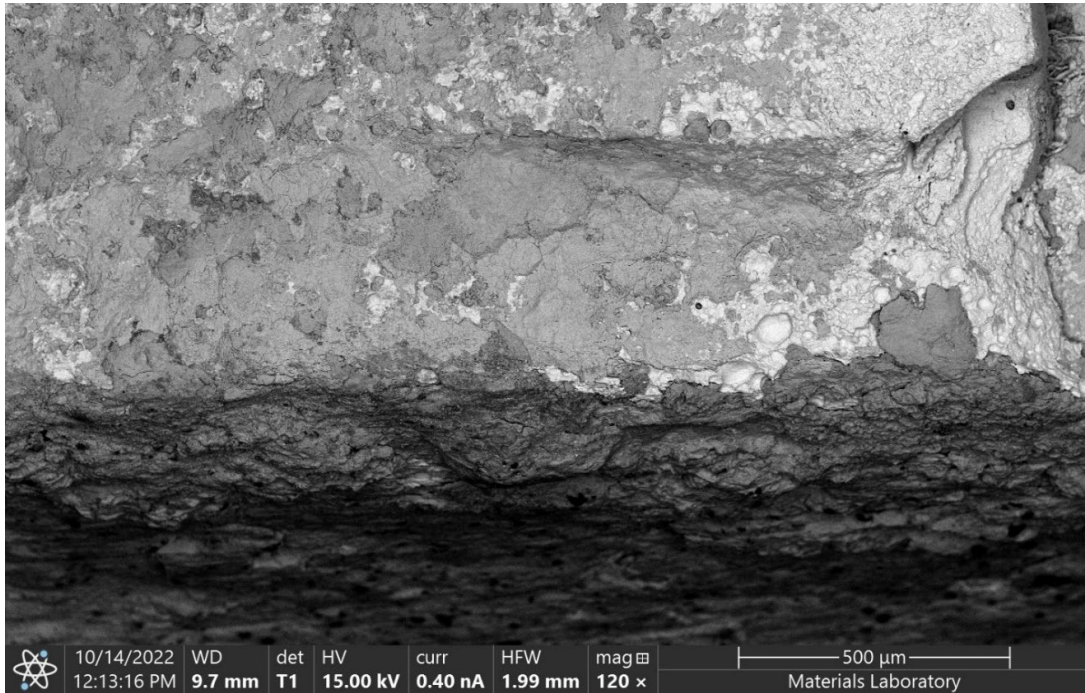
A closer view of the initiation sites is shown in Figures 15 through 17. As shown in backscattered mode, the initiation sites exhibited enough surface corrosion product to obscure the underlying metal, even after cleaning. Examination using EDS again found iron oxides with the elements typical of salt and marine environments.

**Figure 15.** BE micrograph of the initiation region of the fatigue crack left of the large ratchet mark.

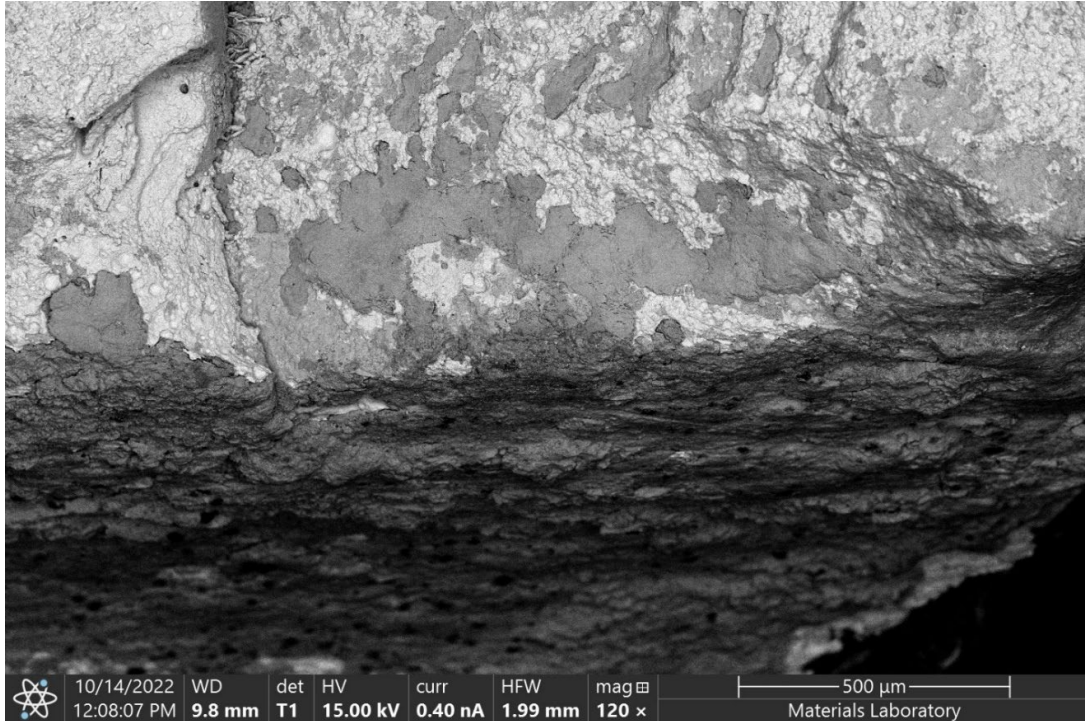
**Figure 16.** BE micrograph of the initiation region of the fatigue crack right of the large ratchet mark.

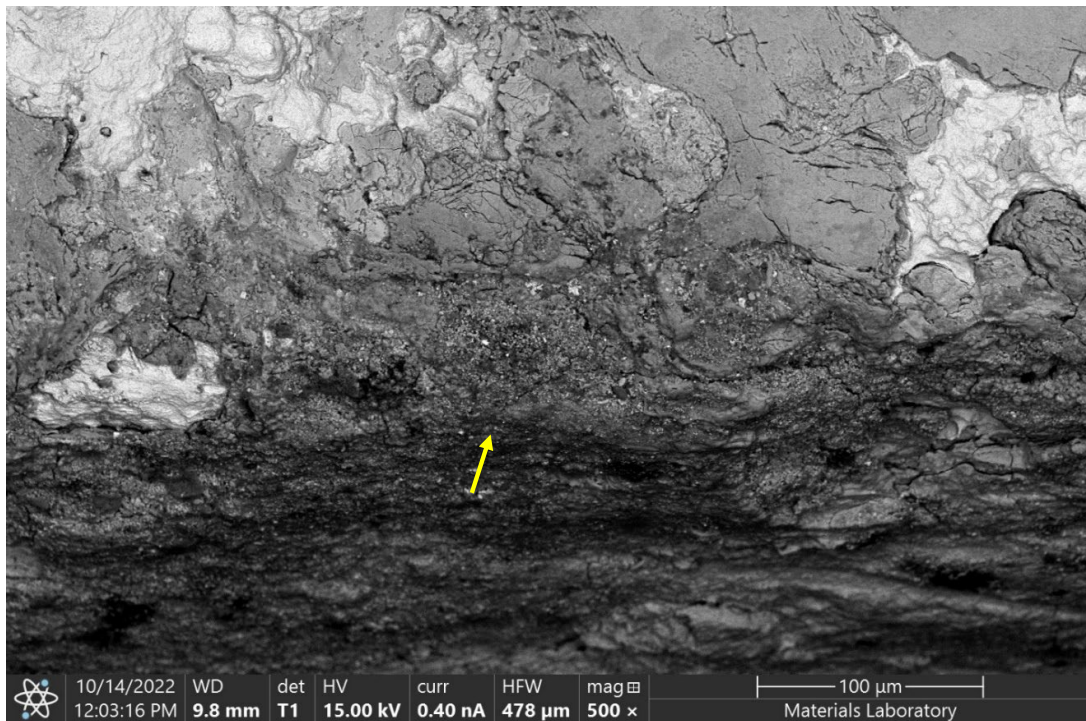
A closer view of the fatigue crack initiation site to the left of the larger ratchet mark found a divot geometry (arrow, Figure 17). This feature was consistent with a corrosion pit. Figures 18 and 19 show an angled view of the underside of the leg remnant, where the area of corrosion was located next to the fatigue cracks.

**Figure 17.** BE micrograph of the crack initiation site of the left fatigue crack, showing a surface pit (arrow) with corrosion compounds.

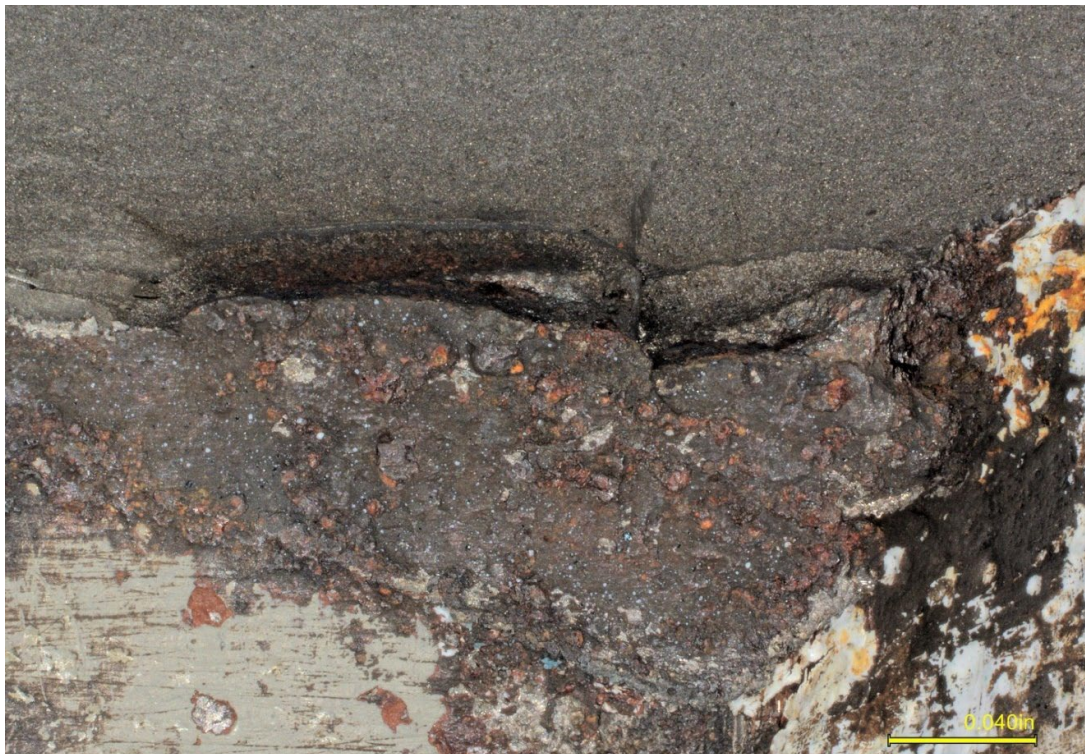
**Figure 18.** Corner of the crack initiation site, showing the corroded underside.

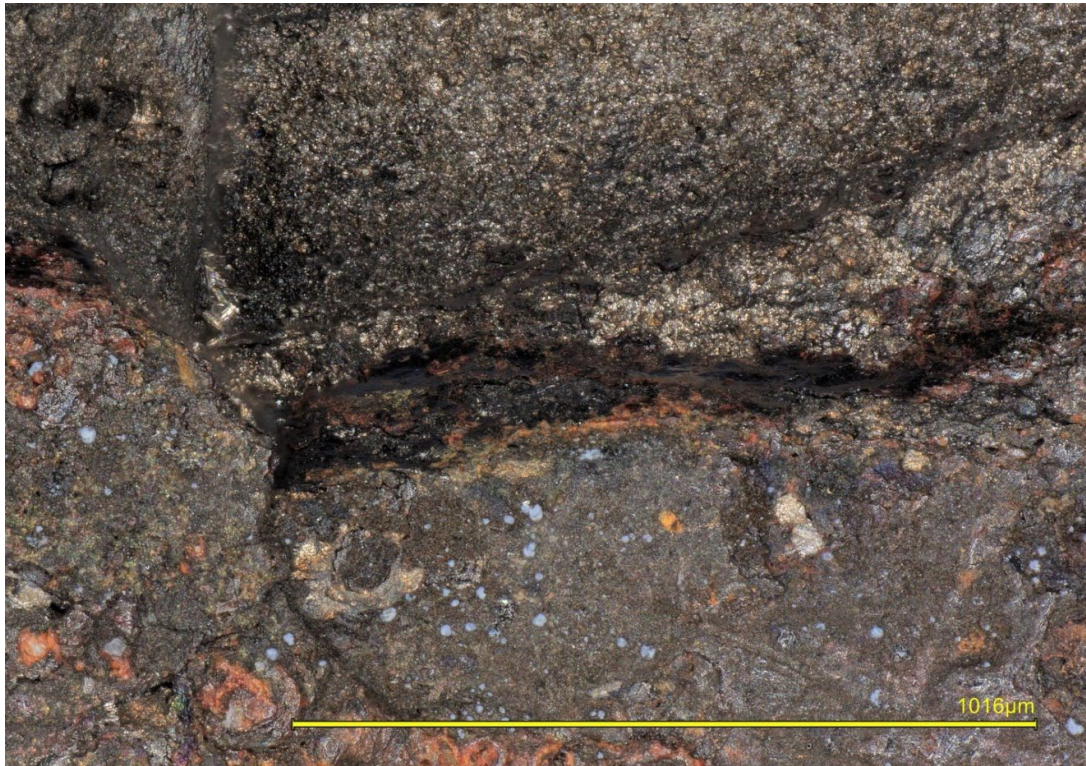
As shown in Figure 19, there were circular areas with discoloration, consistent with thicker surface corrosion products typical of pitting corrosion. After additional cleaning, the pits were found along this region near the fracture surface (see Figure 20). The surface oxide morphology was present throughout the area of corrosion on the underside of the leg remnant (see Figure 21).

**Figure 19.** Closer view of the right initiation side from the surface edge in Figure 18.

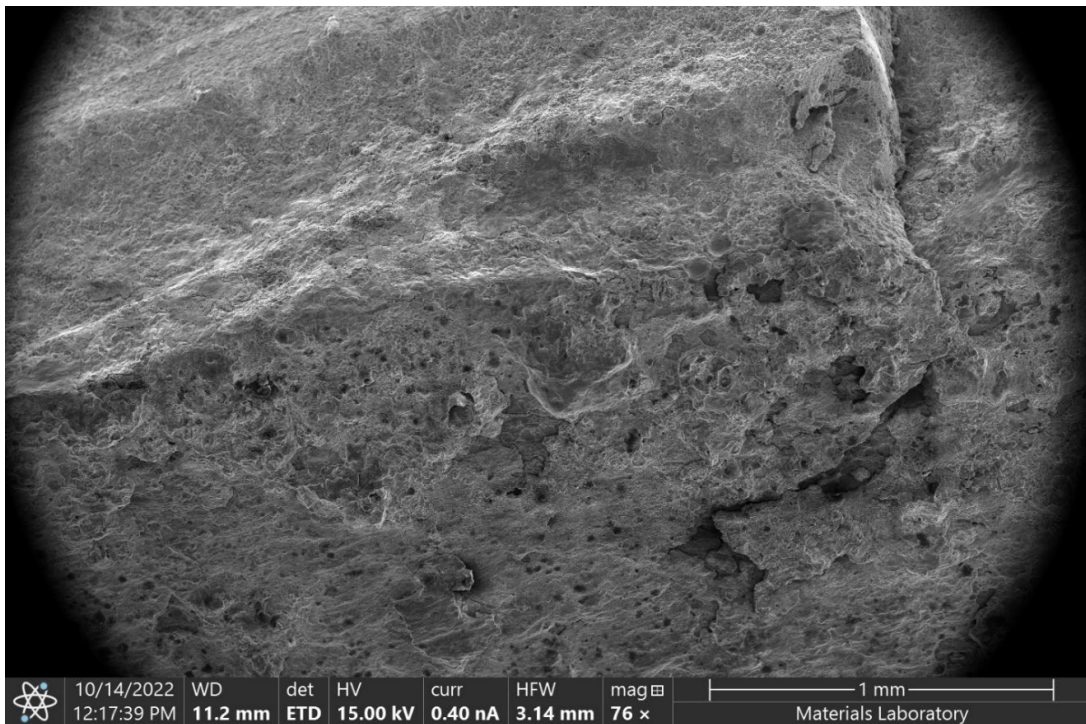
**Figure 20.** SE micrograph of the cleaned area in Figure 19, showing corrosion pits.

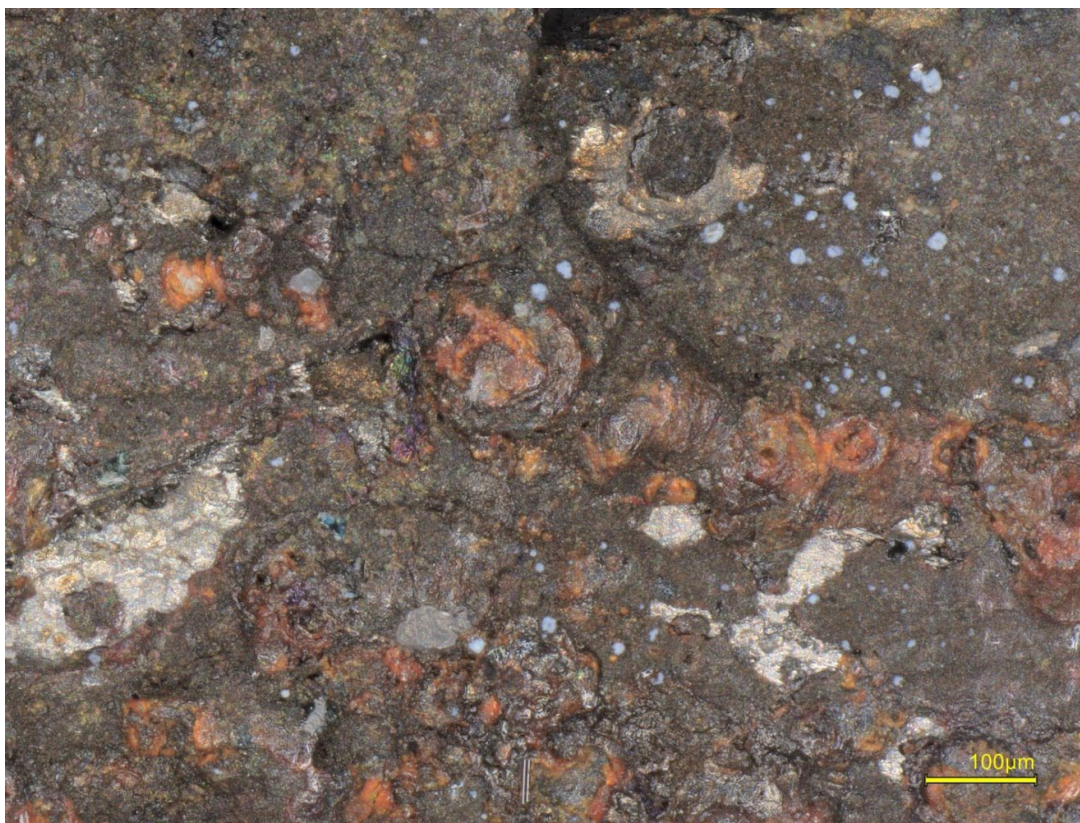
These features were consistent with the leg having fractured during landing, due to the stress concentration of fatigue cracks that had propagated inward from the lower surface of the leg. The fatigue cracks initiated from corrosion pits in an area of the leg that had experienced localized pitting corrosion.

**Figure 21.** Pitting corrosion and corrosion compounds on the underside of the leg remnant adjacent to the fatigue crack initiation sites.
