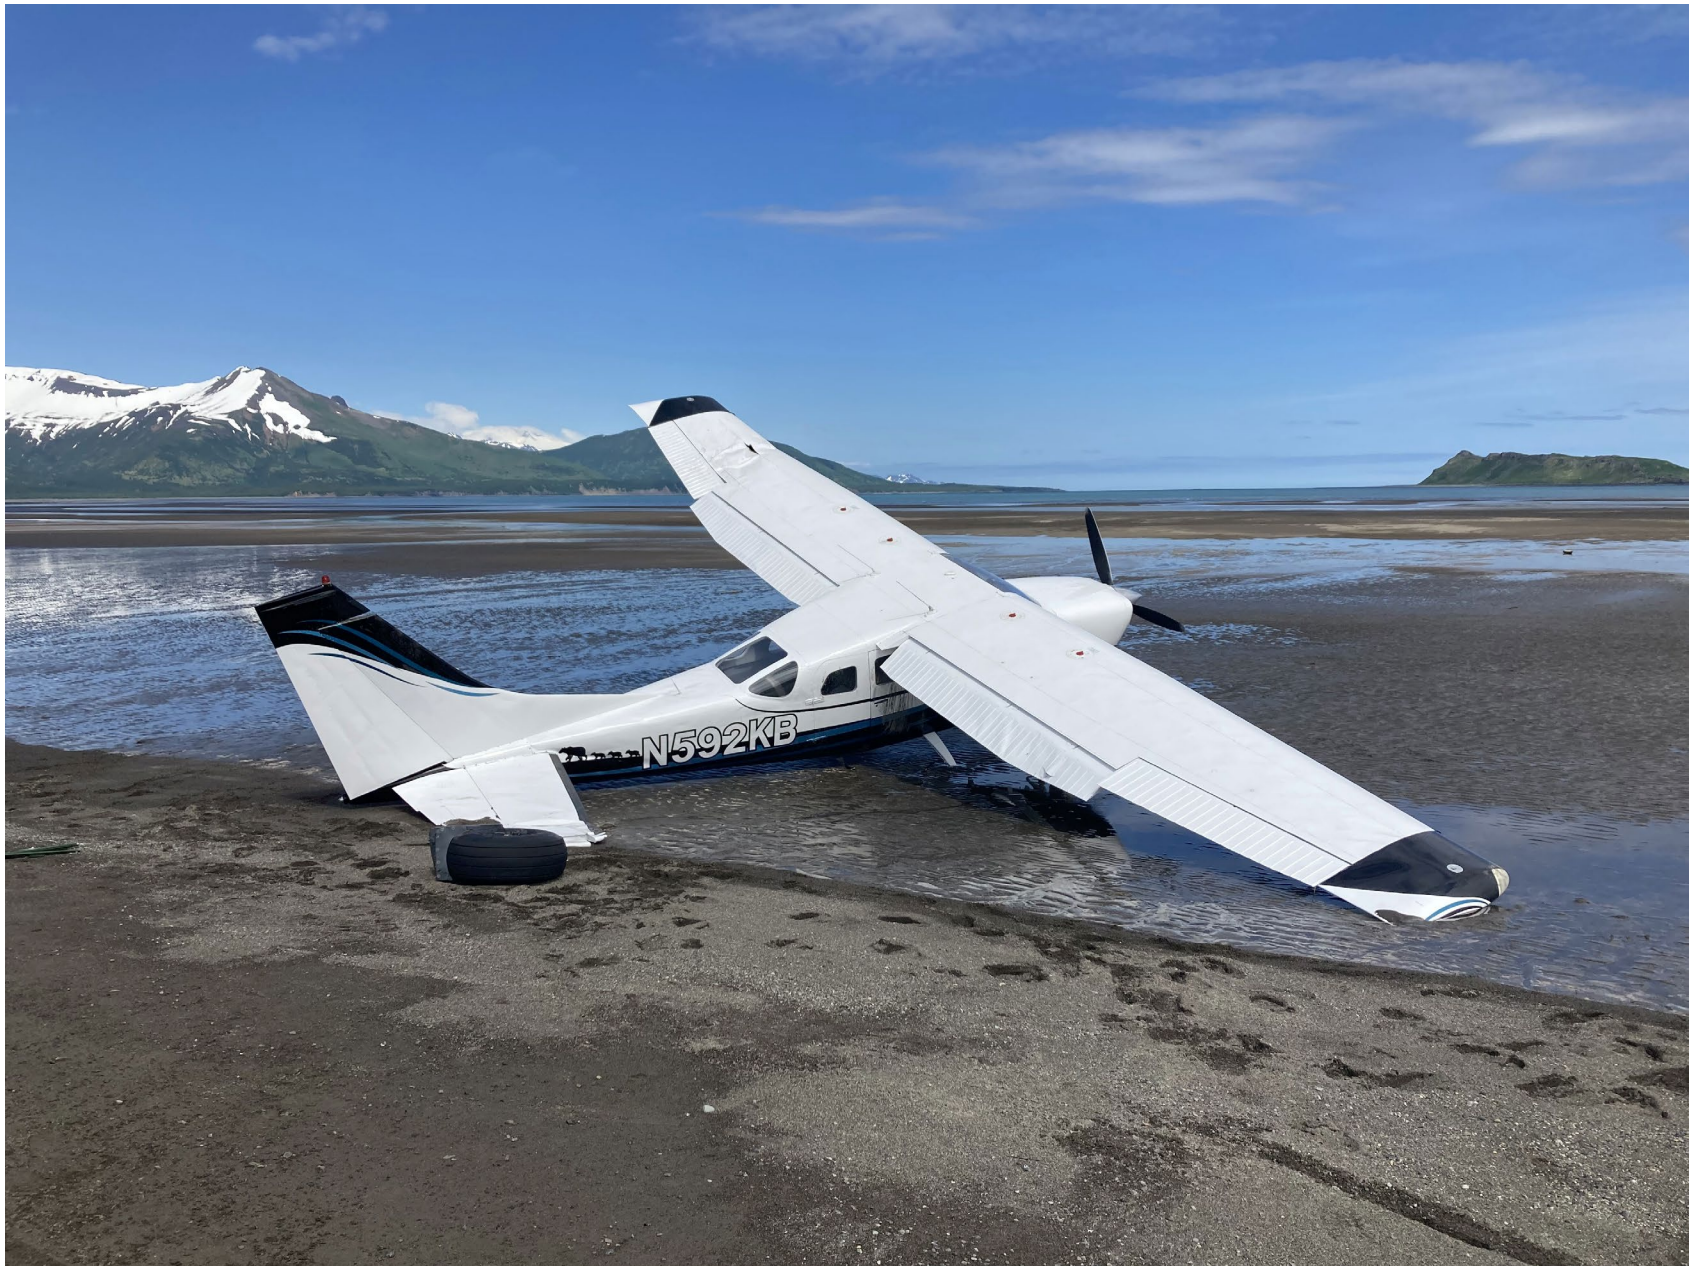
**Photo 1 – Accident airplane (Source: K Bay Air, LLC)**

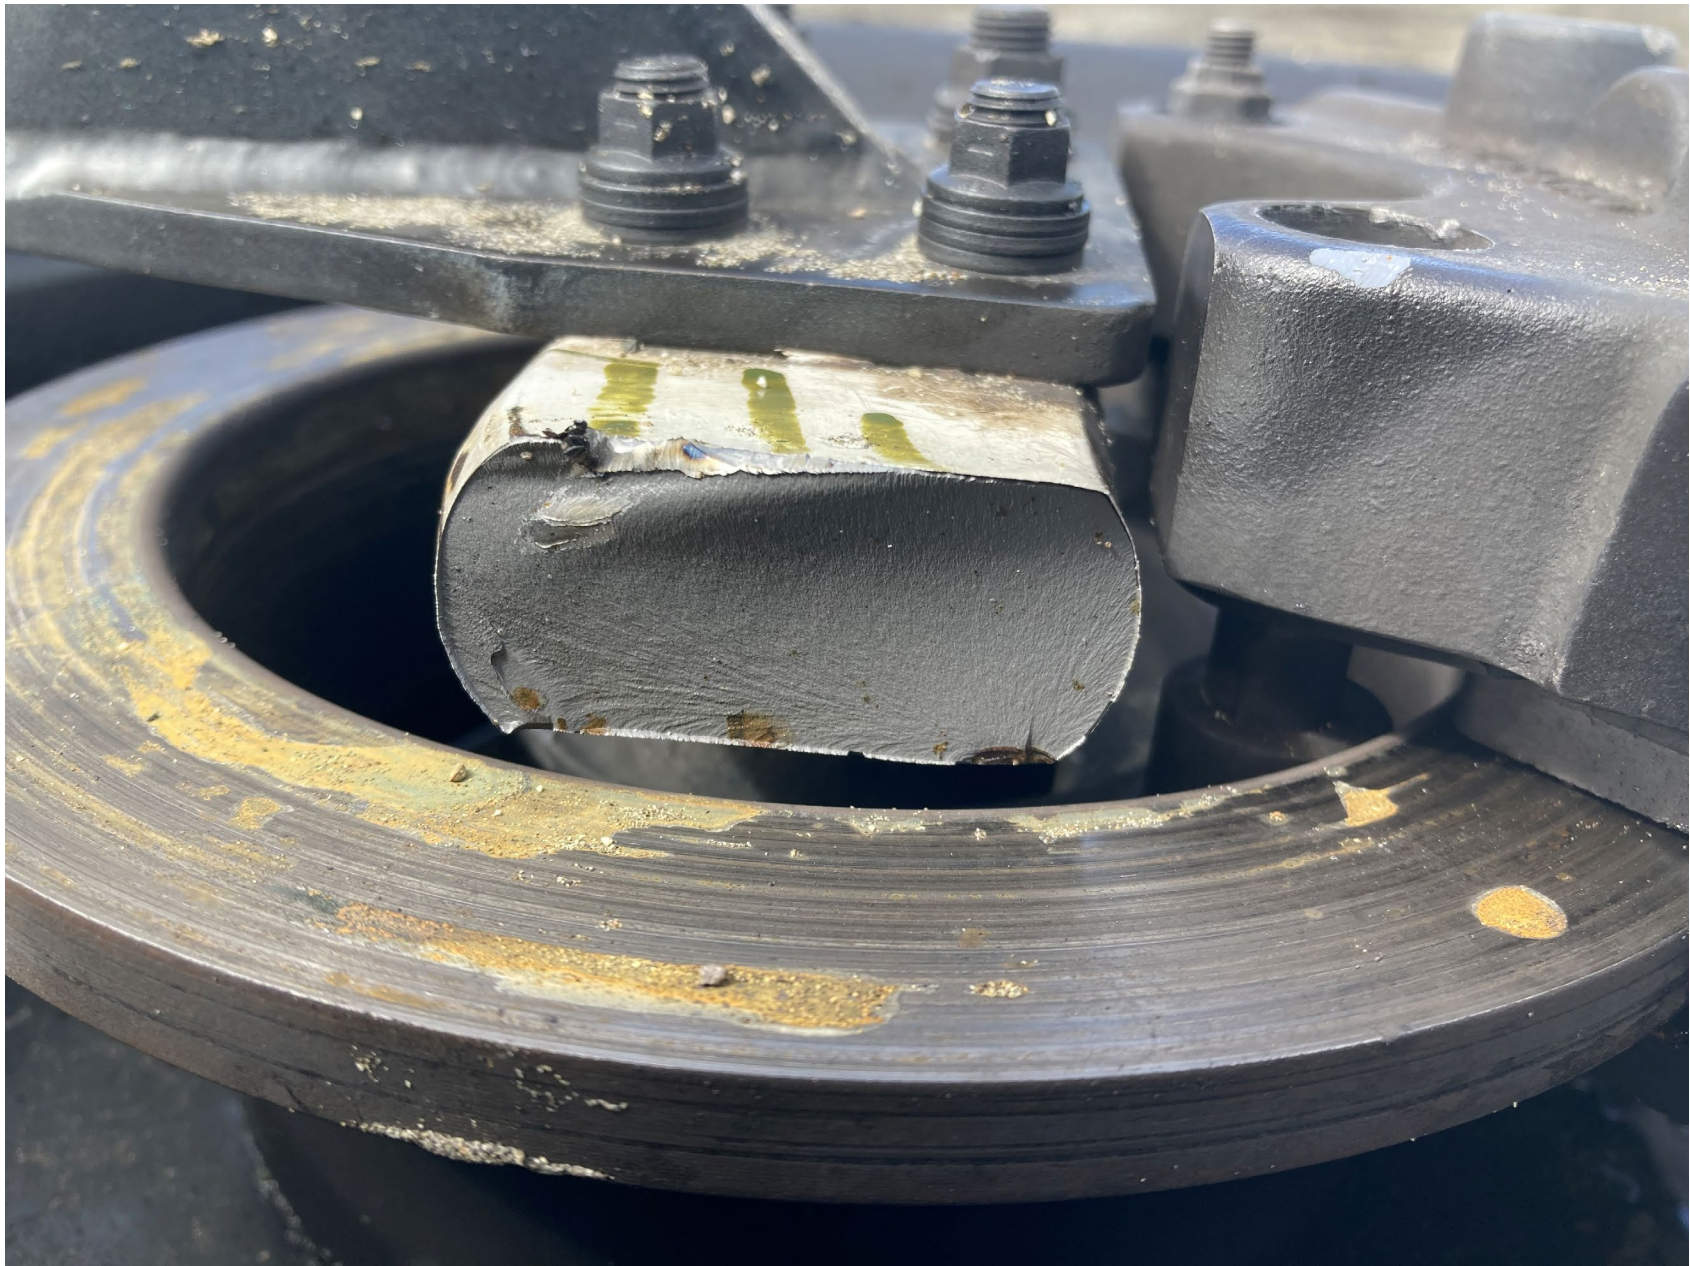
**Photo 2 – Fractured right main landing gear leg (Source: K Bay Air, LLC)**
