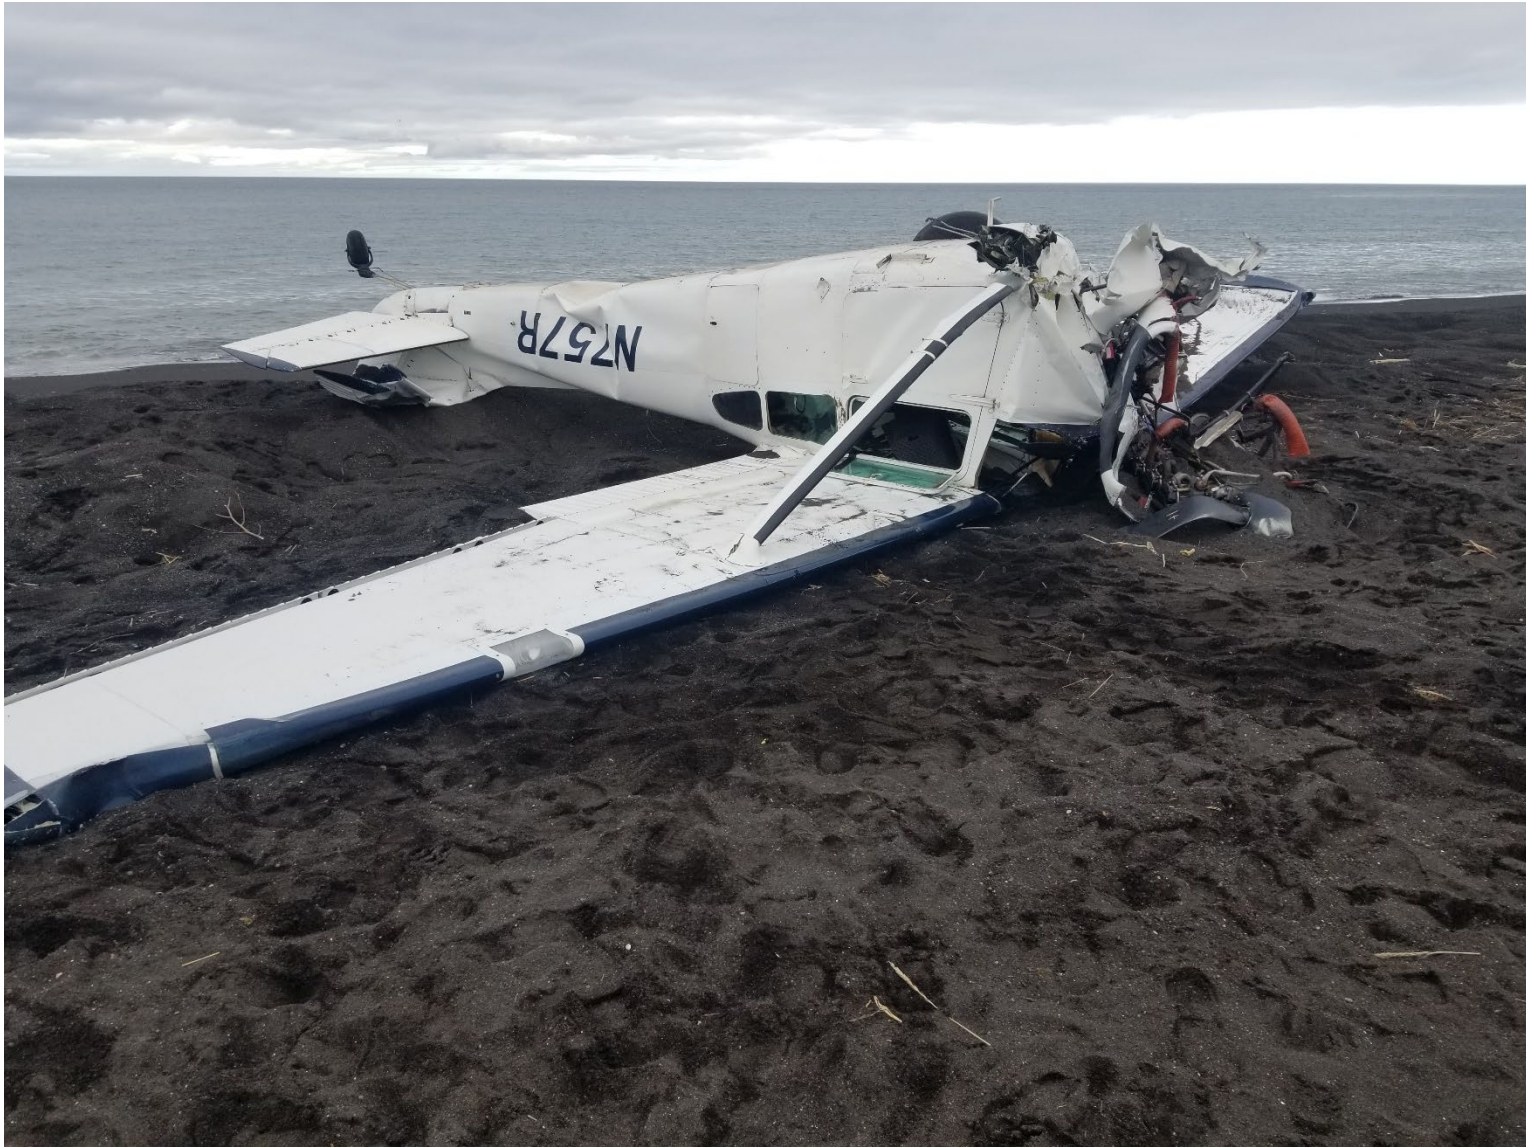
**Photo 1 –Left side view of accident airplane at accident site. Photo provided by owner.**

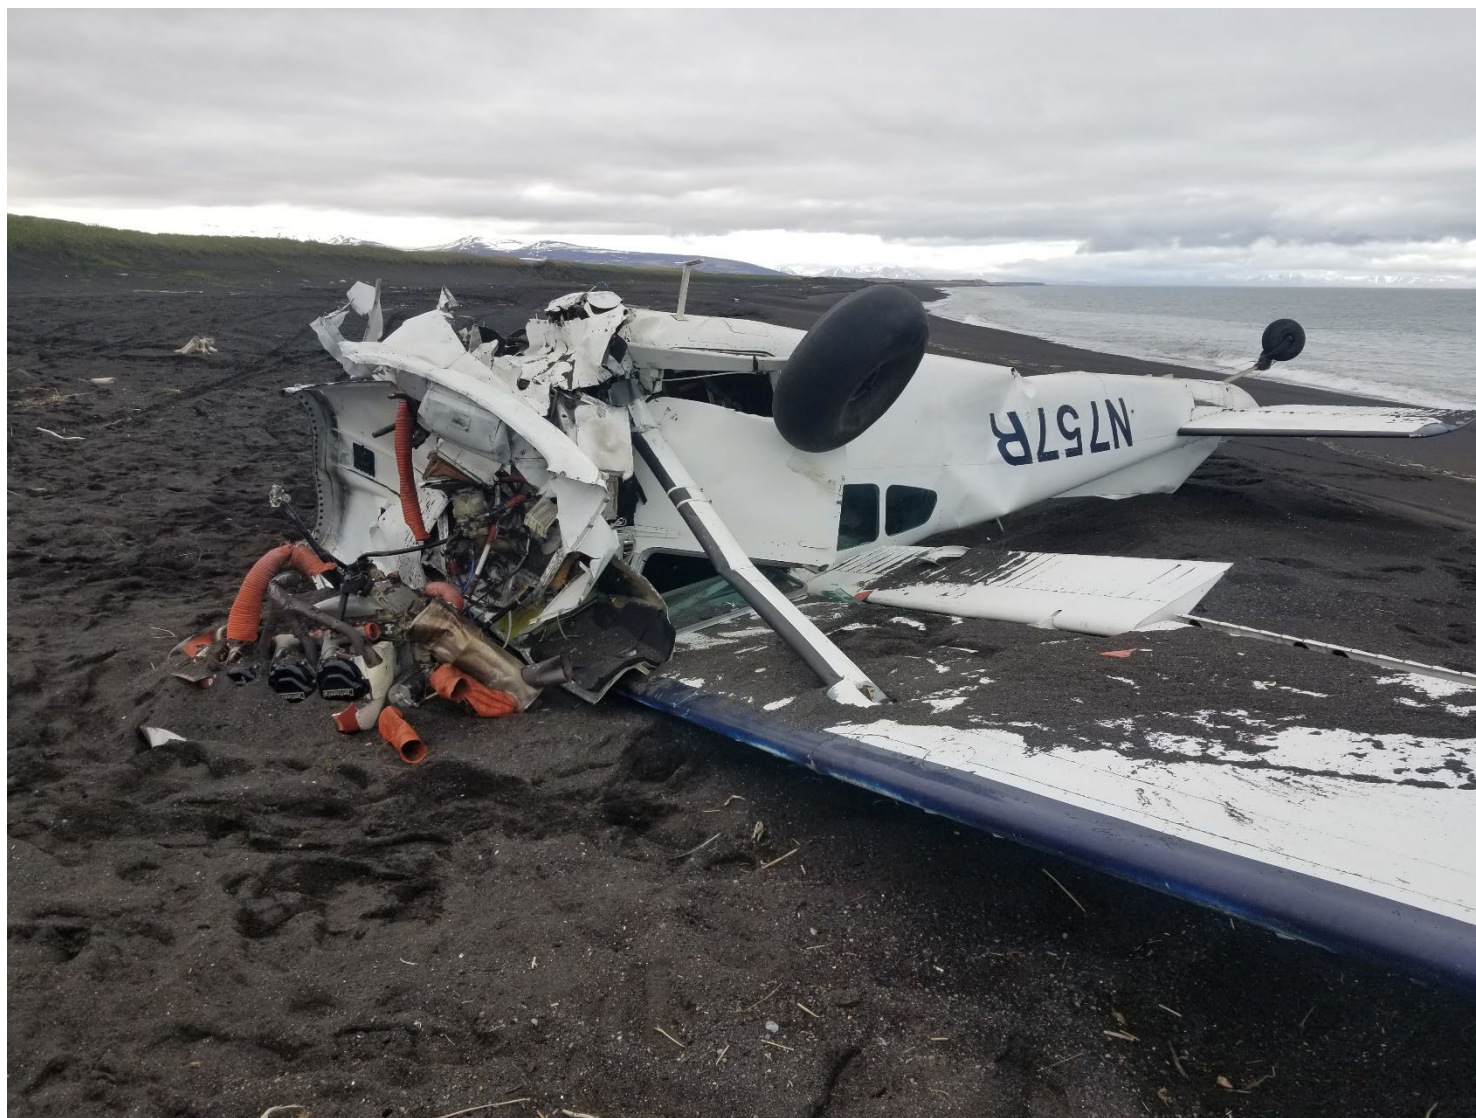
**Photo 2 – . Right side view of accident airplane at accident site. Photo provided by owner.**

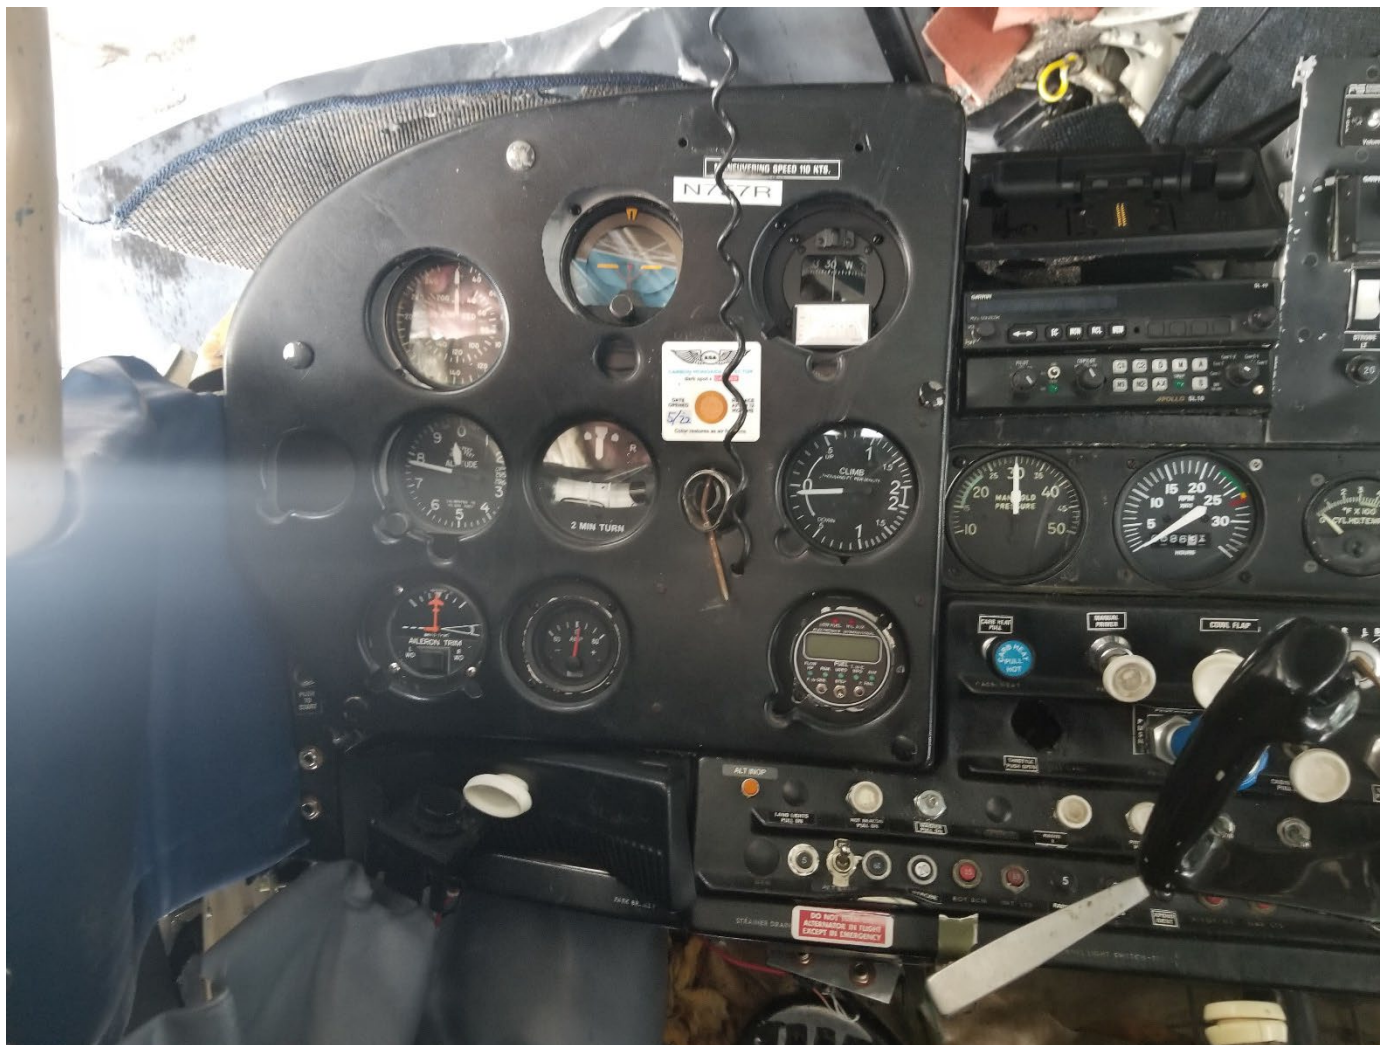
**Photo 3 – Cockpit view of the nail still installed in the yoke gust lock of accident airplane at accident site. Photo provided by the owner.**
