## Air Safety Investigations Aircraft Incident/Accident Technical Report

| Aircraft Incident/<br>Accident Information | Year: 1957 | Make: Cessna | Model: 180A |
| | Serial number: 50026 | | Registration: N9728B |
| Senior Air Safety Investigator: Jennifer D. Barclay | | Report #: ASI-22-CI-T | Report date: 04-03-23 |

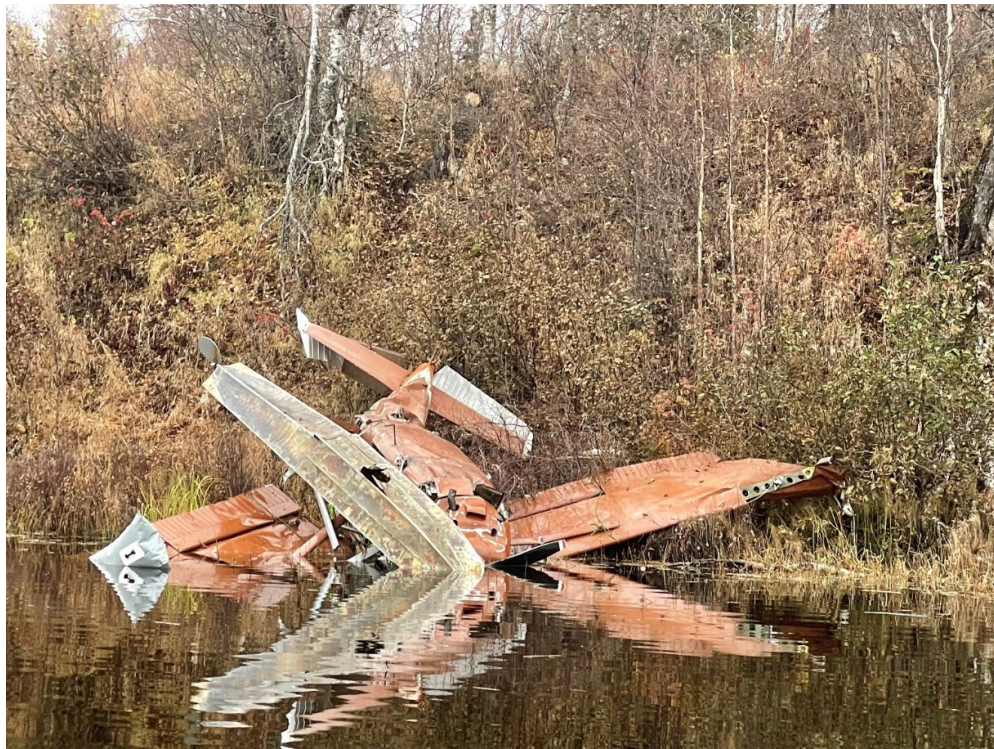
Photo courtesy of dive team

During a reported takeoff attempt, the right wingtip contacted the water and the aircraft cartwheeled causing the floats to spread, separating the left float before the aircraft came to rest inverted and submerged under water. The right wing sustained substantial impact damage to the leading edge from the wing tip to approximately Wing Station (WS) 136. The forward spar was forced aft, and the lower wing skin buckled upward. The right wingtip was not observed. Most of the right aileron remained attached except for an approximately 18" outboard section which was separated and not observed. The left wing separated at the aft attach point and remained attached at the forward attach point. The wing was partially submerged in water and appeared intact. The empennage sustained crush damage aft of the baggage door around the circumference of the aircraft and separated from the fuselage at Fuselage Station (FS) 108. The left elevator torque tube separated, and the rivets exhibited shear overload signatures. The left elevator remained attached at the outboard attach point. The left float, its struts and the aft spreader bar separated from the aircraft and were located approximately 175 yards northeast of the main wreckage. The right float, its struts and the forward spreader bar separated from the aircraft but remained attached by the flying wires. The right float exhibited a separation of the outboard hull approximately 18" forward of the step. No evidence of impact with a foreign object was noted. Both floats exhibited extensive corrosion and evidence of multiple repairs.

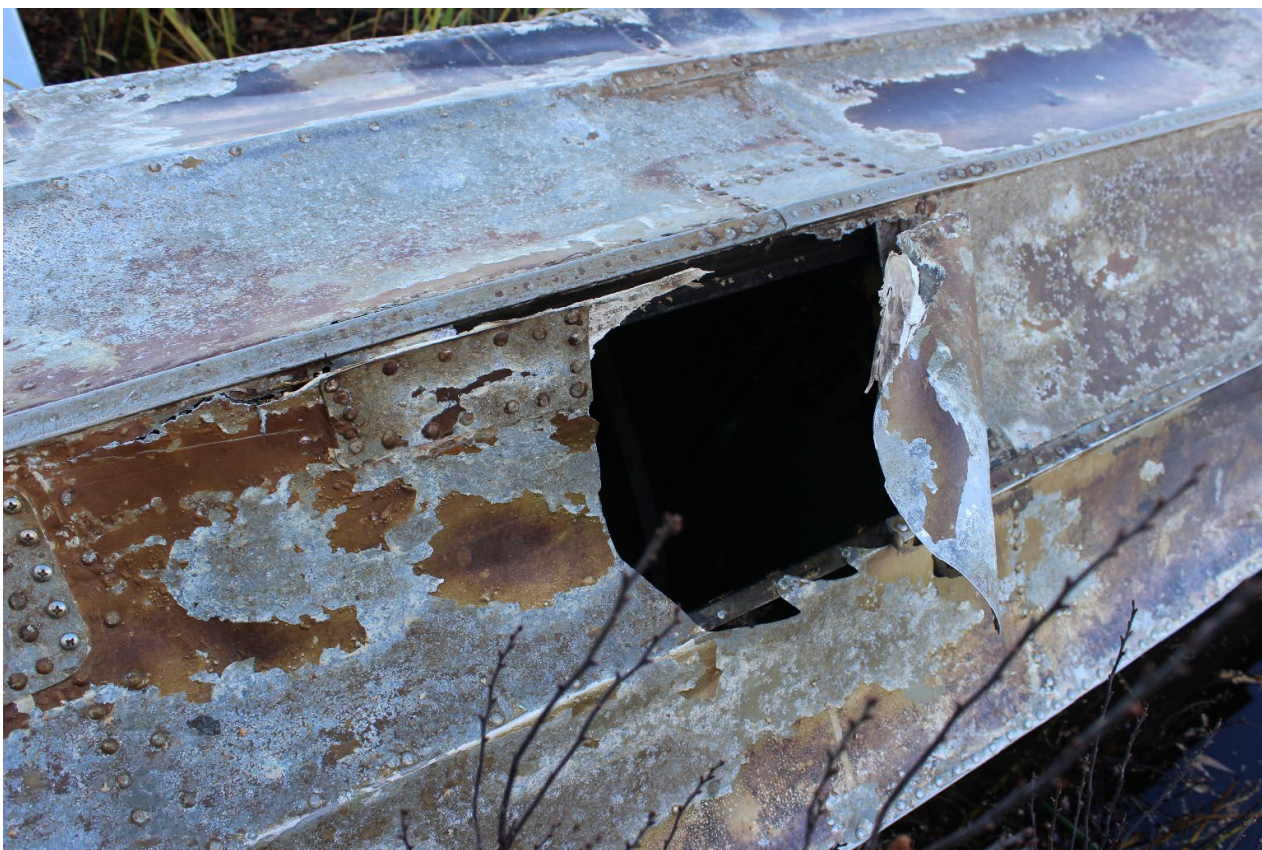
Right float hull separation, NTSB Photograph

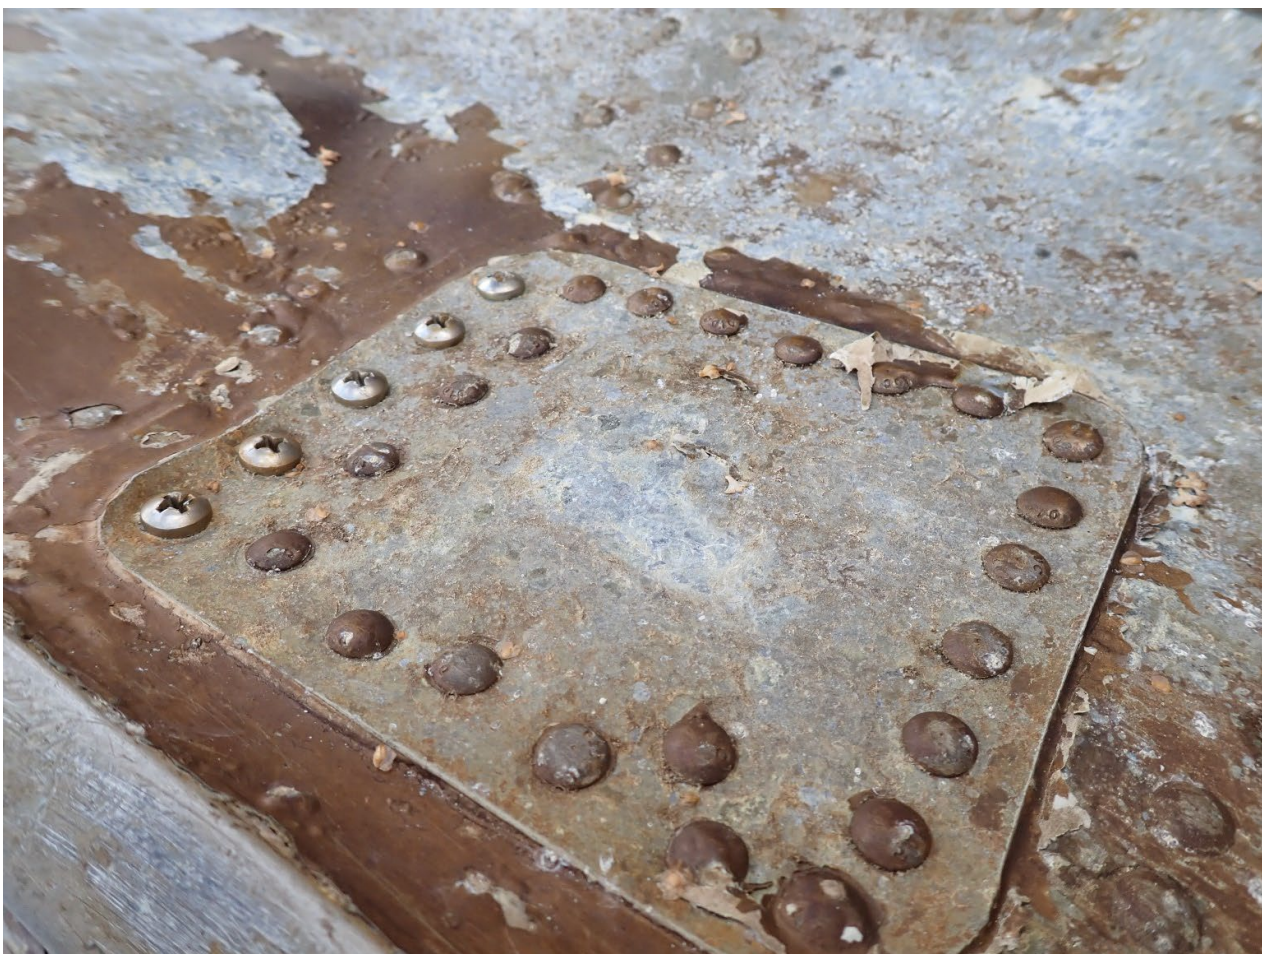
Repair to the hull of the right float, ASI-22-CI-072

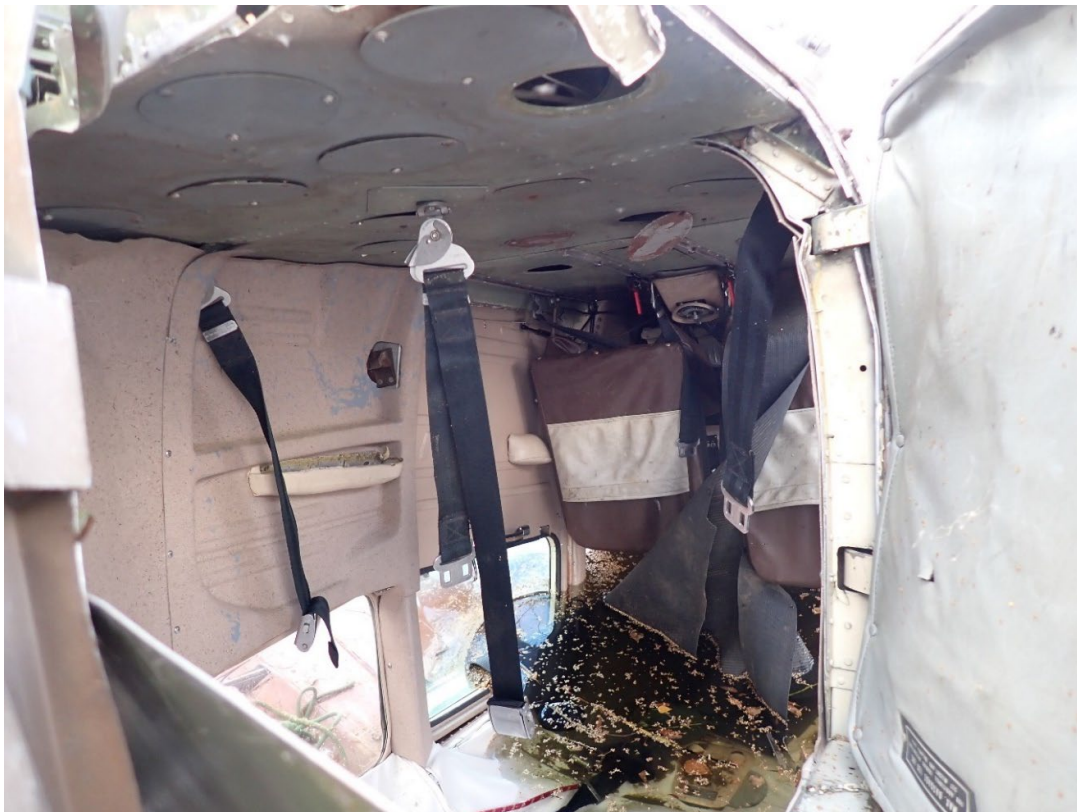
The pilot was utilizing the lap belt portion of the three-point restraint, shoulder harness usage was undetermined. The rear seats were not installed at the time of the accident. The left rear post of the pilot's seat base was fractured.

Cabin overview, ASI-22-CI-068

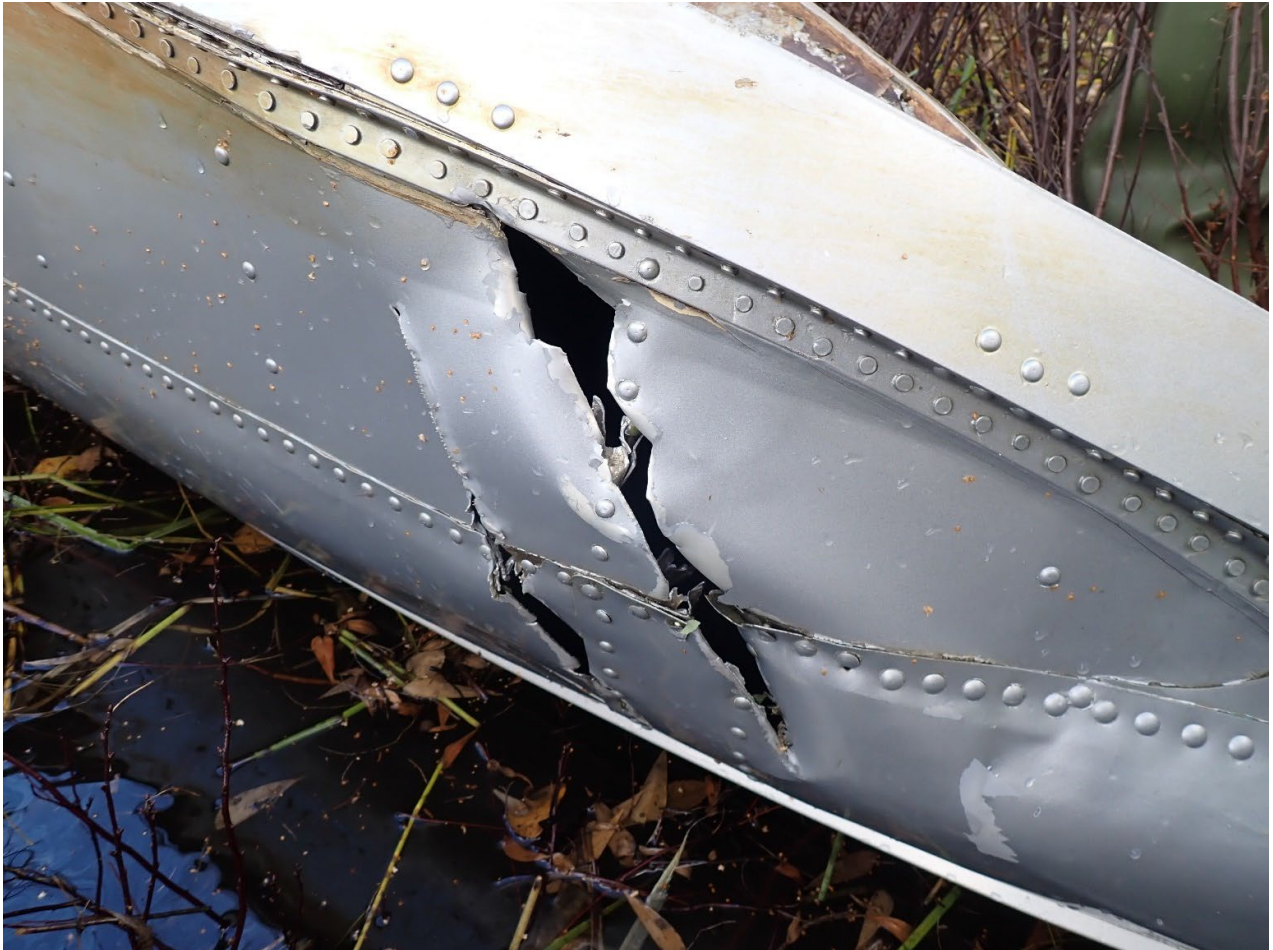
The propeller remained attached to the engine. One blade was curled aft at the tip and split spanwise approximately 1". The second blade was bent aft at midspan. Damage consistent with propeller strikes was noted on the inboard portion of the right float.

Propeller strike damage, ASI-22-CI-070
