## **NATIONAL TRANSPORTATION SAFETY BOARD**

Office of Aviation Safety  
Alaska Region

**Photo Array**

**ANC22LA080**

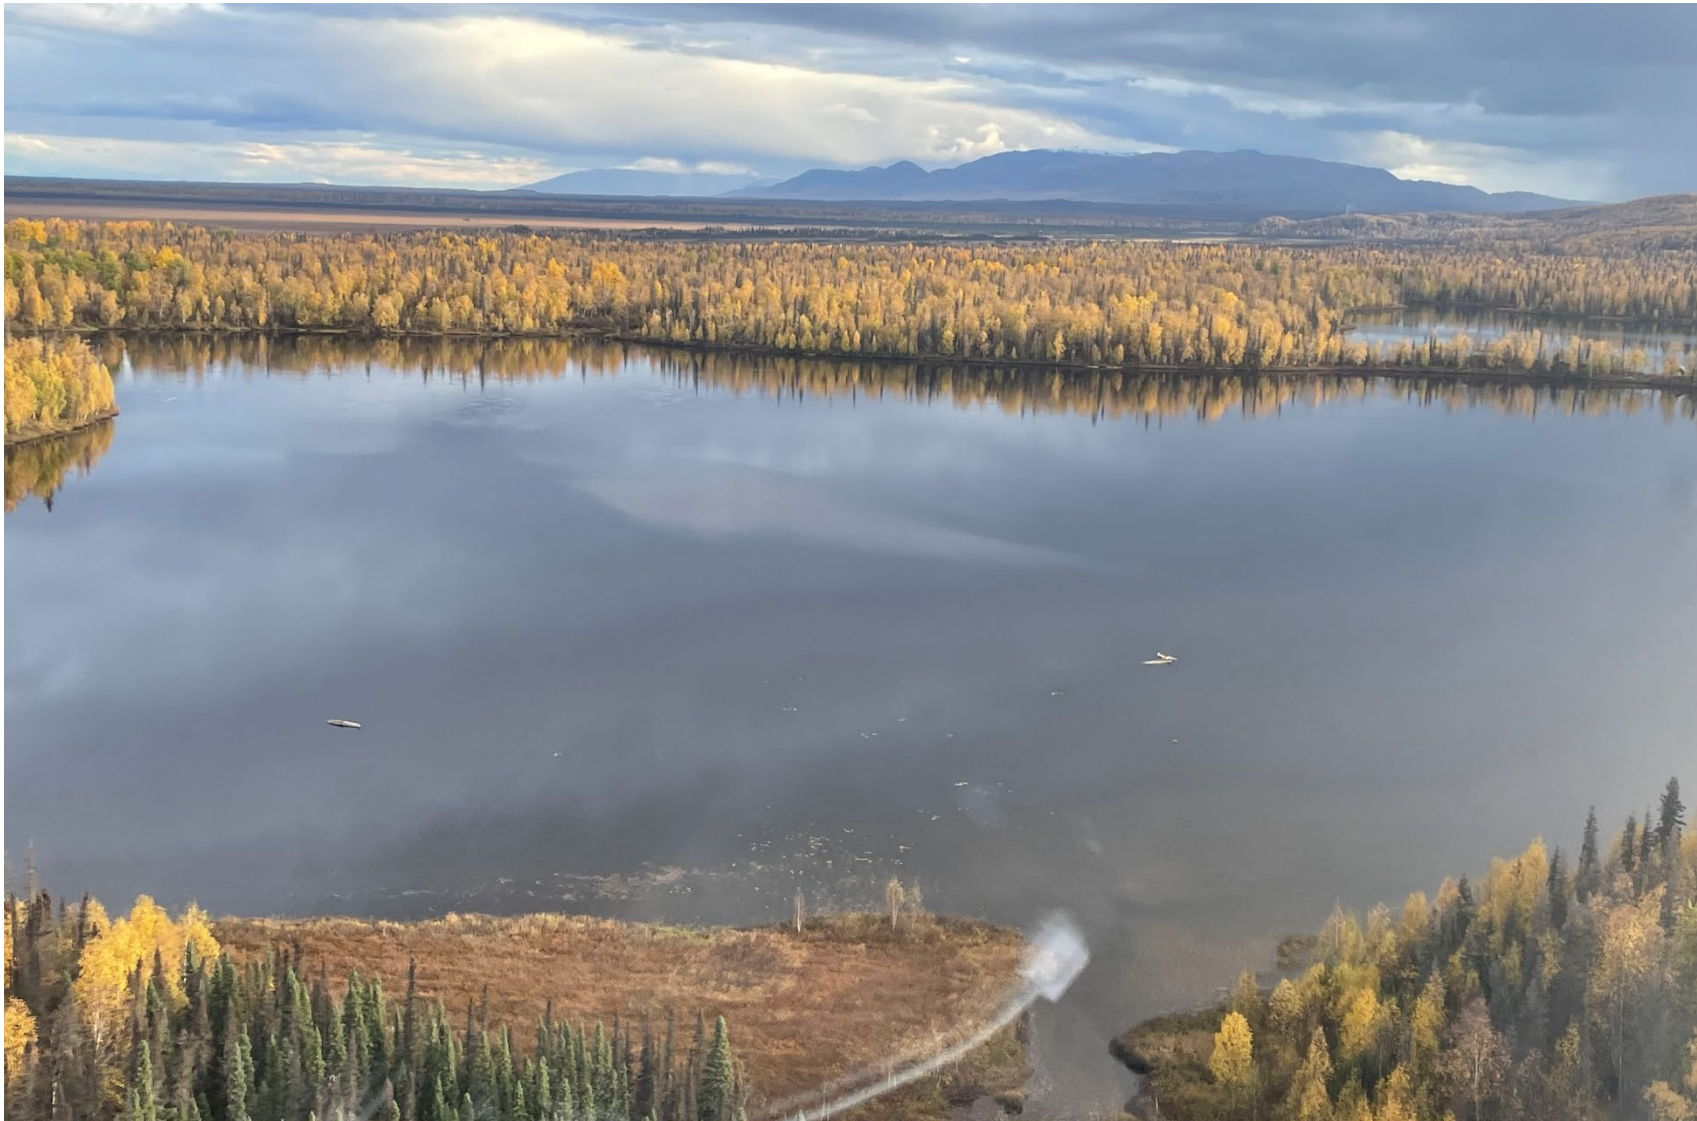
**Photo 1 – View of the airplane and left float in Whiskey Lake (Photo courtesy of Alaska State Troopers)**

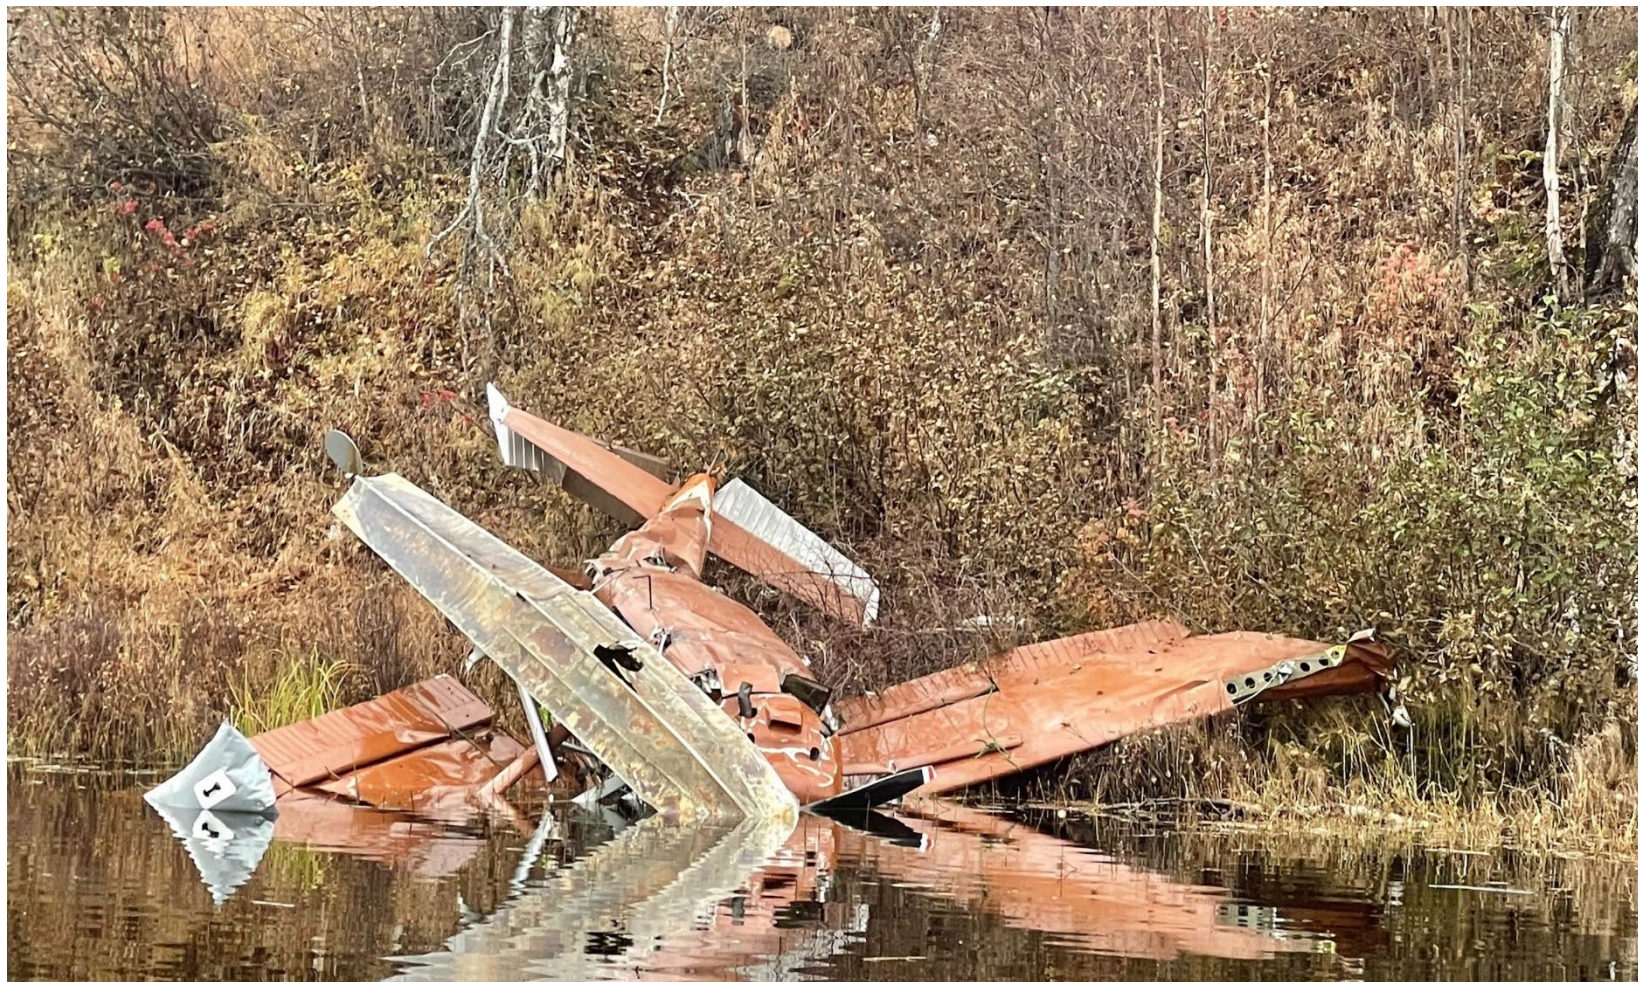
**Photo 2 – View of the airplane on the shore of Whiskey Lake after recovery.**

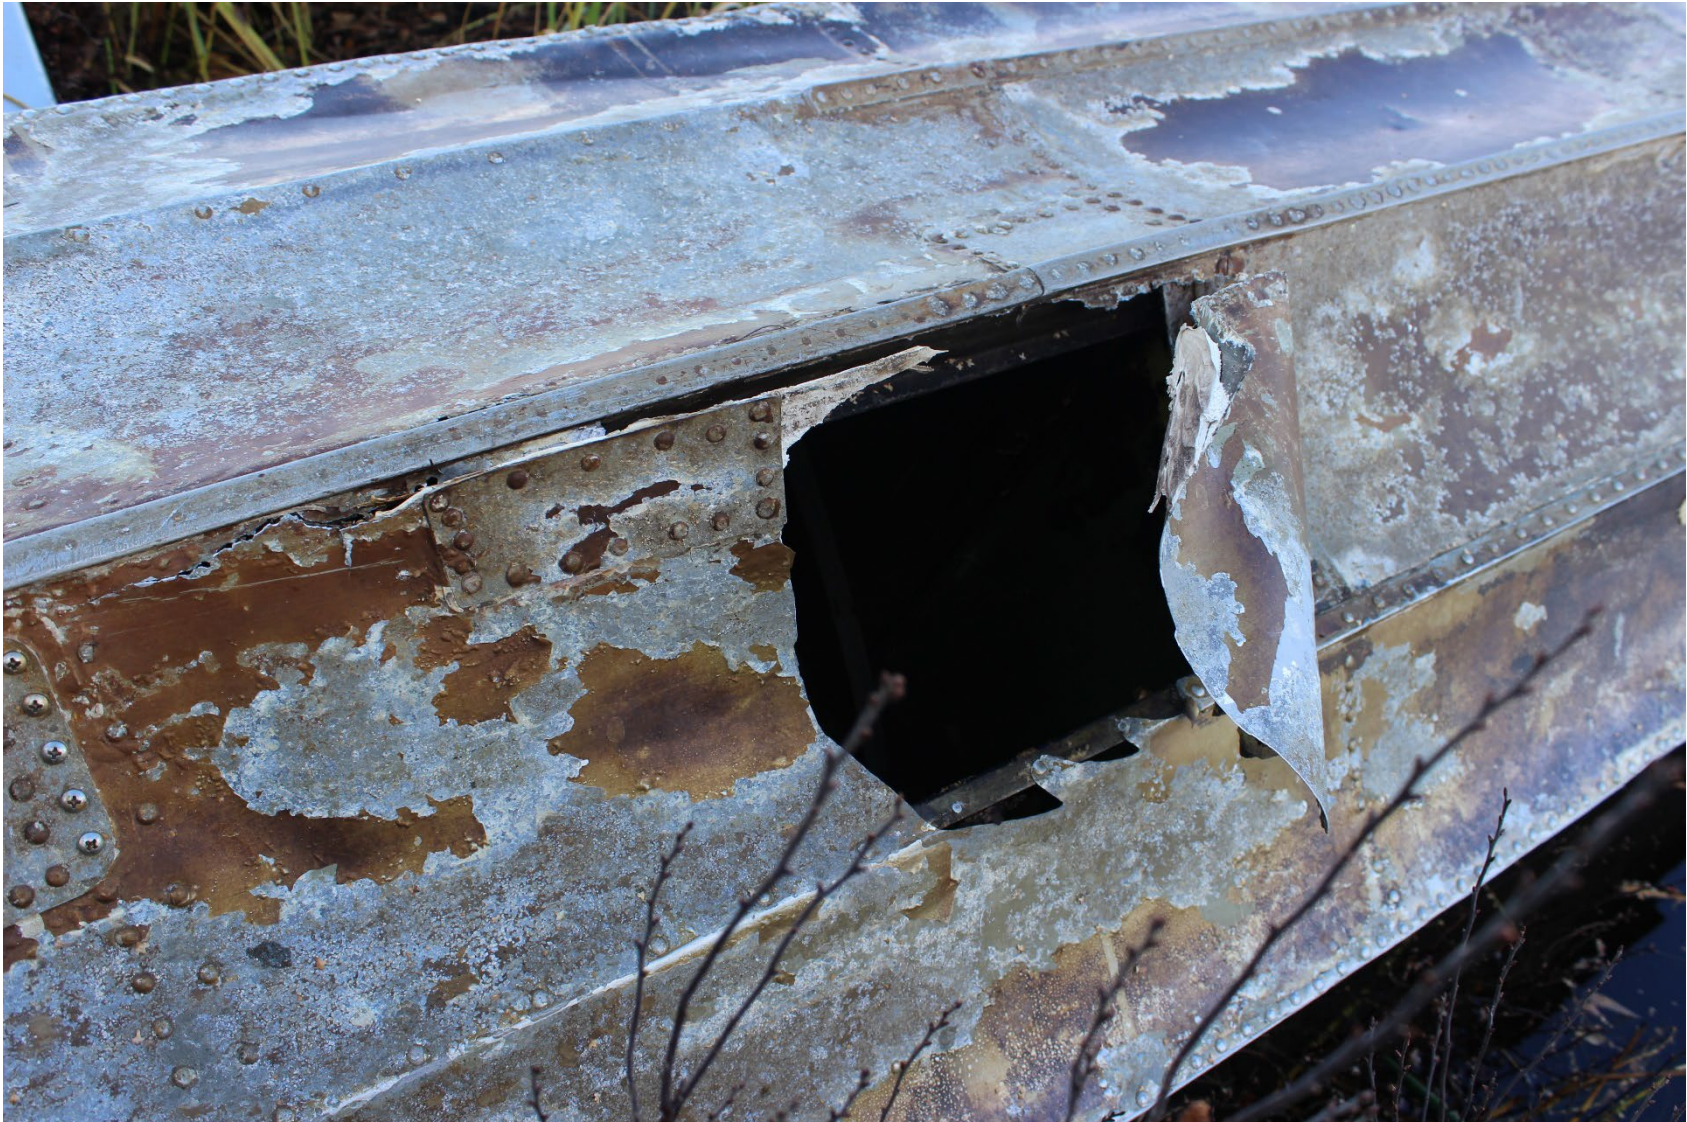
**Photo 3 – View of partially separated section on hull of the right float.**

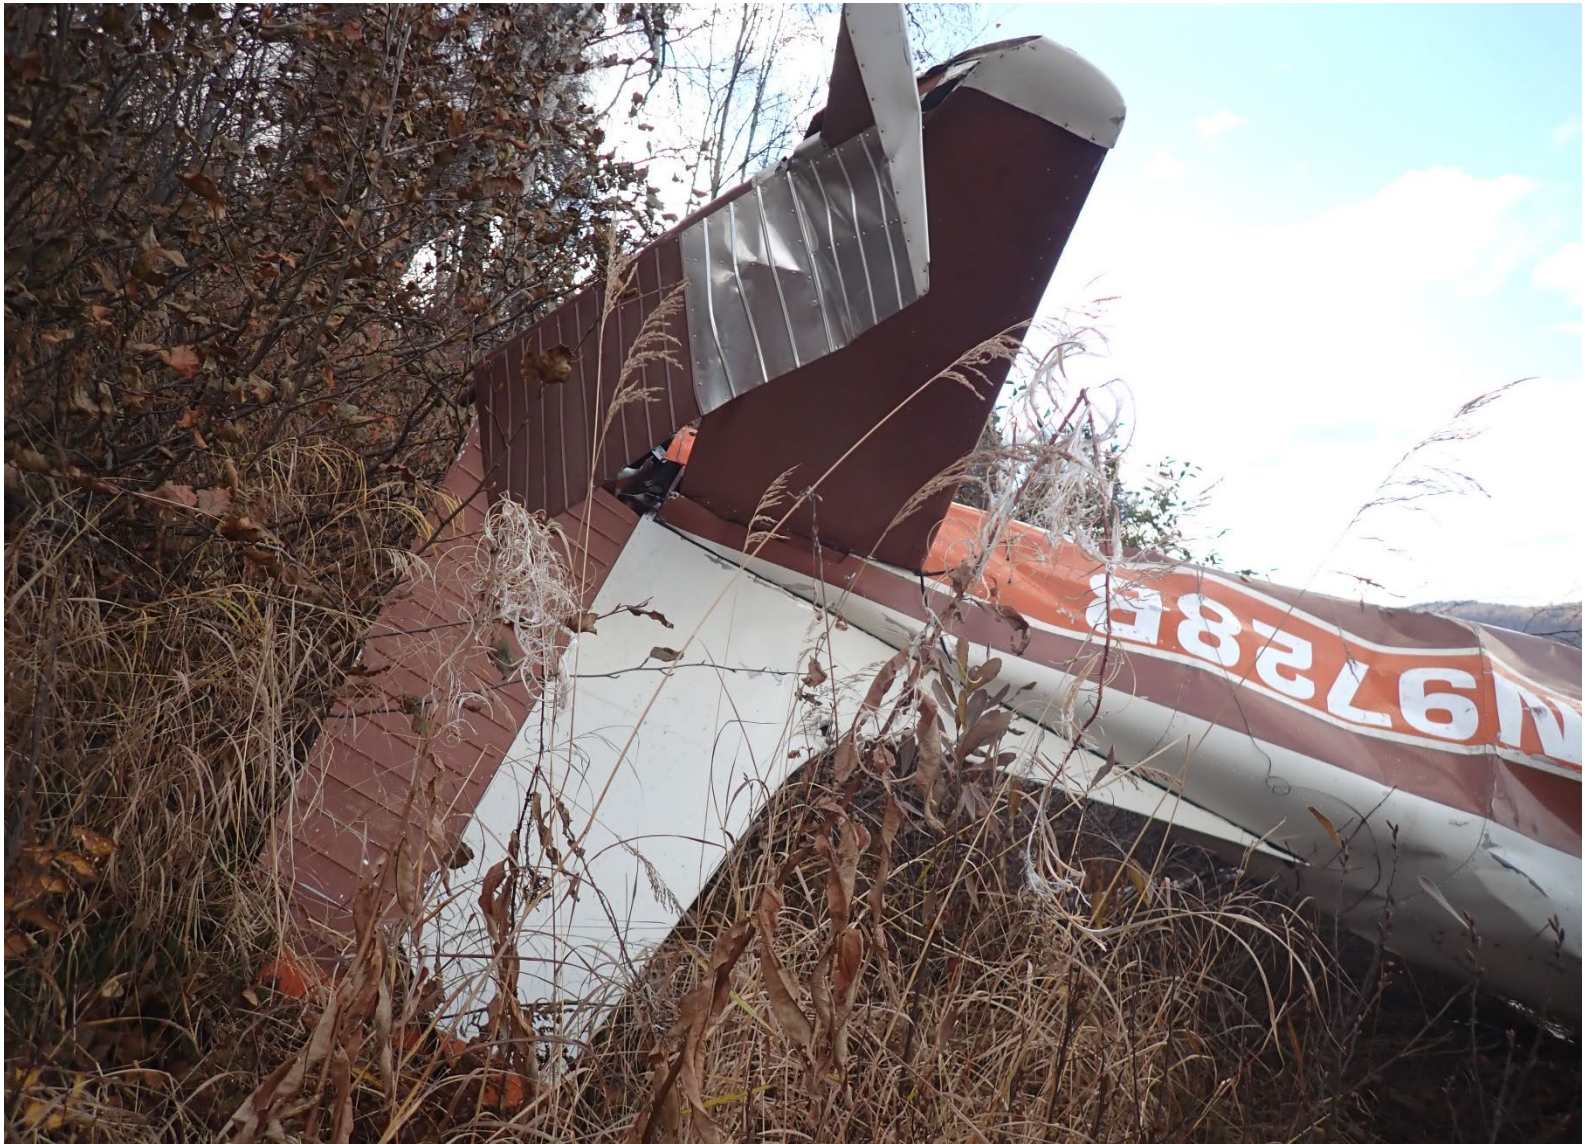
**Photo 4 – View of the empennage (Photo courtesy of Textron)**

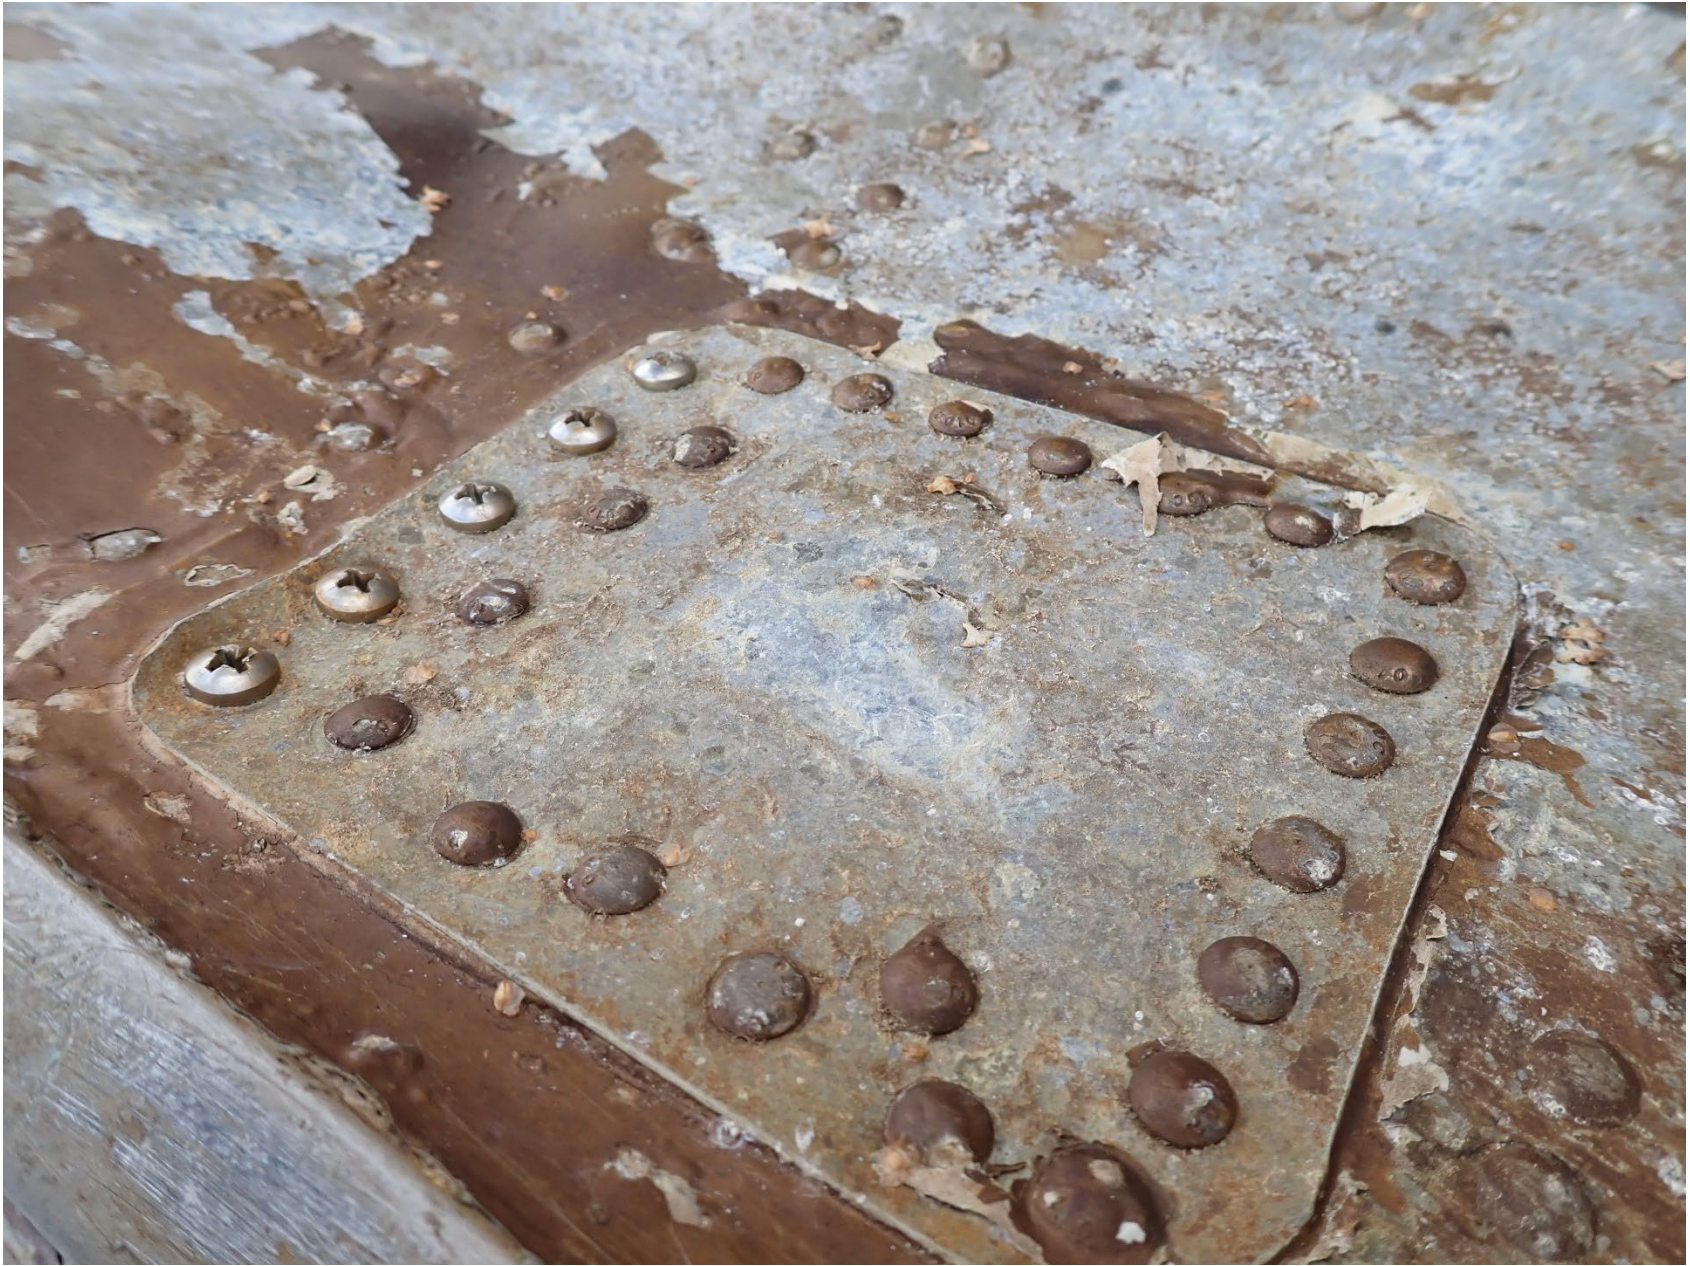
**Photo 5 – View of patch and screws on the hull of the right float. (Photo courtesy of Textron)**

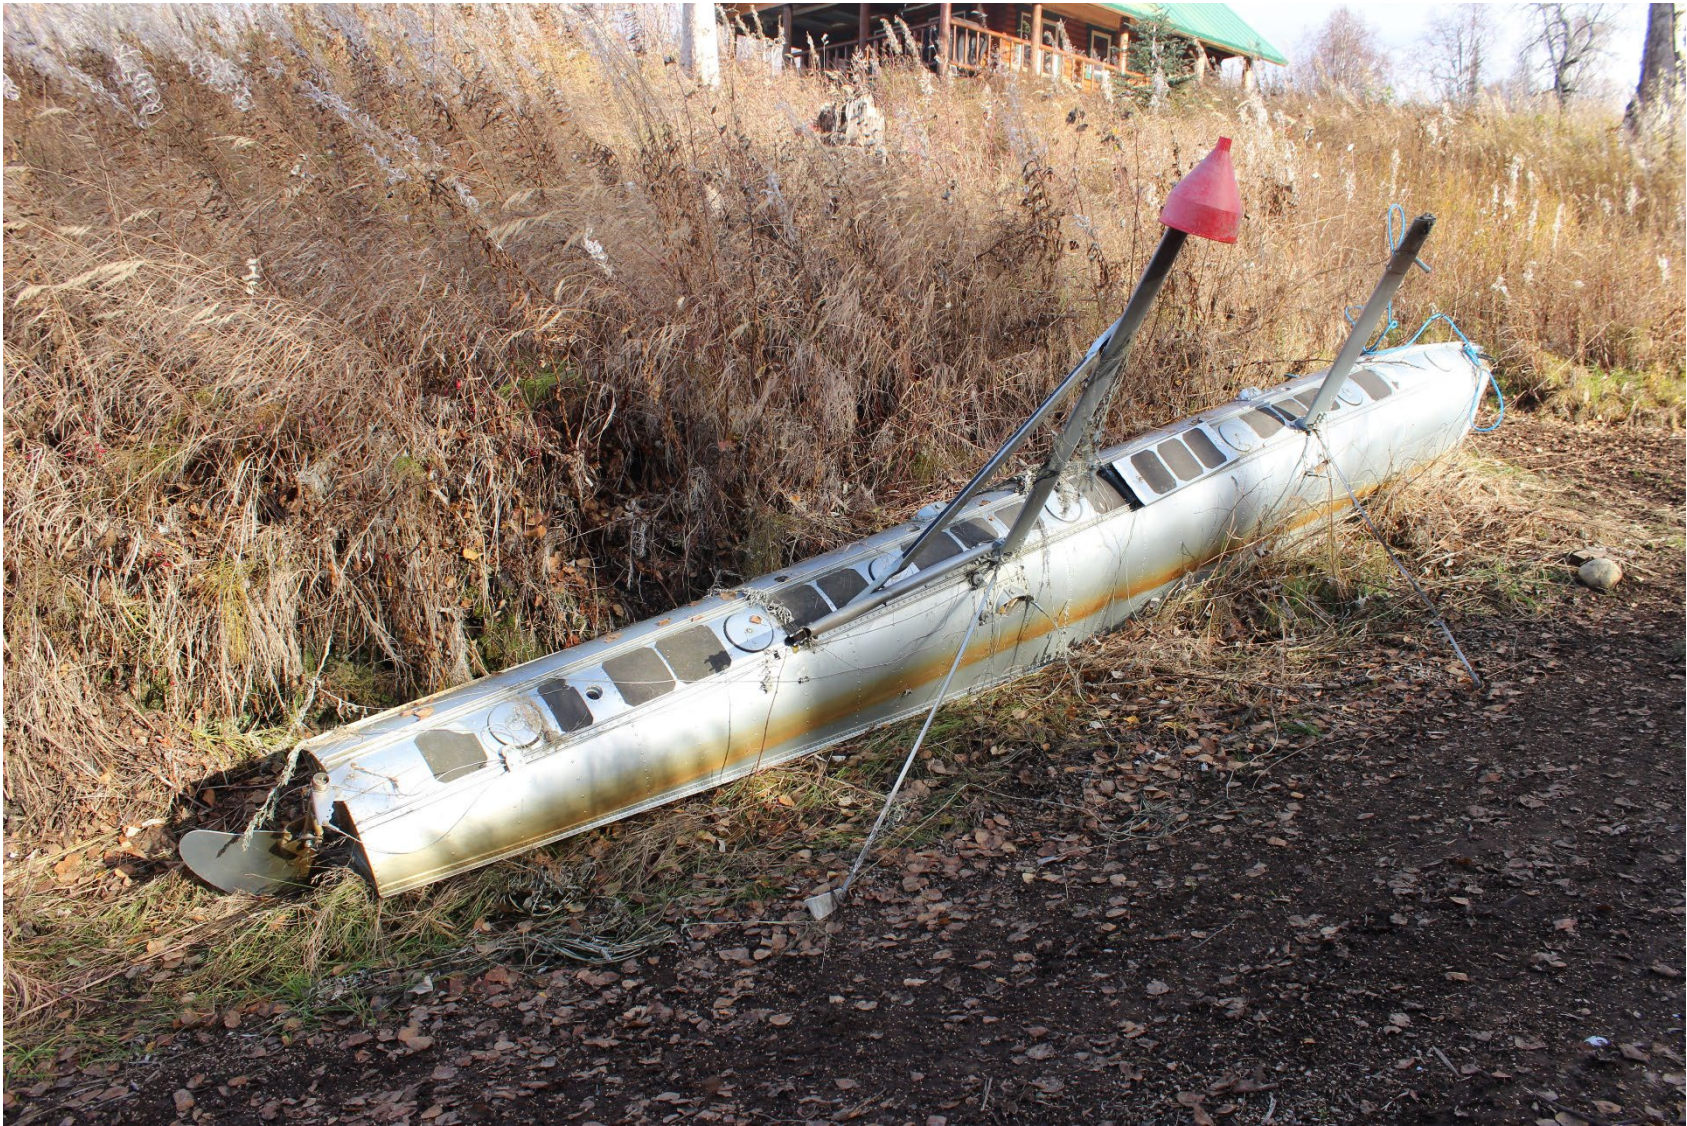
**Photo 6 – View of the left float.**

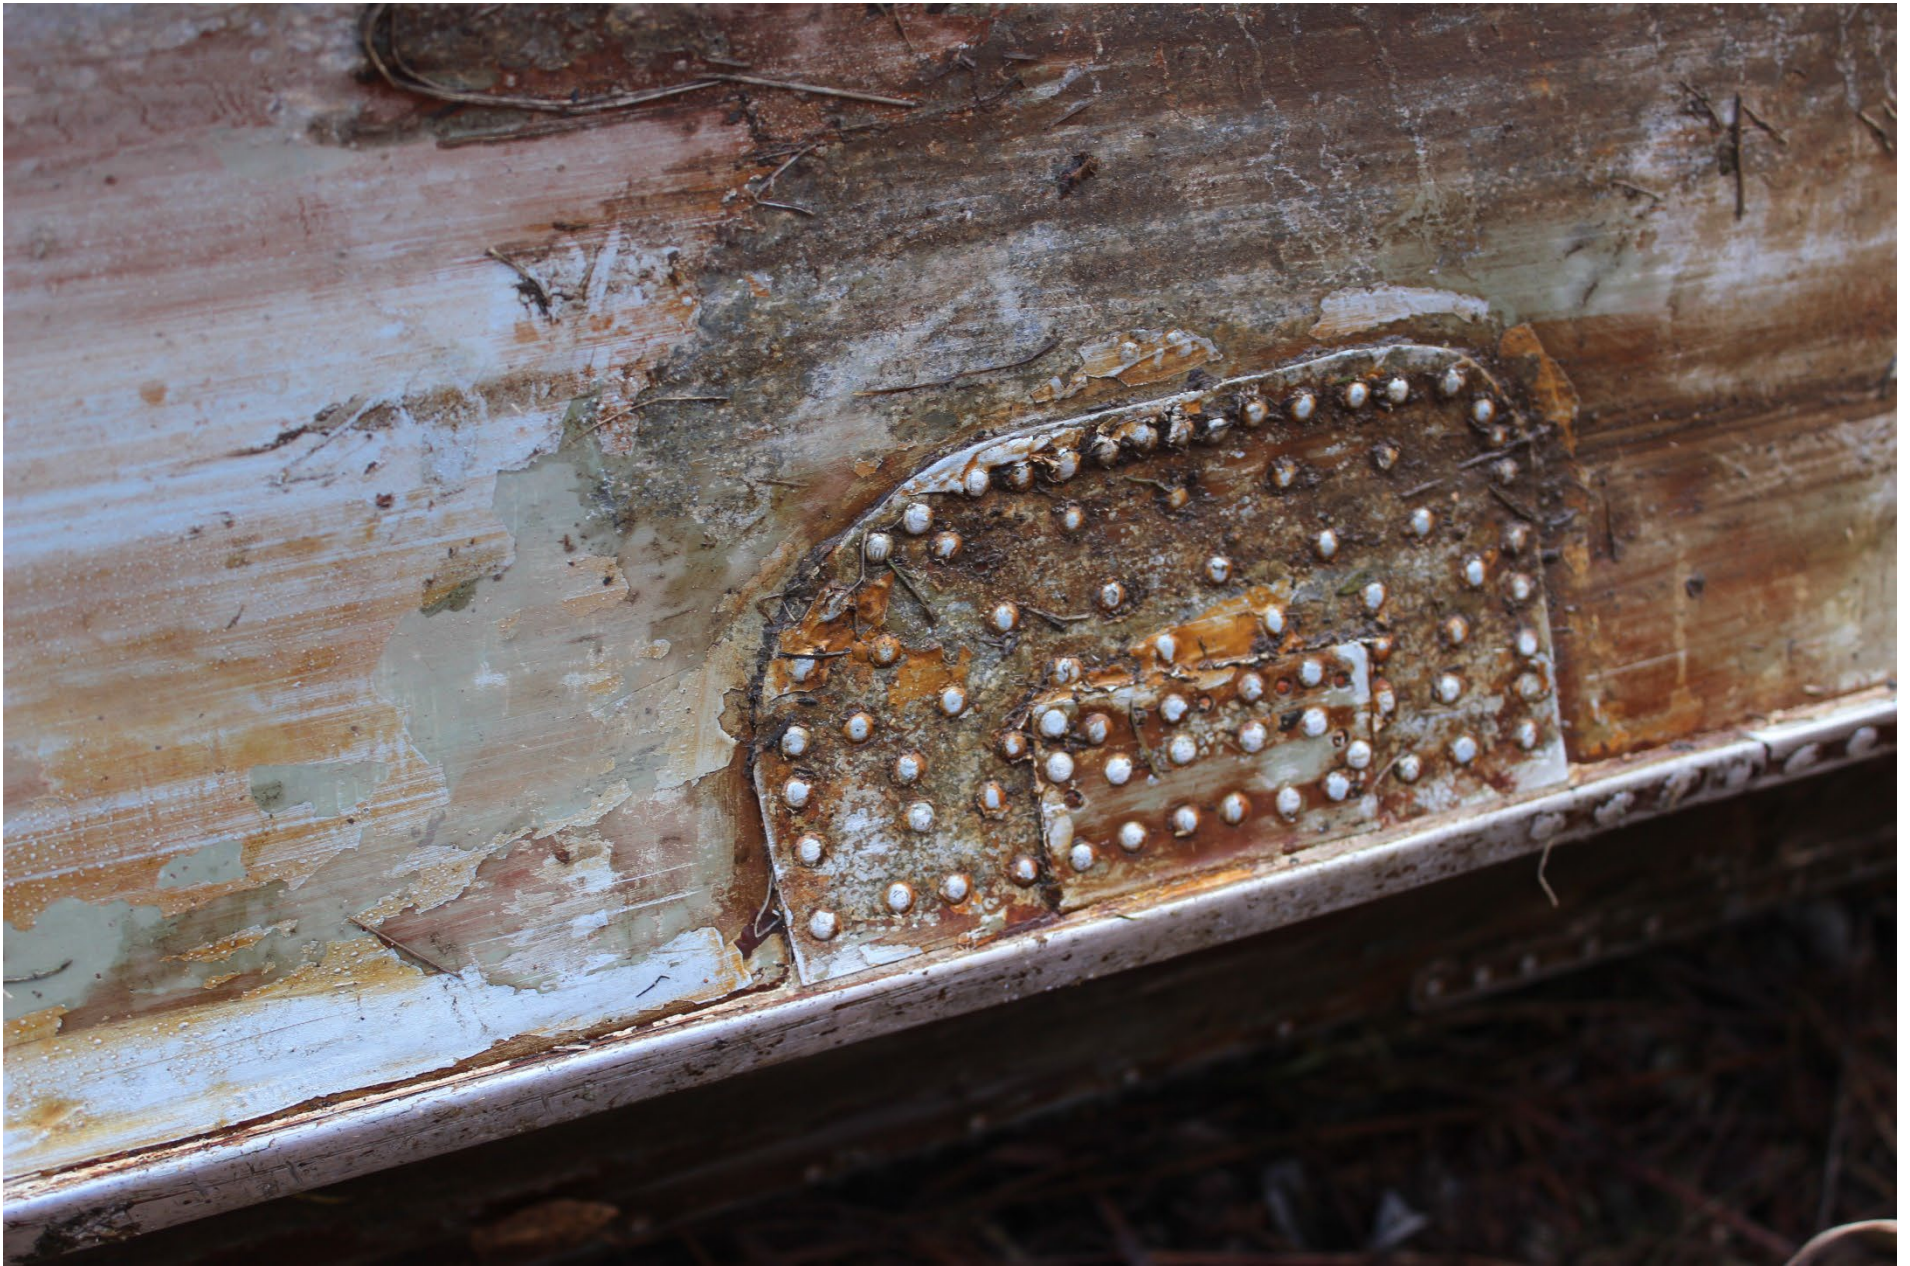
**Photo 7 - View of multiple patches on the left float.**
