# National Transportation Safety Board

ANC22LA080

## **WRECKAGE EXAMINATION SUMMARY**

Location: Skwentna, Alaska  
Date: September 25, 2022  
Time: 1300 AKDT  
Airplane: Cessna 180A, N9728B

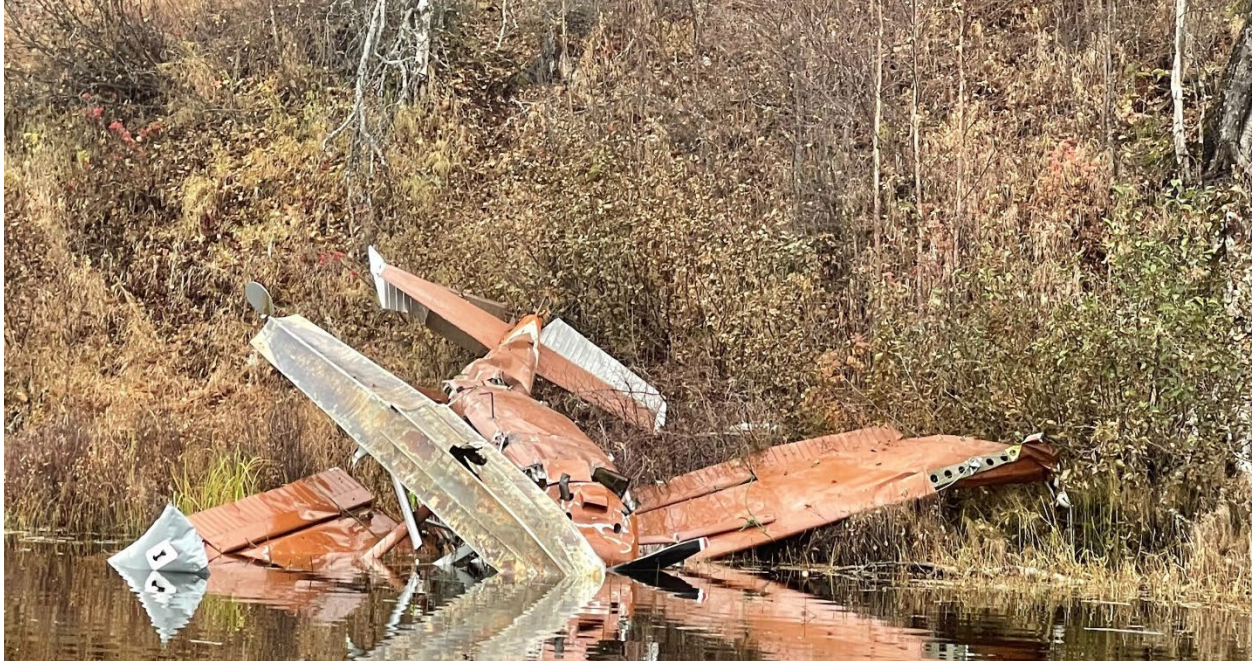
On October 4, members from the Alaska Dive Search Rescue and Recovery Team traveled to Whiskey Lake and subsequently recovered the submerged airplane, then moved it to the shoreline. The airplane rested inverted on the shore, the empennage and right wing were on land, the engine and left wing remained mostly submerged in the lake.

**Figure 1 View of wreckage on the shore of Whiskey Lake after recovery.**

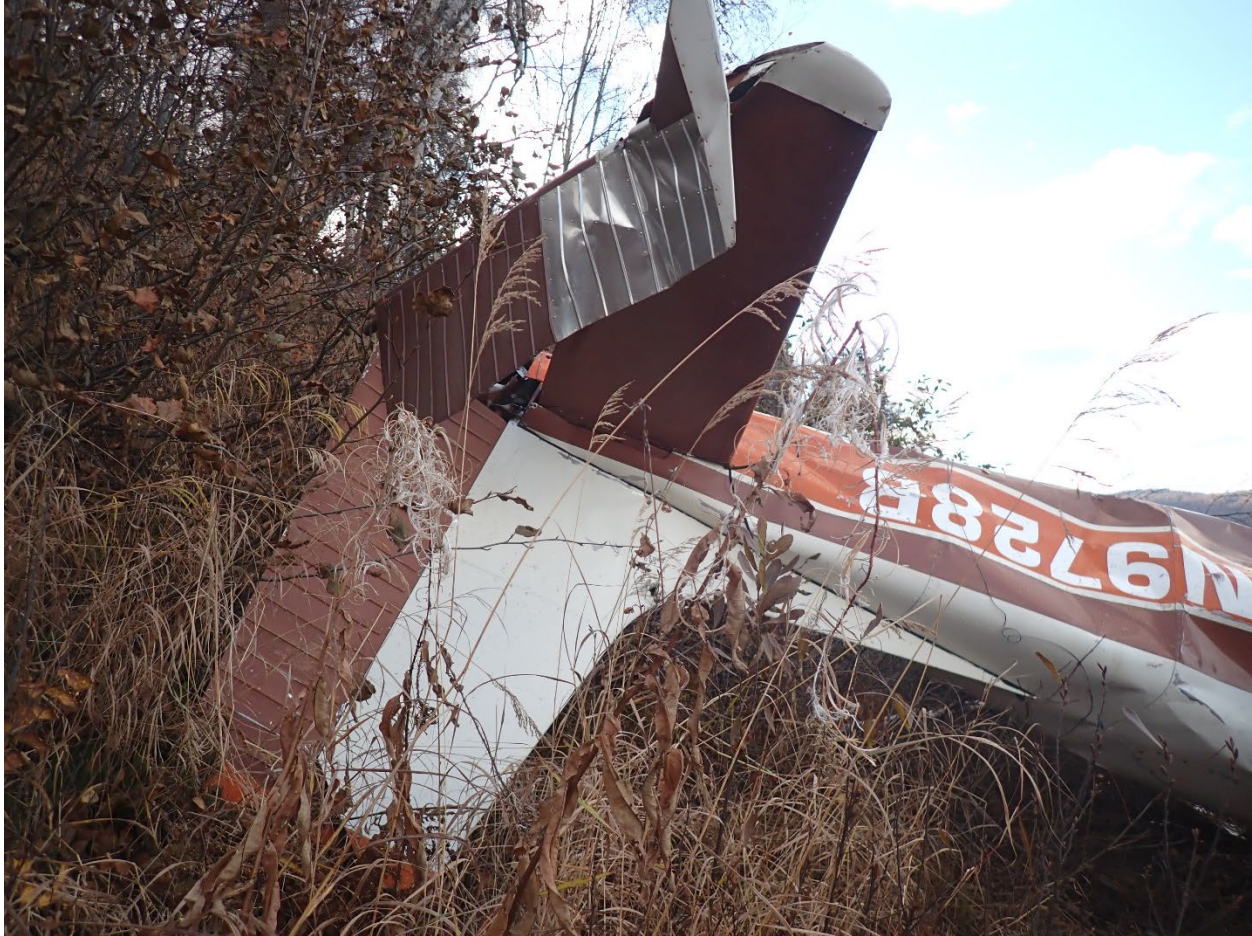
The empennage sustained crush damage aft of the baggage door around the circumference of the aircraft and separated from the fuselage. The left elevator remained attached at the outboard attach point.

**Figure 2 View of the empennage.**

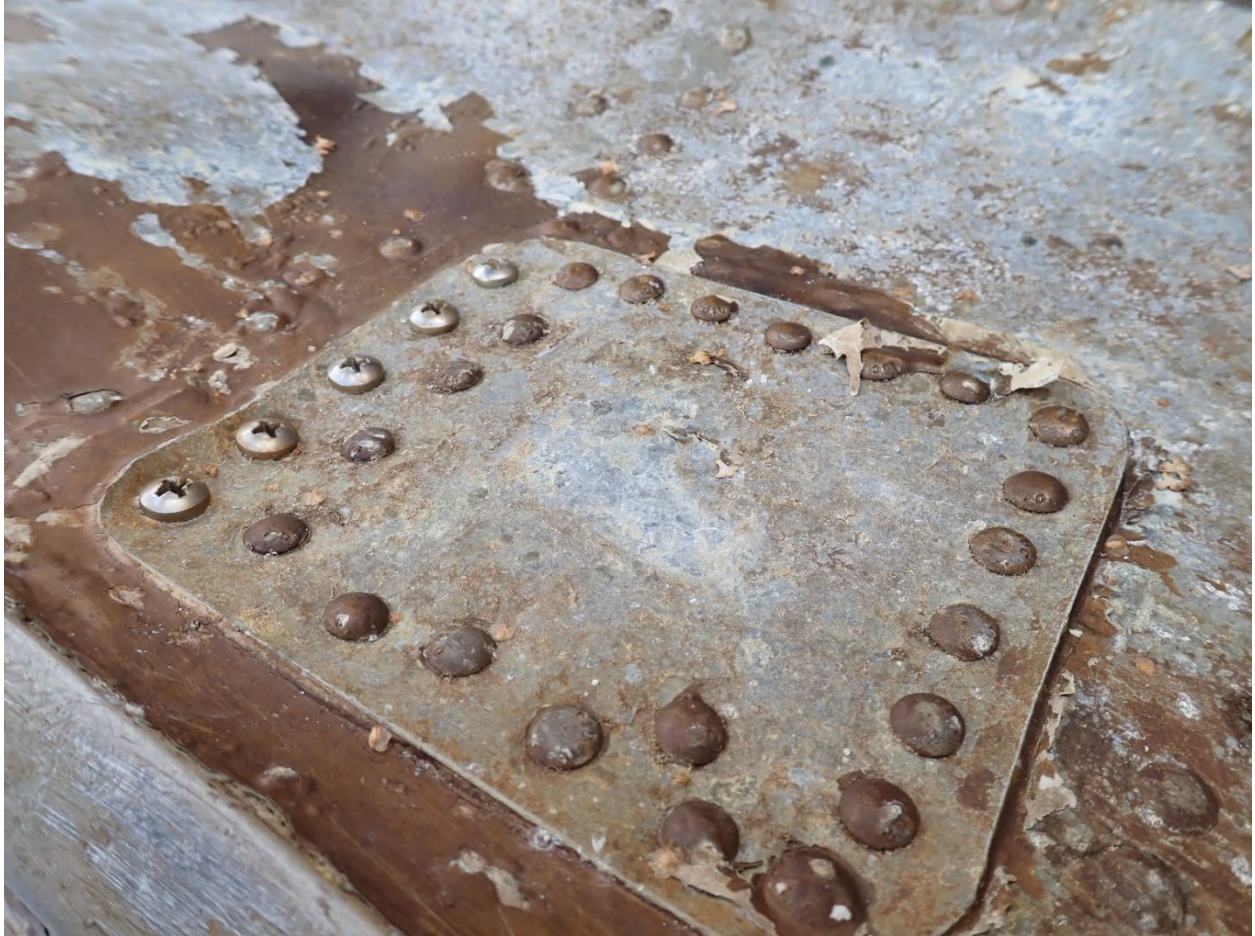
The airplane was equipped with EDO model 249-2870 straight floats. The bottoms of the floats were heavily corroded. The left float, its struts and the aft spreader bar separated from the aircraft and were located approximately 175 yards northeast of the main wreckage. The right float, its struts and the forward spreader bar separated from the aircraft but remained attached by the flying wires. The right float exhibited a separation of the outboard hull approximately 18" forward of the step. No evidence of impact with a foreign object was noted. Both floats exhibited extensive corrosion and evidence of multiple repairs. There were six patches noted on the bottom of the right float. One patch had a row of screws next to a row of rivets. STC paperwork revealed the EDO floats were installed on June 17, 1960.

**Figure 3 View of patch and screws on the hull of the right float (Photo courtesy of Textron)**

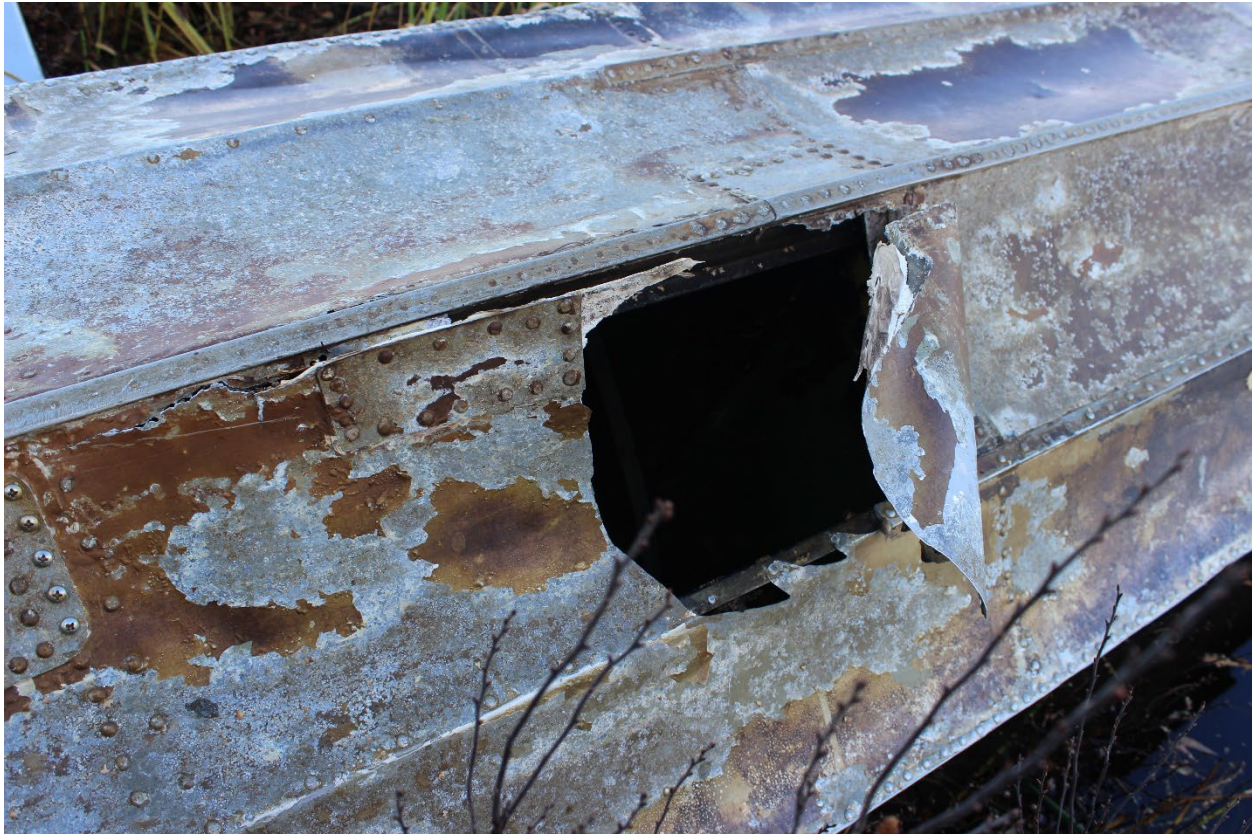
A portion of the right float was partially separated and bent aft, about midspan from the tip of the float to the step. Extensive exfoliation and corrosion were present.

**Figure 4 View of the partially separated section of the right float.**

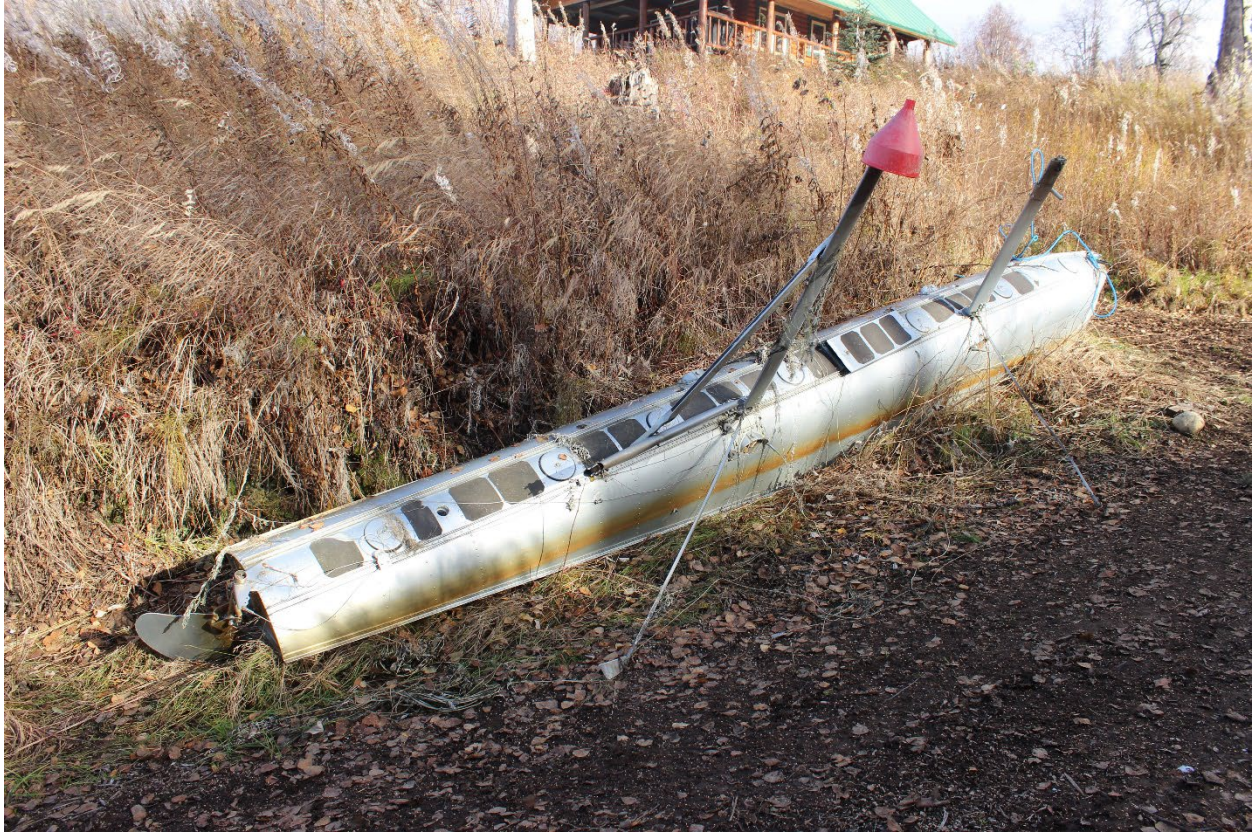
**Figure 5 View of the left float.**

The left float was separated from the fuselage, two patches (one on top of the other) were noted on the bottom of the left float. The left float had impact damage to the front tip of the float.

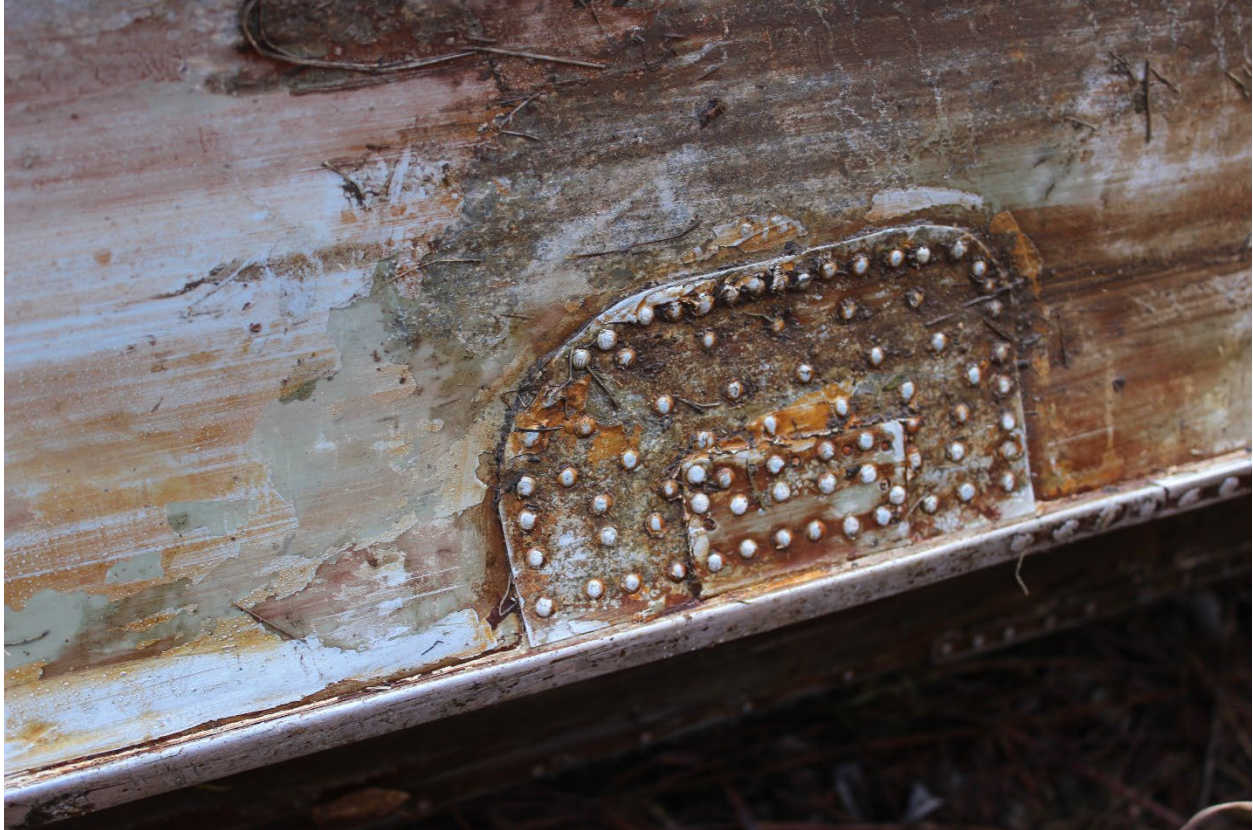
**Figure 6 View of multiple patches on the bottom of the left float.**
