Mark Ward  
ASI  
Alaska Region

**Date:** 2/3/2023  
**Subject:** ANC23FA001 Information provided by the FAA  
**Contact:** Dustin Hopkins ASI FAA FBK AK

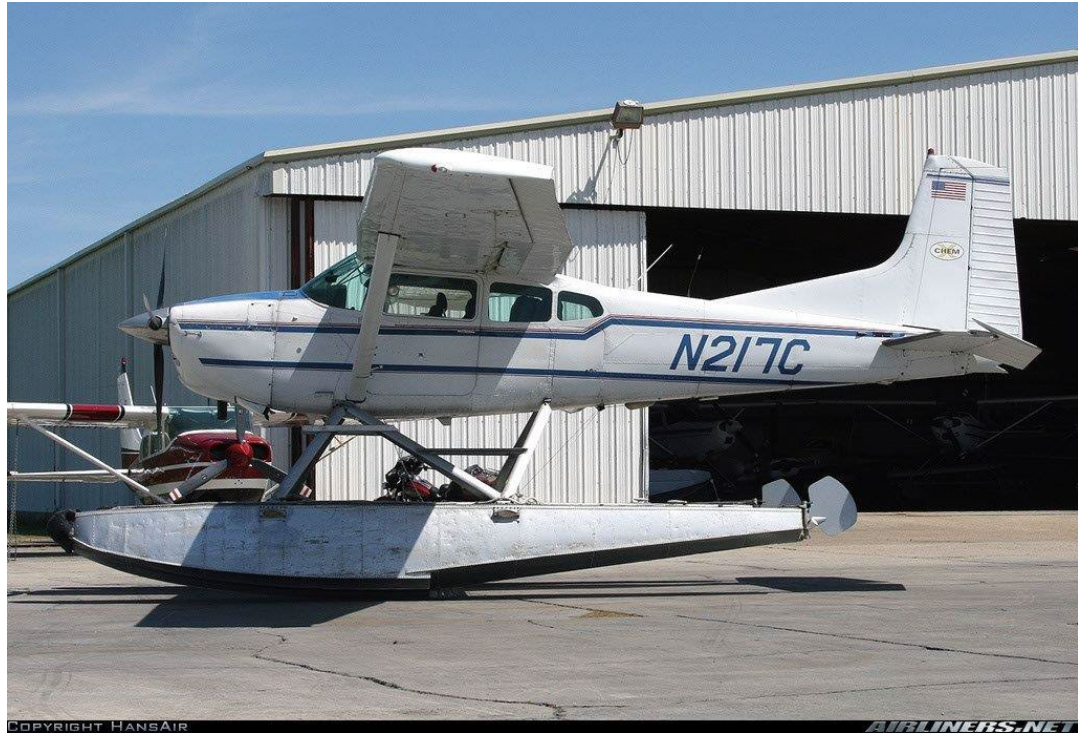
Vincent Stansel, the son of the pilot had made reference that when the aircraft arrived in Alaska the standard bumpers for the EDO 3430 floats were not installed. A tire type material was installed as a bumper. Review of the aircraft records does not indicate when this modification was completed. There was also no evidence that this modification is approved for installation. Further investigation will need to happen.

*Figure 1 Undated photo of N217C with modified front float bumpers*

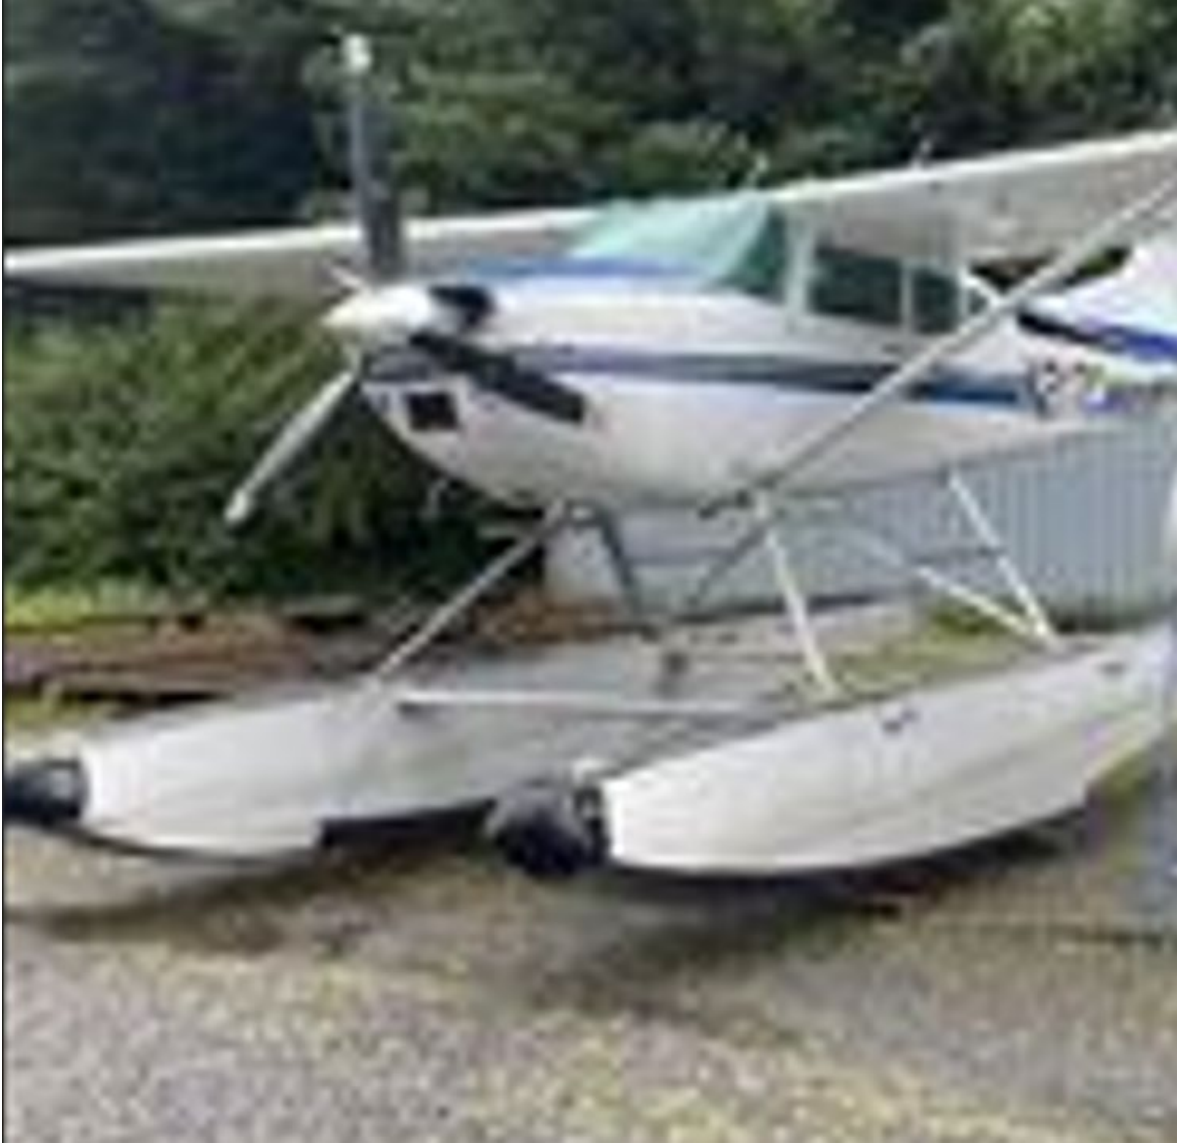
*Figure 2 Undated photo of the larger float bumpers*

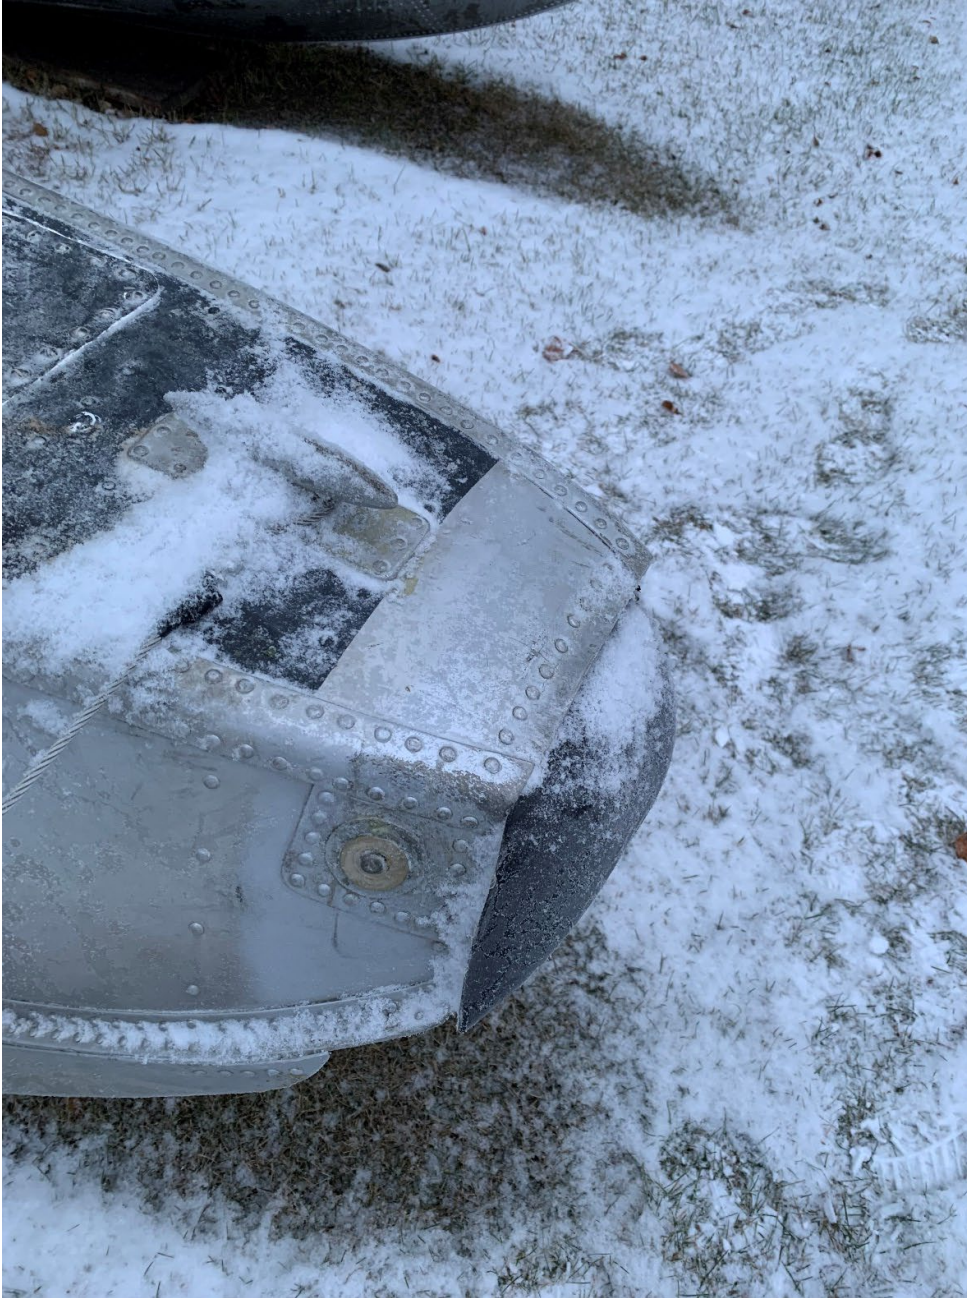
*Figure 3 New bumpers installed by owner*

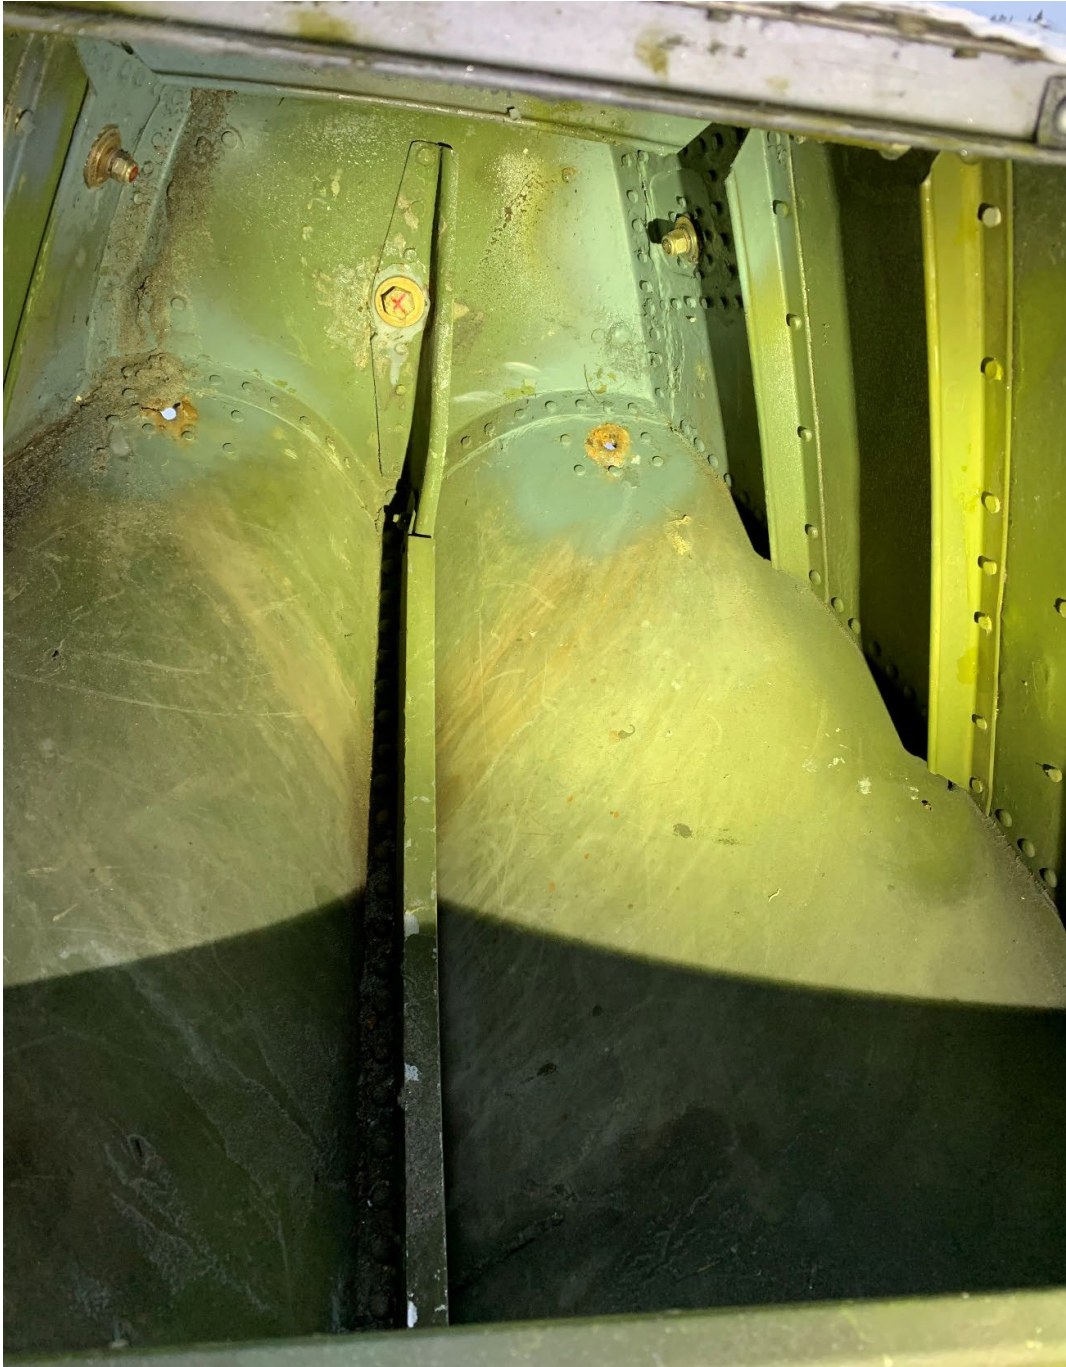
On 10/12/2022 I and another ASI Todd Murray made contact with Jerald Stansel's son to gain access to the accident aircraft. Our intentions were to get a better look at the accident aircrafts floats. We wanted to verify that in the front two chambers of each float pump out tubes for water removal was connected at the top and bottom. We removed access panels required and observed both were connected and observed. No significant hardware was discovered in the floats for the two holes discovered in the bottom of the floats upon accident investigation.

*Figure 4* Inside the float locker. You can see the upper side holes were plugged but the lower center holes were open.
