# National Transportation Safety Board

ANC23FA001

## **WRECKAGE EXAMINATION SUMMARY**

Location: Fairbanks Alaska  
Date: October 5, 2022  
Time: 1758 AKDT  
October 6, 2022, 0158 Z  
Airplane: Cessna 185F, N217C

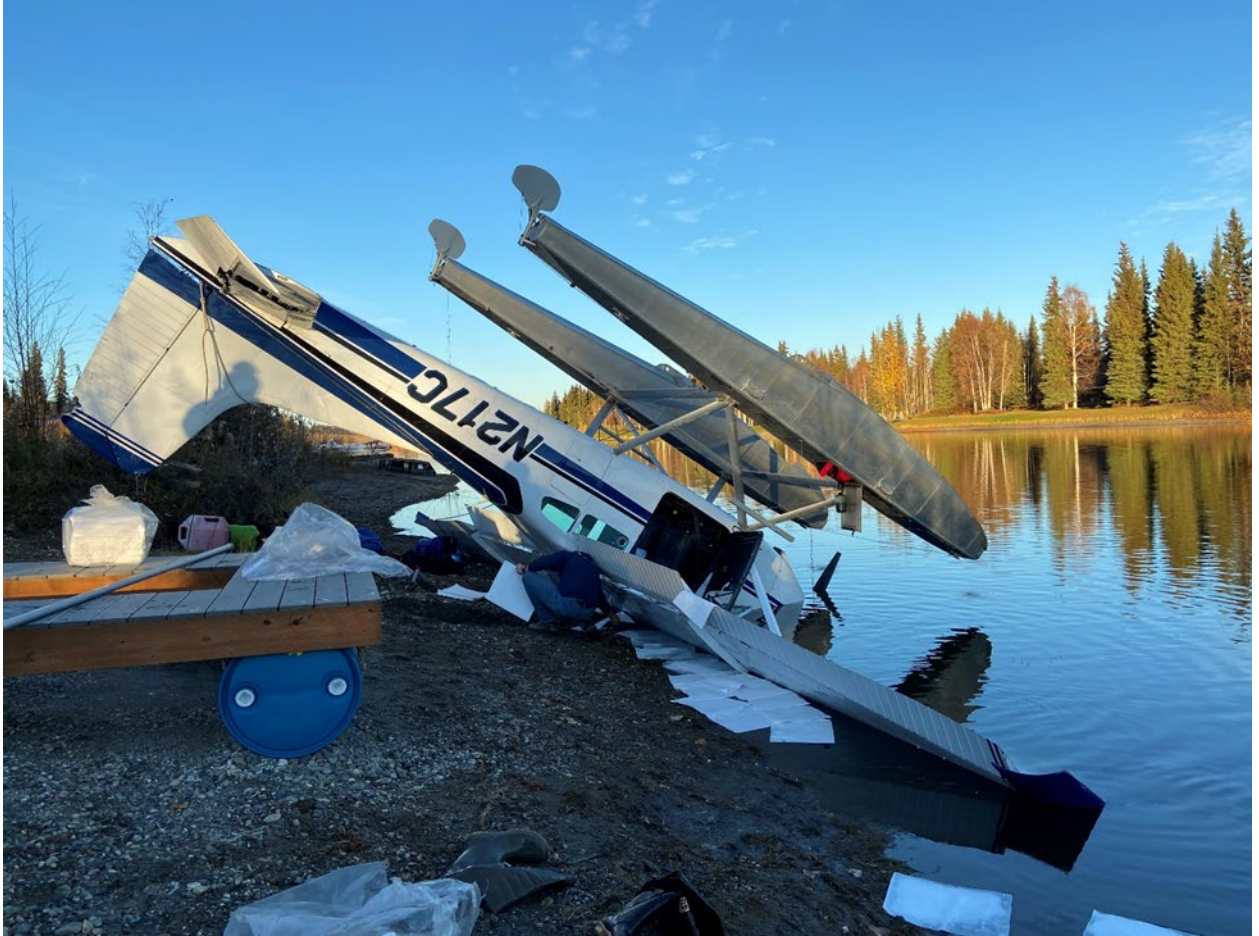
**Figure 2 Left side of accident airplane.**

No damage to airplane. Only damage to airframe was from recovery. The airplane nosed over slowly into the water and had no damage.

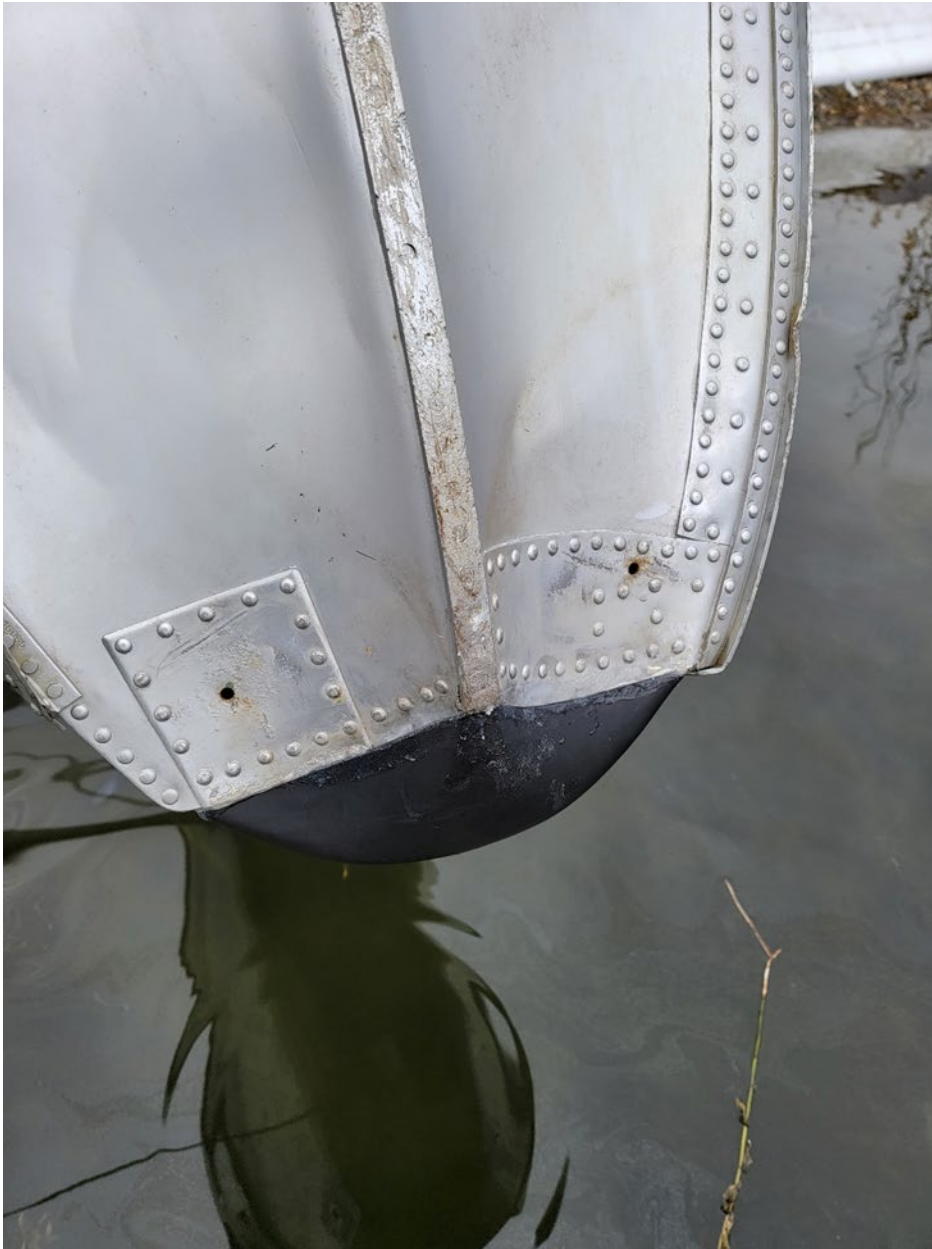
EDO 3430. Both floats had 2 unplugged holes just under the bow bumper. Both floats had patches in poor condition along the keel. The left float had unserviceable wear along the keel.

**Figure 3 Right front under side of float**

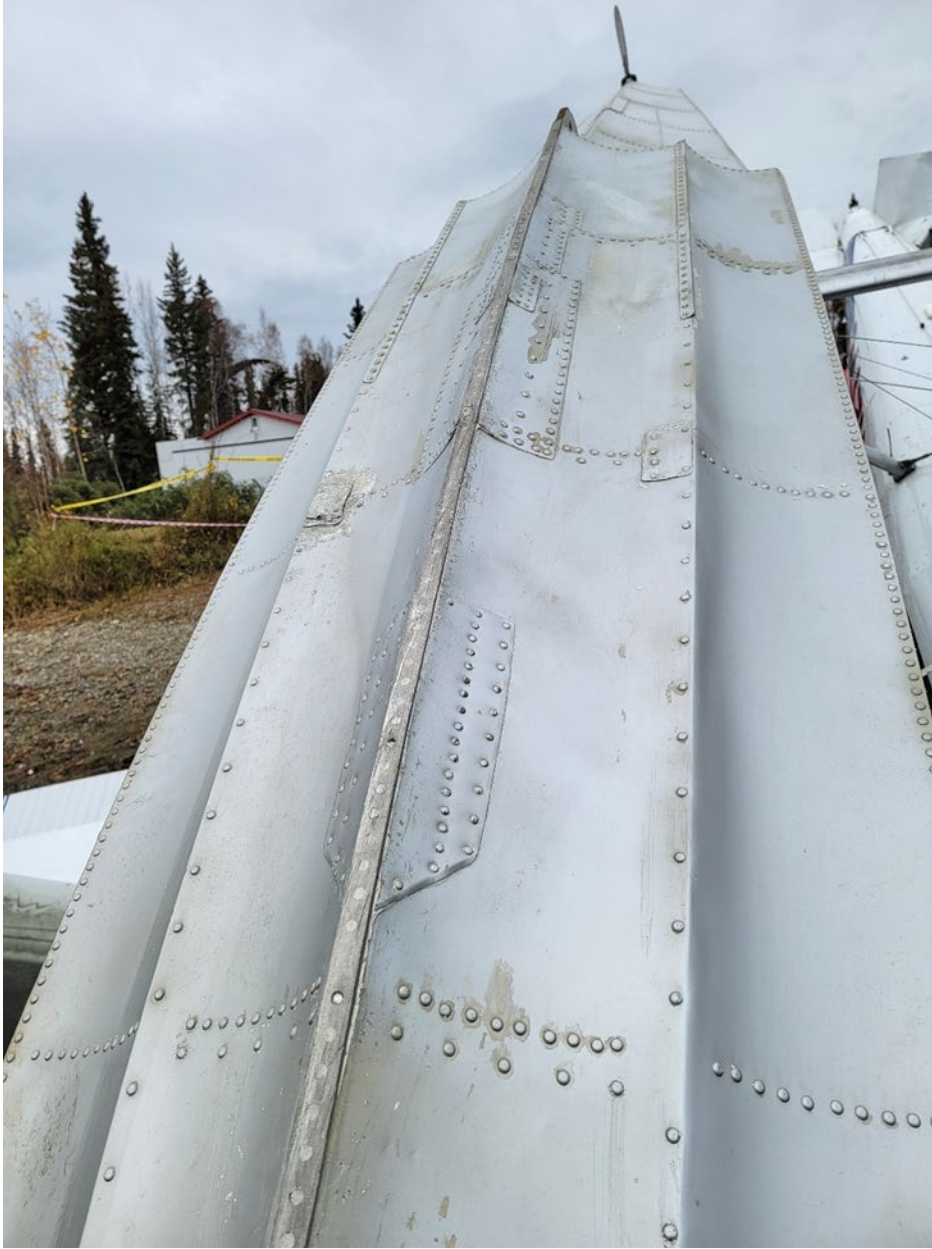
**Figure 4 Left under side of float. Showing wear on the keel.**

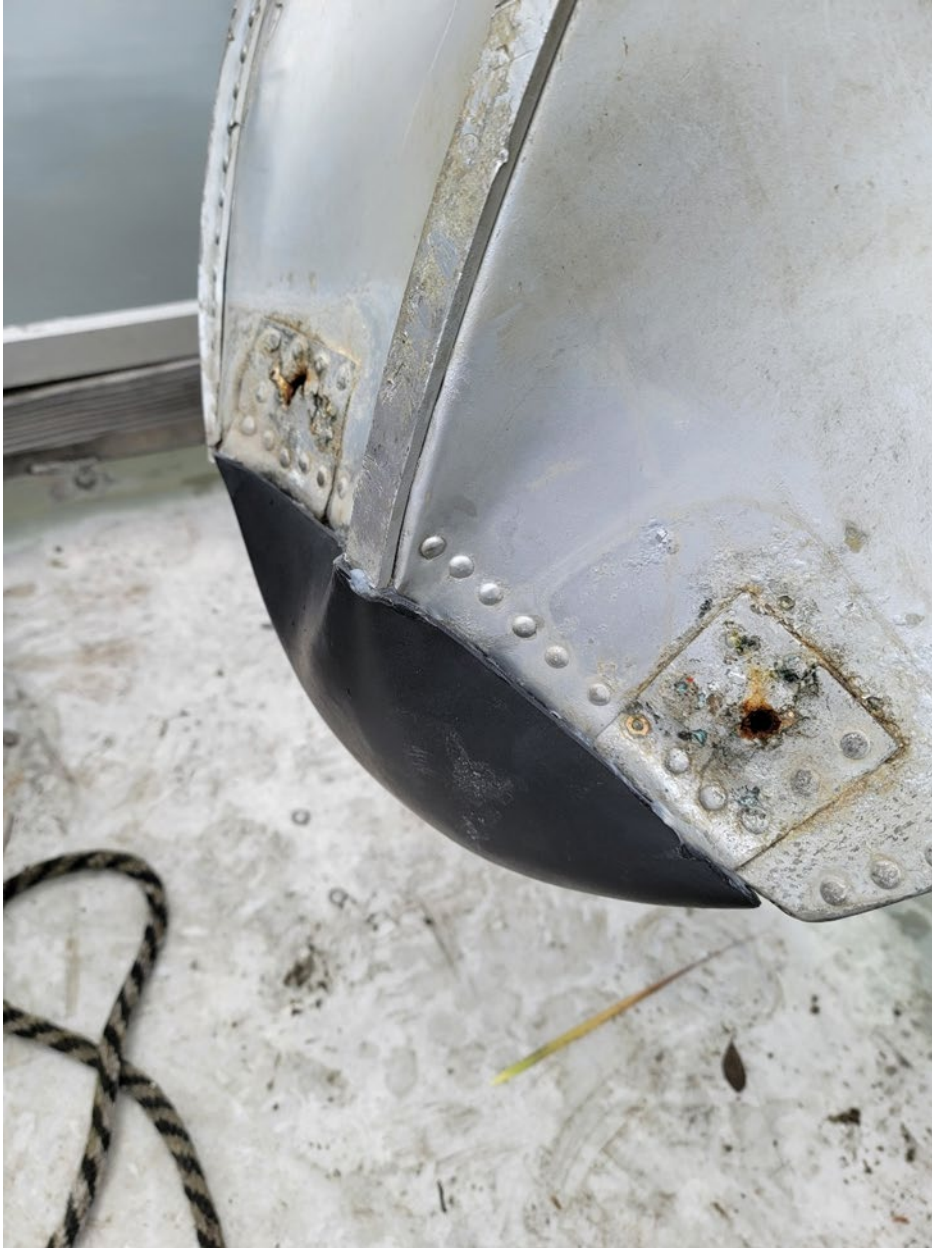
**Figure 5 Left front under side of float**

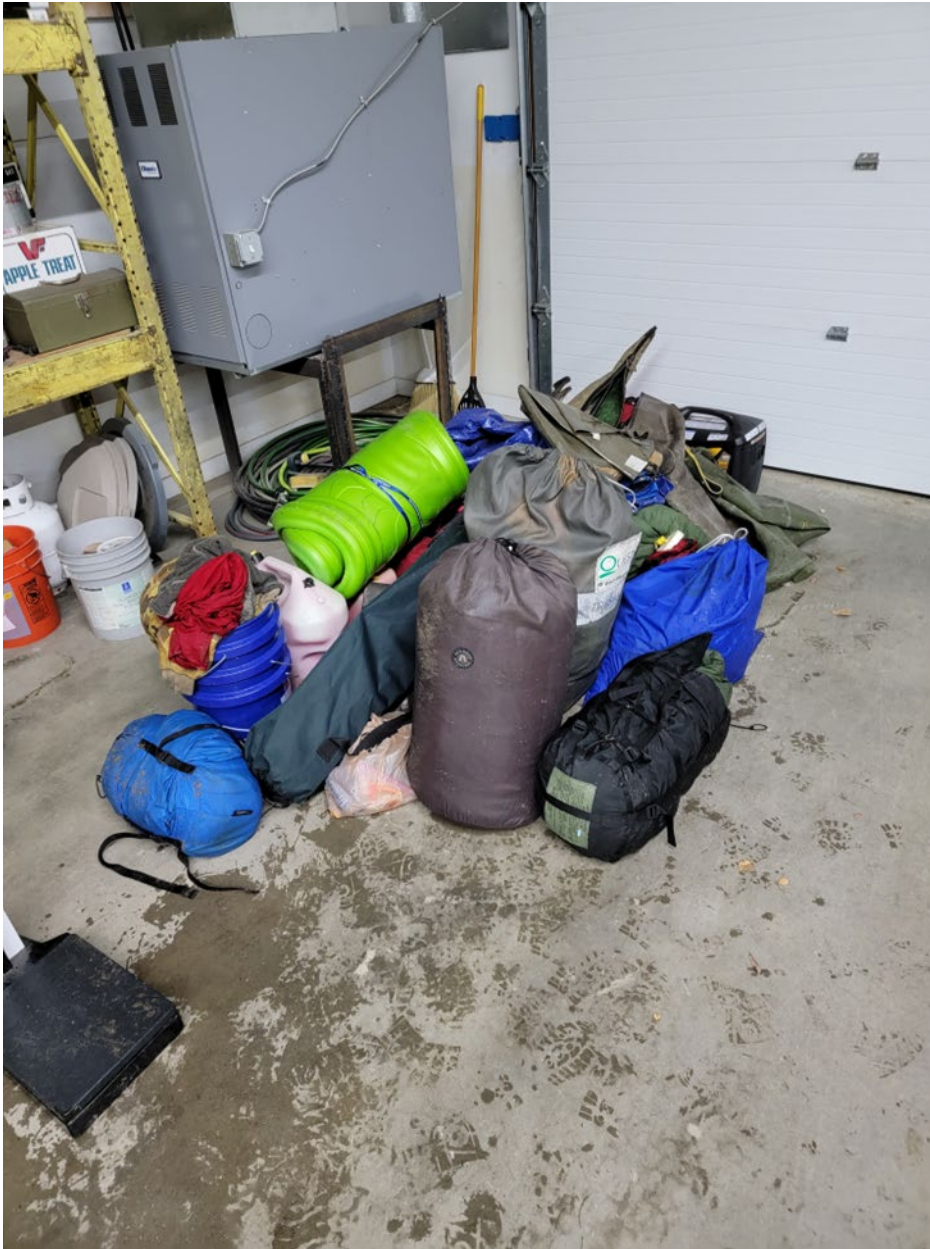
in attempted rescue of the pilot. When the airplane nosed over, the unsecured cargo pinned the pilot to the dash. Below is a picture of the gear they had to remove before they could free the pilot. This is not all the cargo that was in the airplane. Approximately 694.5 pounds of cargo moved forward and trapped the pilot.

Total weight that had to be removed before they could free the pilot- 694.5 lbs.

**Figure 6 Cargo removed from accident airplane.**
