# National Transportation Safety Board

ANC23FA003

## **AUTOMATIC DEPENDENT SURVEILLANCE- BROADCAST (ADS-B) AND VIDEO STUDY**

Aircraft Performance Study

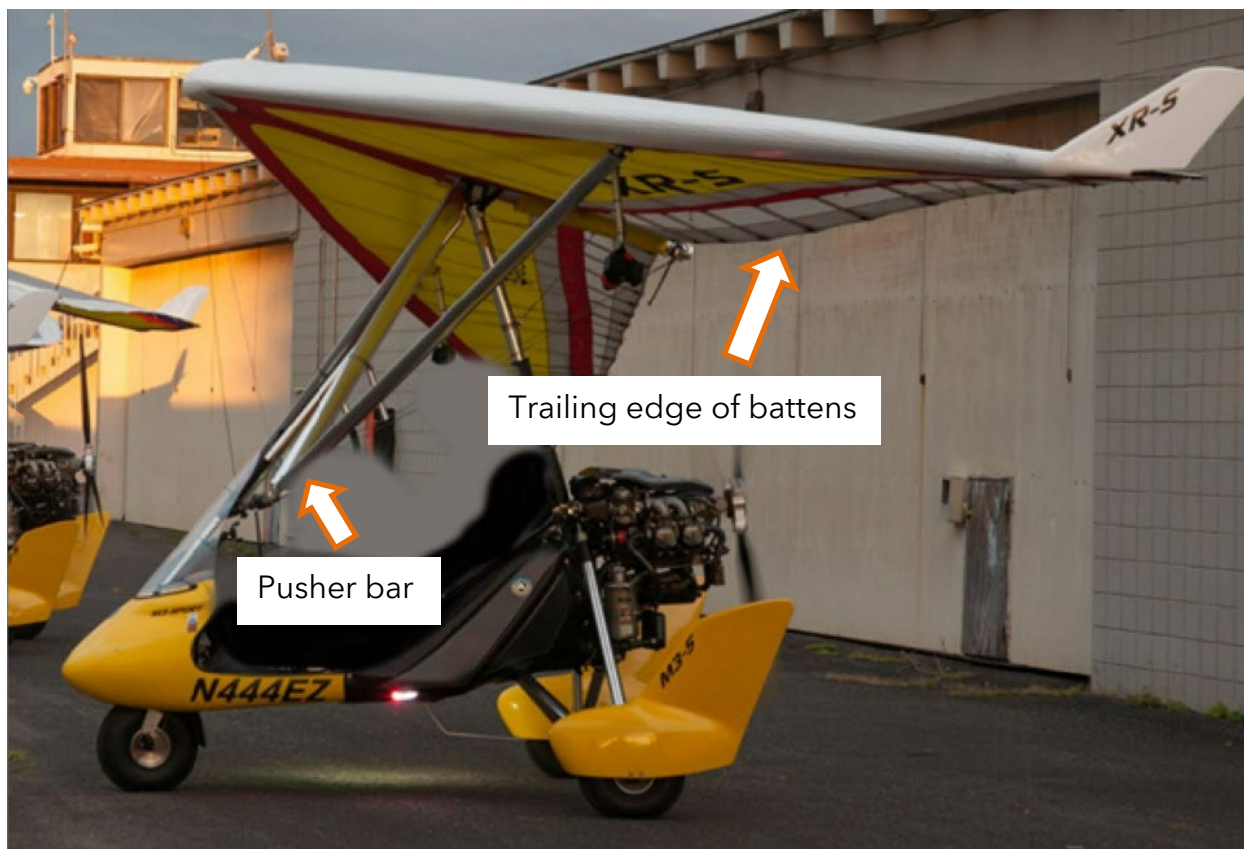
**Figure 1.** The accident aircraft, an Airborne Windsports Edge XT-912-L, N444EZ. The wing is labeled as an XR-S.

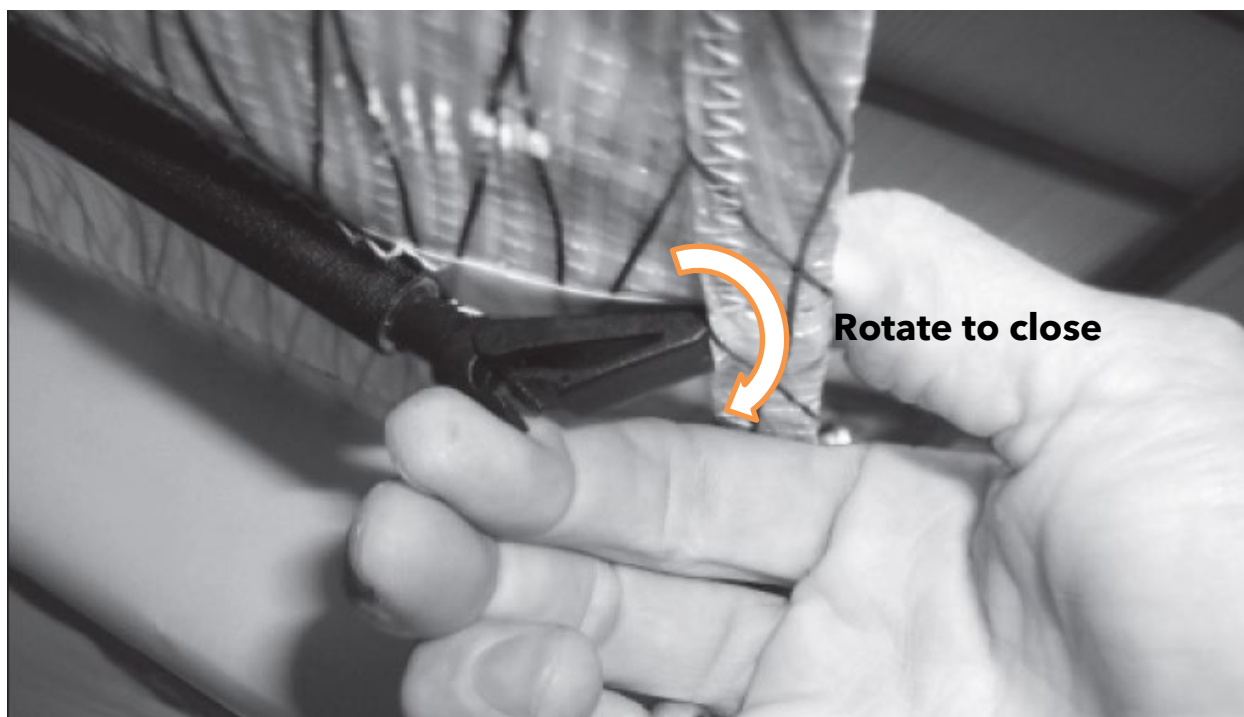
The hang glider-style wing is shaped by a series of battens that run from the leading edge to the trailing edge. The battens are individually tensioned and can be used to tune the shape of the wing as desired. If the airfoil is overloaded, the battens can "pop" out of the hinged batten fitting located on the trailing edge (Figure 2).

**Figure 2.** Picture of an open batten trailing edge from Aircraft Operating Instructions [3].

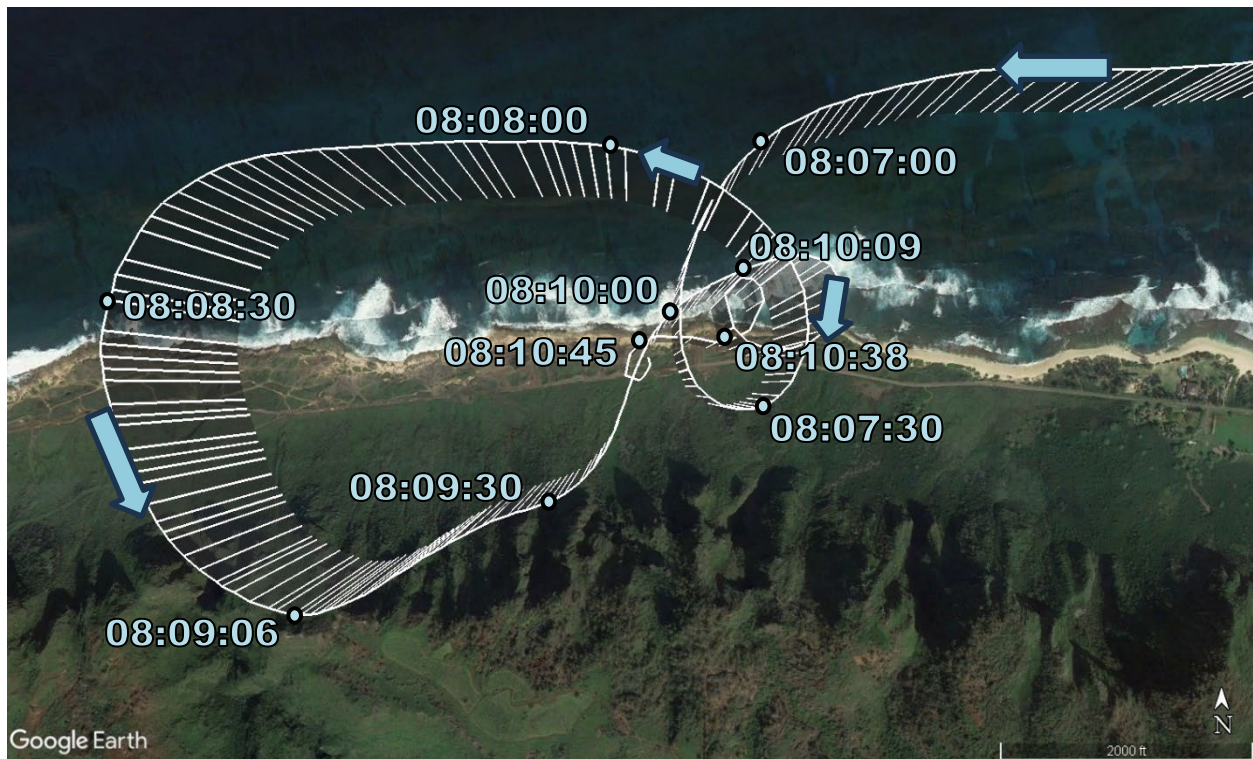
Near the end of flight, the aircraft completed a left 360° turn between 08:07 and 08:08 (Figure 5 and Figure 6) while continuing to climb. It made a large-radius 180° left turn and after 08:09:06 started to descend from 2,700 ft. The aircraft's speed remained between 35 and 40 kts. The aircraft turned left to the north just after 08:09:30 and then right at 08:10:00.

**Figure 5.** Flight path with selected times and altitudes annotated for final five minutes of flight.

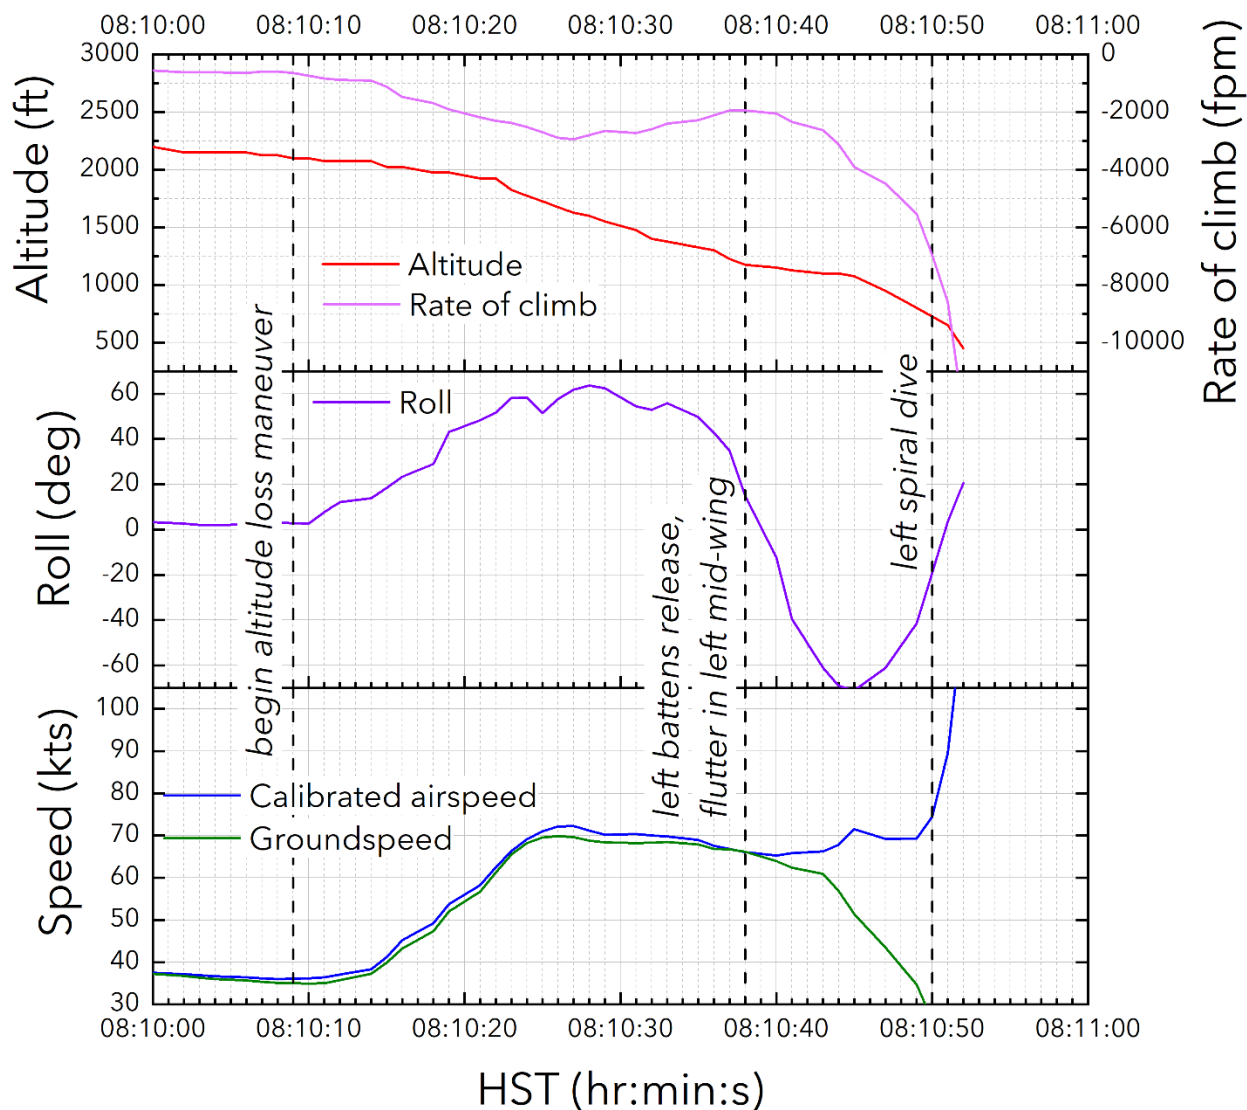
Starting at 08:10:09, the onboard video recorded a comment related to performing a 360-degree spiral turn to lose altitude rapidly. The aircraft's initial altitude was 2,100 ft and its airspeed was 36 kts. At 08:10:15 the descent rate and airspeed rapidly increased and it entered a tight right turn (Figure 6).

A simplified aerodynamic model of the aircraft was used to calculate roll angles and the aircraft held a right wing down roll angle near or exceeding 60° from 08:10:23 to 08:10:33 (Figure 6 and Figure 7). The Aircraft Operating Instructions advise not to exceed 60° [3]. Additionally, the maneuvering speed,  $V_A$ , for the aircraft with the XR-S wing is listed as 73 kts, indicated airspeed. The calculated calibrated airspeed, based on the wind sounding, during the turn was above 70 kts. Indicated airspeed is specific to an aircraft's pitot-static system, but is usually within a few knots of the calibrated airspeed. For about 10 seconds of the right turn the aircraft was near the maximum recommended bank angle and  $V_A$ .

**Figure 6.** ADS-B recorded altitude, calculated rate of climb, groundspeed and calibrated airspeed, and roll angle for the final five minutes of flight.

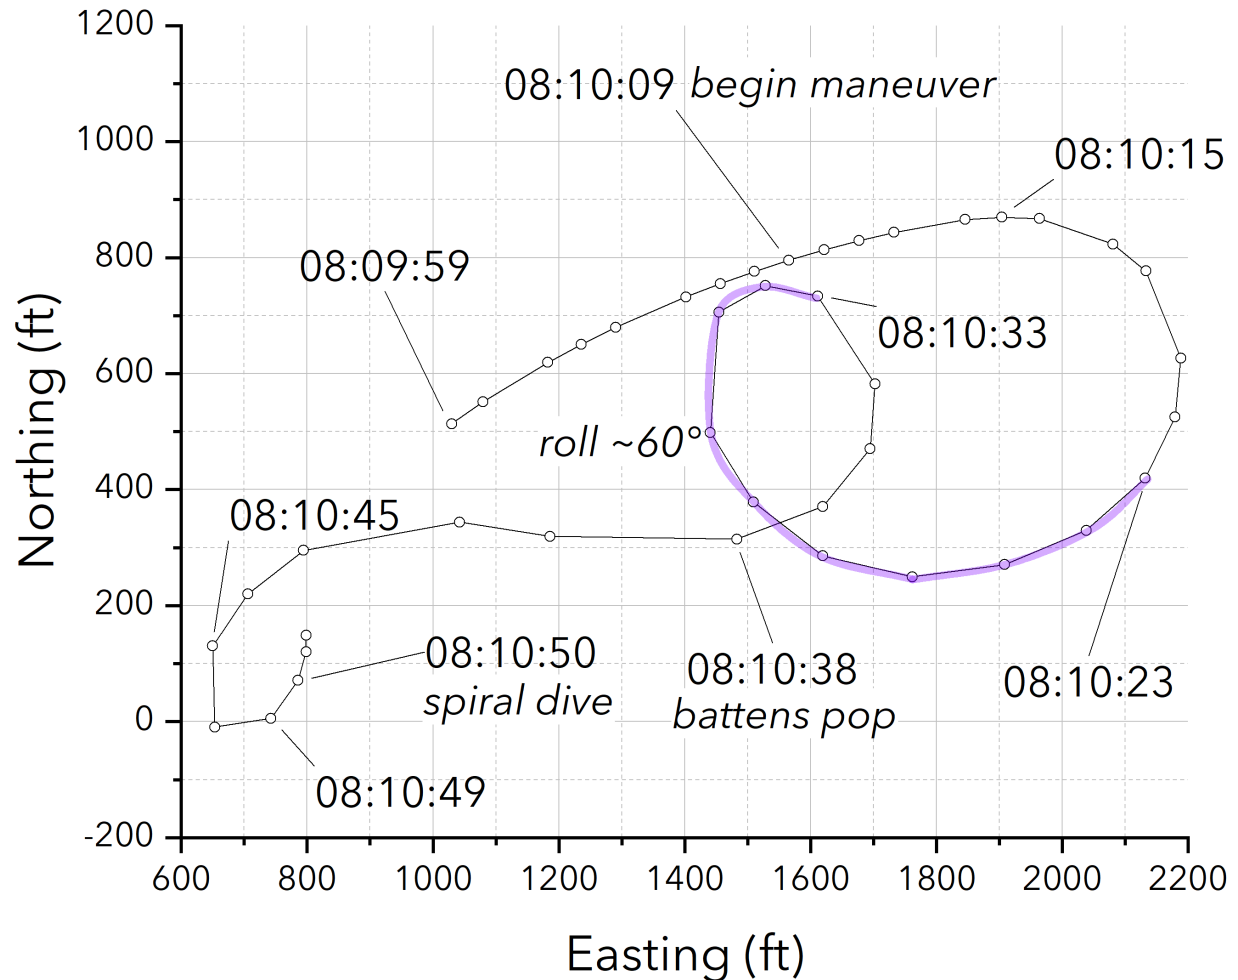
At 08:10:38 the descent rate was arrested at 2,000 fpm and the aircraft was rolling back towards wings level. At the same time, the video showed three of the left

battens released at the trailing edge and the left wing began to flutter. At the loss of lift on the left side, the aircraft rapidly rolled left. At 08:10:45 the descent increased to over 5,000 fpm and it entered a tight left turn. The video showed the aircraft in a spiral dive after 08:10:50. The final ADS-B return was at 08:10:52 when the aircraft was at an altitude of 451 ft.

**Figure 7.** ADS-B end of flight path with selected times and events noted. The purple line highlights the portion of the flight path when the aircraft was near 60° right wing down.
