National Transportation Safety Board  
Office of Aviation Safety  
Washington, DC 20594

ANC23FA003

## **WRECKAGE EXAMINATION REPORT**

Location: Mokuleia, Hawaii  
Date: November 5, 2022  
Time: 0811 Hawaii standard time  
1811 UTC  
Aircraft: Airborne Windsports; Registration N444EZ

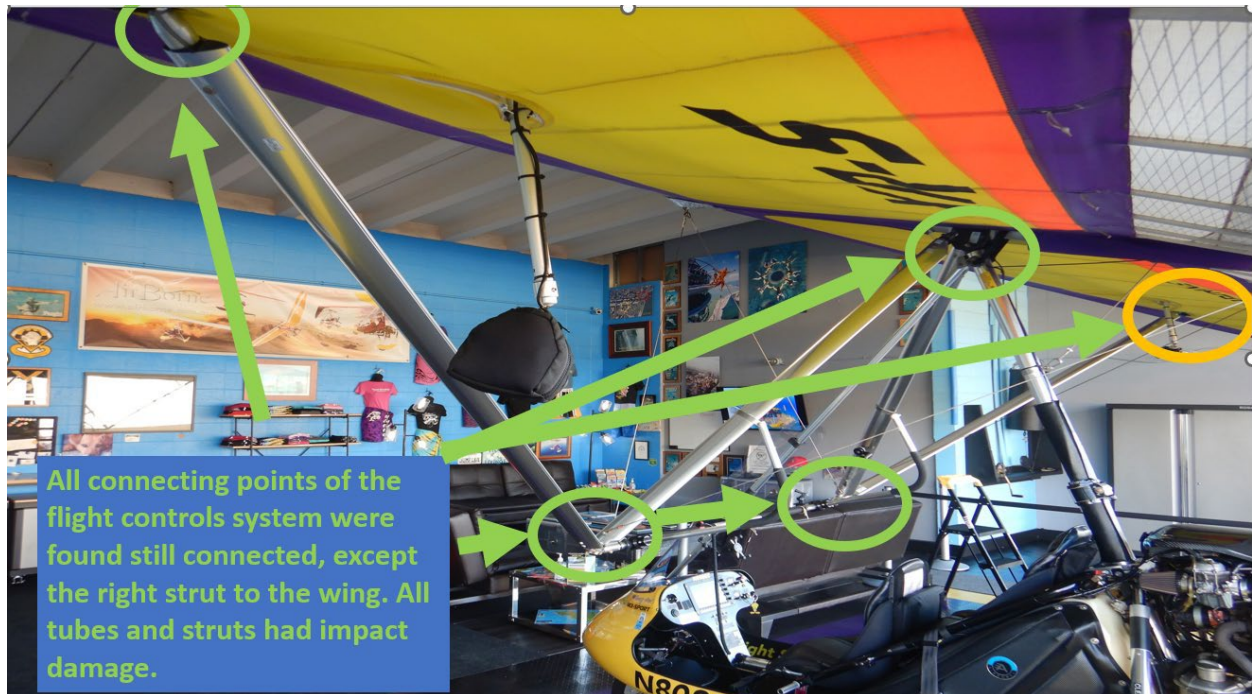
**Figure 2 Illustrated exemplar aircraft flight control connecting points**

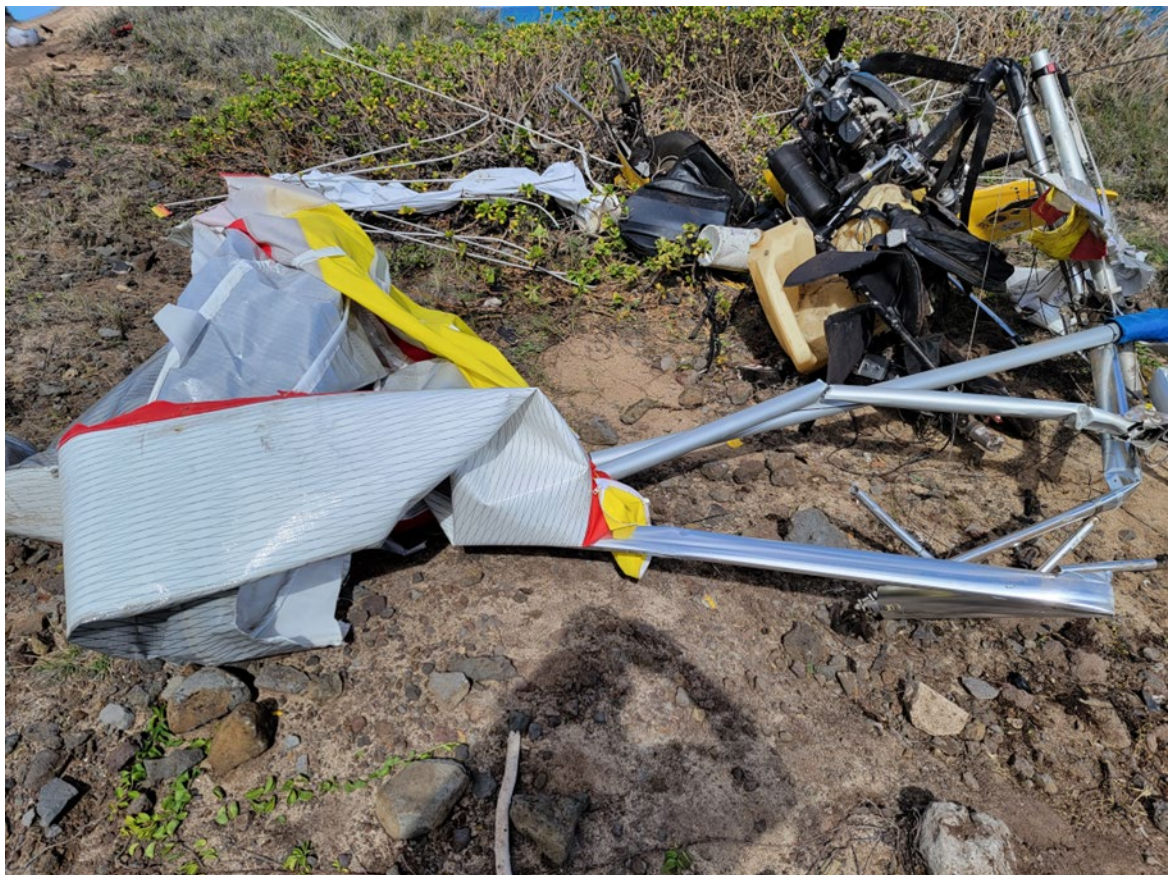
- Impact damage to outboard leading edge of the wing, and wing struts. More damage was present on the right wing leading-edge.
- The mast that holds the wing to the fuselage was impact damaged. It was fractured above the double wall sleeve, a backup safety cable remained attached.
- The left and right wing attachment points remained attached between the wing and the fuselage.
- The cockpit was destroyed from impact with the ground.
- Flight control continuity was confirmed from the control inputs to the control surfaces.
- The three left battens that separated during the flight were not recovered and therefore could not be examined.
- Figure 2 details the connecting points of the flight control system on an exemplar aircraft. On the accident aircraft all of the connecting points of the flight control system remained connected, except for the right wing, which was impact damaged.

**Figure 3 View of the cockpit and wing**

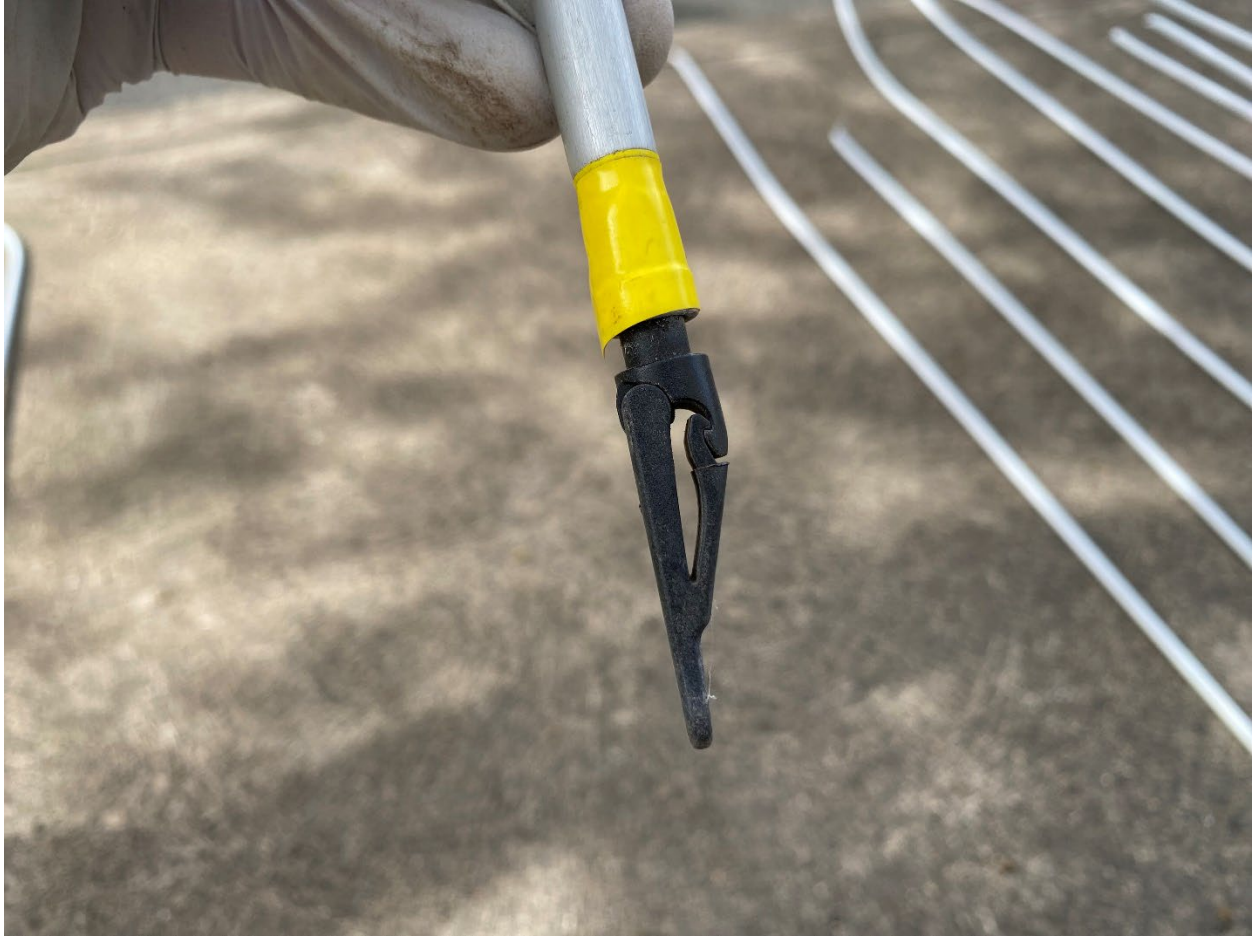
**Figure 4 View of one of the remaining hinged batten fittings.**

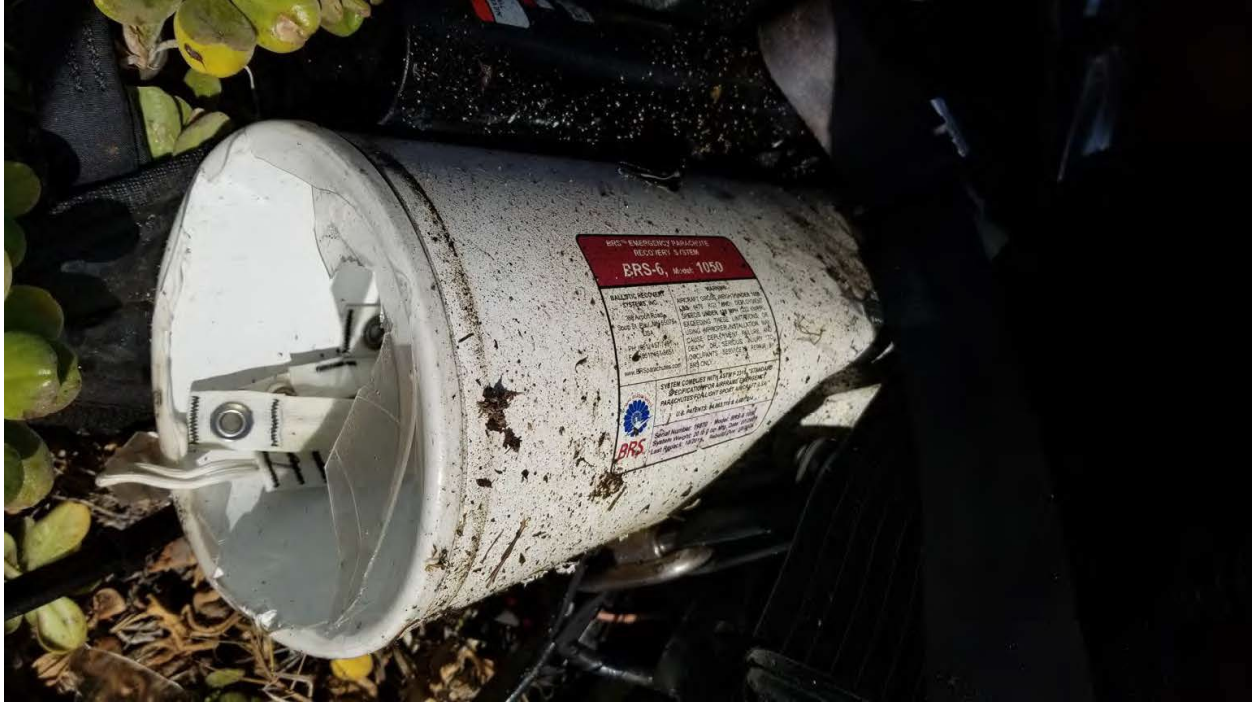
The safety pin was removed from the parachute, and it was partially deployed.

**Figure 5 View of the parachute (Courtesy of Honolulu Police Department)**

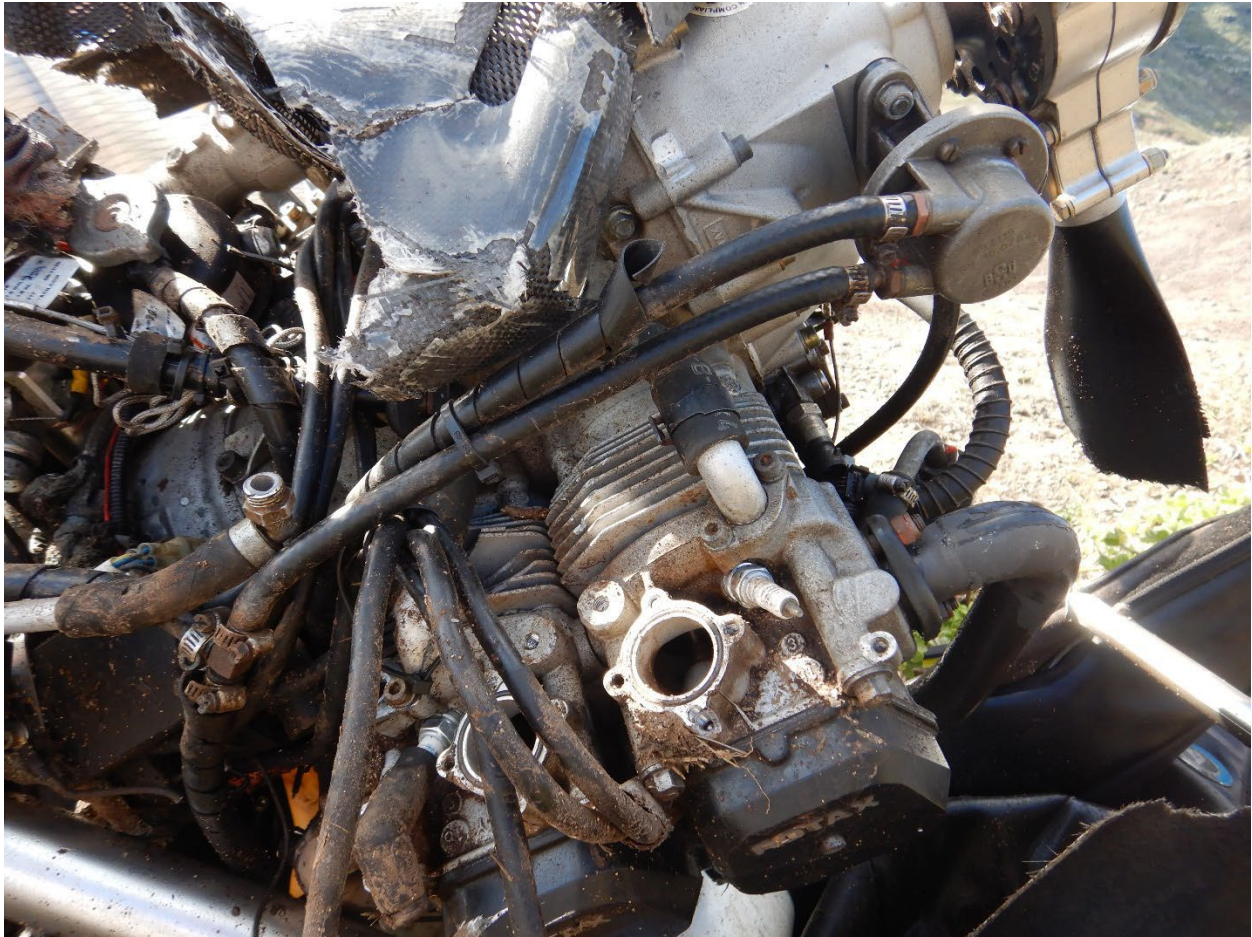
- Left intake tube was missing due to impact damage
- Both carburetors were disconnected from the engine from impact damage
- Both air intake filters were crushed from impact.
- The carburetor bowls were separated due to impact damage. The cable from foot throttle control was cut about 6 inches from the pedal. The cut in the cable lines up with impact damage on the airframe. Throttle cable had numerous locations of damage from tension and cutting from impact damage.
- The engine mounts were broken from impact damage.
- The left side exhaust was pulled away from the engine due to impact damage.
- Right side exhaust remained attached and had impact damage from the right wheel strut impacting the exhaust collector during impact.
- All of the sparkplugs remained in position.

- The right side of the engine had one top sparkplug wire that was damaged during impact.

**Figure 6 View of the engine**

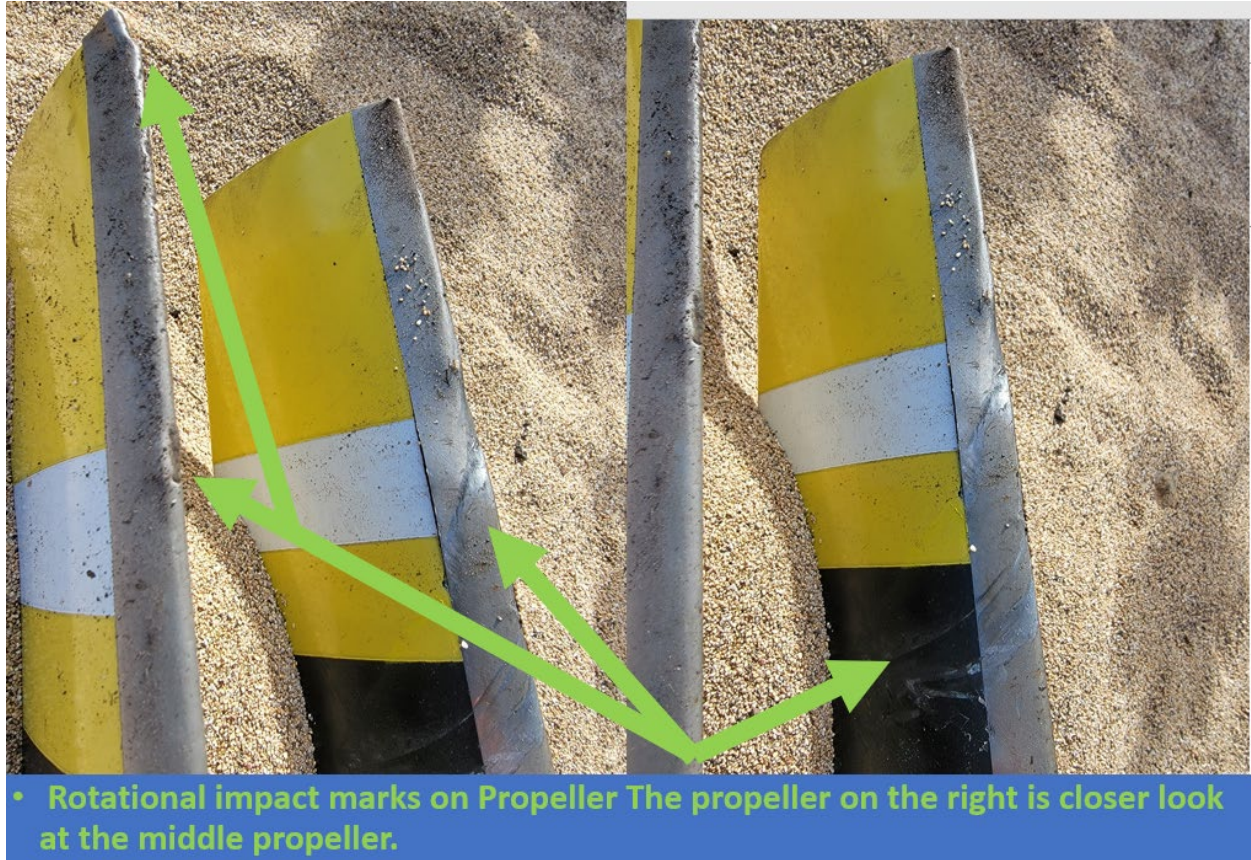
- All three propeller blades remained attached to the hub, the outboard portions of all the blades were impact separated.

**Figure 7 View of the propeller blades**
