# National Transportation Safety Board

ANC23FA003

## **ONBOARD IMAGE RECORDER**

Group Chair's Factual Report

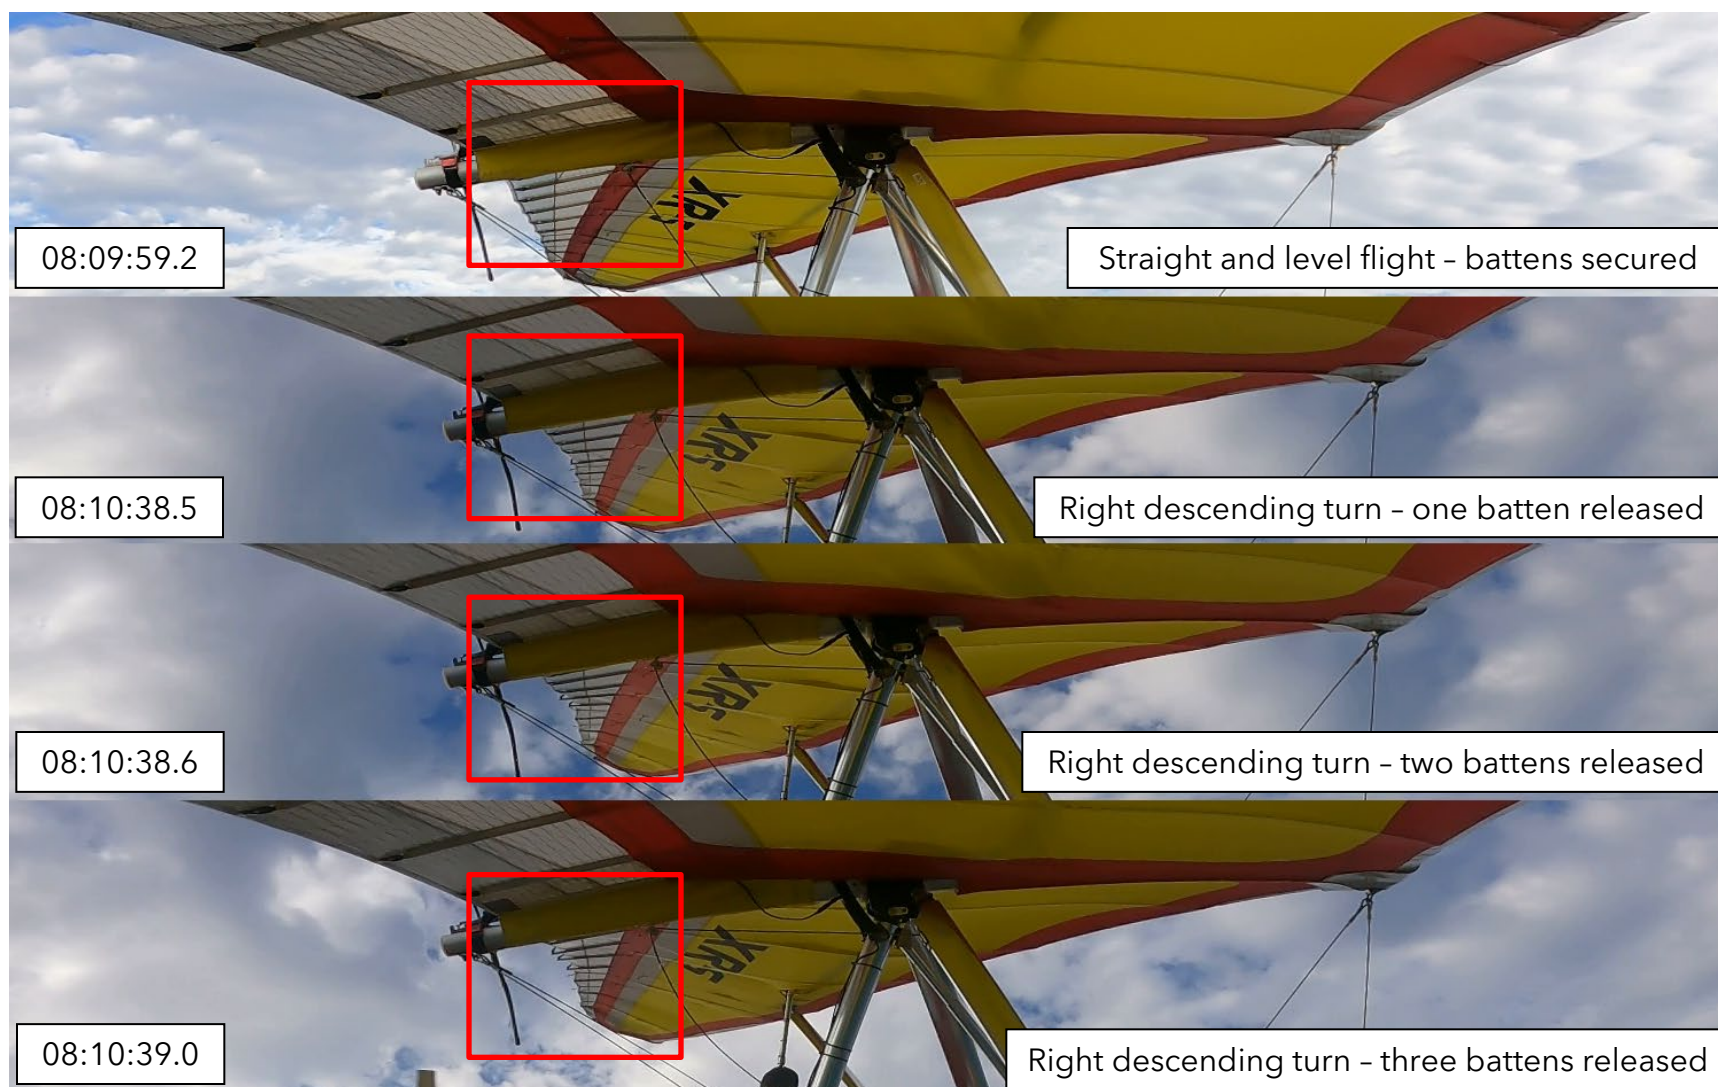
| Time, HST | Observation |
|---|---|
| 08:10:38 | The LSA remained in a right-banked descending turn. Flutter in the trailing edge of the left wing at midspan was noted. As the LSA continued the right-banked descending turn, three of the batten end fittings at the midspan of the left-wing released, as shown in Figure 1 below. |
| 08:10:38 to 08:10:49 | <p>With the batten end fittings released, the LSA started to bank sharply to the left. The LSA appeared to be at the same altitude as the peak of the adjacent mountain.</p> <p>The instructor stated, "let go of the bar. let go of the bar. let go of the bar." The student let go of the D-bar. The instructor stated, "all right good job".</p> <p>The left descending bank rapidly increased to a steep descending left turn. Flutter in the trailing edge of the left wing at midspan continued. The three batten end fittings were still released, as described above. The instructor moved the control bar toward him.</p> |

**Figure 1.** Progression of batten end fittings releasing from 08:09:59 to 08:10:39 HST.
