# Aviation Investigation Final Report

| <b>Location:</b> | Mokuleia, Hawaii | <b>Accident Number:</b> | ANC23FA003 |
| <b>Aircraft:</b> | AIRBORNE WINDSPORTS Edge XT-912L | <b>Aircraft Damage:</b> | Substantial |
| <b>Defining Event:</b> | Aircraft structural failure | <b>Injuries:</b> | 2 Fatal |

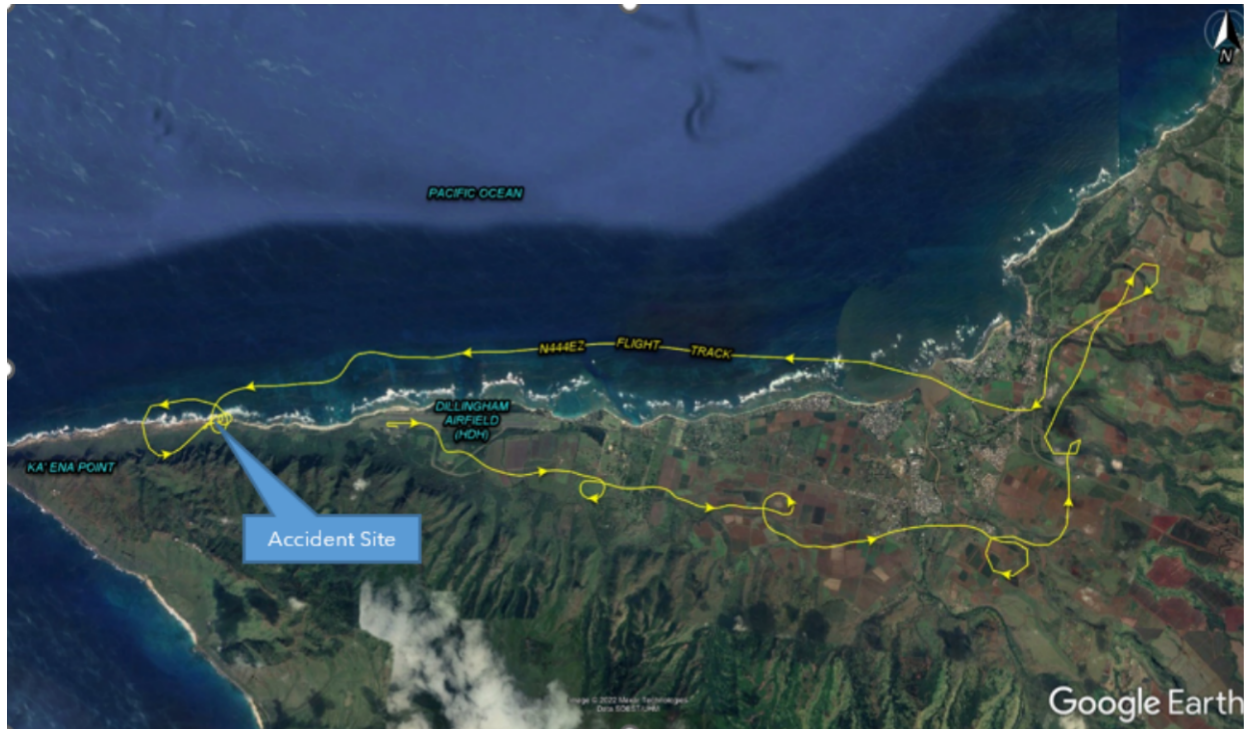
According to ADS-B flight track data and video from a Go-Pro camera recovered from the aircraft wreckage, the aircraft taxied onto the runway for takeoff from Dillingham Airfield (HDH) about 0739. The aircraft flew east of the airport, maneuvering at varying altitudes and making a few 360° turns before turning back to the west. The aircraft flew along the coast towards Ka'ena Point, then made a left climbing turn toward HDH. The aircraft reached a maximum altitude of 5,670 ft mean sea level (msl), then descended to an altitude of 1,200 ft, and then climbed to 2,700 ft. The airplane completed a left 360° and continued to climb. After a second left turn the aircraft began a descent from 2,700 ft (see Figures 1 and 2).

Figure 1. ADS-B flight track for N444EZ, which depicts both outbound and inbound flight tracks.

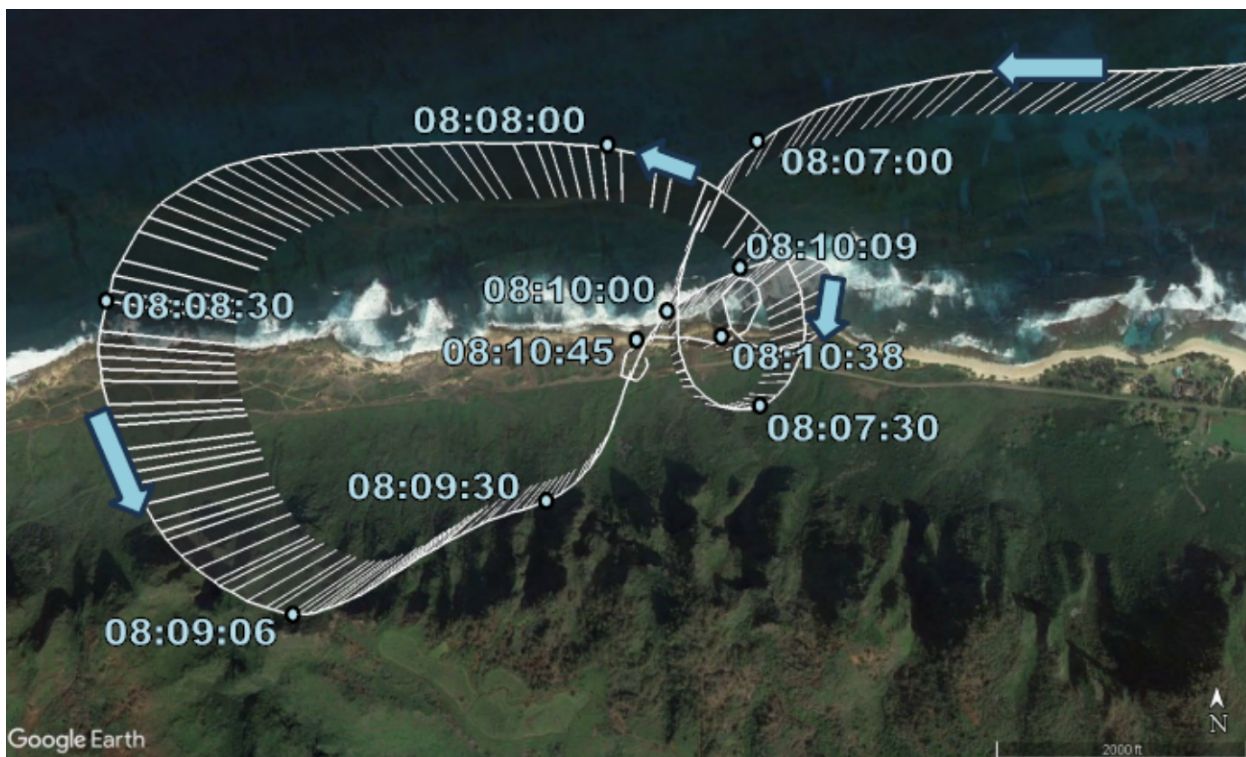
As the aircraft entered a right turn at 2,100 ft, the flight instructor told the student another way for them to lose altitude was to "do spirals." The aircraft then entered a tight descending right turn, rolling to near the recommended limit of 60° and increasing airspeed to near the maneuvering limit of 73 kts. As the aircraft rolled out of the right turn to a near wings-level attitude, three battens connecting the wing fabric to the wing structure released at the trailing edge of the left wing (see Figure 3). The left wing subsequently began to flutter, and the aircraft rapidly rolled left and entered an uncontrolled descending spiral dive. The last track data was observed at 0810, as the aircraft descended through 700 ft msl, at 20 knots.

Figure 2. Overhead view of the ADS-B flight track which depicts the last portion of the flight.

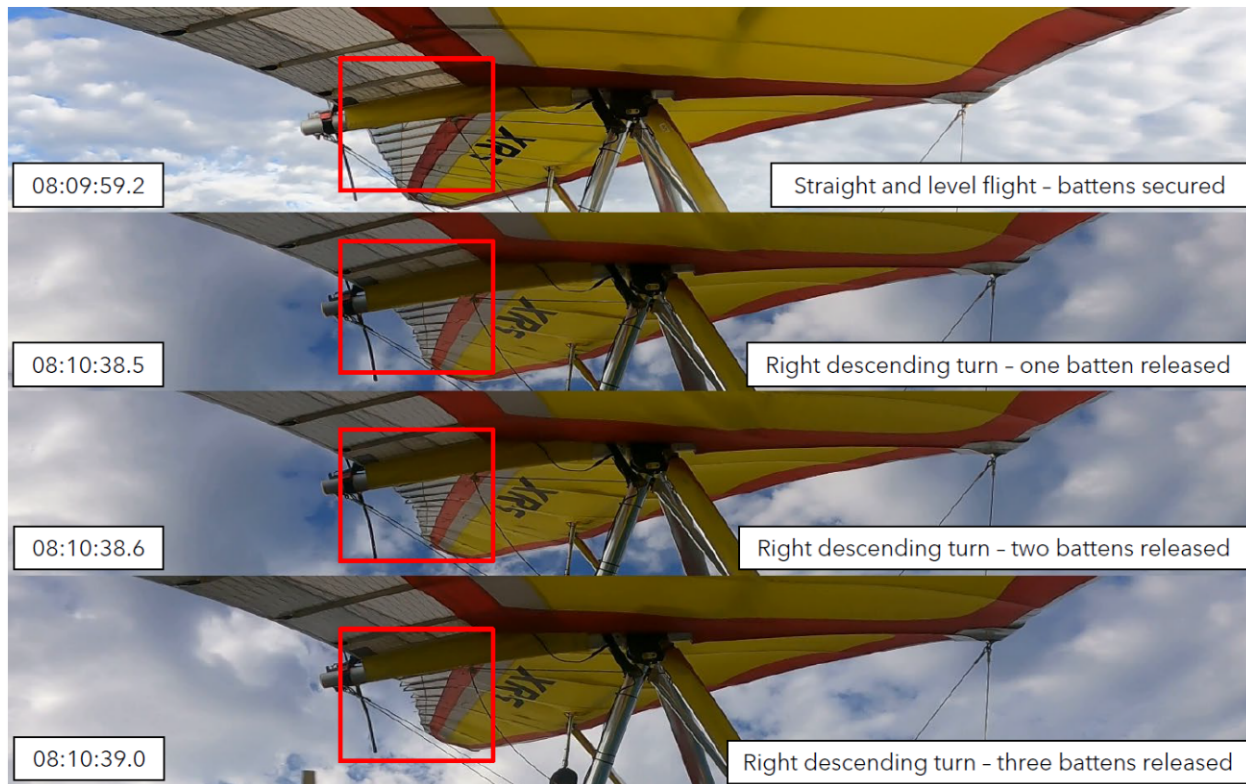
A Service Instruction issued by the aircraft manufacturer listed three different factors that can cause the hinged batten to unload: 1) damage to the latch from incorrect loading of the fitting, 2) overtension of the batten within the pocket, and 3) operation outside the placarded limitation of the aircraft. While the investigation was not able to determine the state of battens before the accident, a performance study determined that the aircraft banked near its maximum recommended bank angle of 60° and near its maximum maneuvering speed of 73 kts in a right turn during the descent.

Figure 3. Sequence of four images from the GoPro camera that captured the batten end fittings release.

The National Transportation Safety Board conducted a performance study for this accident. The study included a review of ADS-B and GoPro video data. The data revealed the aircraft began a steep descending turn near the end of flight. The aircraft rapidly gained speed to near its  $V_a$  while in a bank near its maximum recommended bank angle of 60°. For about 10 seconds of the right turn the aircraft was near the maximum recommended bank angle and  $V_a$ . Shortly after, three left batten hinges released, causing the left wing to flutter before the aircraft eventually entered a left spiral dive.
