# Aviation Investigation Final Report

| <b>Location:</b> | Mokuleia, Hawaii | <b>Accident Number:</b> | ANC23FA003 |
| <b>Aircraft:</b> | Airborne Windsports Edge Xt-912L | <b>Aircraft Damage:</b> | Substantial |
| <b>Defining Event</b> | Aircraft structural failure | <b>Injuries:</b> | 2 Fatal |

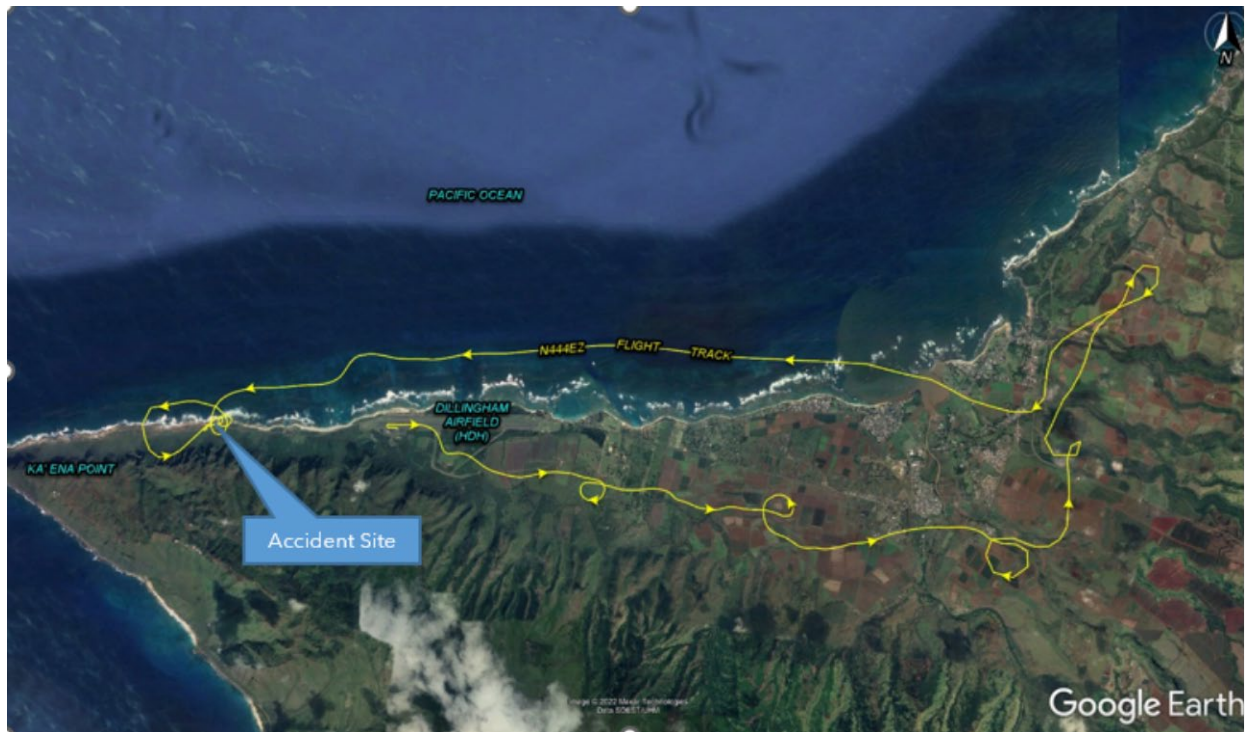
According to ADS-B flight track data and video from a Go-Pro camera recovered from the aircraft wreckage, the aircraft taxied onto the runway for takeoff from Dillingham Airfield (HDH) about 0739. The aircraft flew east of the airport, maneuvering at varying altitudes and making a few 360° turns before turning back to the west. The aircraft flew along the coast towards Ka'ena Point, then made a left climbing turn toward HDH. The aircraft reached a maximum altitude of 5,670 ft mean sea level (msl), then descended to an altitude of 1,200 ft, and then climbed to 2,700 ft. The airplane completed a left 360° and continued to climb. After a second left turn the aircraft began a descent from 2,700 ft (see Figures 1 and 2).

Figure 1. ADS-B flight track for N444EZ, which depicts both outbound and inbound flight tracks.

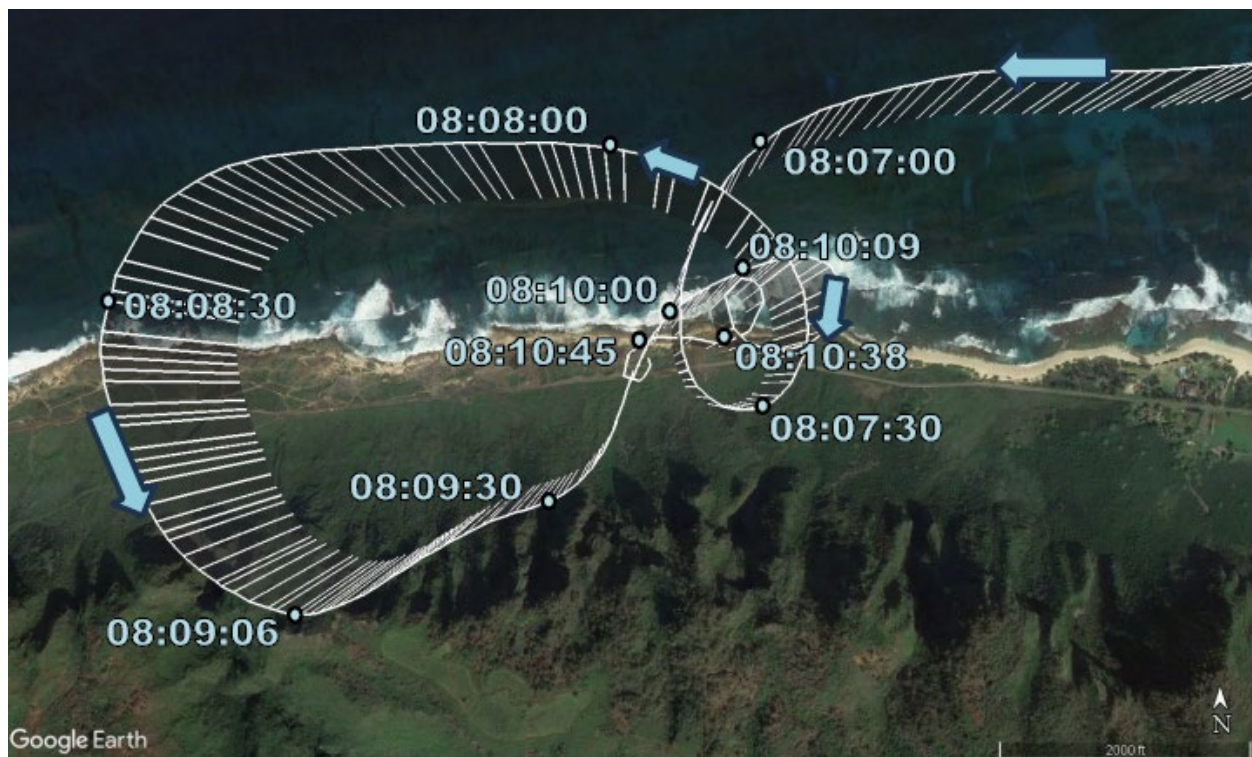
As the aircraft entered a right turn at 2,100 ft, the flight instructor told the student another way for them to lose altitude was to “do spirals.” The aircraft then entered a tight descending right turn, rolling to near the recommended limit of 60° and increasing airspeed to near the maneuvering limit of 73 kts. As the aircraft rolled out of the right turn to a near wings-level attitude, three battens connecting the wing fabric to the wing structure released at the trailing edge of the left wing (see Figure 3). The left wing subsequently began to flutter, and the aircraft rapidly rolled left and entered an uncontrolled descending spiral dive. The last track data was observed at 0810, as the aircraft descended through 700 ft msl, at 20 knots.

Figure 2. Overhead view of the ADS-B flight track which depicts the last portion of the flight.

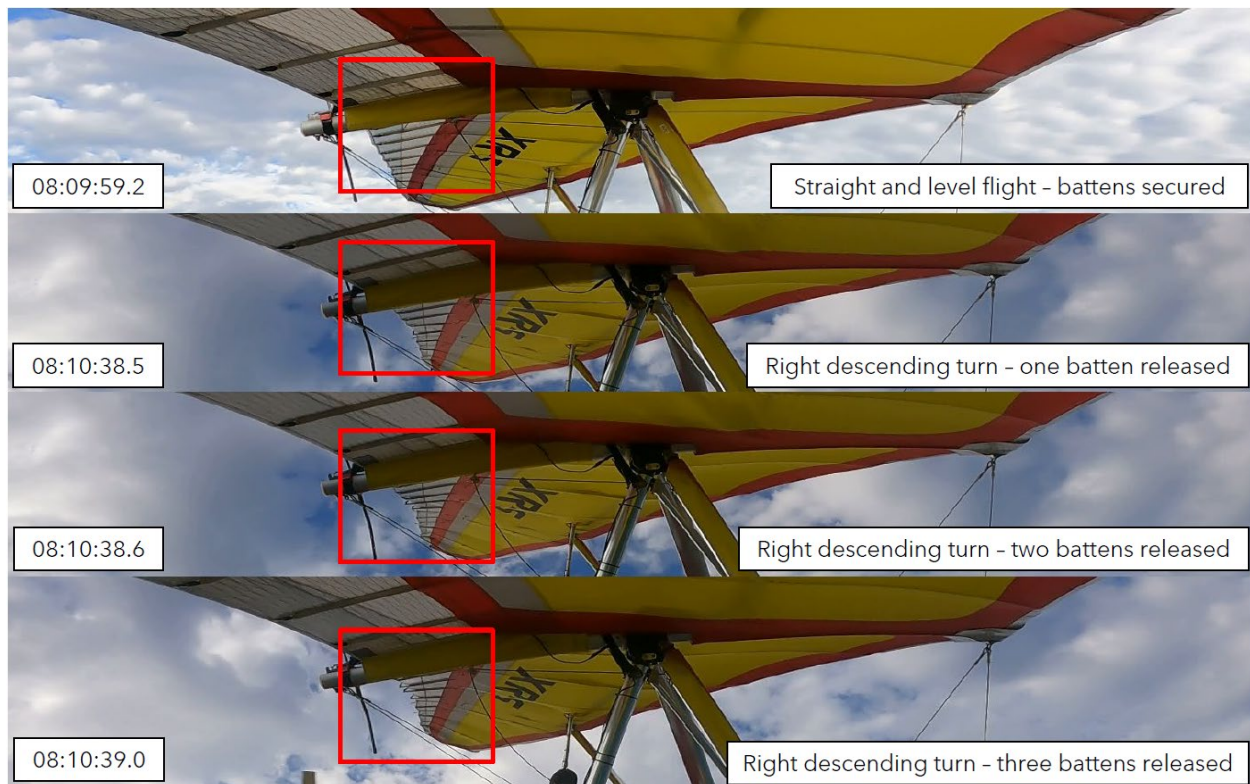
A Service Instruction issued by the aircraft manufacturer listed three different factors that can cause the hinged batten to unload: 1) damage to the latch from incorrect loading of the fitting, 2) overtension of the batten within the pocket, and 3) operation outside the placarded limitation of the aircraft. While the investigation was not able to determine the state of battens before the accident, a performance study determined that the aircraft banked near its maximum recommended bank angle of 60° and near its maximum maneuvering speed of 73 kts in a right turn during the descent.

Figure 3. Sequence of four images from the GoPro camera that captured the batten end fittings release.

The National Transportation Safety Board conducted a performance study for this accident. The study included a review of ADS-B and GoPro video data. The data revealed the aircraft began a steep descending turn near the end of flight. The aircraft rapidly gained speed to near its  $V_a$  while in a bank near its maximum recommended bank angle of  $60^\circ$ . For about 10 seconds of the right turn the aircraft was near the maximum recommended bank angle and  $V_a$ . Shortly after, three left batten hinges released, causing the left wing to flutter before the aircraft eventually entered a left spiral dive.
