# National Transportation Safety Board

ANC23FA004

## **WRECKAGE EXAMINATION**

On November 10, 2022, about 1140 Alaska standard time, a Piper PA-18 airplane, N7123K, was substantially damaged when it was involved in an accident near Chickaloon, Alaska. The student pilot was fatally injured. The airplane was operated as a Title 14 Code of Federal Regulations Part 91 personal flight.

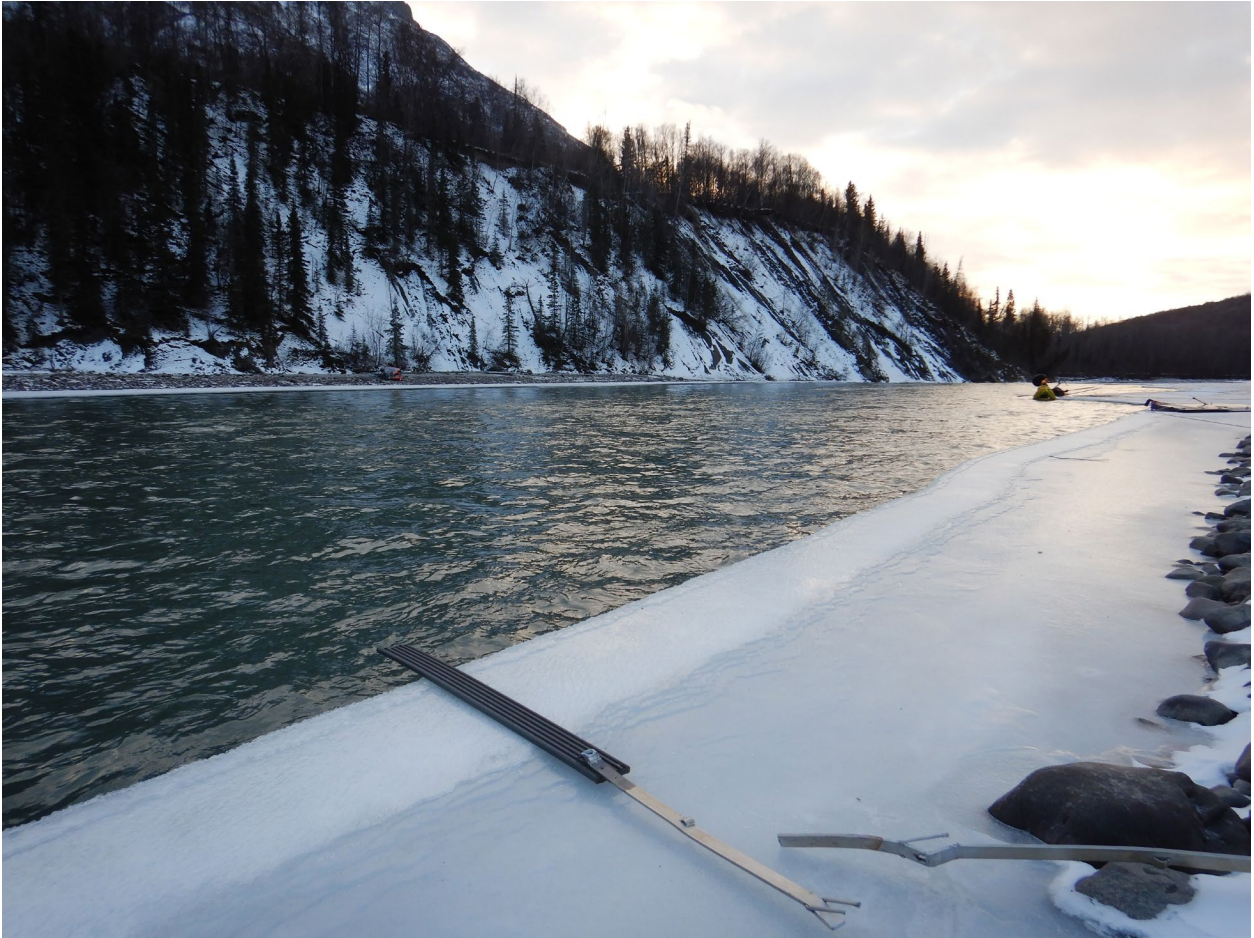
The airplane hit a cable that crossed over a river. The cable provided access to a home located on the south side of the river. The cable was about 30 ft above the water. After the airplane contacted the cable, the right and left wings were severed by the cable and the fuselage came to rest into the river.

**Figure 1 Accident location**

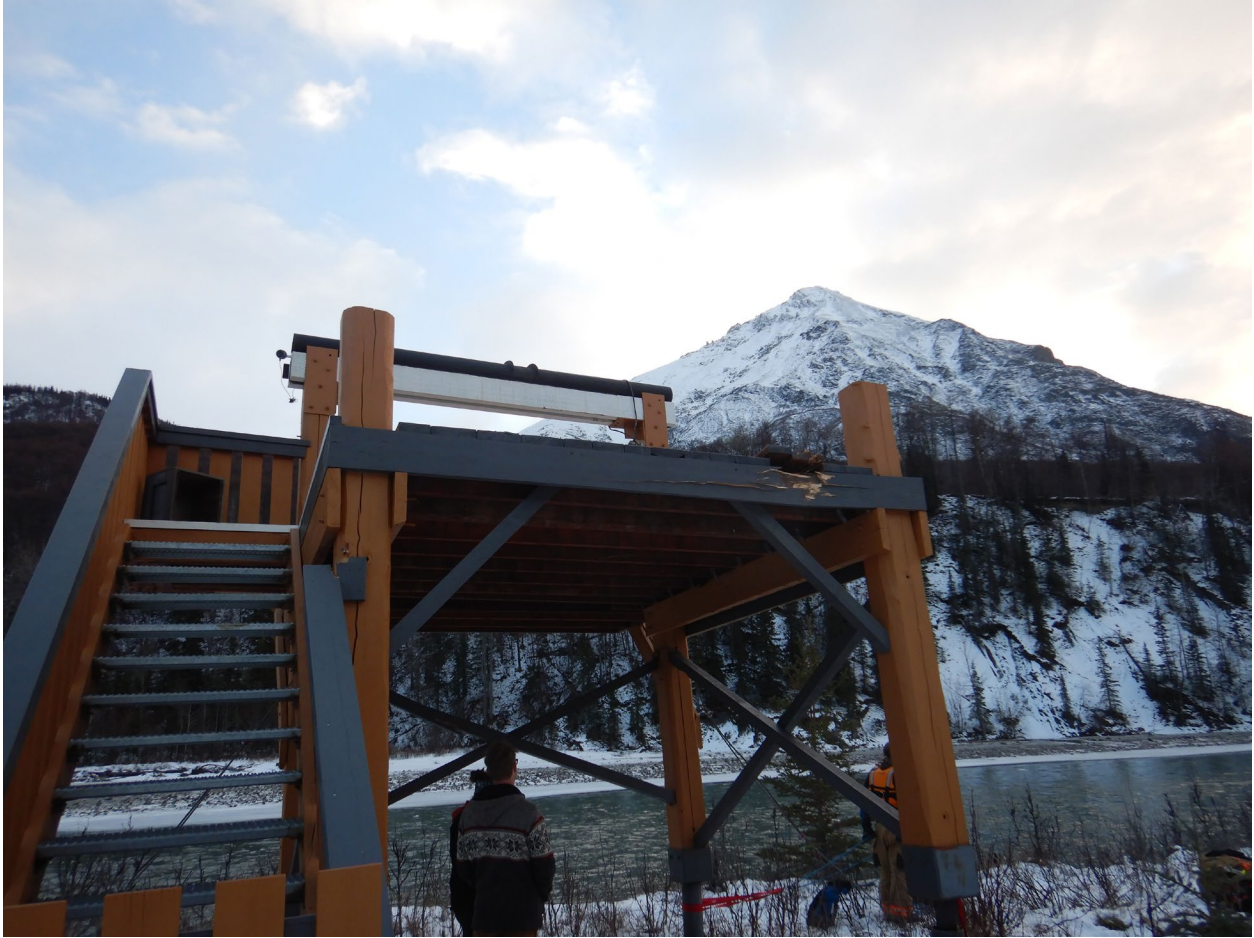
**Figure 2 Cable attachment point on the north side of the river.**

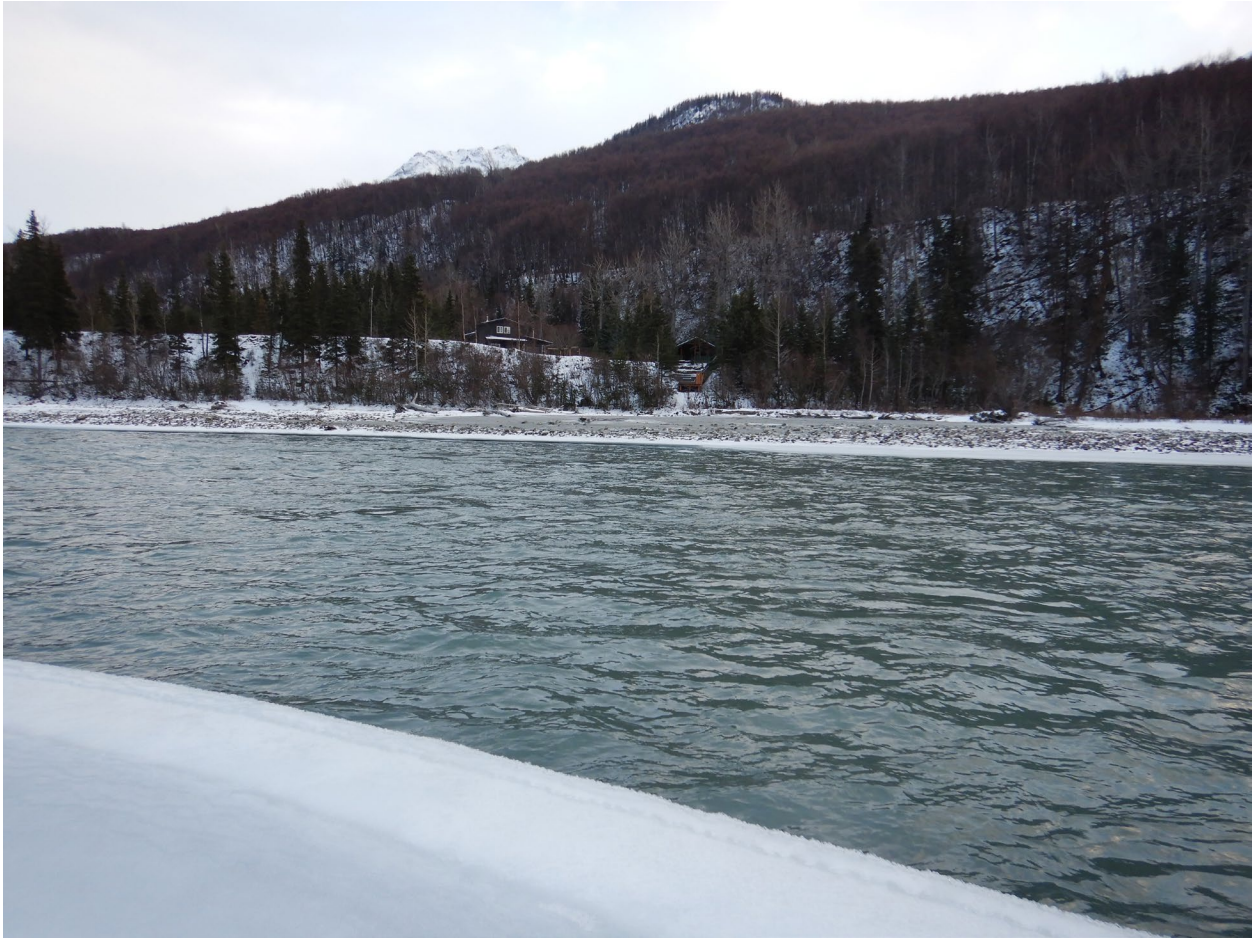
**Figure 3 House and cable attachment point on the south side of the river.**

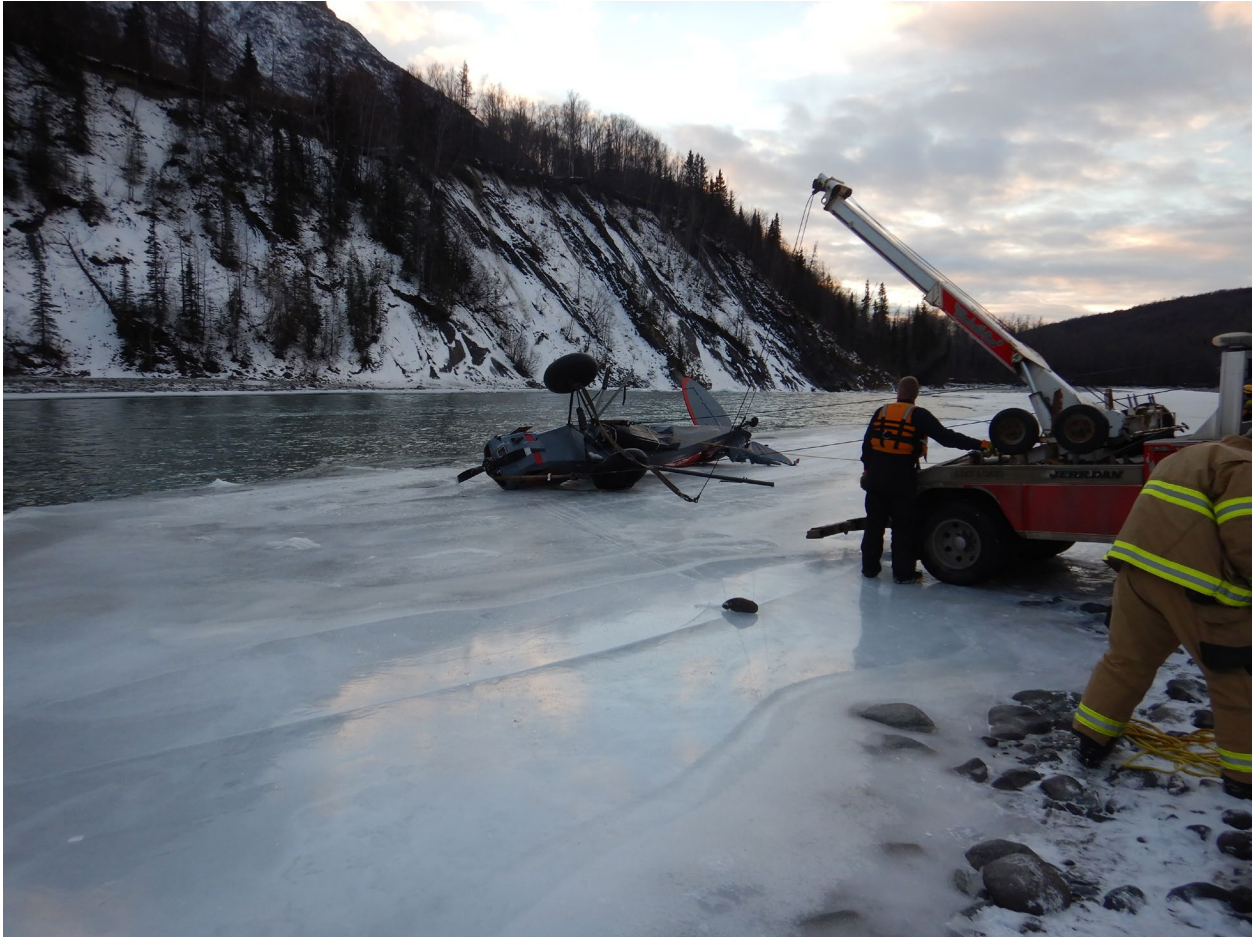
The fuselage was intact with frame damage from the cable impacting the right horizontal stabilizer.

**Figure 4 Accident airplane after recovery from the river.**

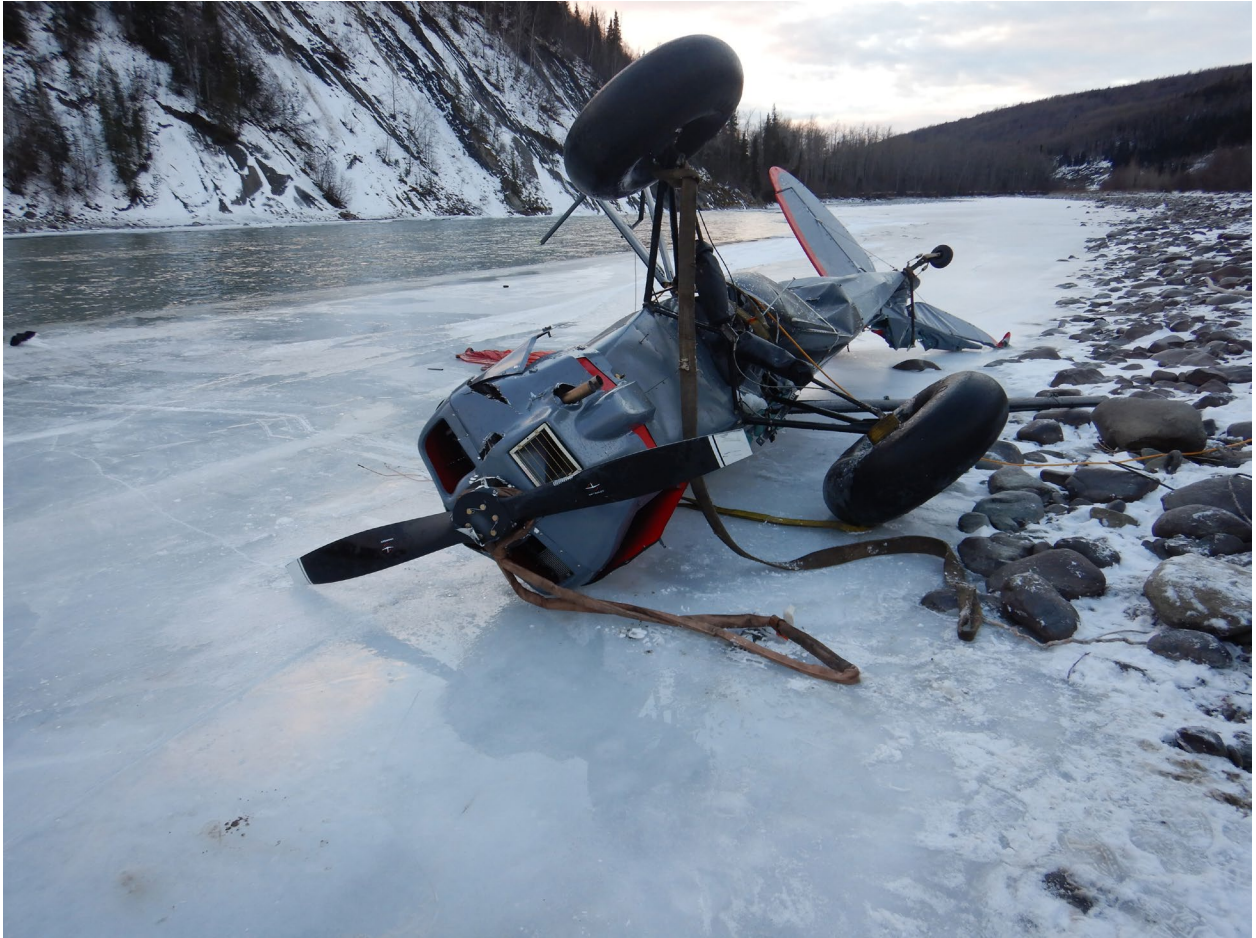
**Figure 5 Front bottom view of the accident airplane.**

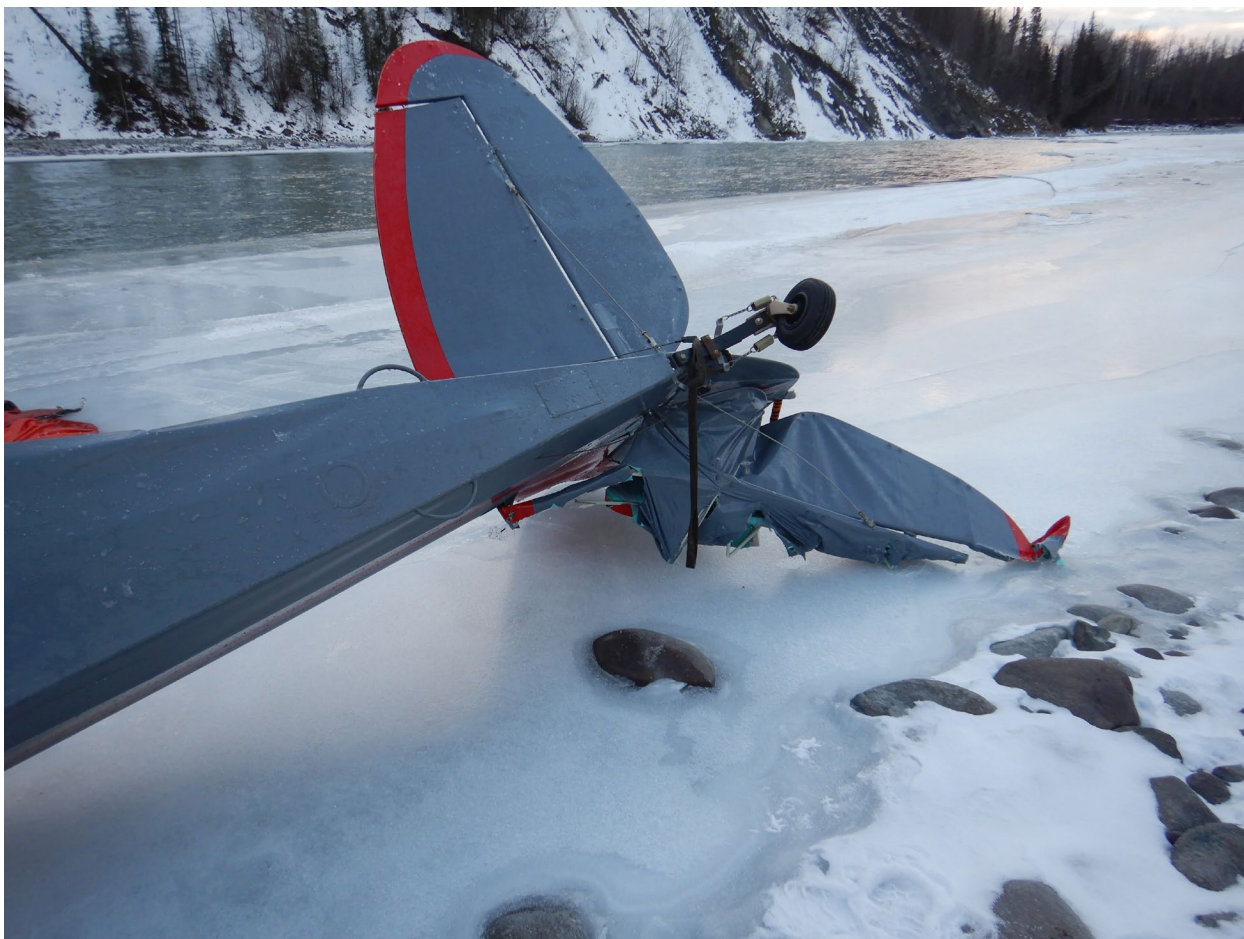
The left side of the empennage was undamaged. The right side had impact damage to the right horizontal stabilizer. Control cables to the rudder and elevators were still attached and the rudder had minor impact damage.

**Figure 6 View of the bottom side of the horizontal stabilizer and elevator.**

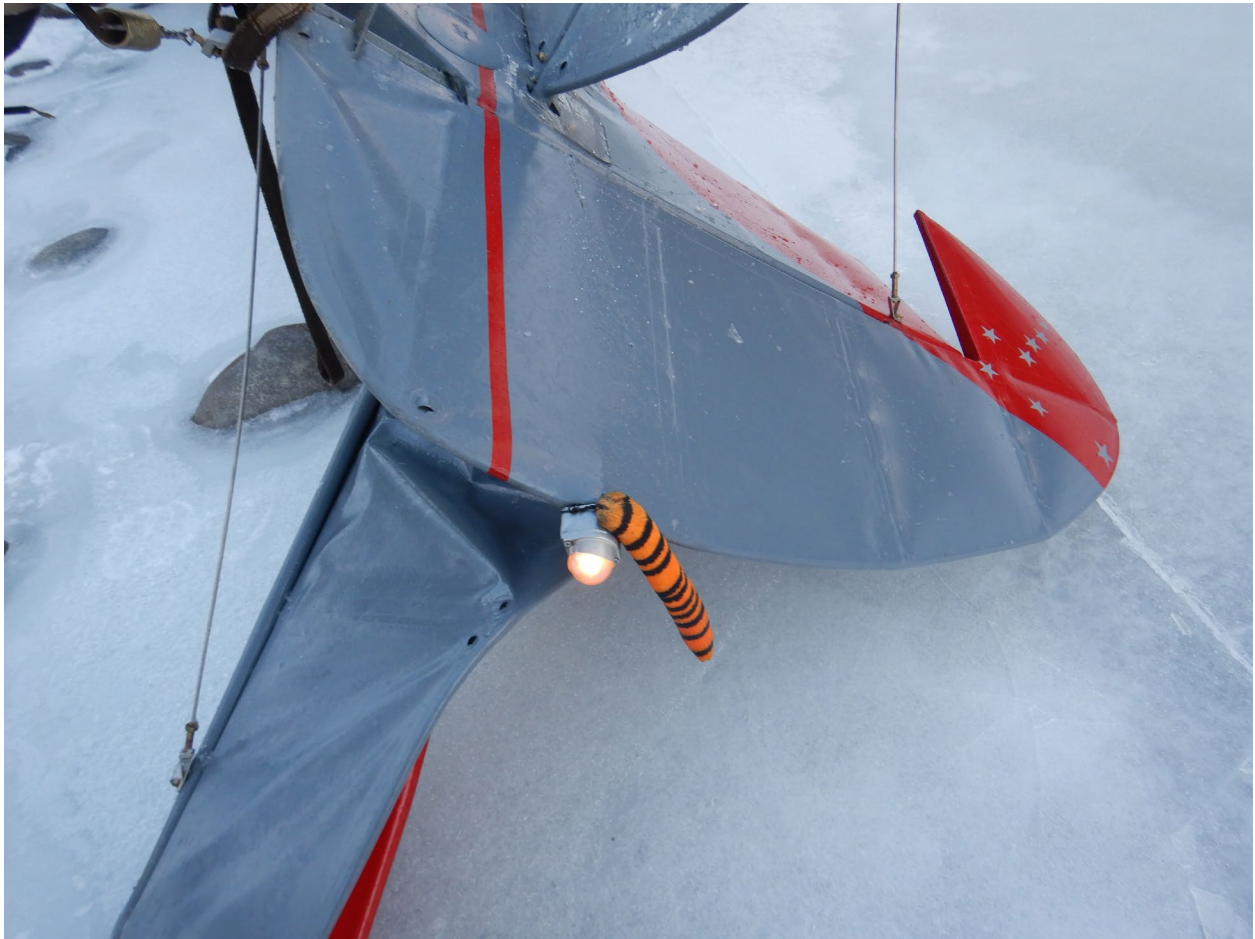
**Figure 7 View of left side of the rudder. Battery power was still on.**

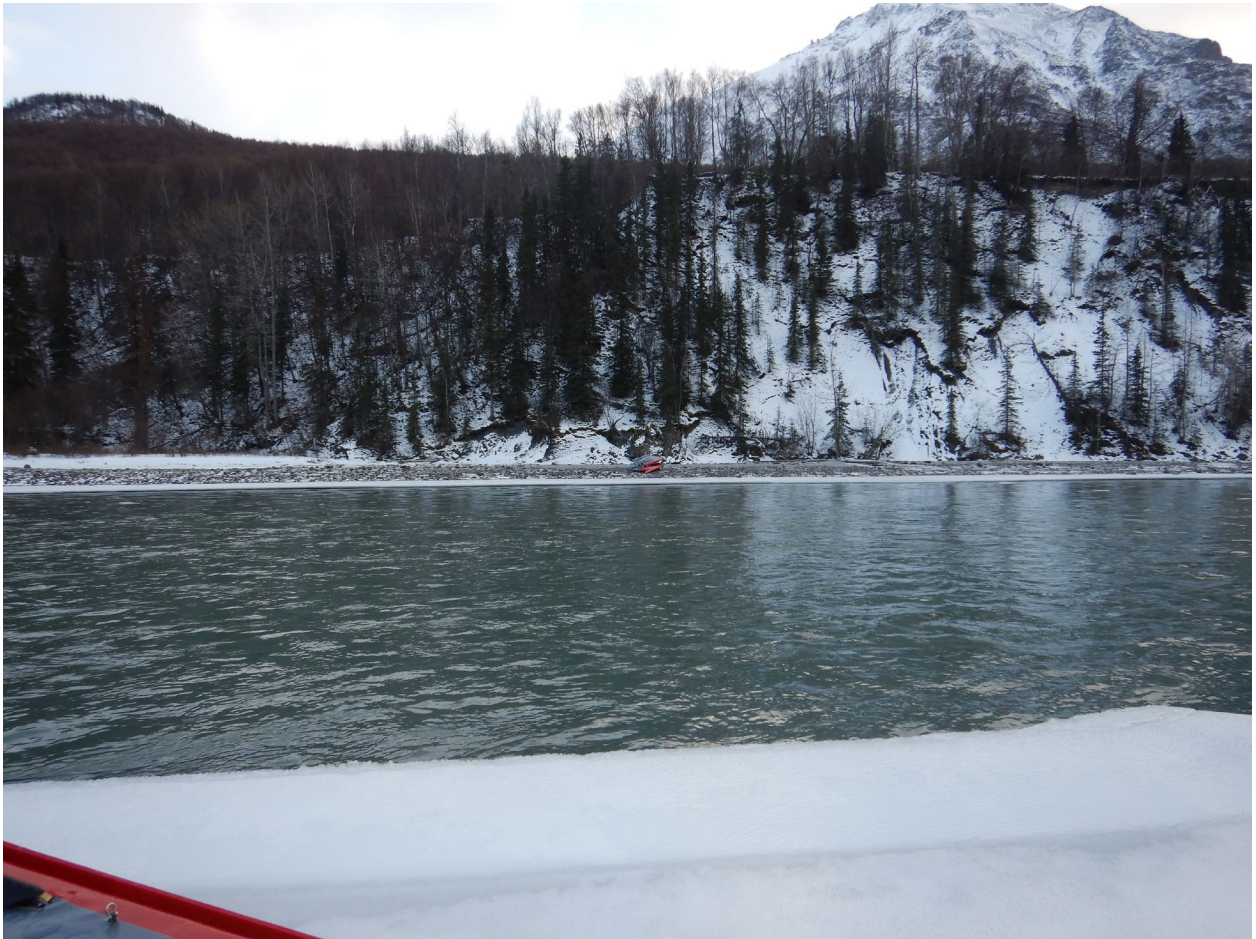
Both wings were separated from the airplane from impact with the cable that crossed over the river. The right wing was located on the south side of the river with the cable still wrapped around the wing and folded over about mid span. The left wing was mostly intact and was located on the north side. Both wings were about equal distance from the cable location with the fuselage located further down river.

**Figure 9 View of right wing on the south side of the river.**

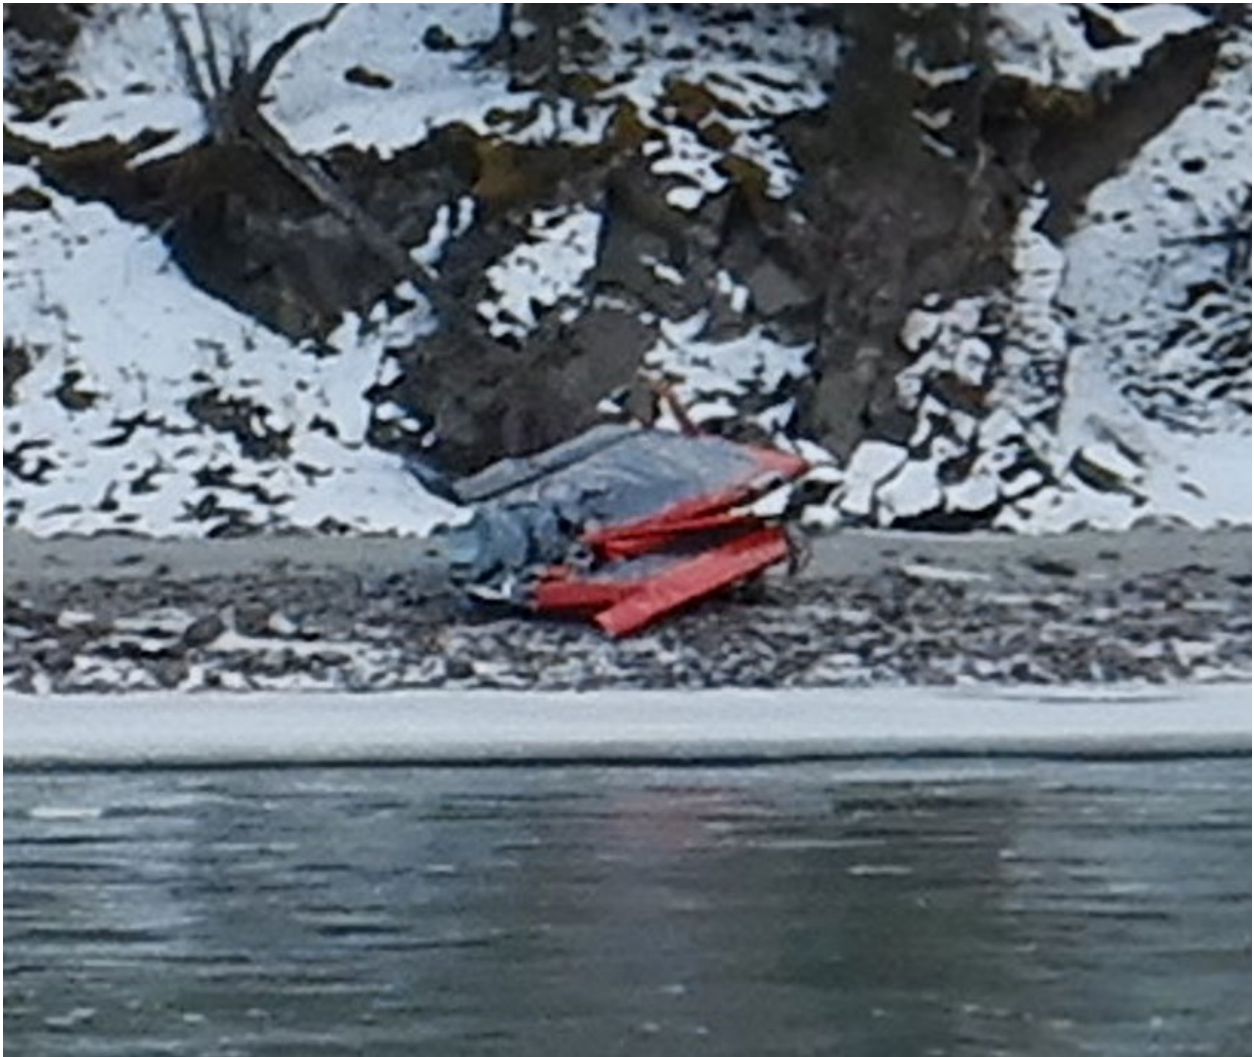
**Figure 10 Zoomed in view of the right side wing. The cable was wrapped around the wing.**

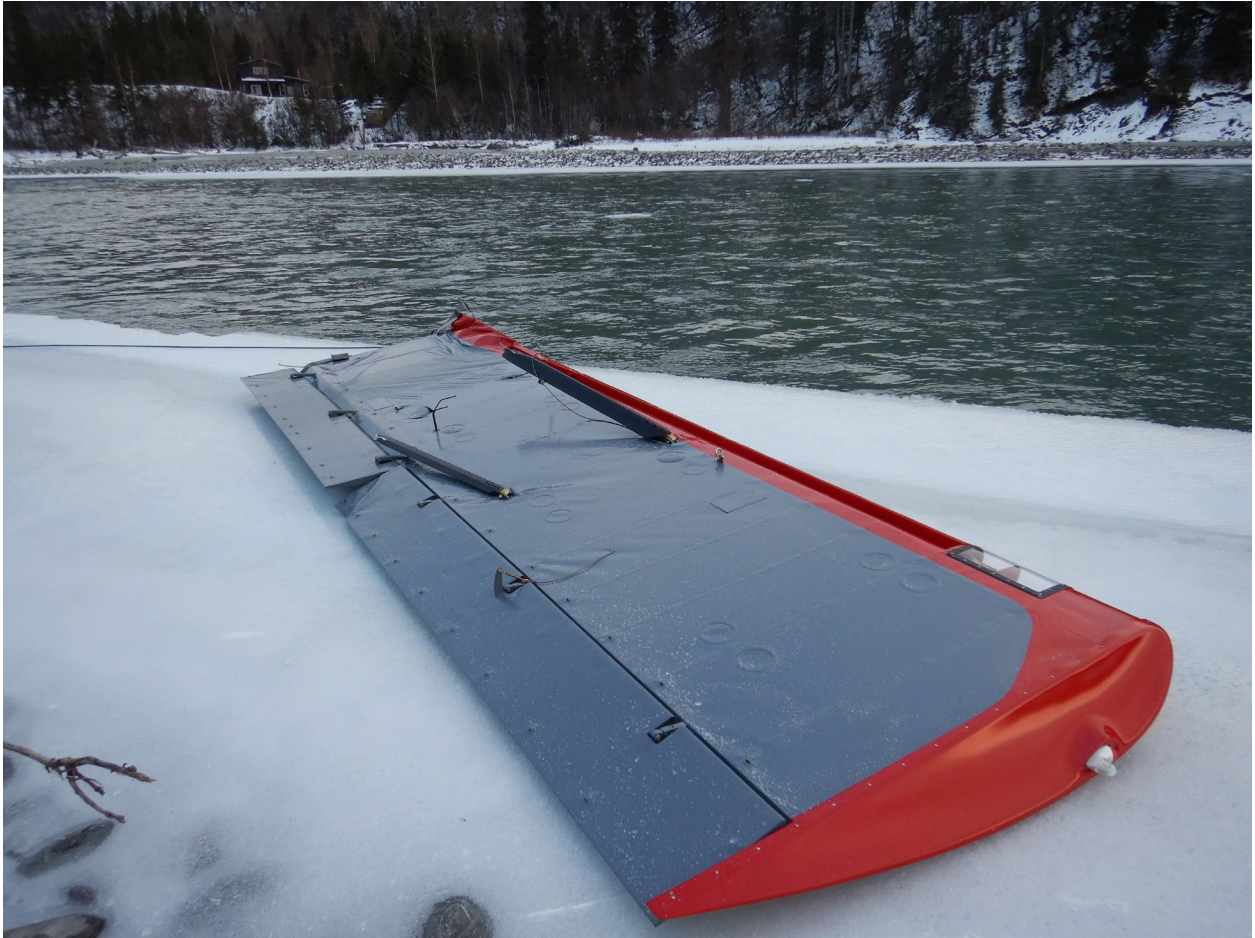
**Figure 11 Left side wing of accident airplane.**

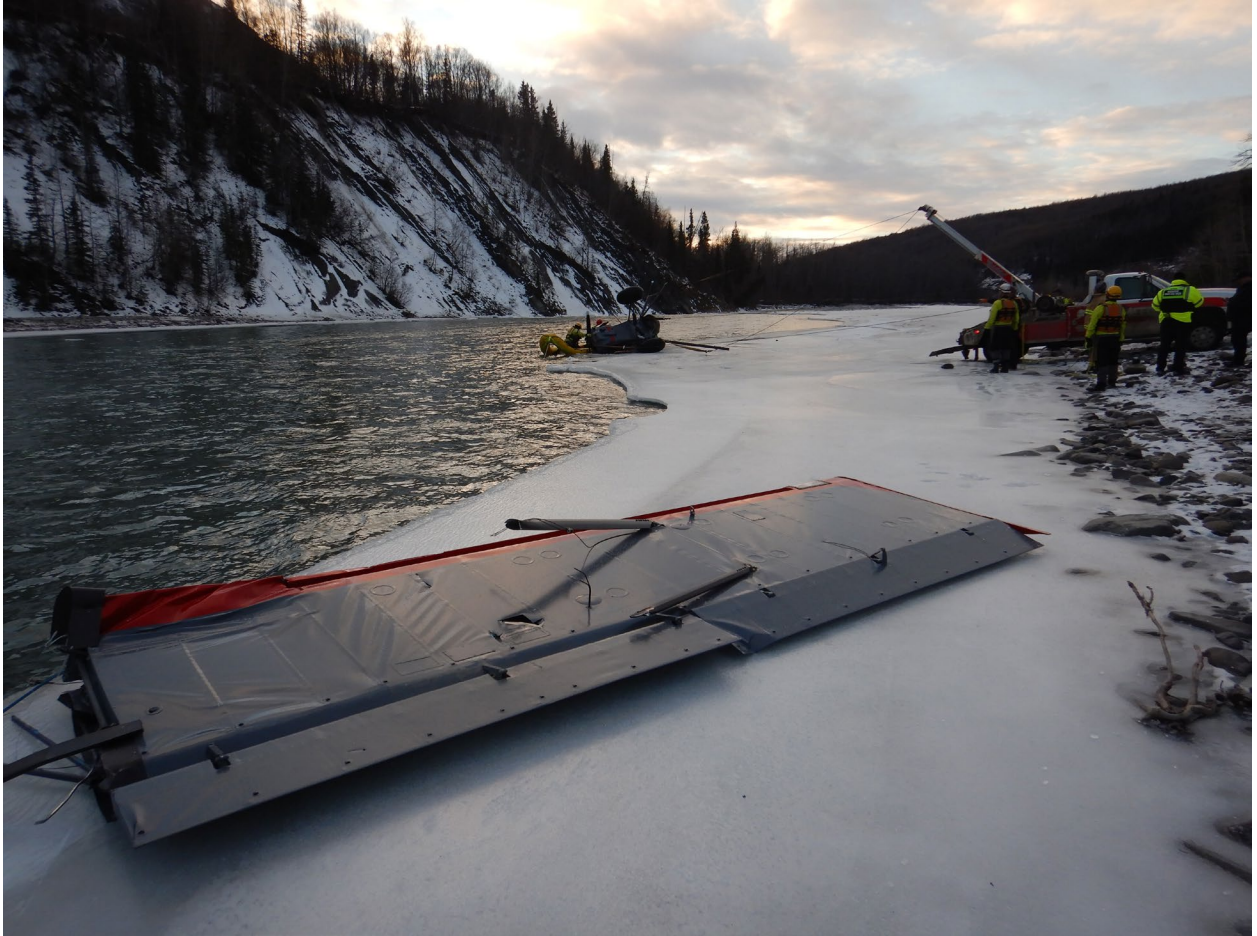
**Figure 12 Left wing on north side of the river in relationship to the final resting location of the fuselage.**

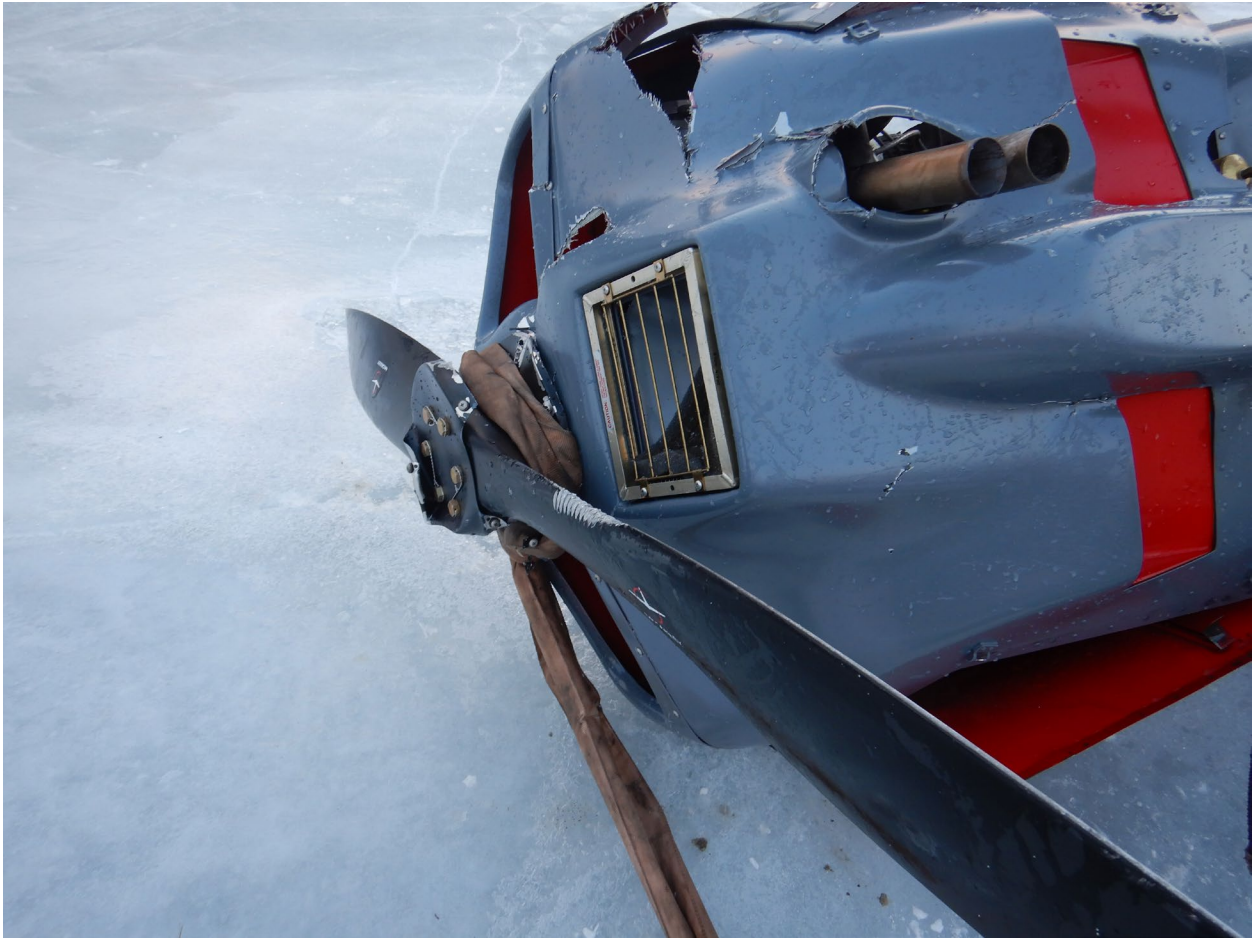
**Figure 13 Bottom side of engine cowl. View of the airplane propeller.**

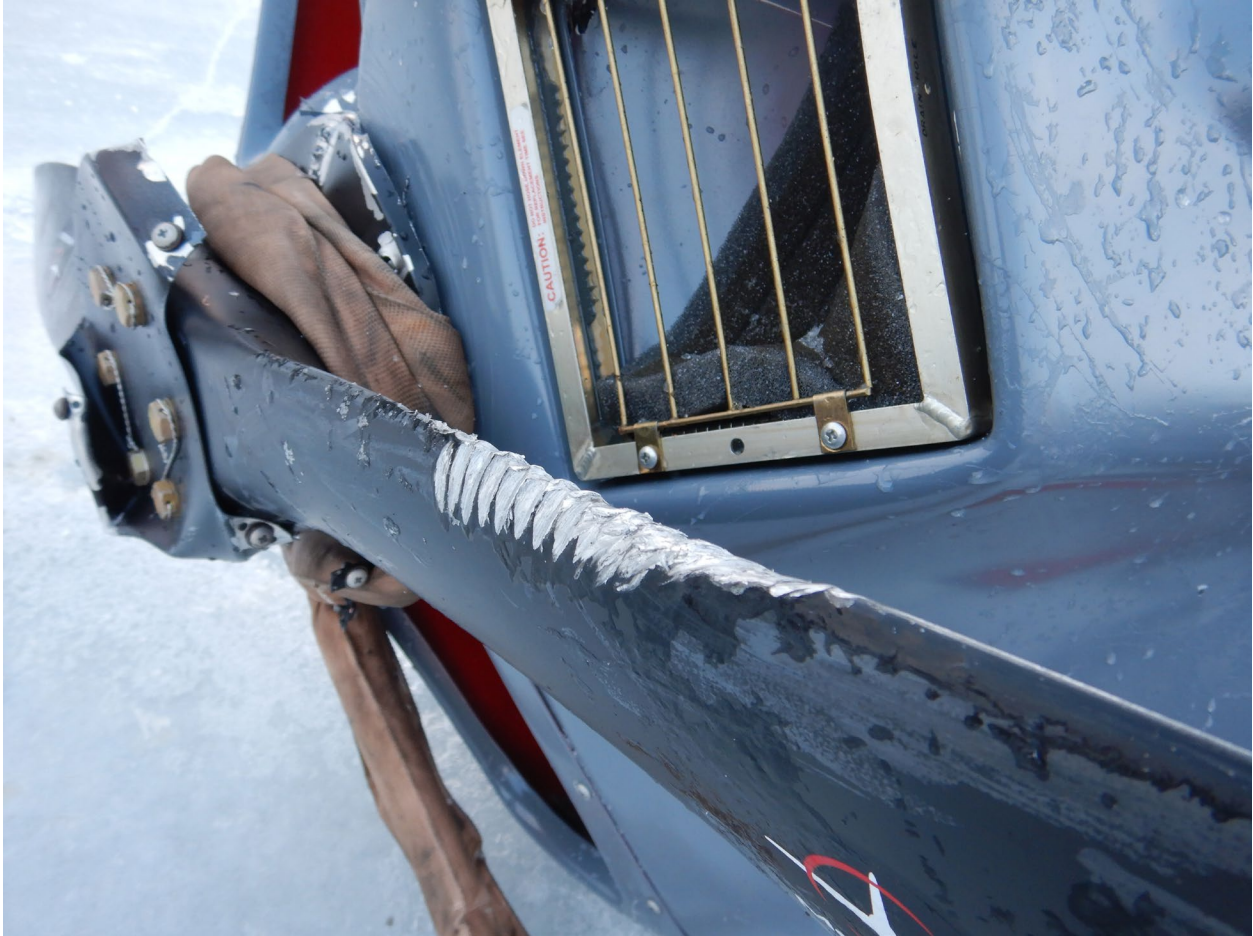
The airplane propeller had witness marks along the leading edge of the propeller consistent with the engine producing power.

**Figure 14 View of damage to the propeller caused by contact with the cable under power.**

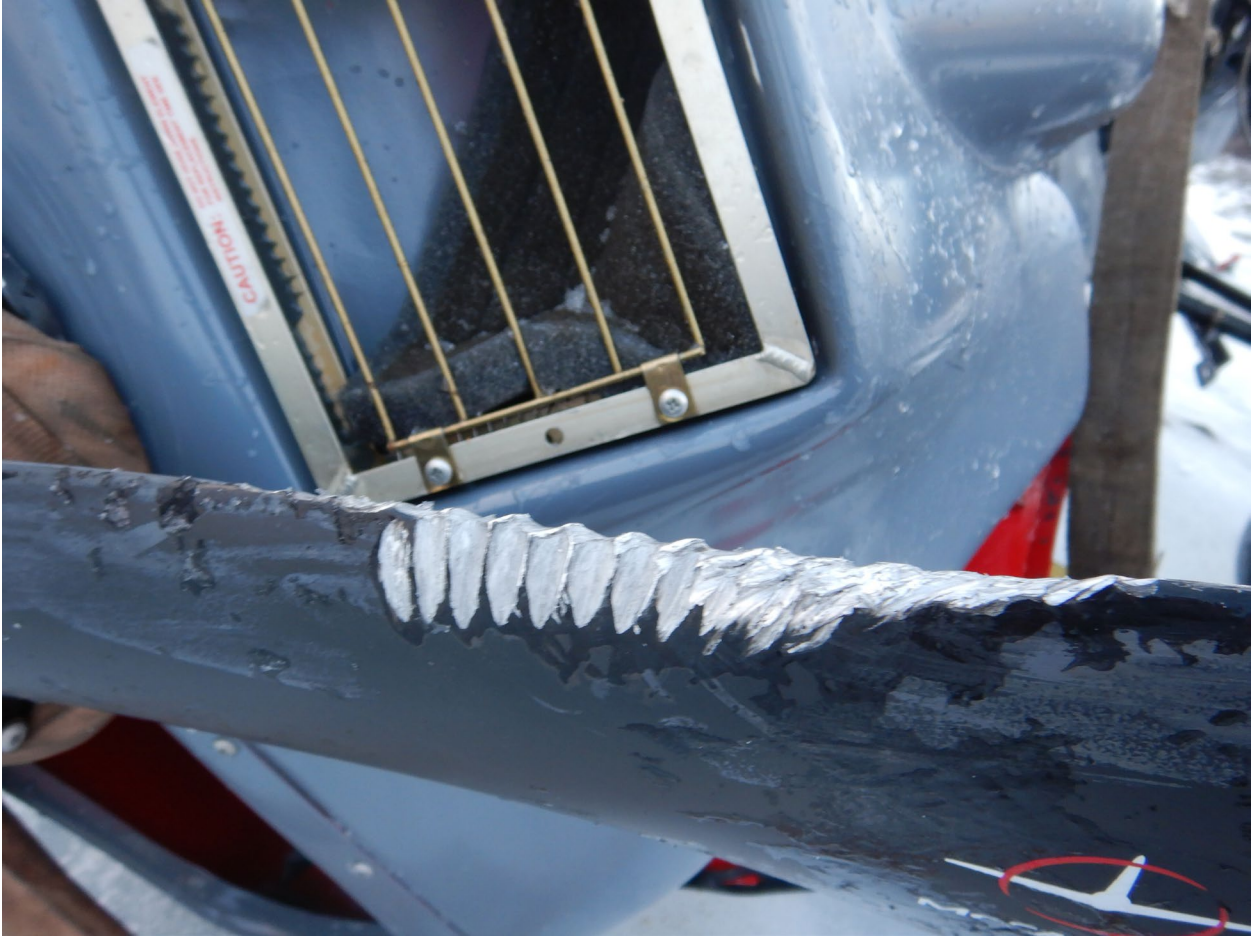
**Figure 15 Close up view of the damage to the propeller.**
