# National Transportation Safety Board

ANC23FA008

Group Chair's Factual Report

Location: Kaupo, HI  
Date: December 15, 2022  
Time: 2114 Hawaii standard time (HST)  
0714 coordinated universal time (UTC), December 16, 2022  
Airplane: Raytheon Aircraft Company C90A King Air, N13GZ

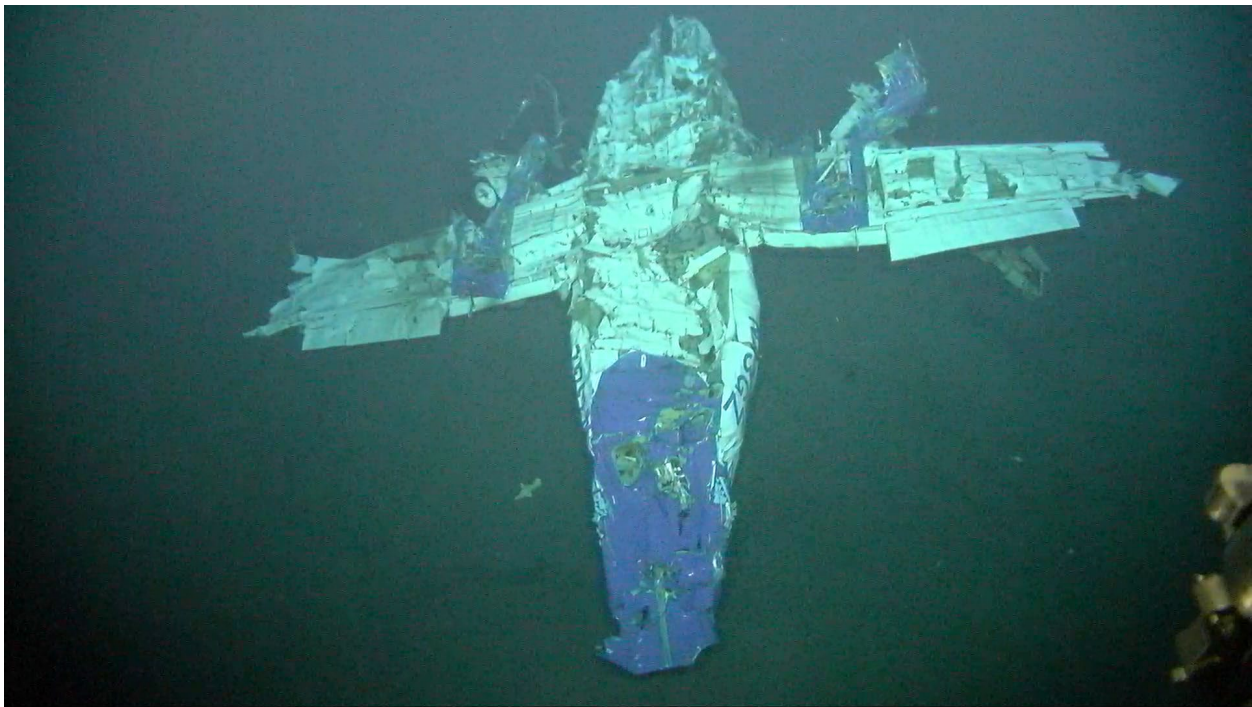
During all operations the vessel mounted ultra-short baseline (USBL) high precision acoustic position (HiPAP) receiver was set to listen for emergency beacons EMA and EMB at 37.5 kHz. Weak signals were detected across the area, but the positions were deemed unreliable. During one of the transits a stronger, more consistent signal was detected, and it was decided to dive on that location. As a result, on January 9 at 05:30 HST the ROV located the airplane main wreckage on the seabed at a water depth of approximately 1960 m. The wreckage was found about 360 m south of the last known position from the flight track. The airplane was lying upside down, with the fuselage largely intact and both inboard wing sections still attached (Figure 6). The outboard wing sections, part of the tail section and both engines were separated.

**Figure 6.** Airplane wreckage on the seafloor (OI photo)

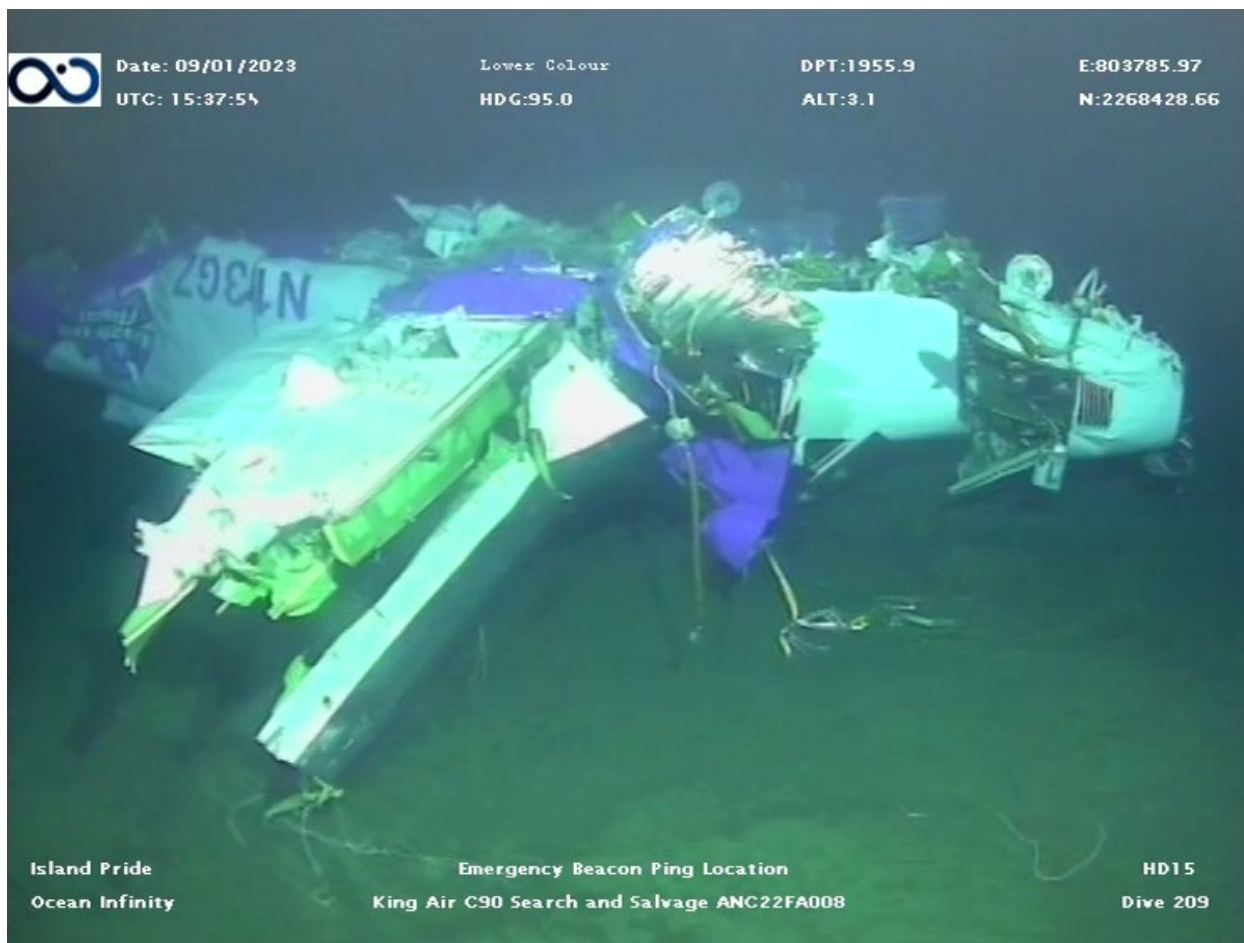
The ROV performed a detailed visual inspection of the wreckage to assess the structural integrity of the fuselage in preparation for recovery (Figures 7 and 8). Examination of the underwater imagery revealed that the fuselage was mostly intact from the nose to the tail. The horizontal stabilizer, elevators, vertical stabilizer, and rudder were separated. The left and right wings were mostly intact but damaged from the roots out to beyond the end of the outboard flaps. The lower fuselage and lower surface of the wings had significant upward crushing damage. The nose and right main landing gear remained attached and were in the retracted position. The left main landing gear was separated and recovered by the USCG after the accident. Further ROV examination confirmed the presence of possible human remains inside the fuselage.

**Figure 7.** Airplane wreckage, left side (OI photo)

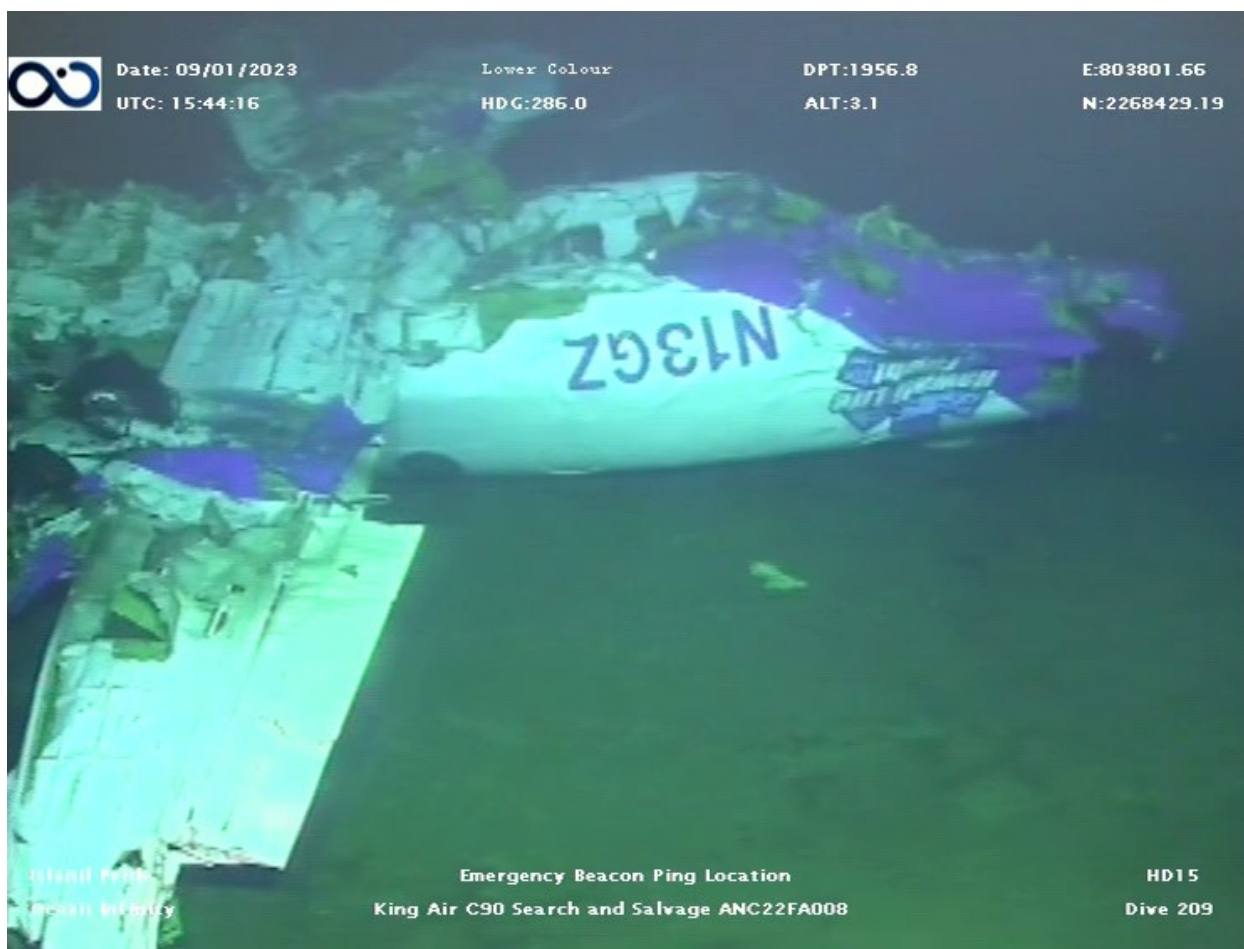
**Figure 8.** Airplane wreckage, right side (OI photo)

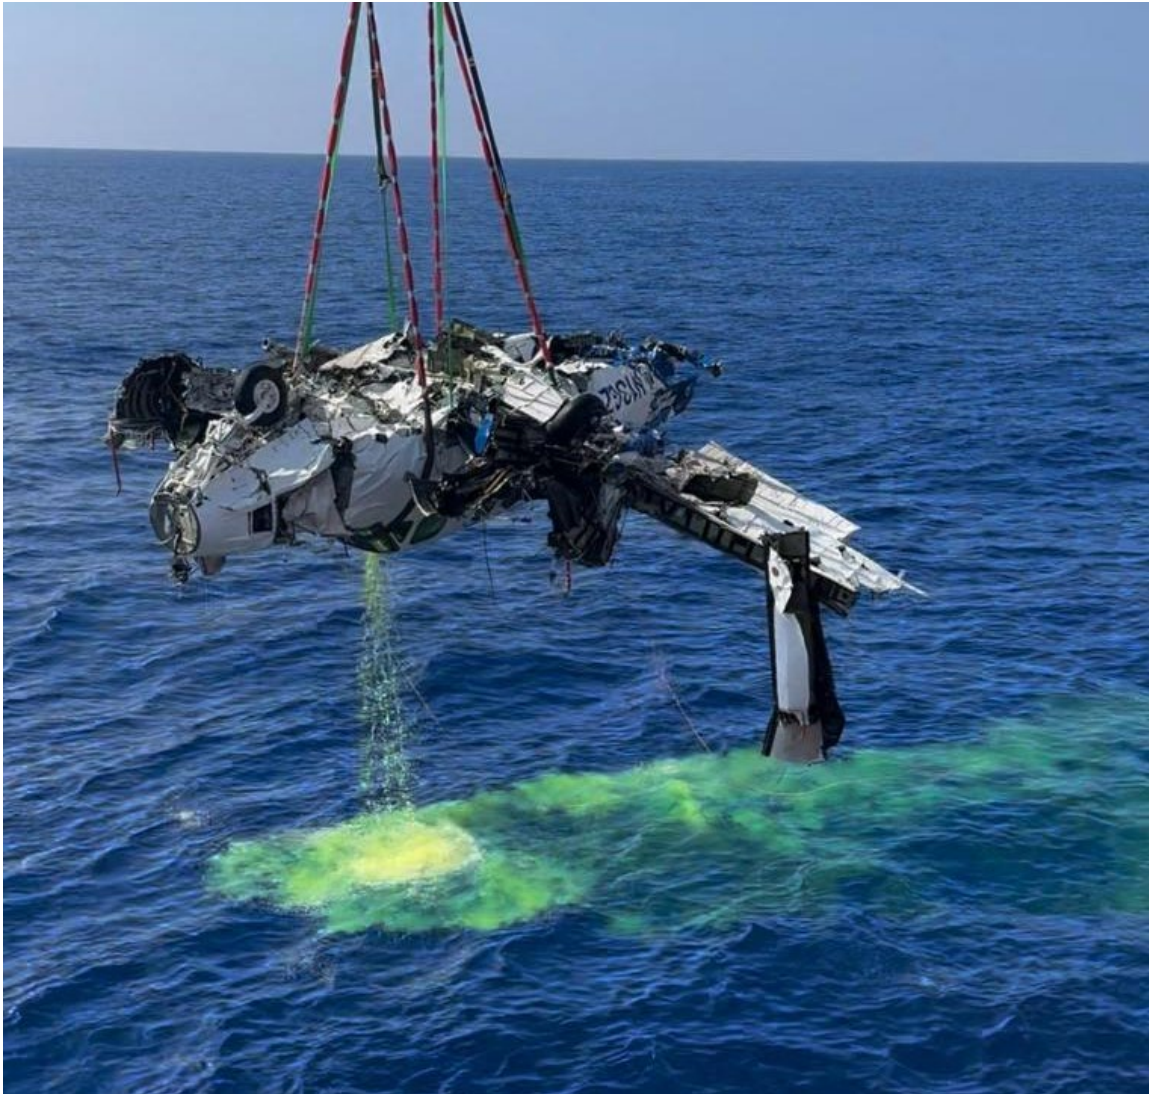
The airplane fuselage was lifted slowly through the splash zone and held above the surface to allow for water to drain before continuing the lift onto the ship's back deck. In the final stages of water draining from the fuselage, a distinct fluorescent green hue was observed, forming a very visible layer on the water surface (Figure 10). The airplane's onboard survival kit included a life raft, dye pouch, and other survival equipment. The substance observed was consistent with the Fluorescein Dye Marker from the survival kit. The visible layer dispersed entirely within several minutes. There were no traces of any oily substances observed on the surface throughout the recovery operation.

**Figure 10.** Green dye on water during airplane recovery (OI photo)

- 4) Prevent discharges or chemicals and other fluids dissimilar from seawater into the water column.  
RESPONSE: During recovery a distinct, fluorescent green substance was discharged into the water. Observation and research indicated the substance was SAR Fluorescein Dye Marker from the airplane survival kit. The MSDS was attached as B to the report.

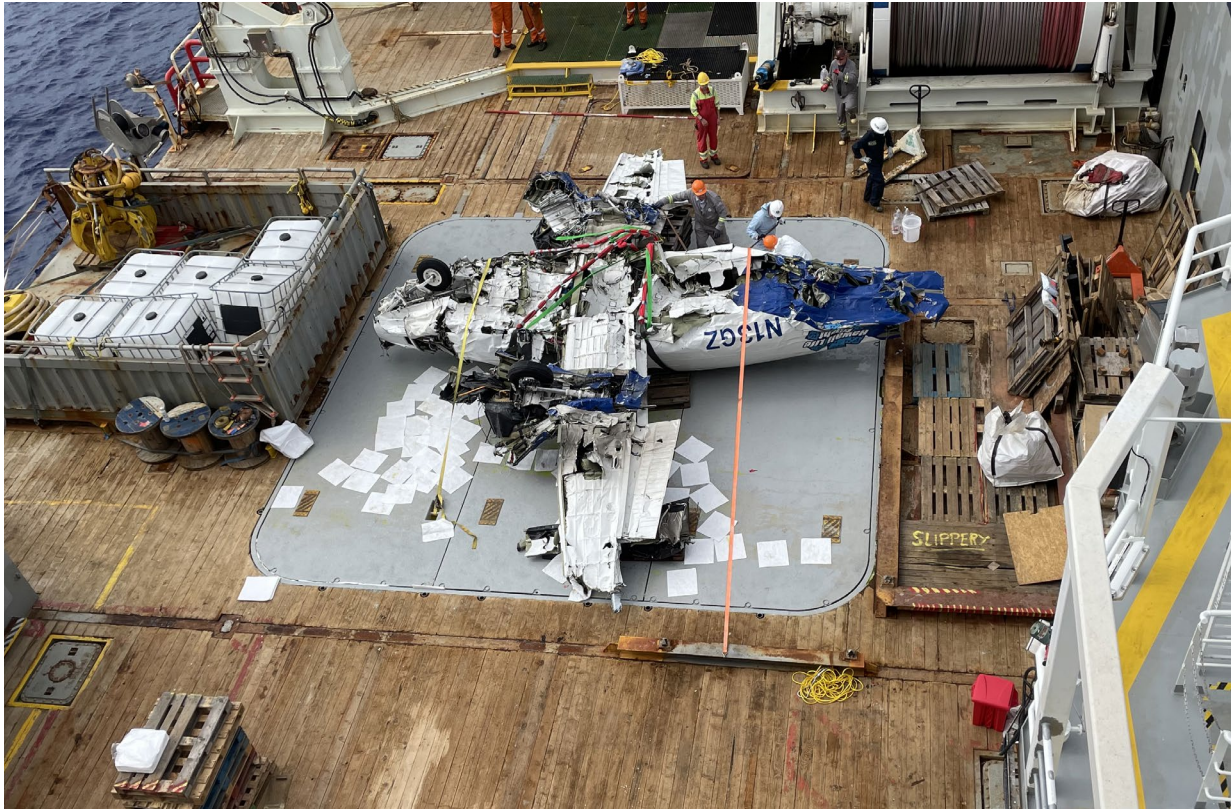
The main fuselage was secured to the deck of the *M/V Island Pride* (Figure 11) and the CVR, SkyTrac, Stratus, and Appareo units were recovered from the airplane and secured in fresh water for transport to the NTSB lab.

**Figure 11.** Main airplane wreckage secured to deck (OI photo)

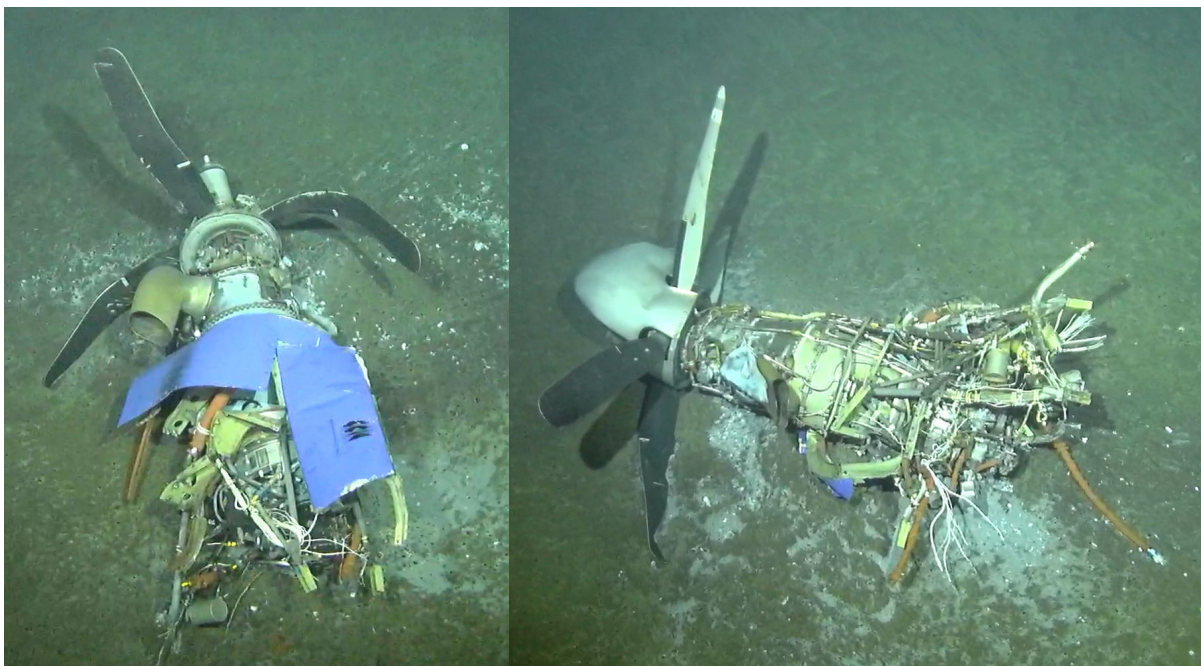
The ROV was redeployed following the recovery of the main fuselage to recover both engines with attached propellers (Figure 12) and a section of wing flap identified in the AUV sonar data. The recovery operation was completed the afternoon of January 11 and the *M/V Island Pride* transited to Honolulu overnight. The airplane wreckage was offloaded to waiting trucks and Guardian Flight and NTSB personnel disembarked. The operation was completed about 14:00 HST January 12, 2023.

**Figure 12.** Airplane engines (OI photo)
