# National Transportation Safety Board

ANC23FA008

## **SYSTEMS**

Group Chair's Factual Report

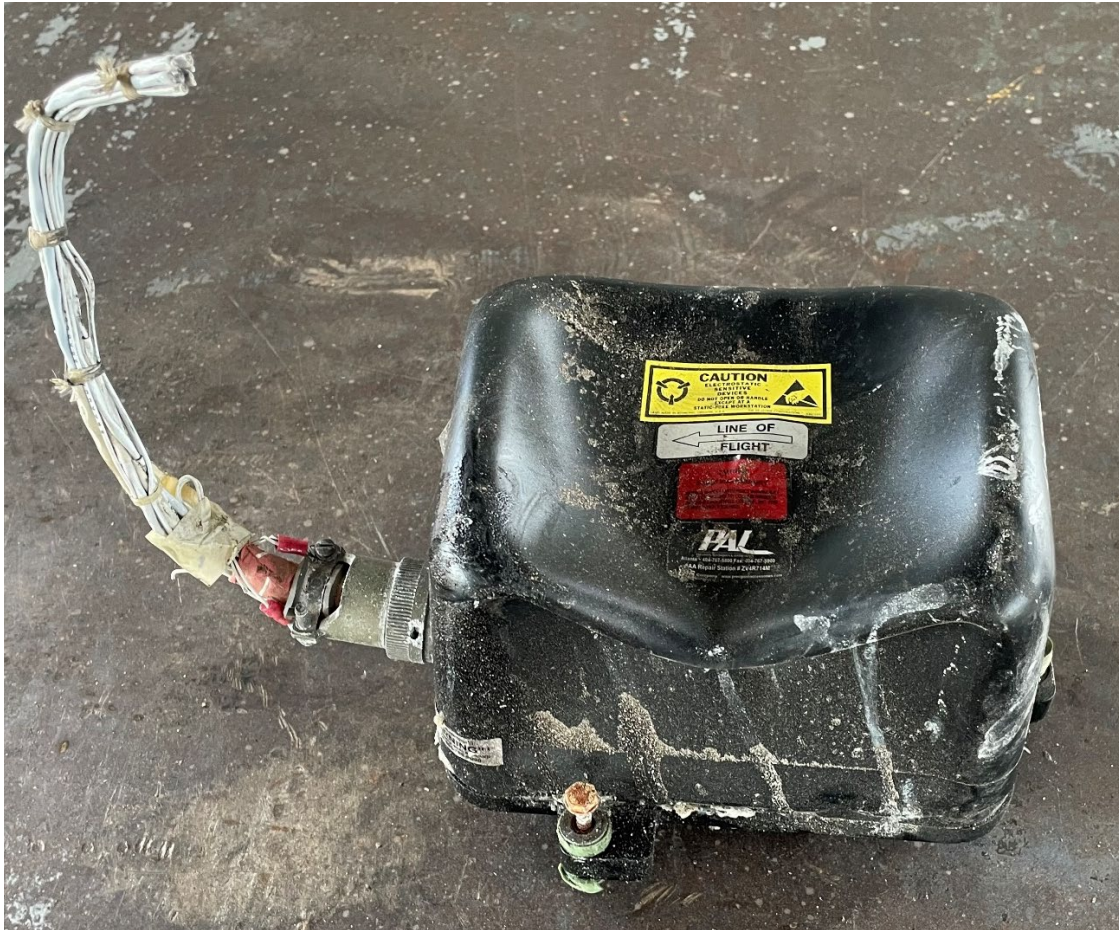
The group met at the Air Transport facility in Phoenix, Arizona, on August 02, 2023, to re-examine the airplane wreckage. The vertical gyro was located in the nose of the aircraft and removed. The unit was photographed (see Figures 6 and 7) and retained for further examination. The unit had water inside it, and this was drained as much as possible before shipping the unit to Collins Aerospace.

**Figure 6.** Photo of vertical gyro after removal from wreckage.

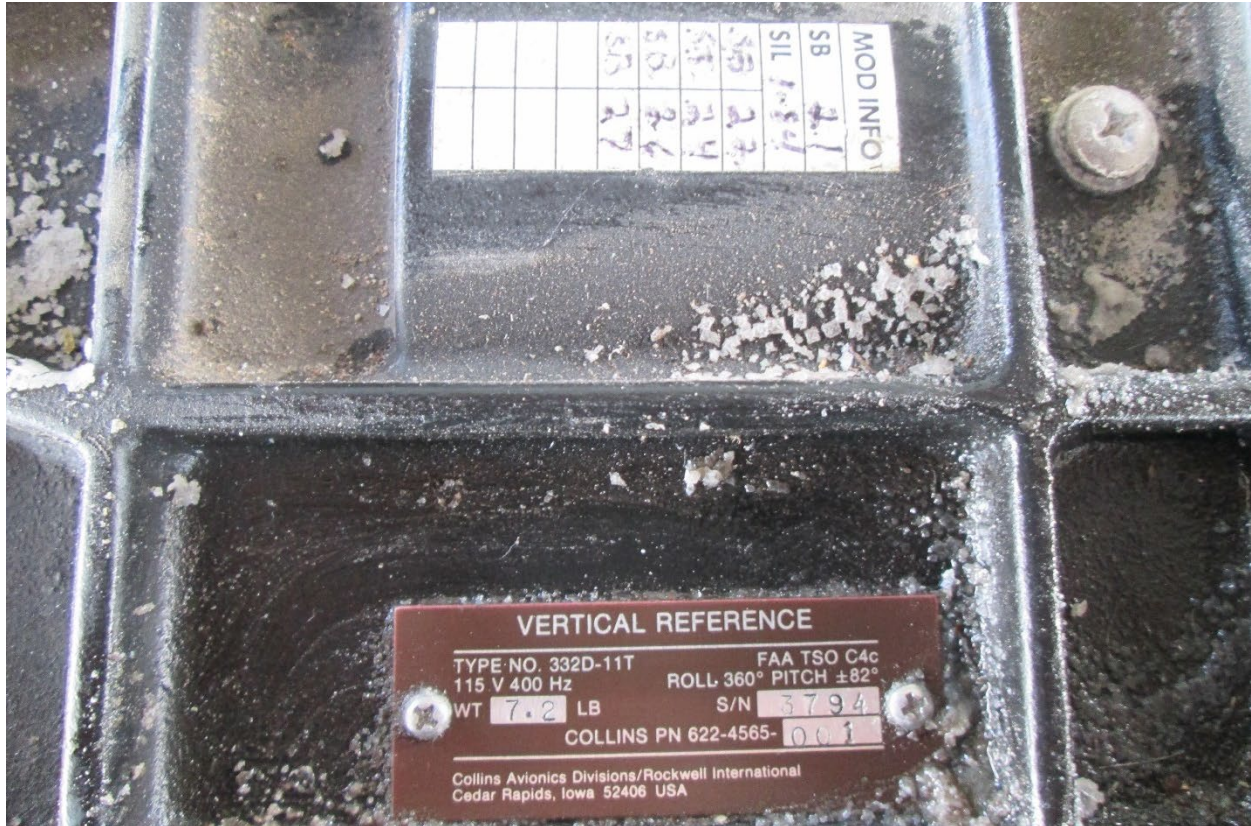
**Figure 7.** Photo of vertical gyro nameplate.

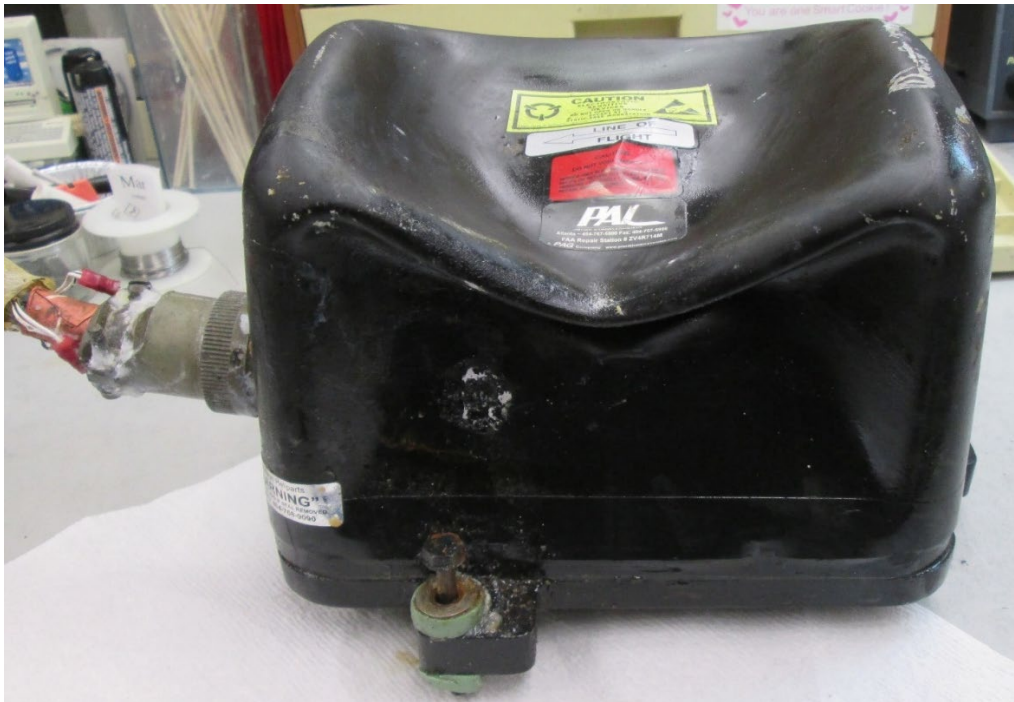
A detailed external inspection was completed. Photos were taken of the unit as received. The unit was crushed inward on the top and 2 sides (see Figure 8). The crushing of the case is consistent with excessive external water pressure. There were salt deposits on the electrical connector. There was a Precision Accessories Inc. (PAI) repair label on the unit. There was a Precision Heliparts warranty sticker on the part. There was no smell or odor perceived from the unit.

**Figure 8.** Vertical gyro at start of examination.

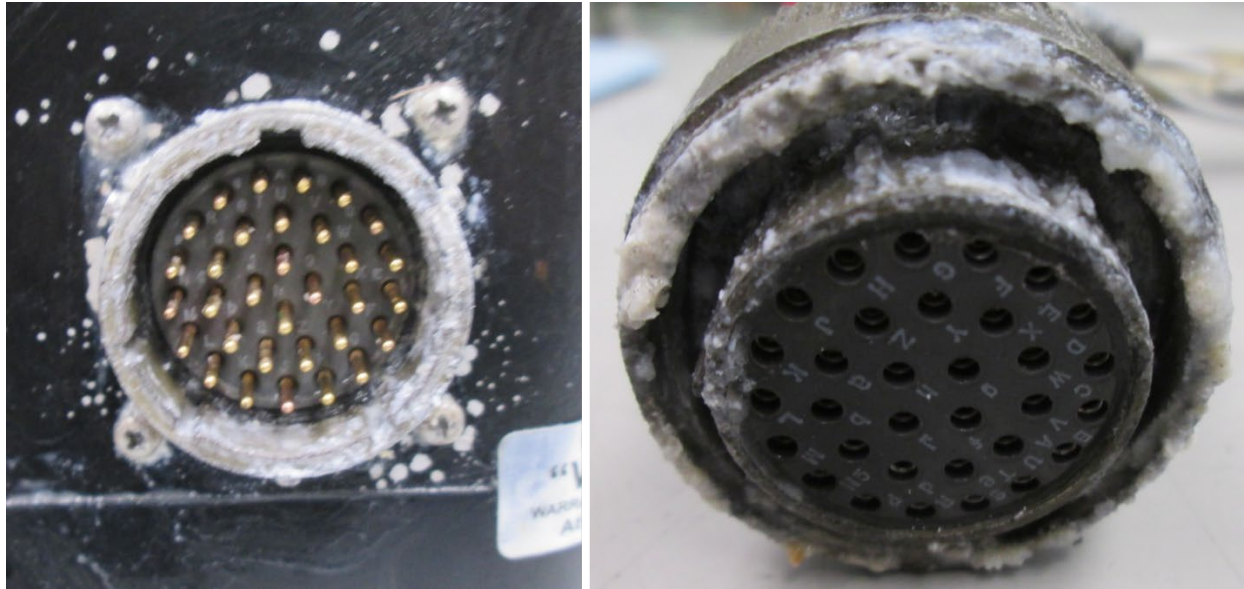
The airframe electrical connector was removed. The pins were straight. The sockets on the aircraft side of the connector were present and none appeared to be recessed (see Figure 9).

**Figure 9.** Photo of vertical gyro electrical connector and mating electrical harness connector.

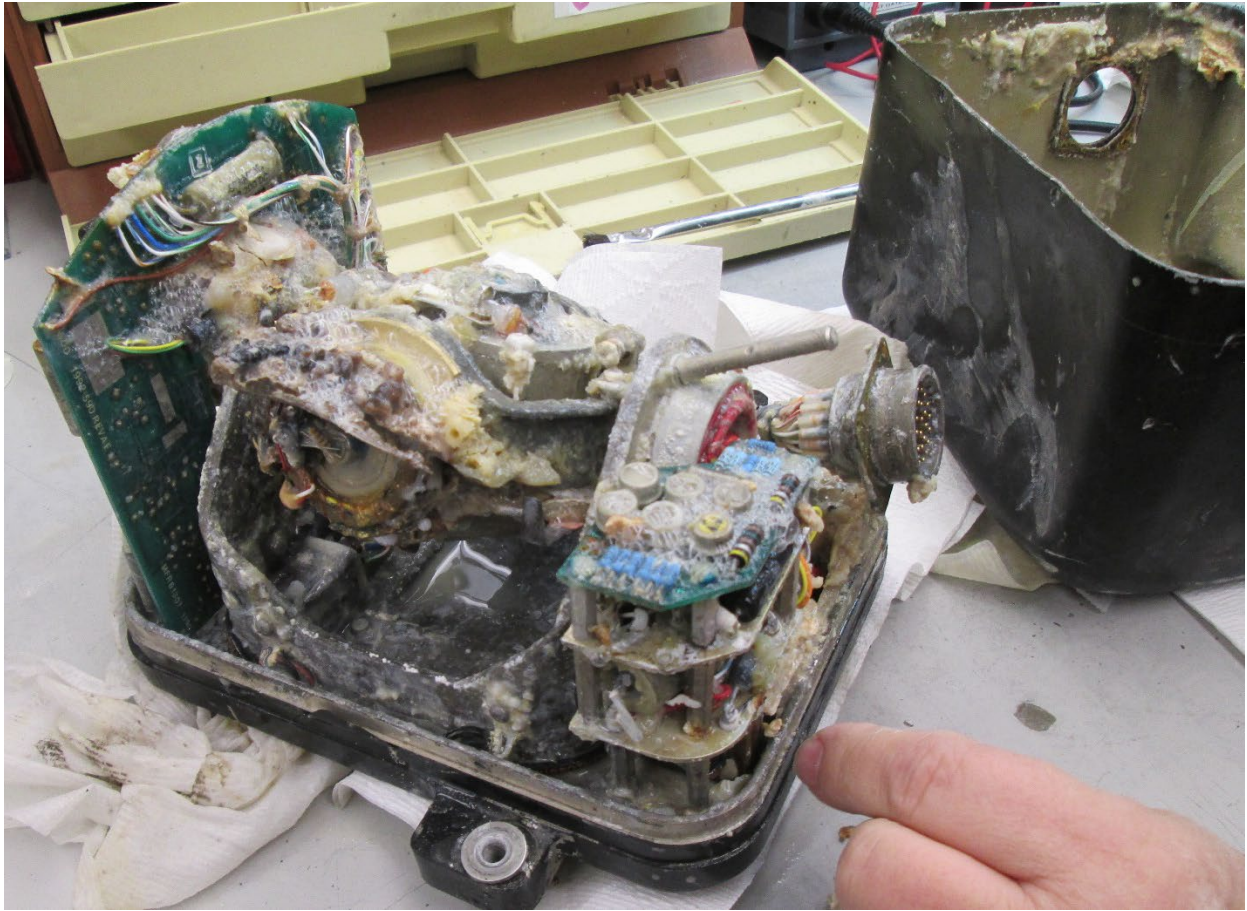
The preservation sealing tape around the base of the unit was removed. Water was present and dripped out of the unit. The water was drained from the unit. The cover was removed. The interior of the unit was covered in marine growth and deposits (see Figure 10). The unit was washed with de-ionized water and some of the marine growth was removed (see Figure 11).

**Figure 10.** Photo of interior of the vertical gyro showing marine growth and deposits.

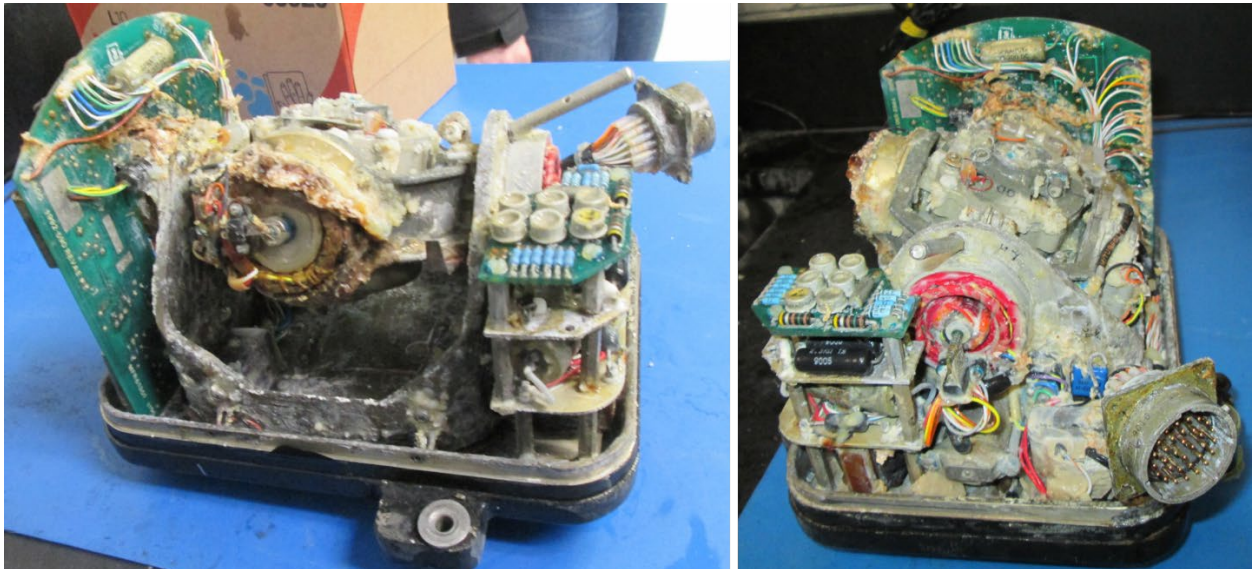
**Figure 11.** Photos of the vertical gyro after rinsing with de-ionized water.

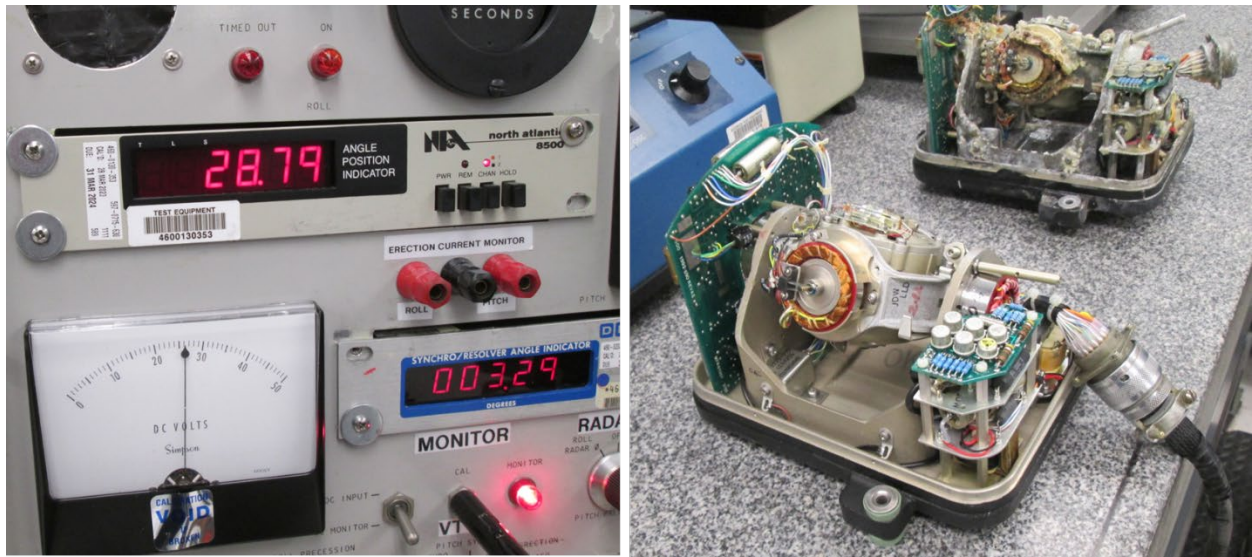
An exemplar unit was set to approximately the same position as the accident gyro. This corresponded to approximately 29 degree right roll and 3.5 degree pitch down position (see Figure 12).

**Figure 12.** Photos of exemplar vertical gyro set to the same position as the accident unit.

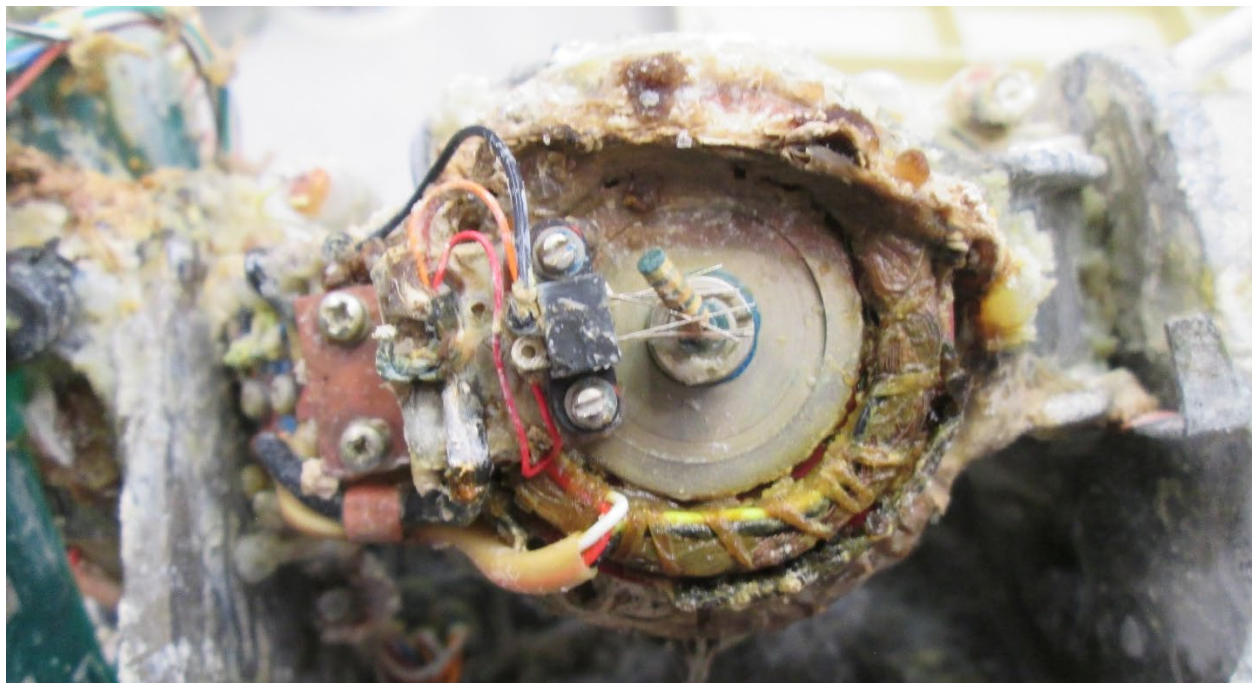
The slip ring was damaged, and the damage appeared to correspond to the crushed cover (see Figure 13). Several components on the unit were observed to be crushed. An example of the crushed components is provided in Figure 14. The S1 switch was broken, and the damage appeared to correspond to the crushed cover (see Figure 15). Damage to a wire wound resistor (R61) on terminal board 7 (TB7) was observed (see Figure 16).<sup>1</sup> The resistance across the resistor was measured at 83.5 ohms as found. One of the wires between the resistor and the board was cut to isolate the resistor. The resistance across the resistor was re-measured at 83.4 ohms. (Note that R61 resistor has a nominal value of 82 ohms.) Terminal board 7 was removed from the unit for additional examination at Collins Aerospace.

**Figure 13.** Photo of the vertical gyro showing damaged slip ring.

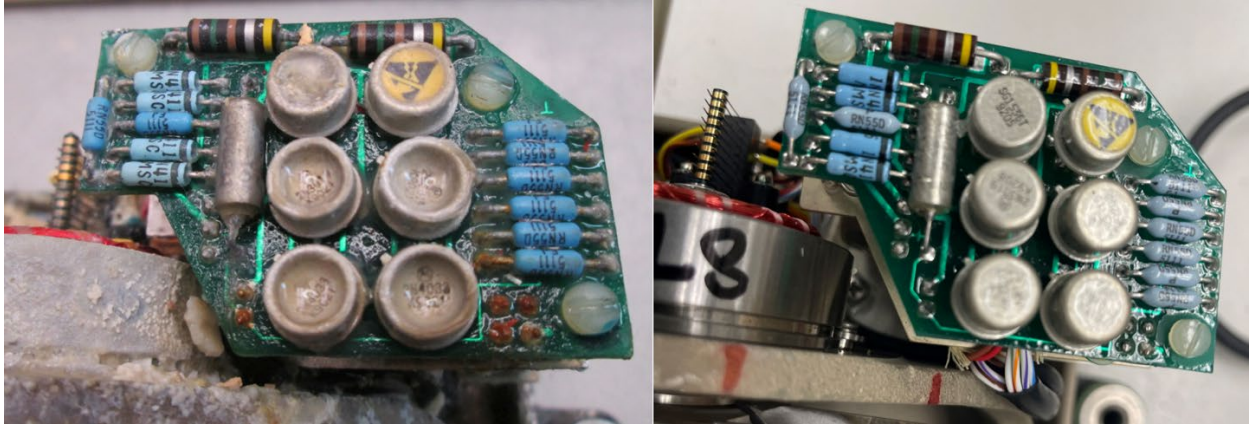
**Figure 14.** Photo of crushed components in the vertical gyro (left) and exemplar unit (right).

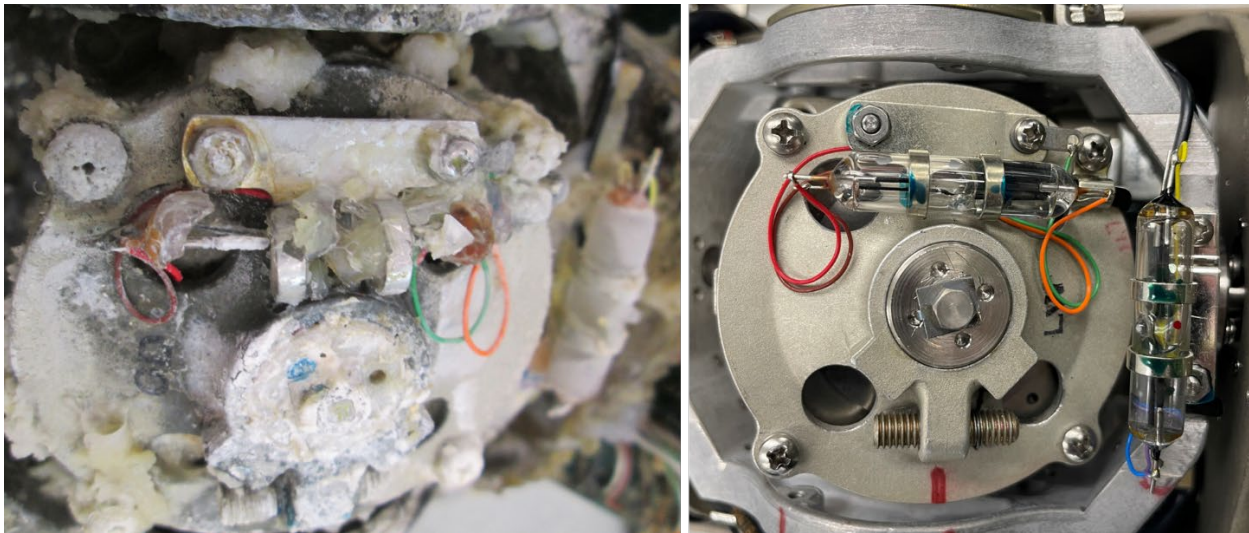
**Figure 15.** Photo of the vertical gyro showing damaged S1 switch (left) and an exemplar unit S1 switch (right).

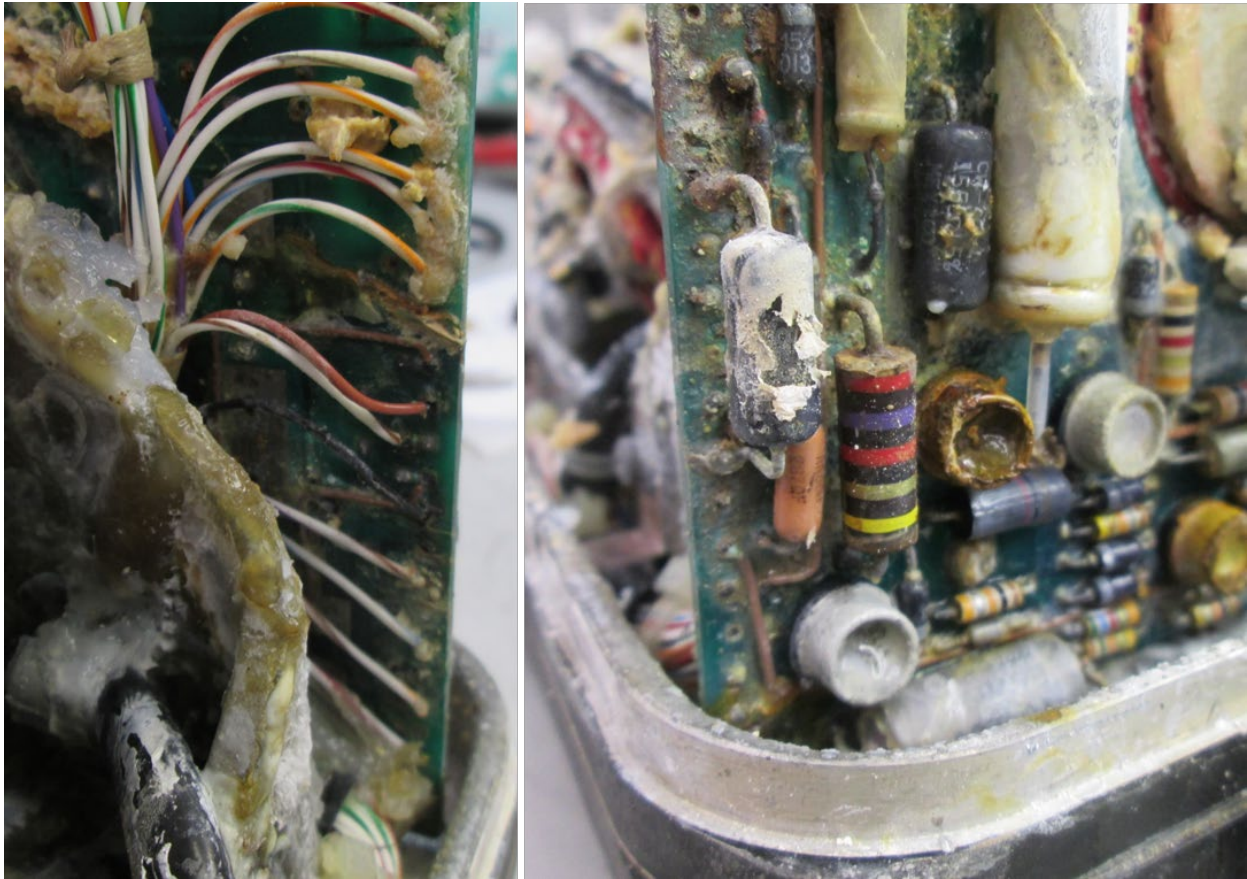
<sup>1</sup> The R61 resistor was added to TB7 per 332D-11A/T/V-22-27 Service Bulletin 27. Service Bulletin 27 was added because unplugging the unit with power applied could cause a shorted or blown transistor on control board TB7. Resistor R61 was part of the short circuit protection added per the service bulletin.

**Figure 16.** Photos of damage to TB7 resistor R61.

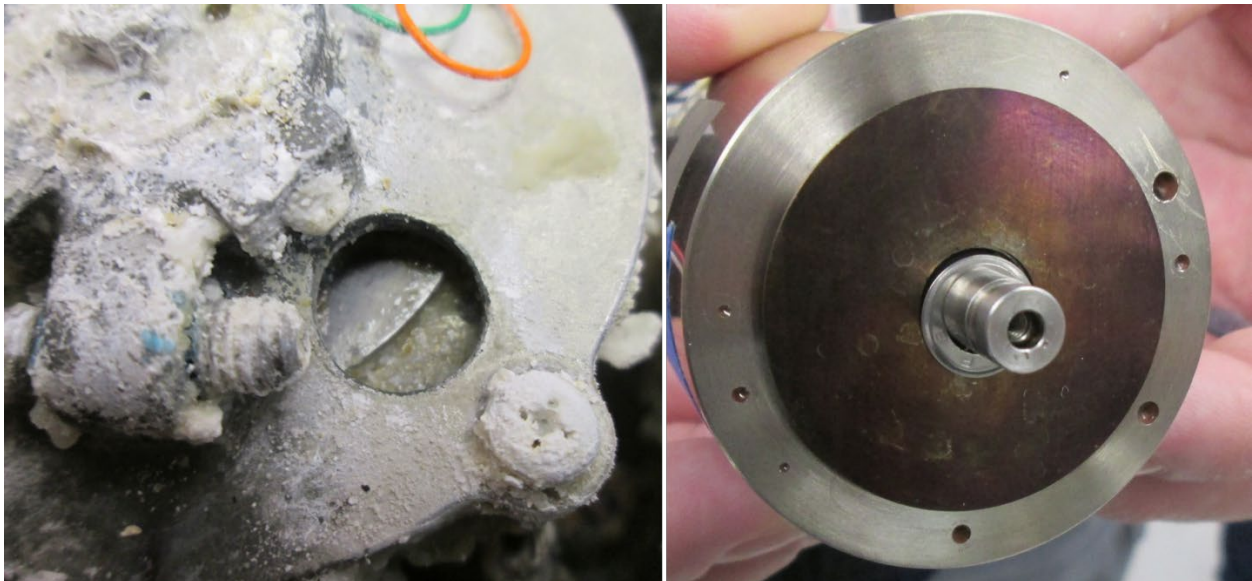
The motor/spinning mass casing was observed to be normal in color. If the motor seizes, the motor/spinning mass casing becomes discolored due to overheating (see Figure 17).

**Figure 17.** Photo of the vertical gyro motor/spinning mass casing inside hole (left) and exemplar overheated unit (right).

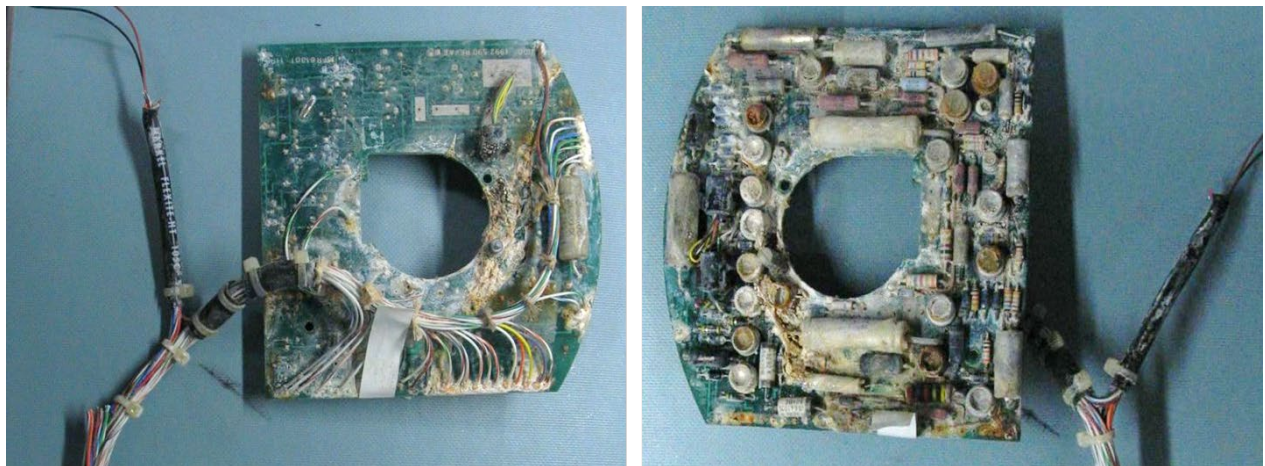
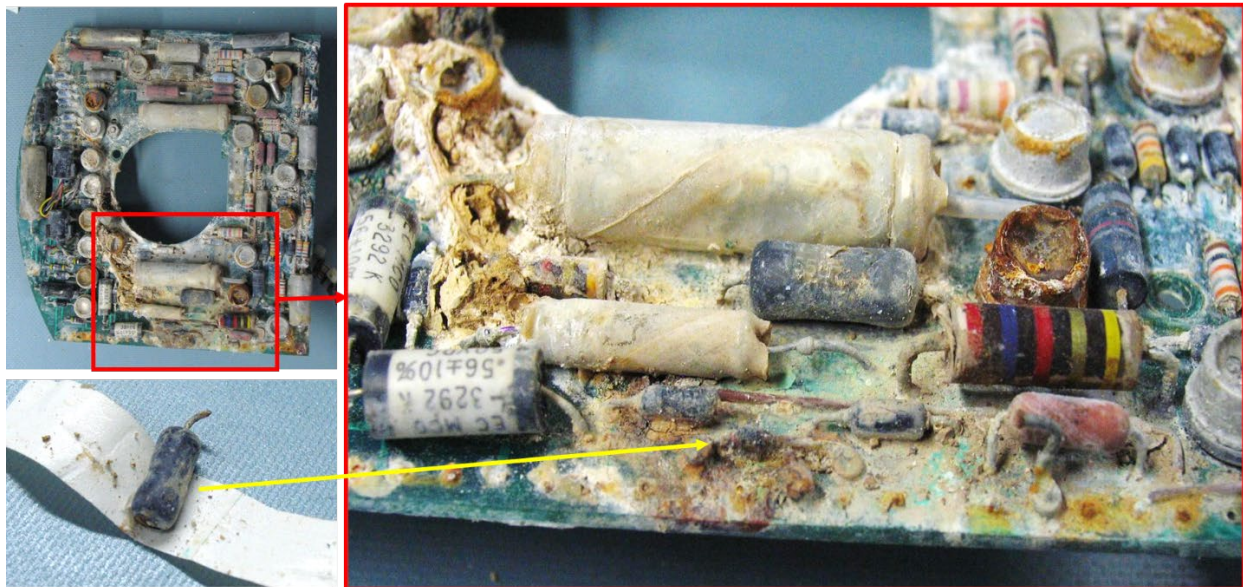
Terminal board 7 was examined at the Collins Aerospace facility on 04 March 2024. The R61 resistor was separated from the terminal board as received (see Figures 18 and 19). The terminal board was cleaned with an alkaline soap and water mixture and a nylon brush. The board was examined after the cleaning (see Figures 20 and 21). The area where the R61 resistor was located showed some corrosion deposits but no thermal damage.

**Figure 18.** Photos of TB7 as received at Collins Aerospace.

**Figure 19.** Photos of TB7 and R61 resistor as received at Collins Aerospace.

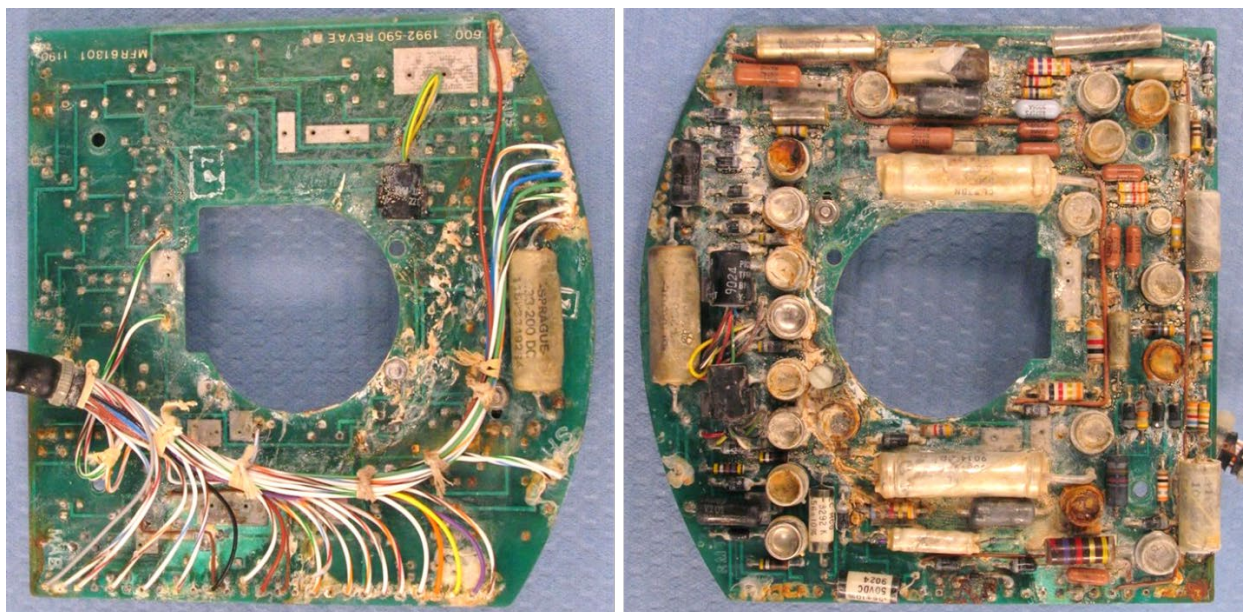
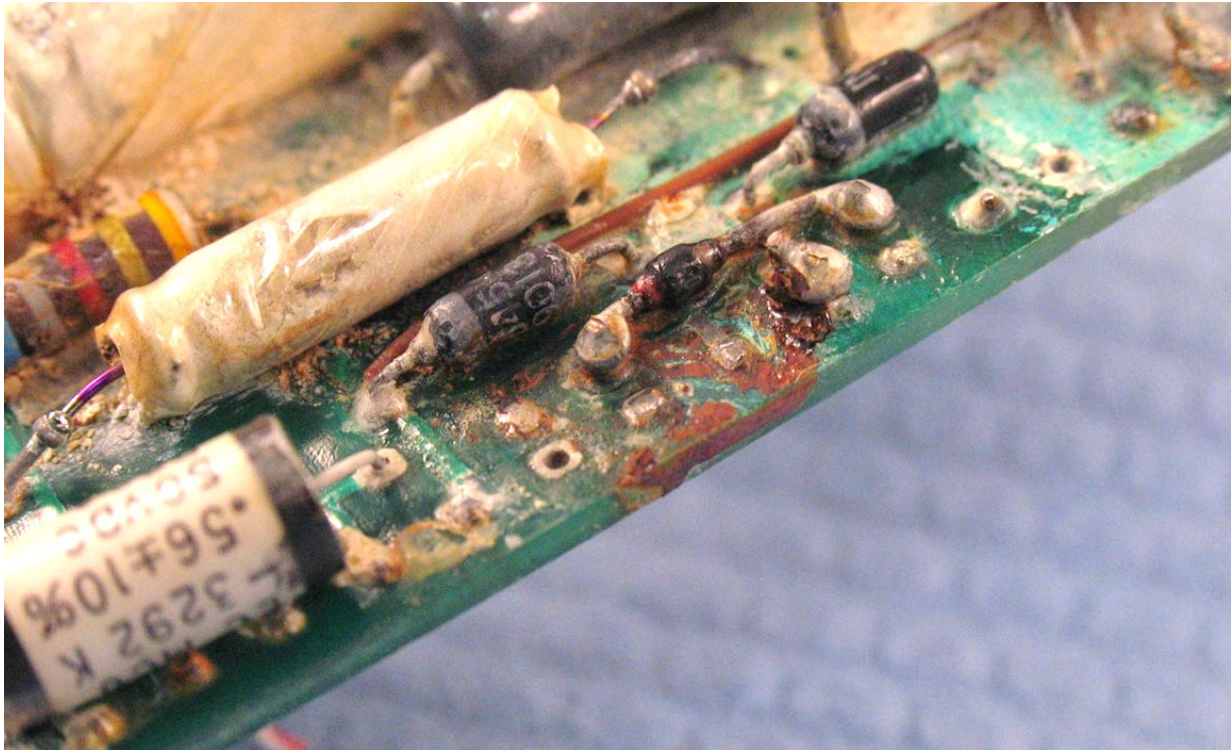
**Figure 20.** Photos of TB7 after being cleaned with an alkaline soap and water mixture and nylon brush.

**Figure 21.** Photo of TB7 where the R61 resistor was located.

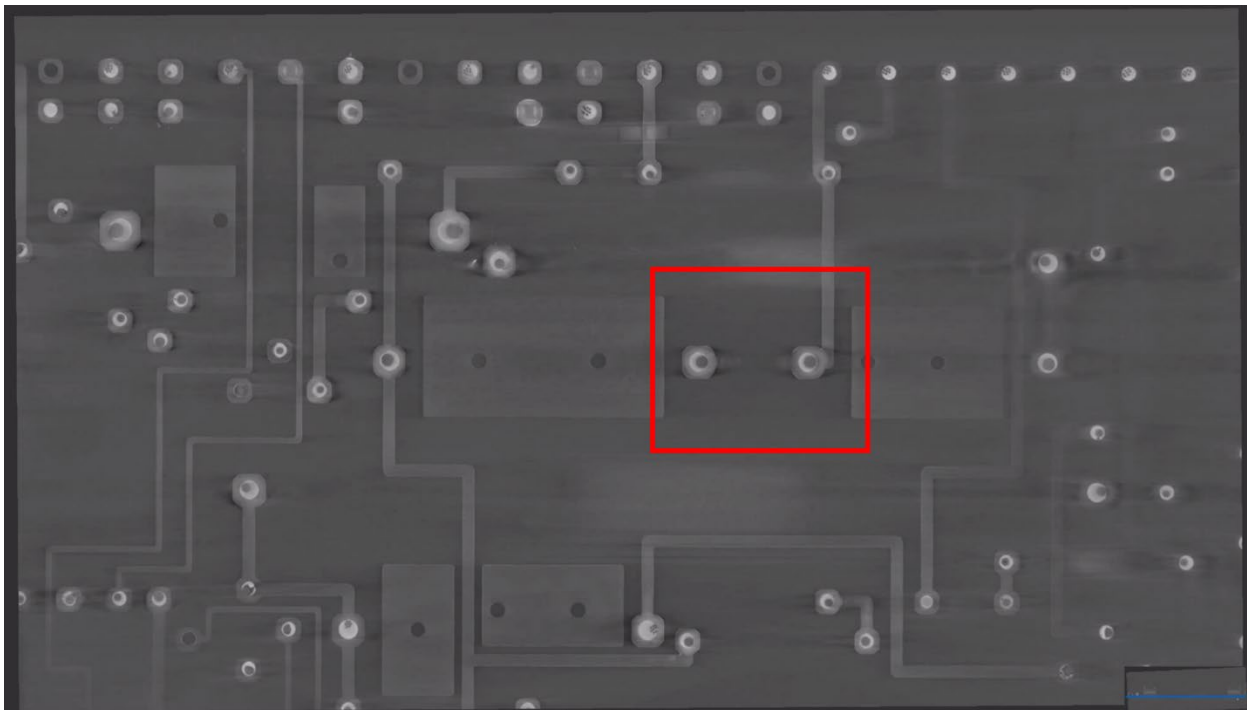
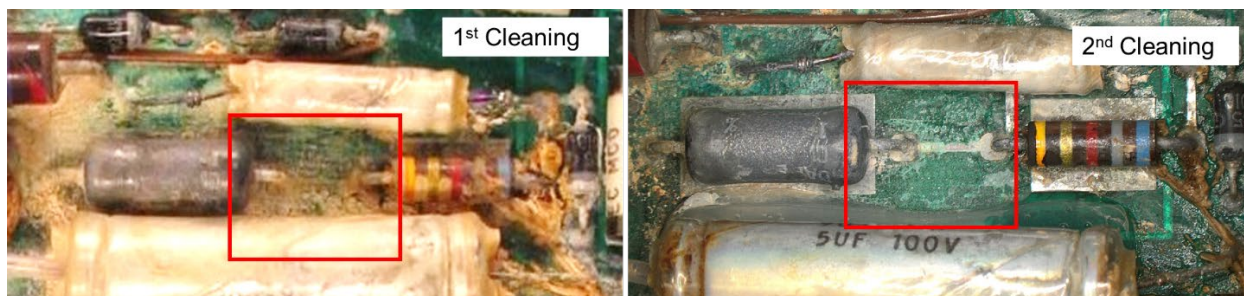
Collins Aerospace also completed a computed tomography (CT) scan on the terminal board and R61 resistor. The CT scan showed indications of a break in a connection between 2 components (see Figure 22). The terminal board was cleaned again in this area, and it was confirmed that the connection was present (see Figure 23).

**Figure 22.** CT image of TB7 where indication of a break in a connection was located.

**Figure 23.** Photos of TB7 where the CT scan showed an indication of a break in a connection.
