# National Transportation Safety Board

ANC23FA08

## **AIRFRAME AND ENGINE EXAMINATION REPORT**

Location: Kaupo, Hawaii  
Date: December 15, 2022  
Time: 2214 HST  
Airplane: Raytheon Aircraft Company C90A

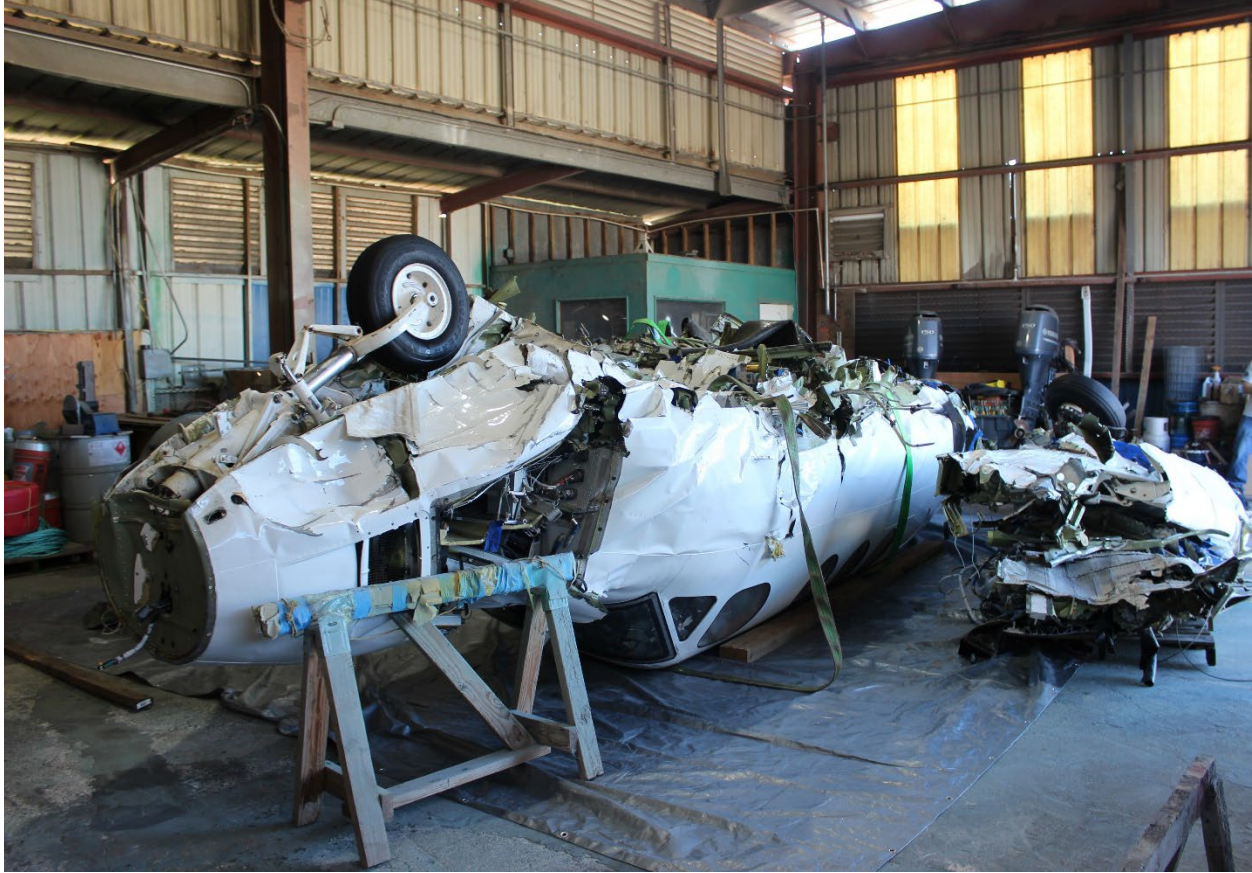
From the nose to the tail section was impact damaged and compressed upward. The aileron autopilot servo rotated freely when pulling on the aileron cable.

The elevator flight control cables were continuous from the aft elevator bellcrank to the cockpit. Each elevator aft bellcrank push/pull rod tubes were separated. The rod ends remained attached to the bellcrank. The rudder cable is continuous from the tail section to the cockpit. The second rudder cable was not located.

The pilot seat was partially separated. The 4-point restraint was intact, the lap belt portion remained connected and was released to facilitate recovery.

**Figure 1 View of the fuselage and wings.**

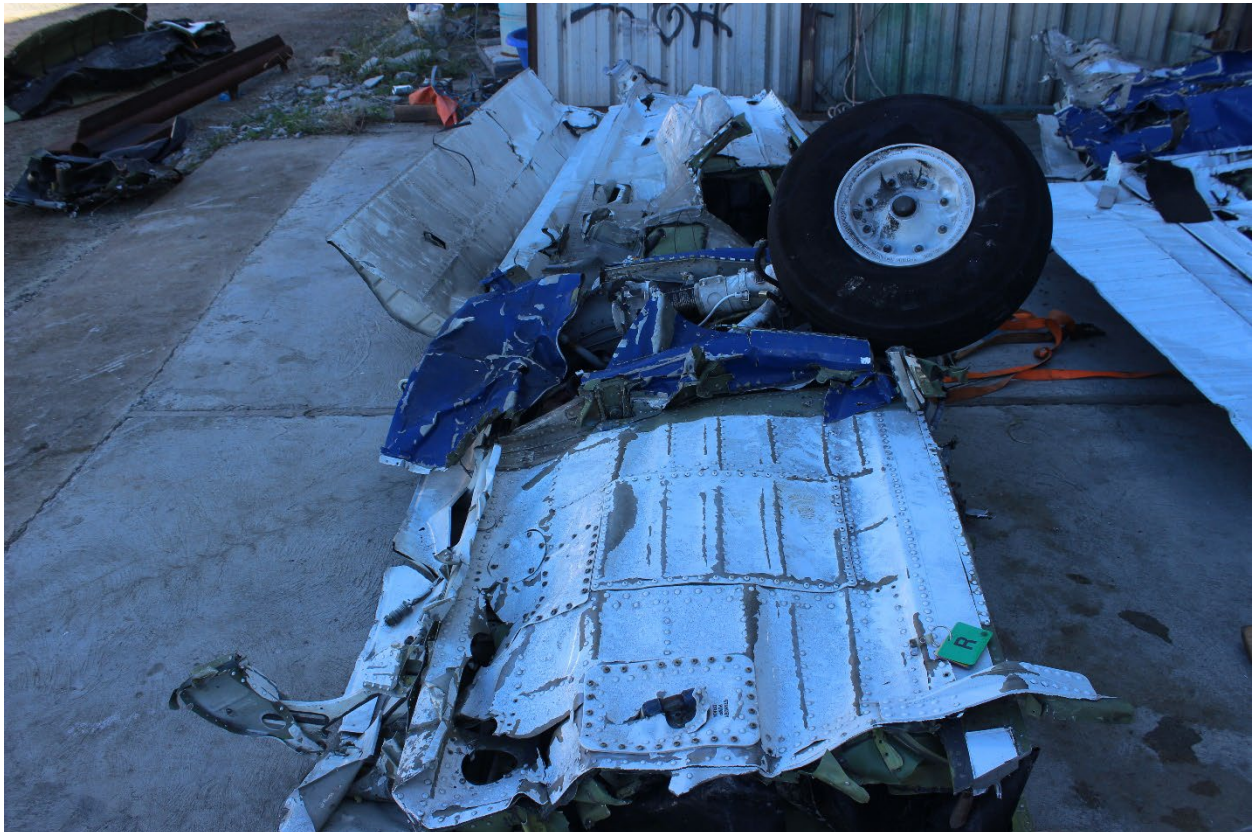
The right wing was cut at the fuselage to facilitate recovery. The right wing remained partially attached to fuselage, the top front spar separated, the bottom front spar was cut. The top spar fracture surface was shiny. The top and bottom aft spar were separated. The bottom of right wing showed upward hydraulic compression along the surface.

The right wing leading edges outboard of the engine separated from the wing along the front spar rivets. All wing separations exhibited signatures consistent with tension overload. The outboard right wing remained attached to the inboard section, it was separated outboard of the aileron center hinge about 12 inches. The right wingtip was not recovered

The right inboard flap actuator remained attached to the aft wing spar, but separated from the inboard flap. The right outboard flap actuator separated from its attachment points, only the actuator housing remained attached to the wing. Inboard flap actuator measured to be about 2 inches, which corresponds with 0°, flaps up. The outboard flap remained attached to the inboard and outboard hinges and exhibited impact damage.

The right aileron separated from the right wing and was not recovered. The center hinge remained attached; the outboard hinge was not recovered. The aileron flight control cables were continuous from the cockpit for each respective wing aileron outboard bellcrank with cables separated at each wing root. The right wing aileron bellcrank was separated from the wing but remained attached via control cables.

The fuel bladders were breached. There was hydraulic deformation present on all wing fuel tanks. The right wing fuel tank caps remained installed in their respective fuel tanks.

**Figure 2 View of the right wing.**

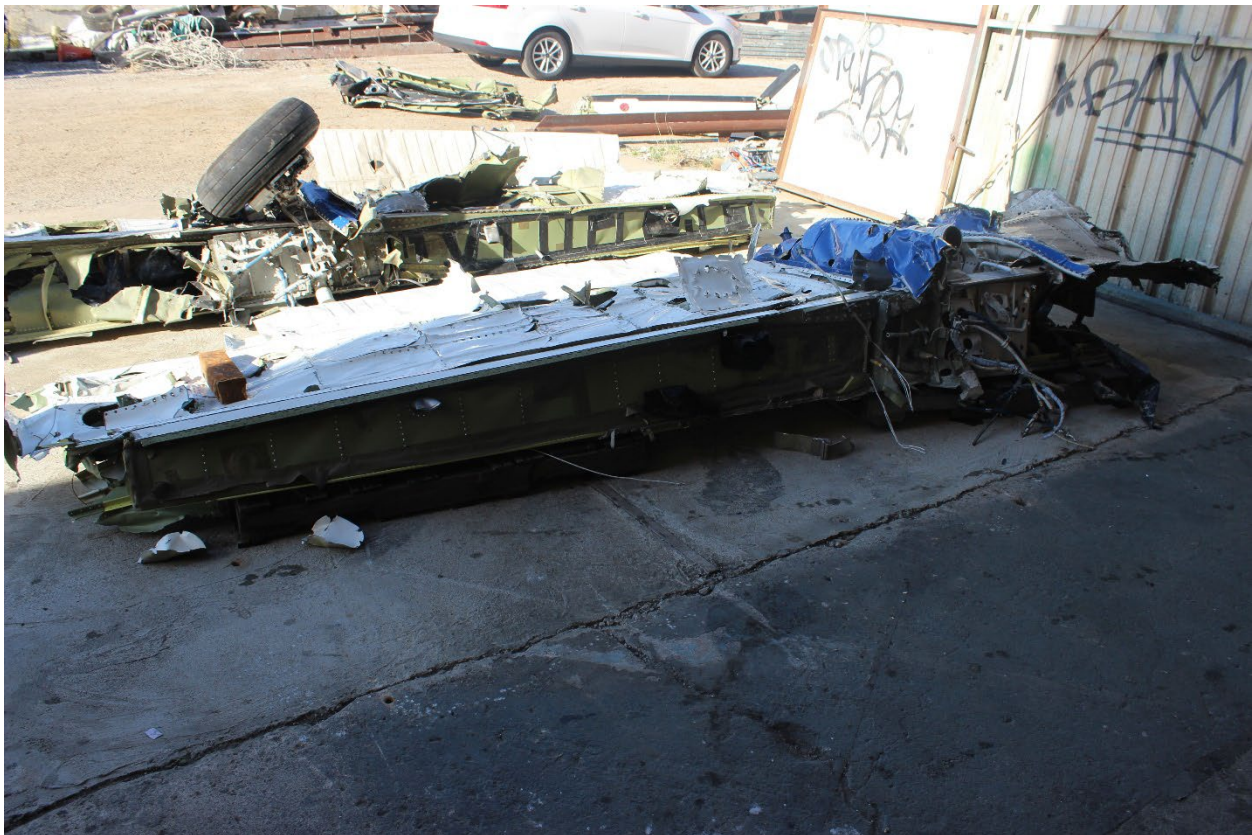
The left wing was cut at the fuselage to facilitate recovery. The outboard left wing remained attached to the inboard/center section. The left wing front and aft spars were cut at the fuselage point. The left wing leading edge was partially separated, the outboard (from just outboard of the engine) section of the inboard wing was not located. The left wing leading edges outboard of the engine were separated from the wing along the front spar rivets. The bottom of left wing showed upward hydraulic compression along the surface.

The left inboard flap was separated, the outboard flap remained attached to the wing. The left flap actuator remained attached to the aft wing spar and was found extended about 2.25 inches, which correlates to about 1°, flap up. The outboard actuator remained attached to the aft wing spar. The outboard flap actuator measured to be about 1.5 inches, which corresponds with 0°, flaps up.

The left aileron separated from the left wing, about 30 inches was recovered. The left aileron trim was about 1 inch, which corresponds to about 2° trailing edge up.

The fuel bladders were breached. There was hydraulic deformation present on all wing fuel tanks. The left wing fuel tank caps remained installed in their respective fuel tanks.

**Figure 3 View of the left wing.**

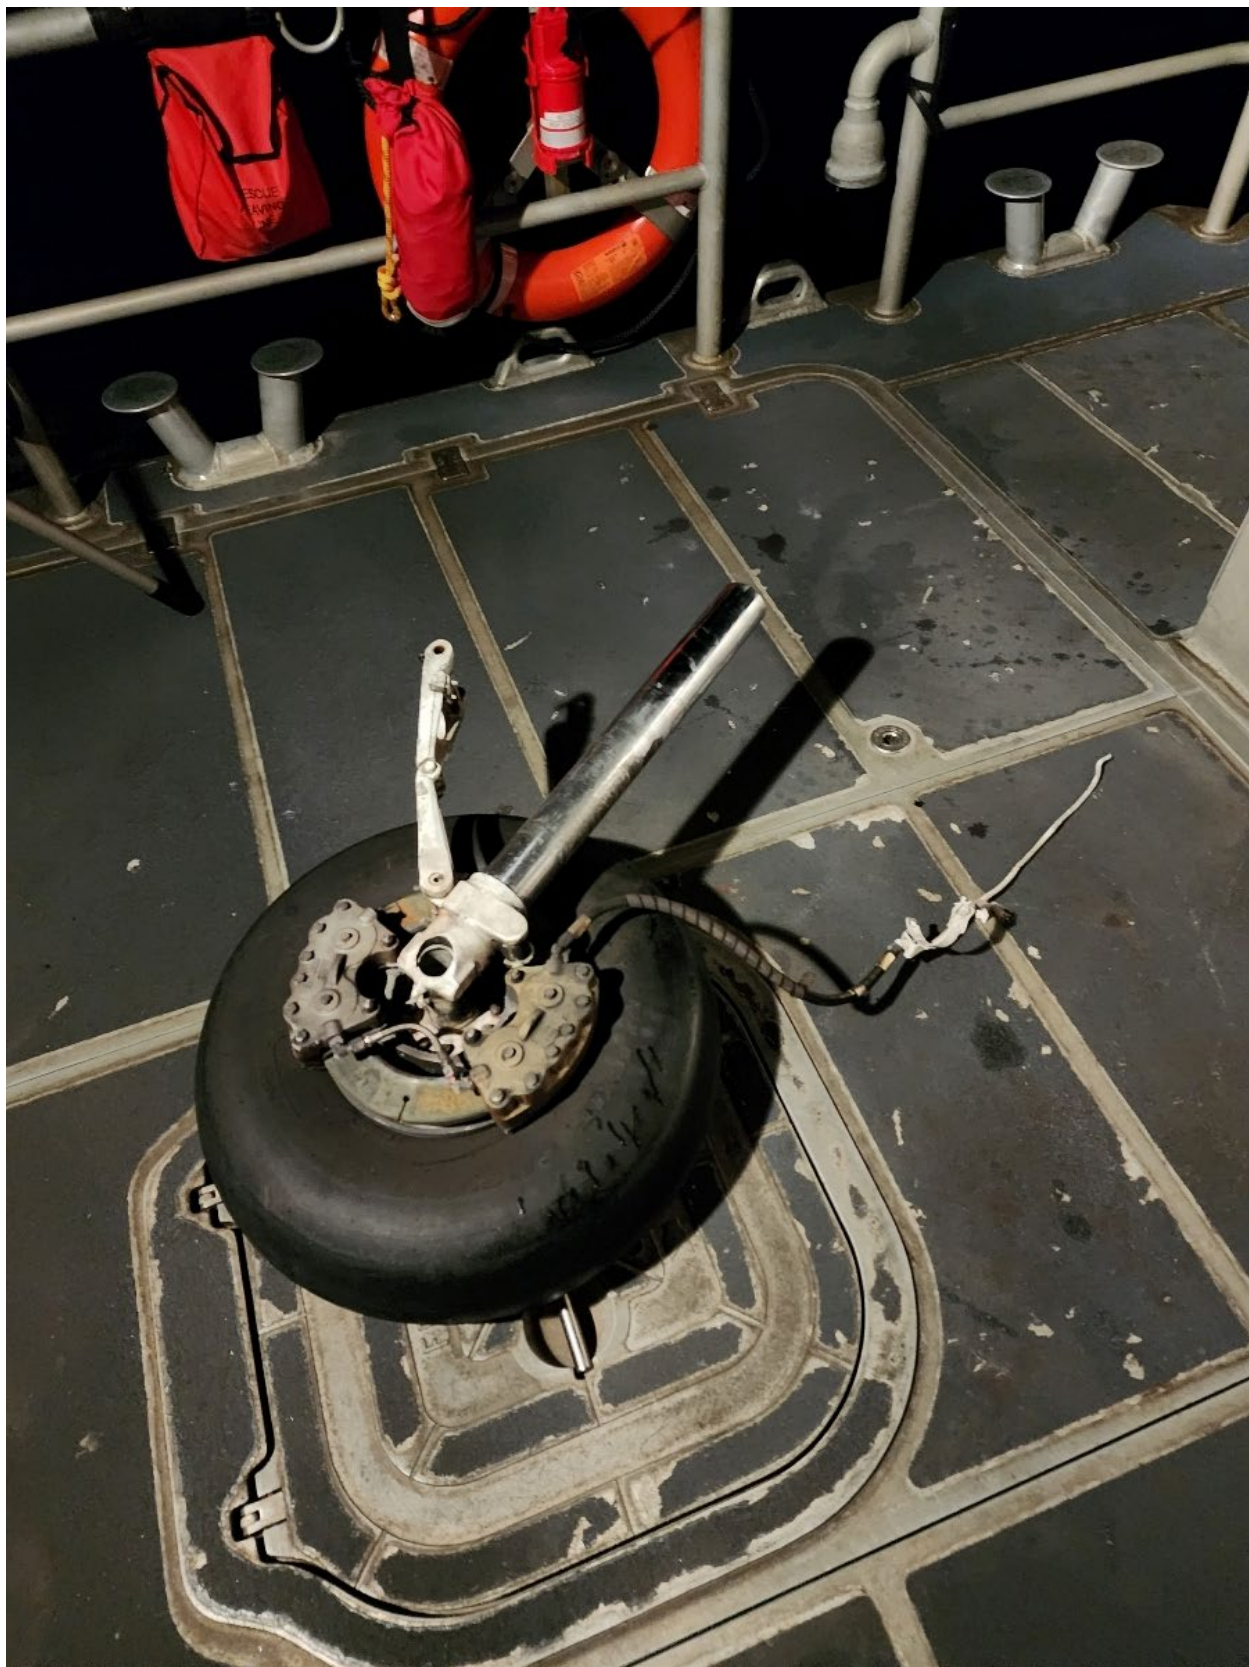
The right landing gear attachment point remained attached to the wing. Positioning was undetermined. Landing gear actuator remained attached to the wing and drag brace. The actuator appeared to be retracted. The left main landing gear was separated and recovered by the USCG after the accident.

The left landing gear remained attached to the left wing. The oleo and wheel were separated from the trunnion. Positioning was undetermined. The left landing gear actuator remained attached to the wing and drag brace. The actuator appeared to be retracted.

**Figure 4 View of left main landing gear recovered by the USCG.**

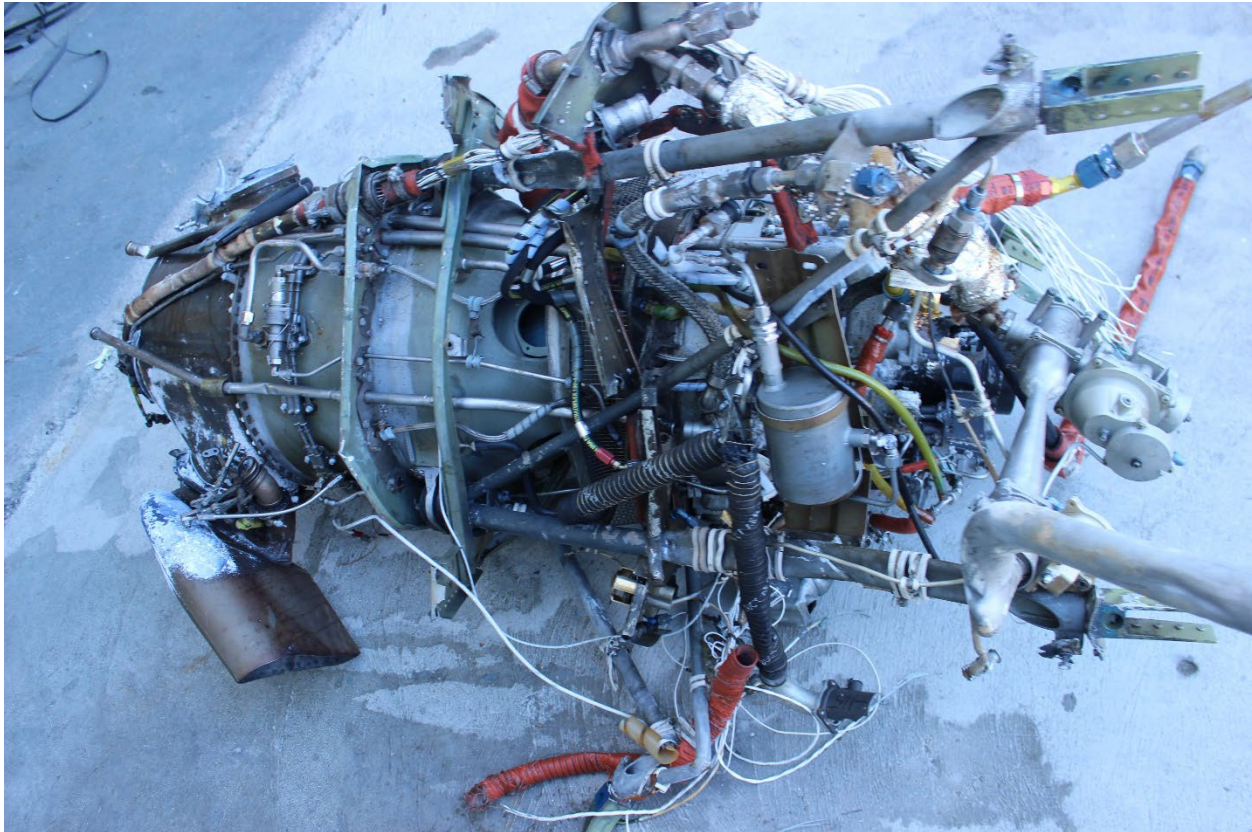
The right engine S/N: PE0198. The 1<sup>st</sup> stage Compressor blades were intact and seized. The PT blades intact, 10° percent are fractured due to impact crushing of the exhaust case. The exhaust case was crushed, and the exhaust flange was separated at flange "A". The reduction gearbox case was corroded (magnesium) and separated exposing 1<sup>st</sup> stage reduction gears, all gears present, the teeth were not fractured. 2<sup>nd</sup> stage reduction gear box, all gears present, the teeth were not fractured.

The gas generator case was split and crushed. The FCU power lever control arm was bent seized. Power lever was at idle position. The FCU condition lever fractured and separated from FCU. The P3 line was intact and dented. There were no rotational signatures on the 1<sup>st</sup> stage compressor due to sudden impact. The inlet struts were intact. The 2<sup>nd</sup> stage planetary gears intact. The power lever was at idle.

The engine was borescoped, the compressor turbine blades were intact. Accessory gearbox case was heavily corroded exposing the gear and seized.

**Figure 5 View of the right engine.**

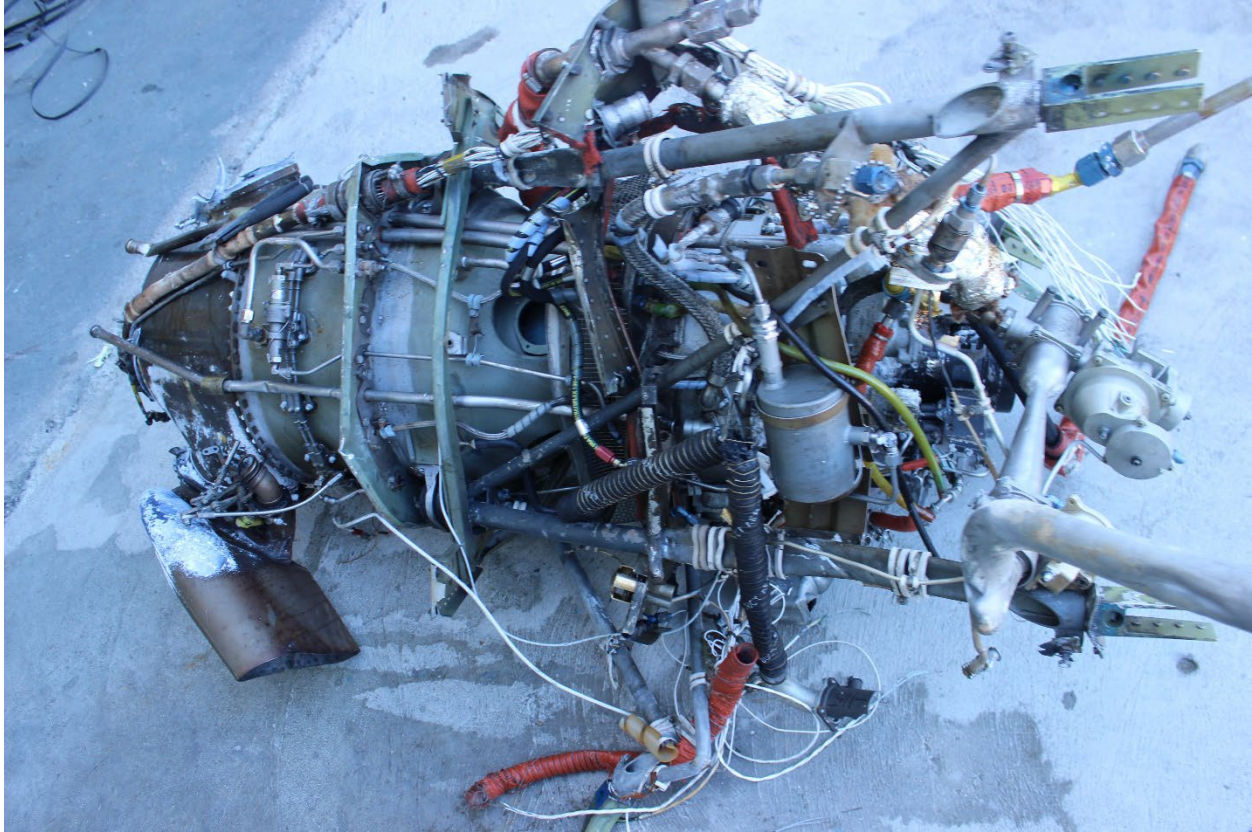
The left engine S/N: PE0033. 40% of the power turbine blades were cracked and midspan from the T/E to L/E and bent in opposite direction of rotation. The inlet struts were intact. The 1<sup>st</sup> stage compressor blades were intact and seized. No rotational signatures on the 1<sup>st</sup> stage compressor due to sudden impact. FCU power lever control arm was bent and seized. Power lever was at max position. FCU condition lever was bent. The power lever was at max. The spinner backing plate was deformed forward. The exhaust case was split open in 2 locations, 12 o'clock and 5 o'clock position. The P3 line was crushed and intact. The generator case was buckled from about 3 o'clock position thru the 6 o'clock. The inlet struts were intact. The right side engine mount was twisted.

The engine was boroscoped, the compressor turbine blades were intact. Accessory gearbox was heavily corroded exposing the gears and seized.

**Figure 6 View of the left engine.**
