# National Transportation Safety Board

ANC23FA008

## **ONBOARD IMAGE RECORDER (APPAREO)**

Location: Kaupo, Hawaii  
Date: December 15, 2022  
Time: 2114 Hawaii-Aleutian Standard Time (HST)  
0714 Coordinated Universal Time (UTC)  
Airplane: Raytheon Aircraft Company C90A, Guardian Flight, N13GZ

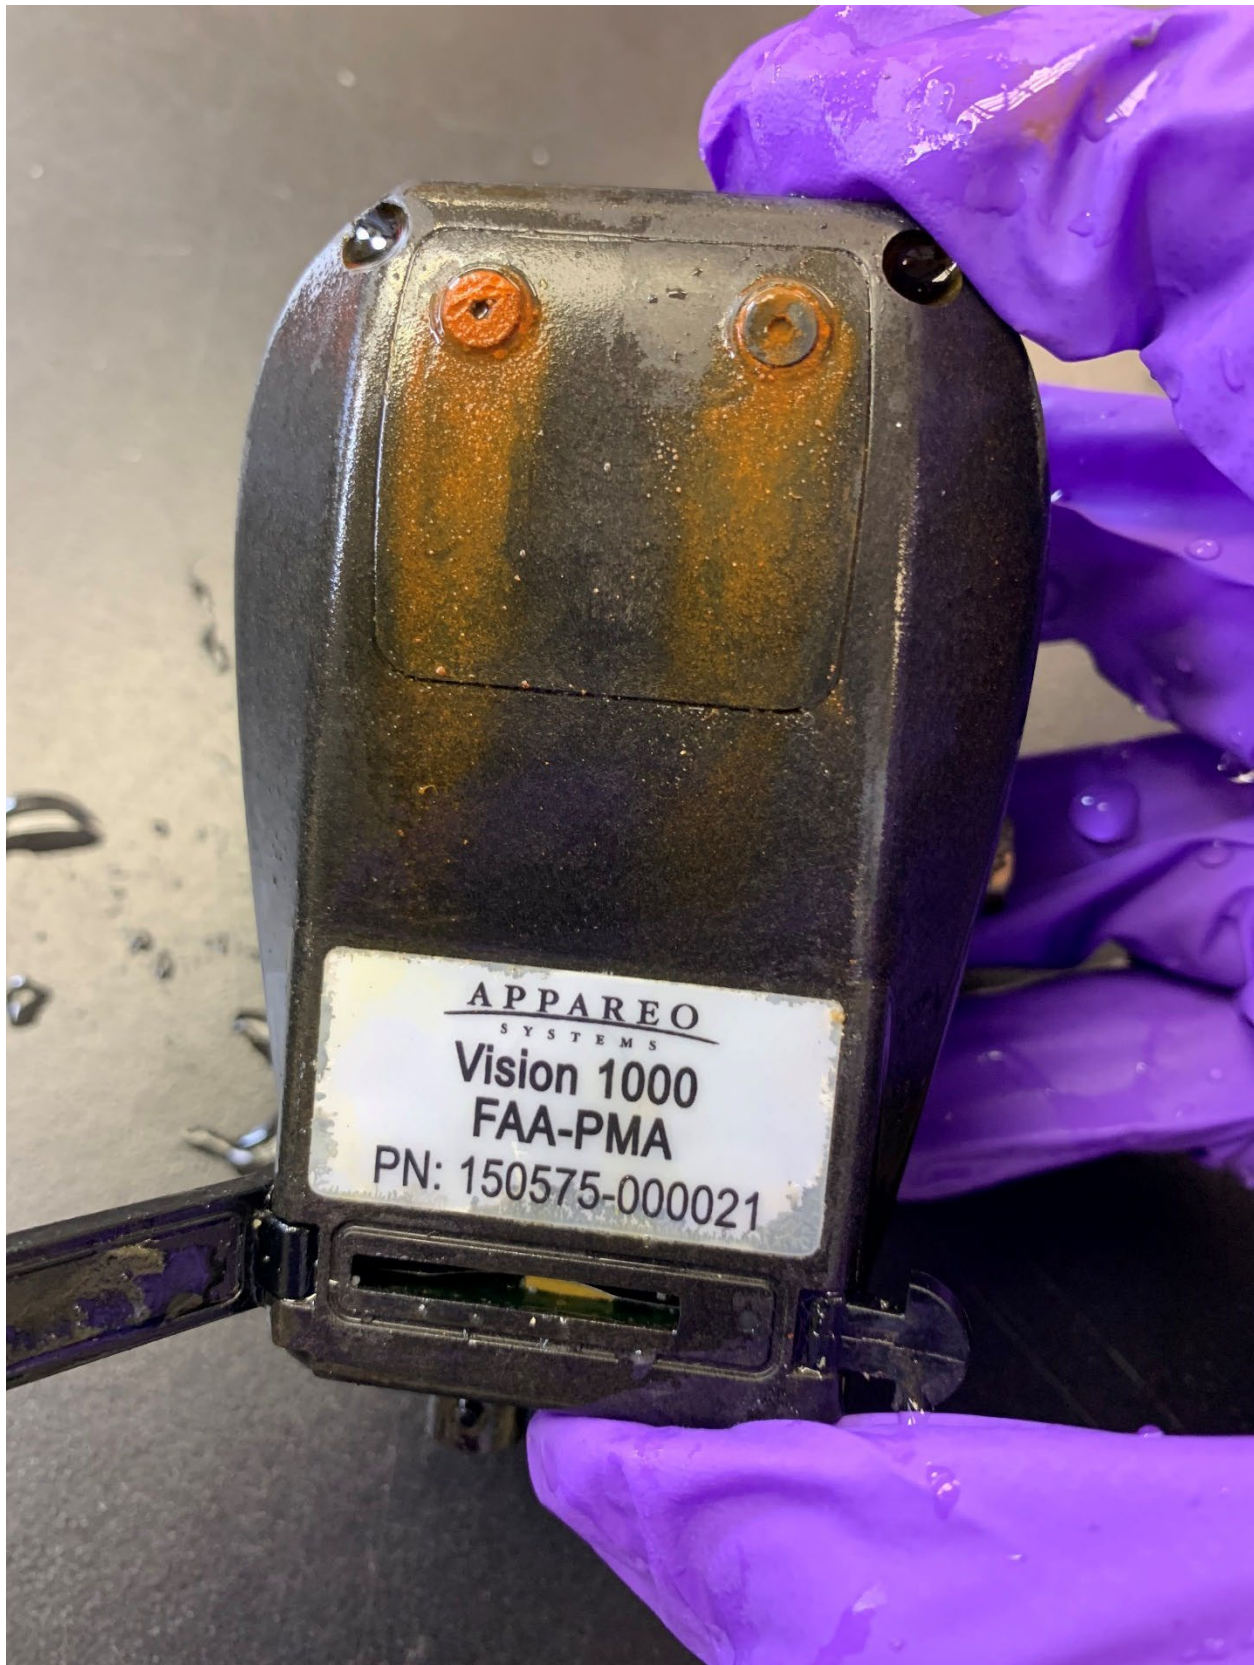
**Figure 1.** Device

The device was damaged in the event and was submerged under 6,400 feet of saltwater for a month. The extent of the damage is shown in figure 1. The extraction of the memory module is shown in figures 2 and 3.

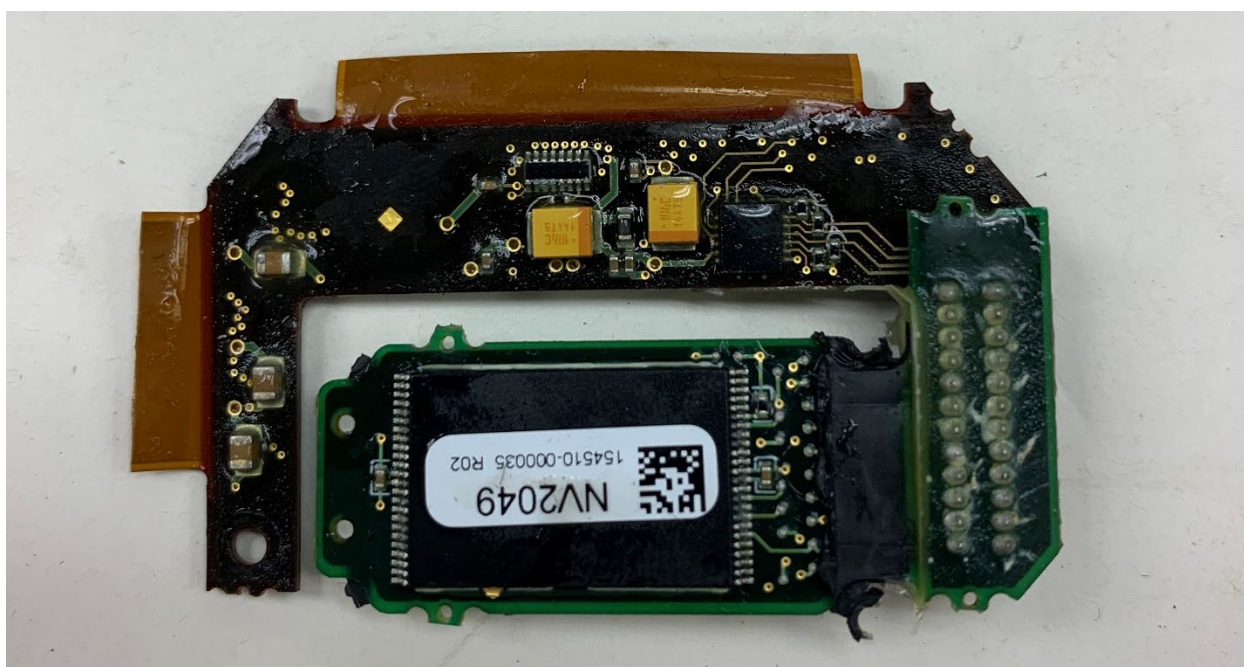
As provided to the lab, the Vision 1000 did not contain an SD Card. The device was disassembled, and the memory module was removed (figure 3).

**Figure 3.** NVM Chip and circuit board after removal of metal cover piece.

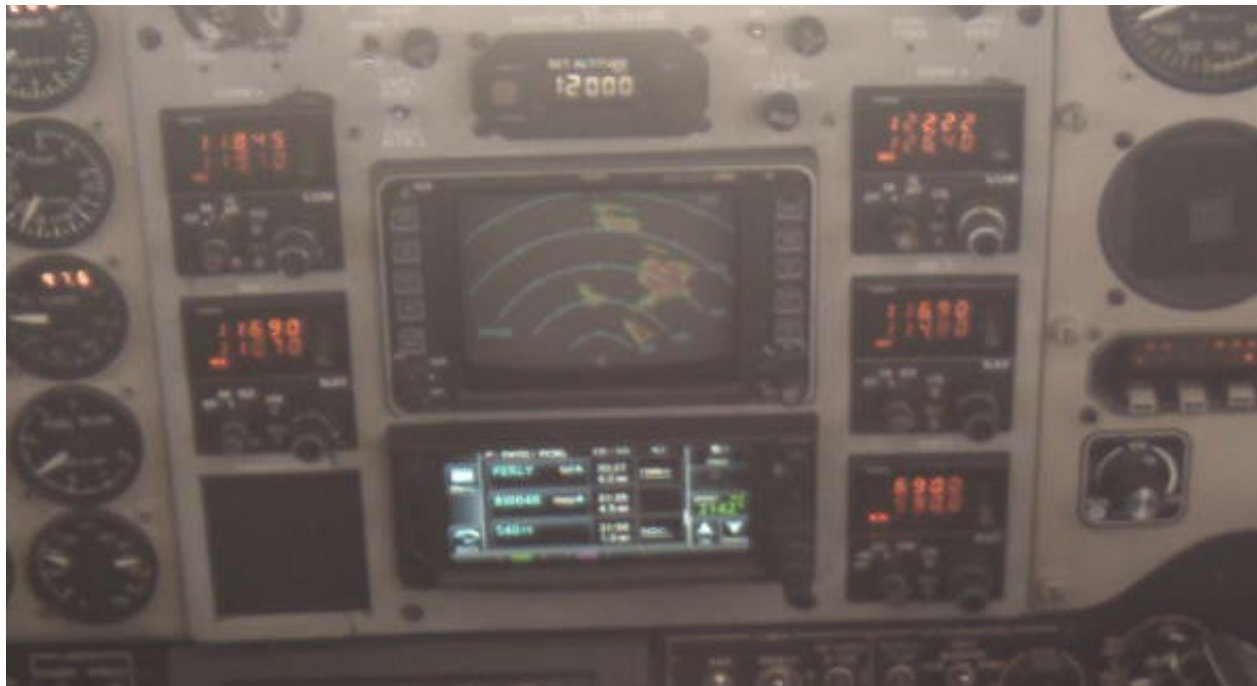
The Collins MFD was not working in the last four flights of recorded video. However, images were found in the over-run area that showed the MFD working normally at an undetermined time in the past. (figure 5).

**Figure 5.** Image showing the Collins MFD working on a previous flight. The time of this image being taken could not be determined.

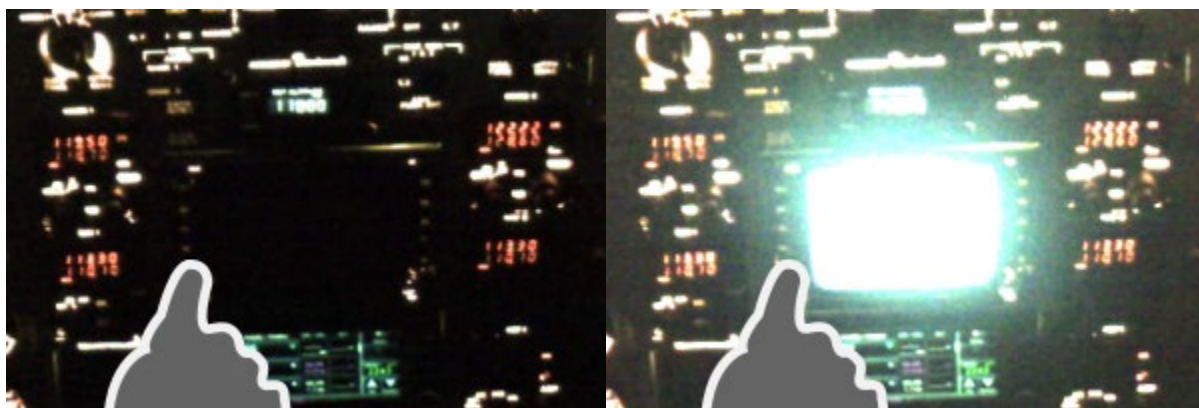
Figure 7 is two cropped frames from the video showing the dark Cathode Ray Tube (CRT) from the Collins MFD, and the one frame where it briefly lit up. The time of this event is later referenced in this report.

| 21:00:39 -<br>21:01:11 | The plane climbed through 8000 ft. The pilot repeatedly attempted to manipulate the buttons on the Collins MFD, but the screen remained blank and unresponsive. |
| 21:01:11 | The Collins MFD CRT flashed very brightly for one frame of video, and then returned to darkness. (figure 6) |

**Figure 7.** Collins MFD with dark CRT vs. the one frame it was lit up. Consecutive video frames at 21:01:11 HST.

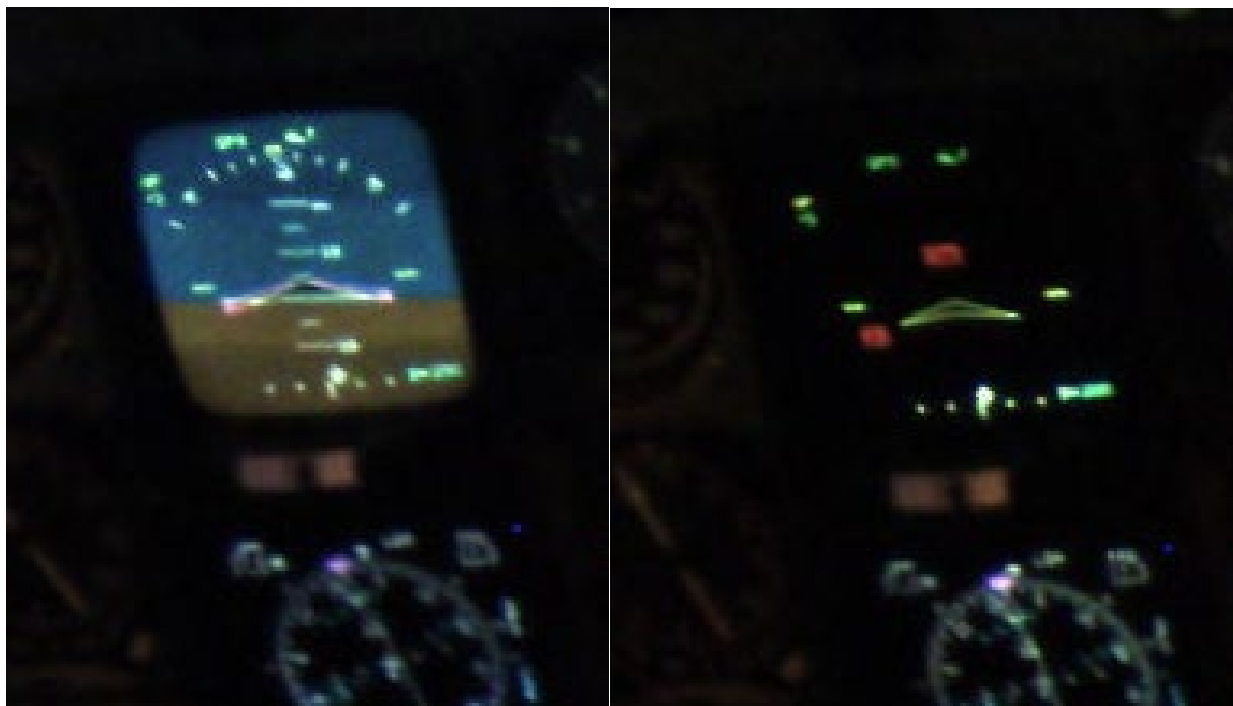
Figure 8 is two cropped frames from the video showing the Electronic Flight Instrument System (EFIS) before and after the attitude reference failure. The time of this event is later referenced in this report.

| 21:06:58 | <p>The sound of the autopilot disconnect alert tone was audible, and the autopilot disconnect indicator (AP DIS) light illuminated on the annunciator panel.</p> <p>The EFIS no longer displayed attitude information, but was in a powered state, and was still showing some symbology. The AP DIS (autopilot disconnect) light flashed approximately 8 times and went solid after the pilot reset the master caution. Then the AP DIS extinguished. Red warnings on the EFIS flashed several times, and then remained lit.</p> <p>The pilot's EFIS did not show an artificial horizon for the remainder of the accident recording. The EFIS symbology before and after the illumination of the AP DIS annunciator is shown in figure 8. The pilot has been redacted.</p> <p>This event is also depicted as a vertical line on figures 9, 10 and 13.</p> |

**Figure 8.** Pilot's EFIS in normal operation vs. error state. Consecutive video frames at 21:06:58 HST.

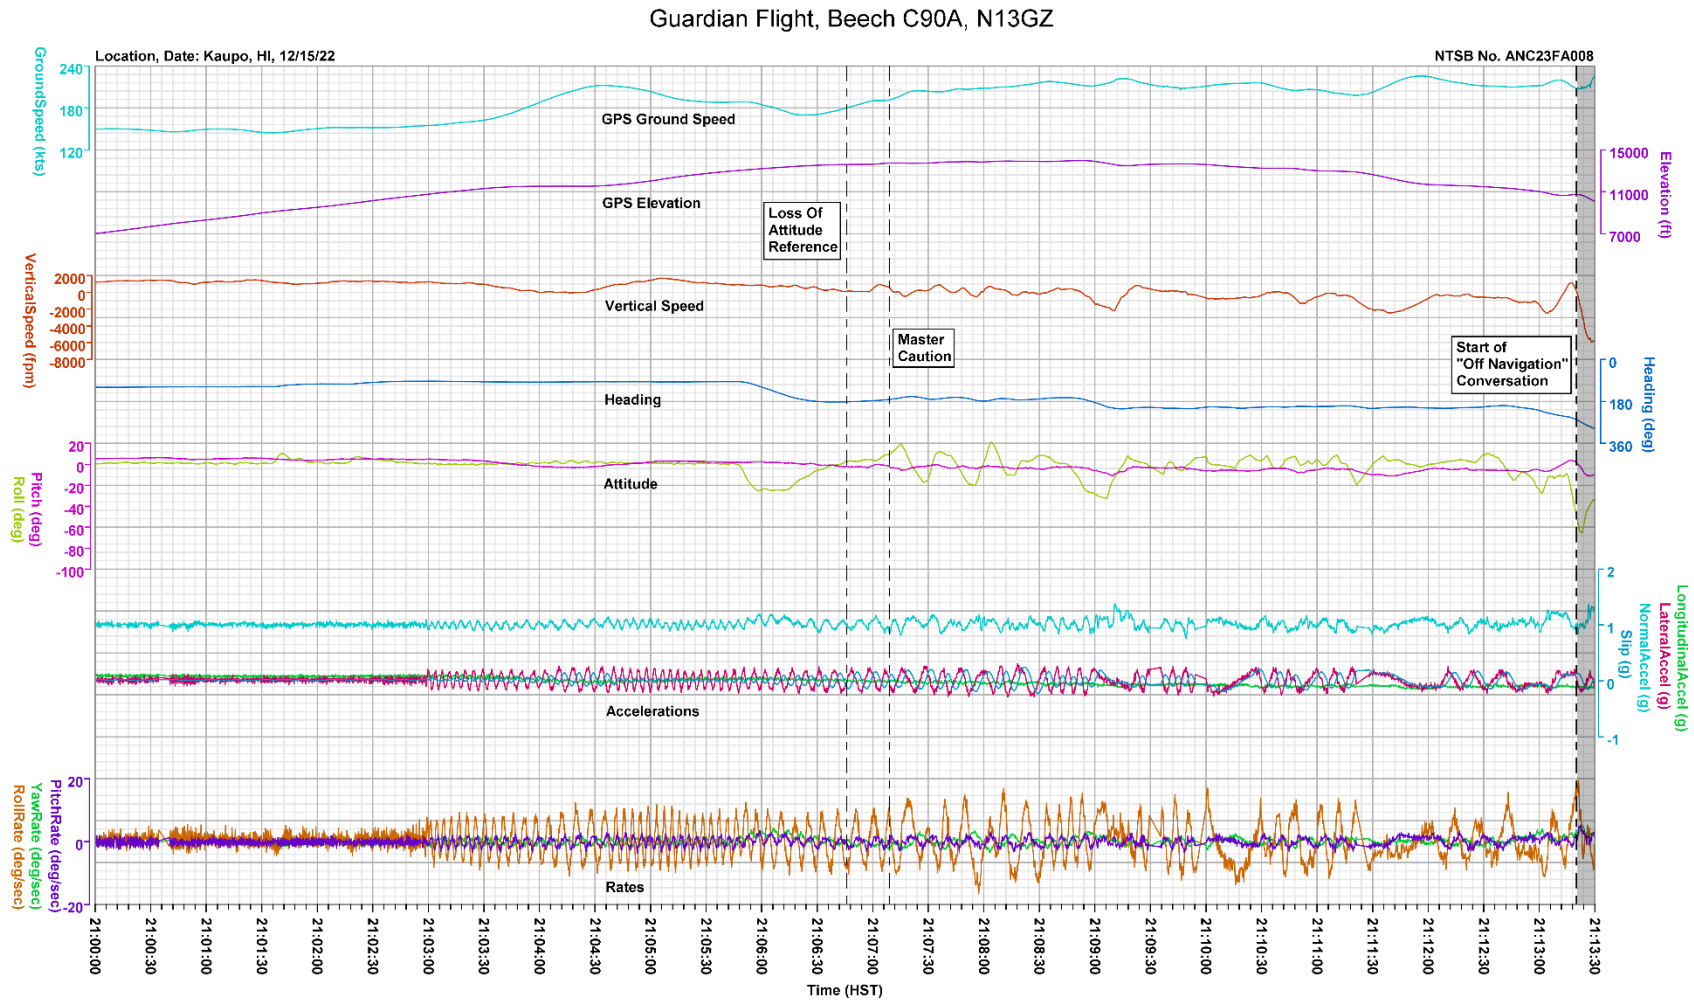
Figure 10 is a chart of the middle portion of the flight, specifically before and after the time of the loss of attitude reference.

**Figure 10.** Mid-flight plot before and after loss of attitude reference. The plotted time interval is between 2100 and 2113 HST. The grey bar denotes the time span of the 'off navigation' conversation on page 26 of the transcript and also depicted on figures 9, 11 and 14.

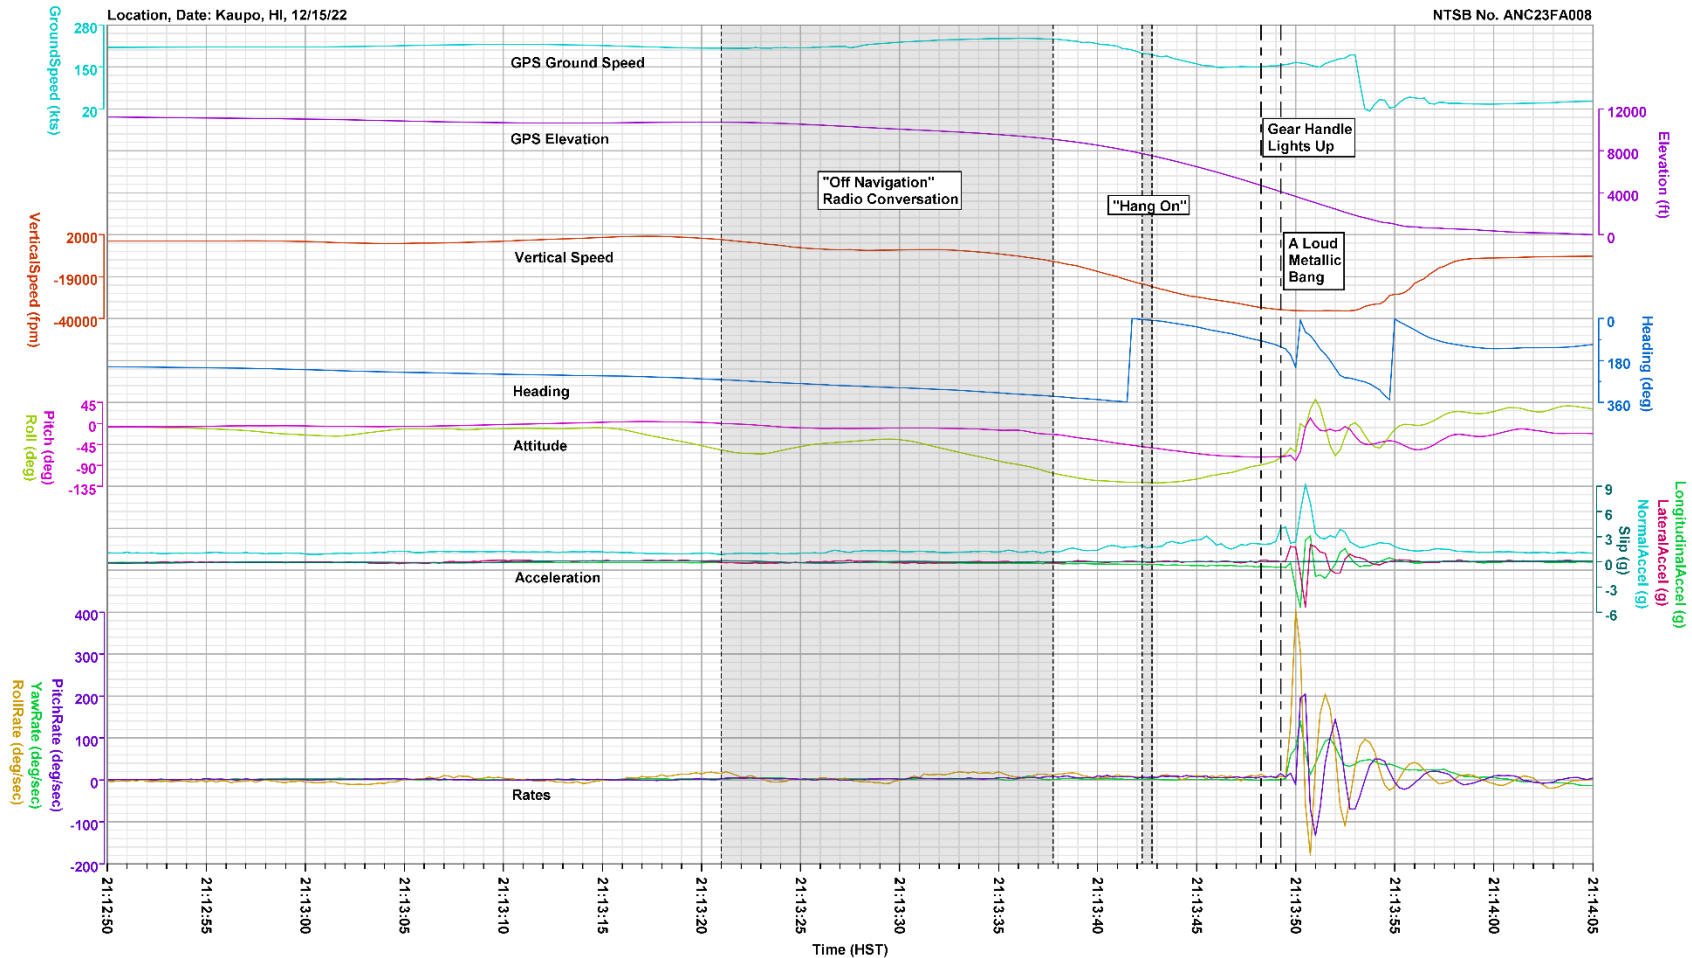
Figure 11 is a chart that shows the end of the flight through the "Off Navigation" radio conversation, the loud metallic bang, and the end of the recording.

| 21:13:51 | <p>The indicated altitude was 4,000ft and rapidly decreasing. All other instruments appeared mostly unchanged. The ambient wind noise was noticeably increasing.</p> <p>The yoke seemed to move quickly forward and then aft in a jolt like manner. As the movement towards the aft position of the yoke occurred, a sound similar to a loud metallic bang was audible. The camera recorded a rapid jolt, and the field of view of the recorded image noticeably changed. The control panel illumination appeared to be extinguished, consistent with the aircraft main power bus failing, and switching over to battery power. Several annunciator panel lights were suddenly illuminated, their state was unable to be identified by the group. The engine throttle levers remained unchanged.</p> <p>After this event, only 3 instruments in camera view remained illuminated (pilot's altimeter, HSI, and EFIS). Two of the five radio heads appeared to have power and showed frequency information. The Garmin GTN-650 was dark, consistent with a loss of power.</p> <p>This event is depicted on figures 11 and 15 as a vertical line.</p> |

**Figure 11.** The Accident portion of the recording. The plotted time interval is between 21:12:15 and 21:14:05 HST. Last data occurred at 21:14:05 HST. The grey bar denotes the time span of the 'off navigation' conversation on page 26 of the transcript and also depicted on figures 9, 10 and 14.

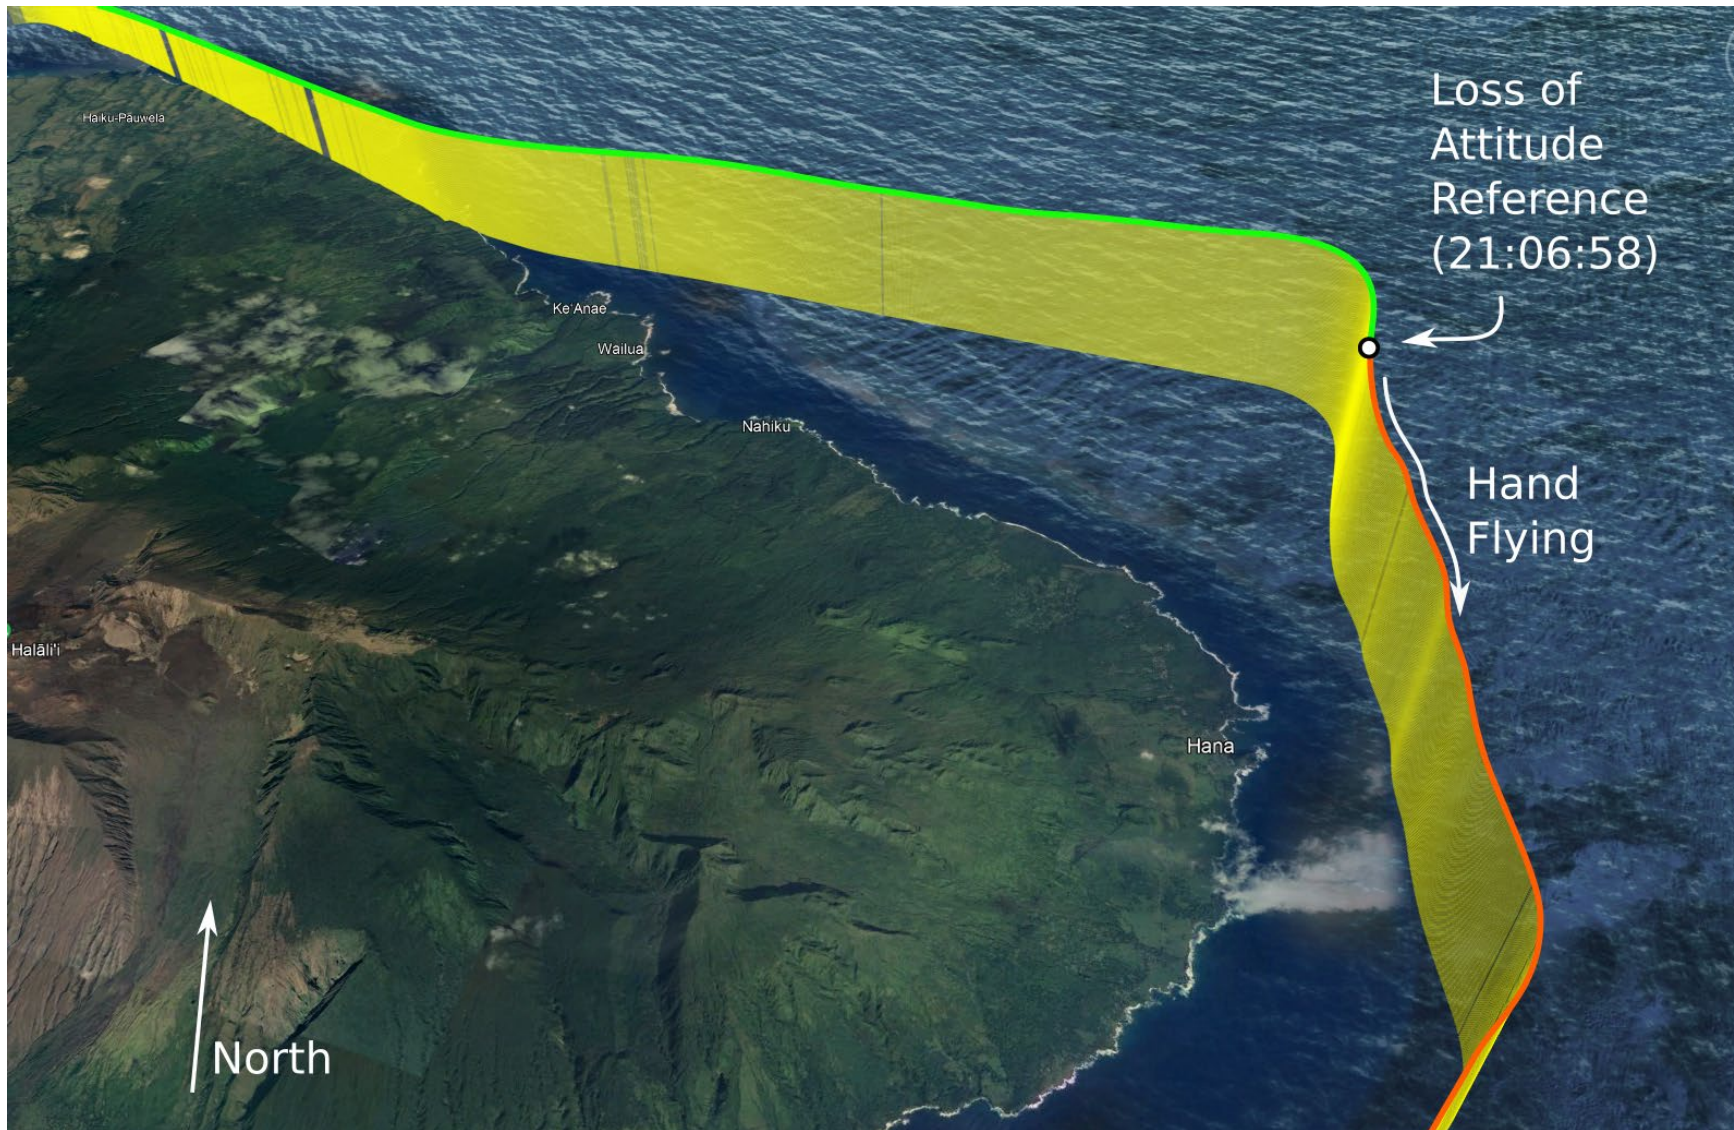
Figure 13 is a Google Earth map overlay of the middle portion of the flight, showing before and after the loss of attitude reference, at which point the autopilot was disabled and the pilot started hand flying the aircraft.

**Figure 13.** Mid-flight Map showing the middle portion of the flight before and after the loss of attitude reference at 21:06:58 HST.

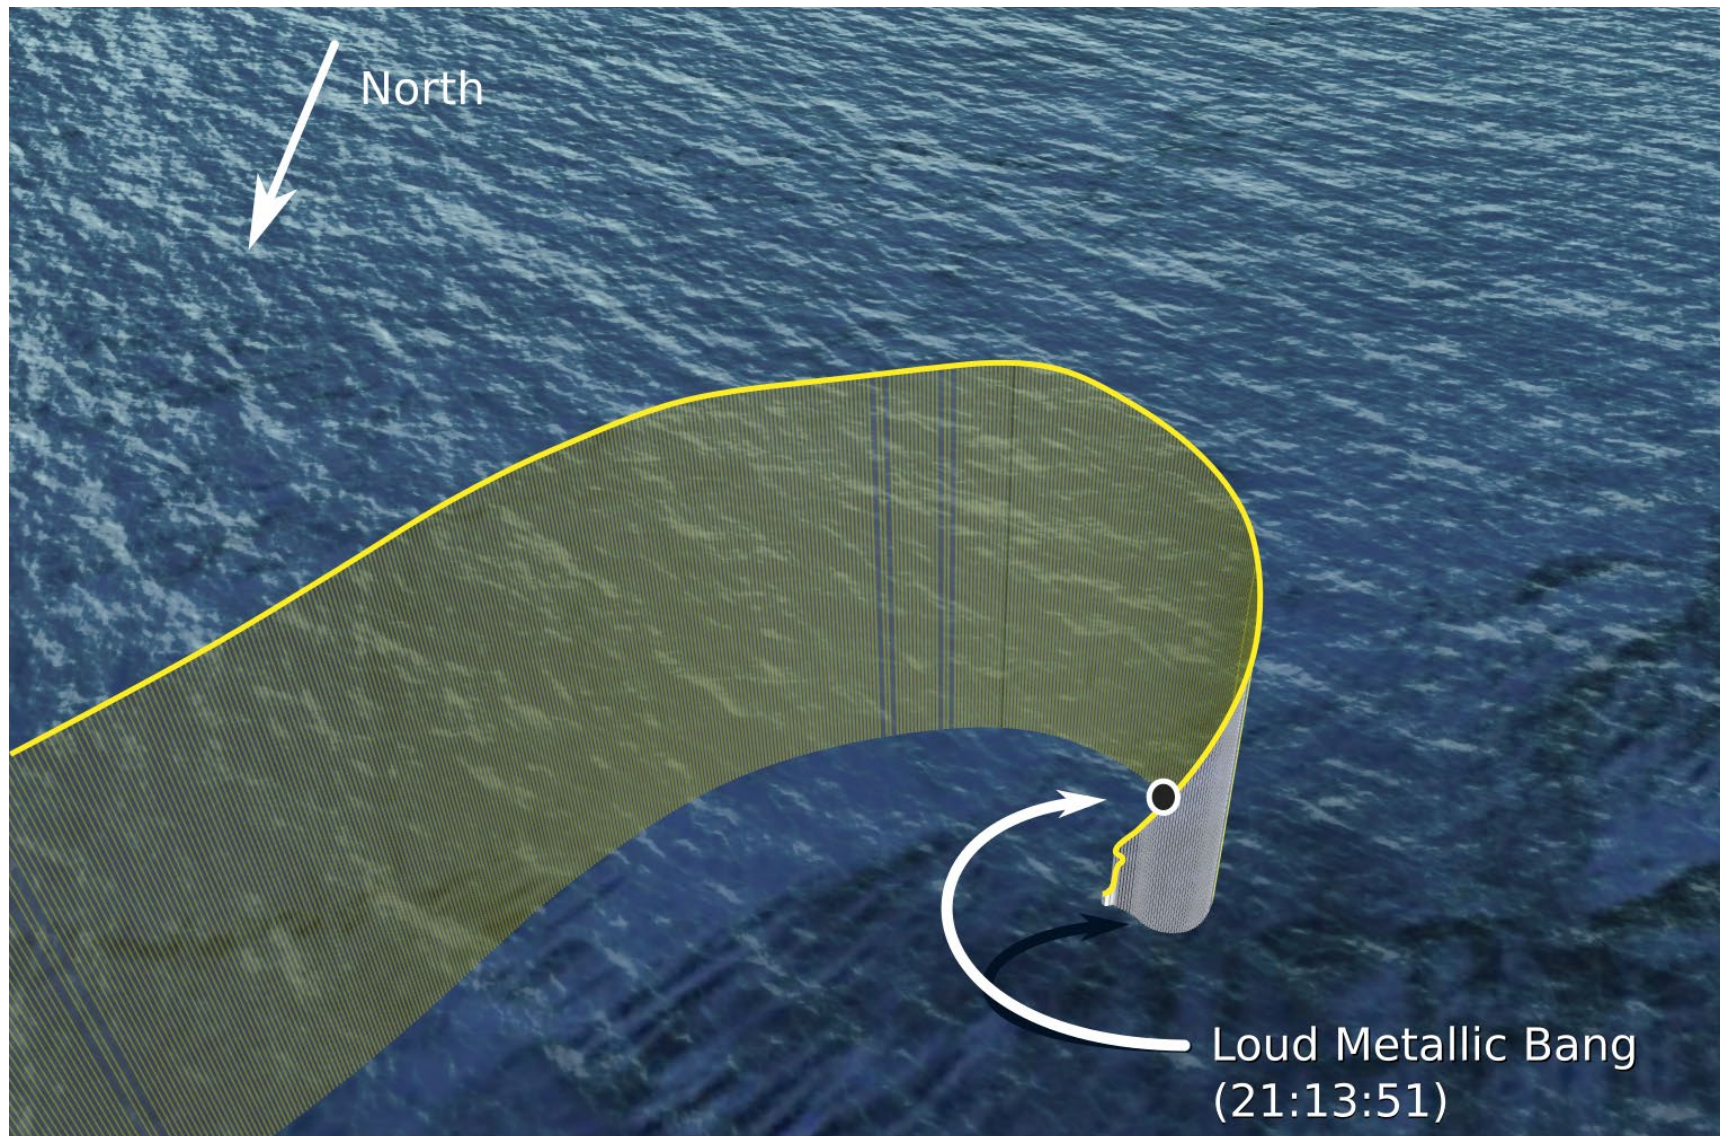
Figure 15 is a Google Earth map overlay of the end of the recording, but rotated around from the previous figure to show more clearly where the loud bang occurred.

**Figure 15.** Aircraft track during the final moments of the flight.
