ANC23FA042

## INVESTIGATION PHOTOGRAPHS

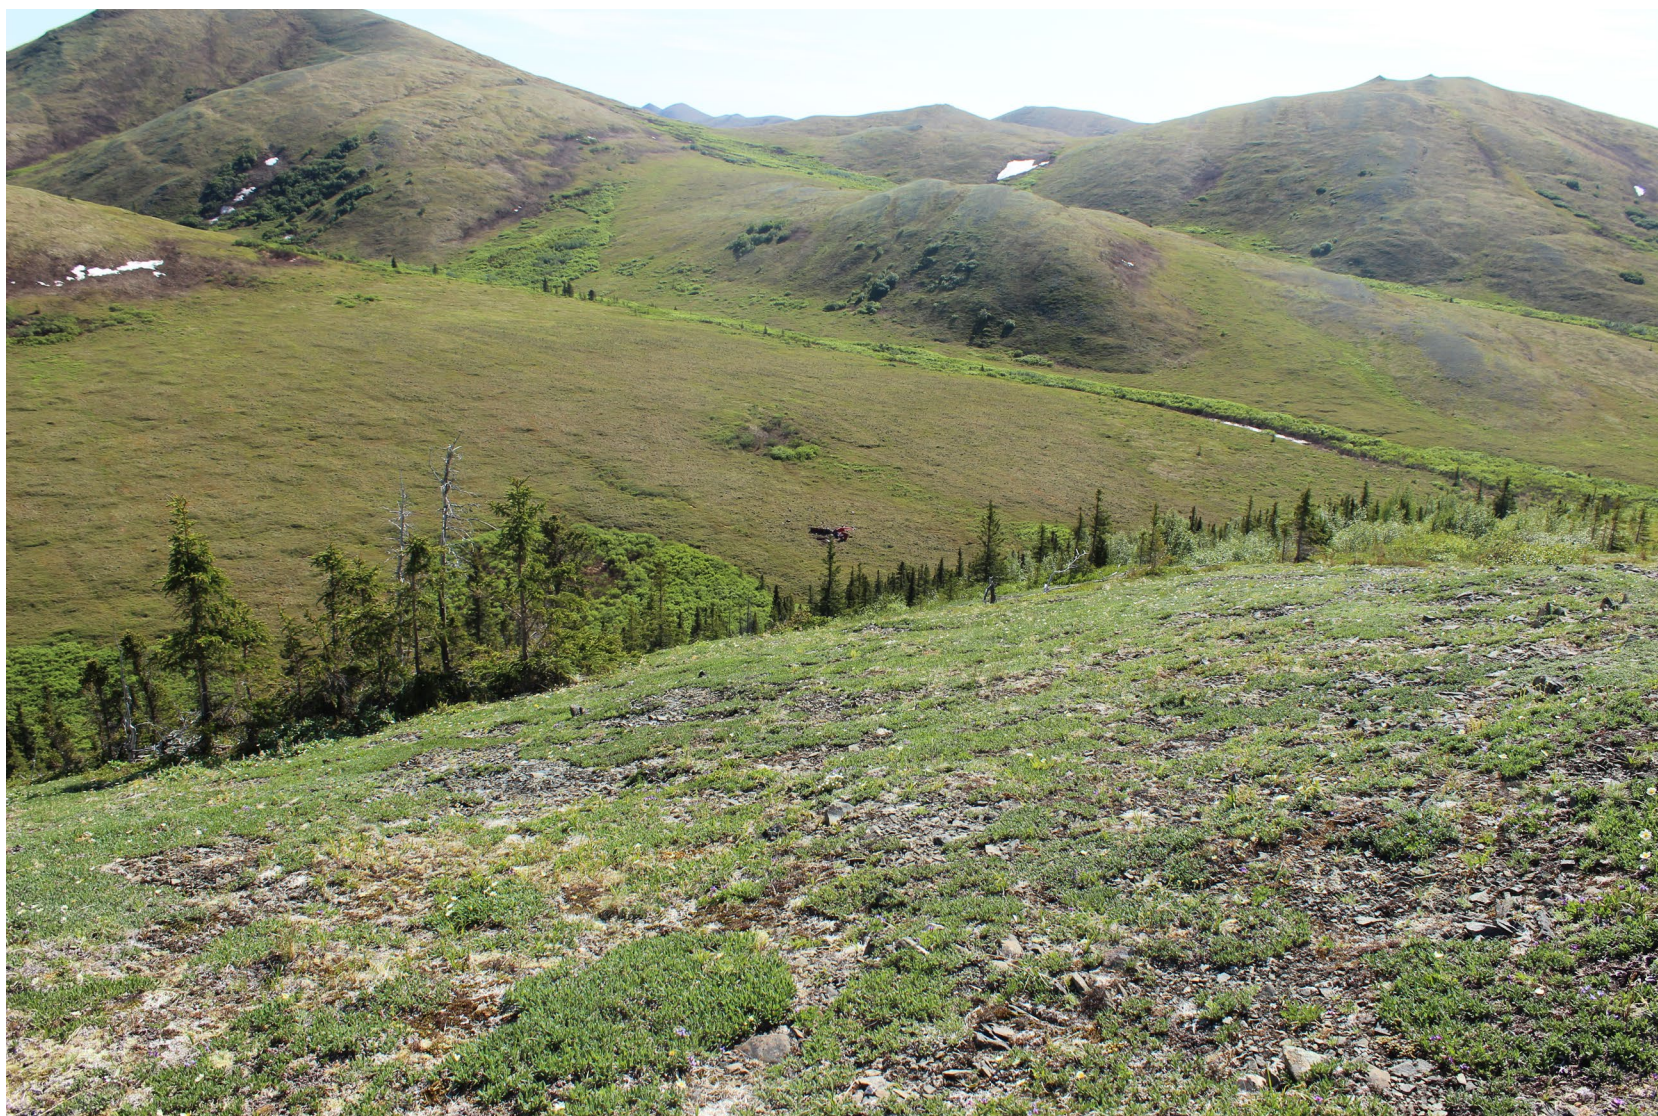
**Photograph 1 - View of where the airplane came to rest from the departure end of the airstrip.**

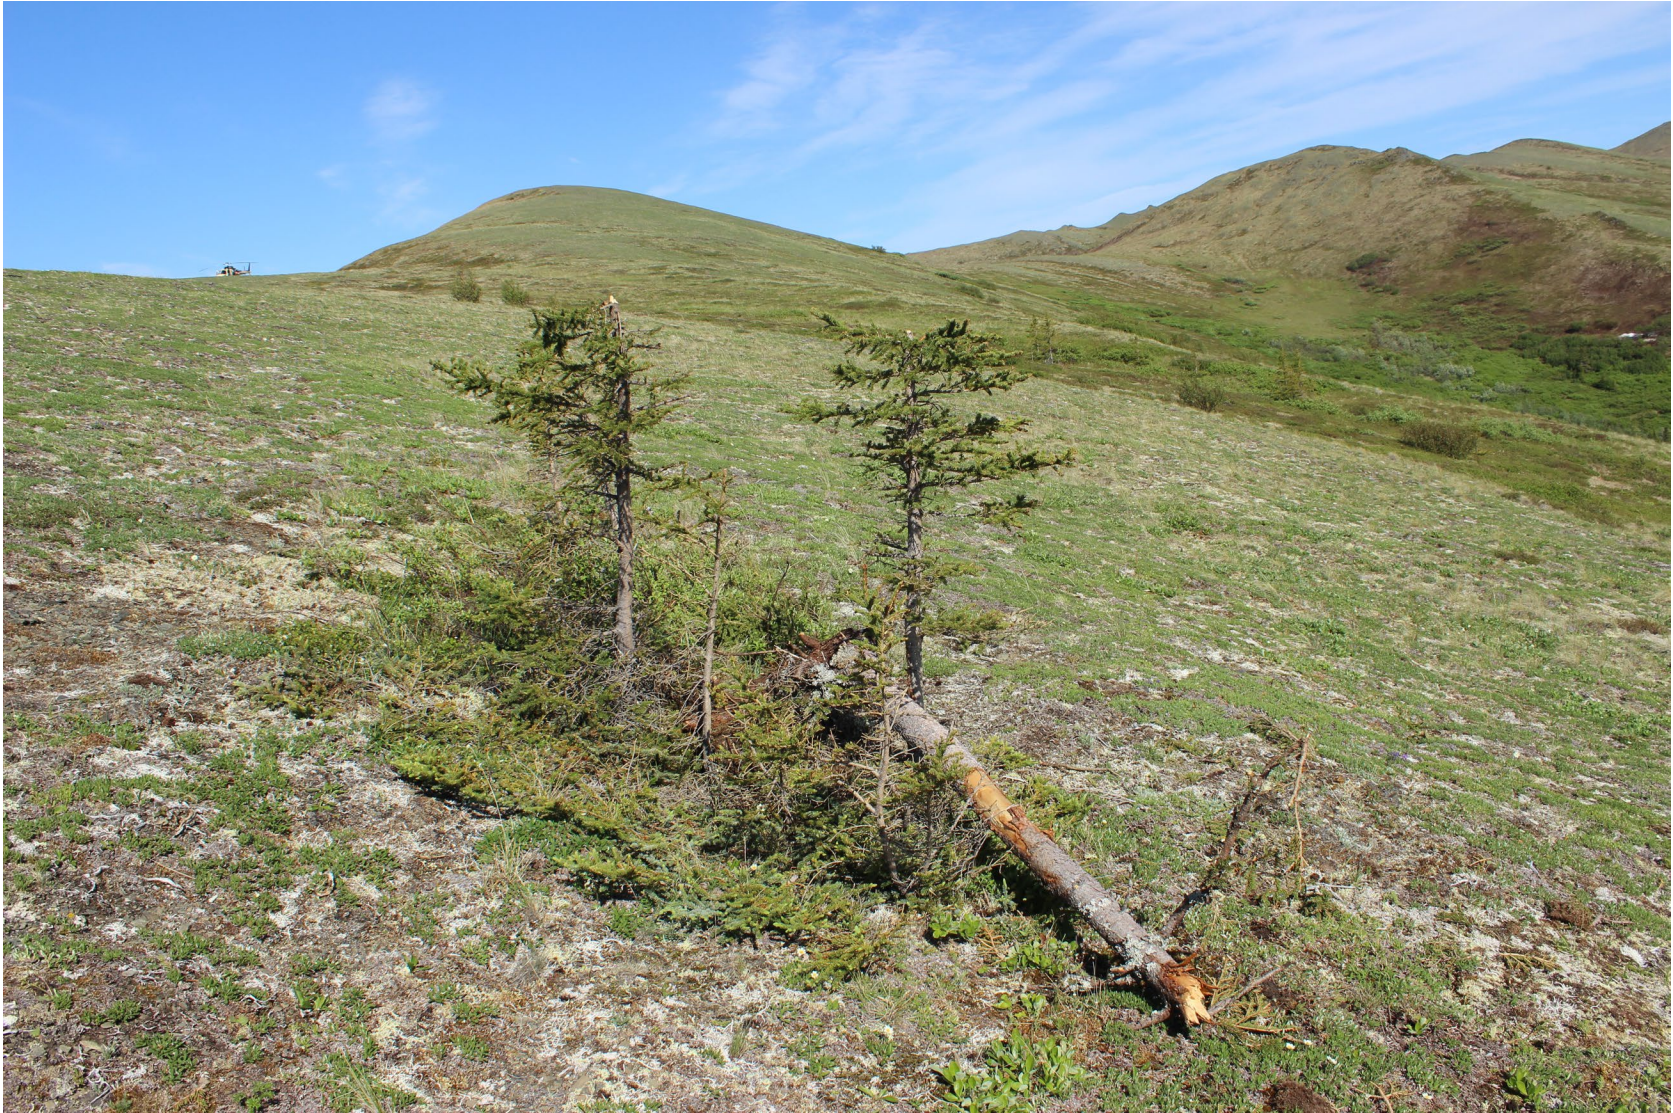
**Photograph 2 - View of the tree with impact damage and fragments of red paint.**

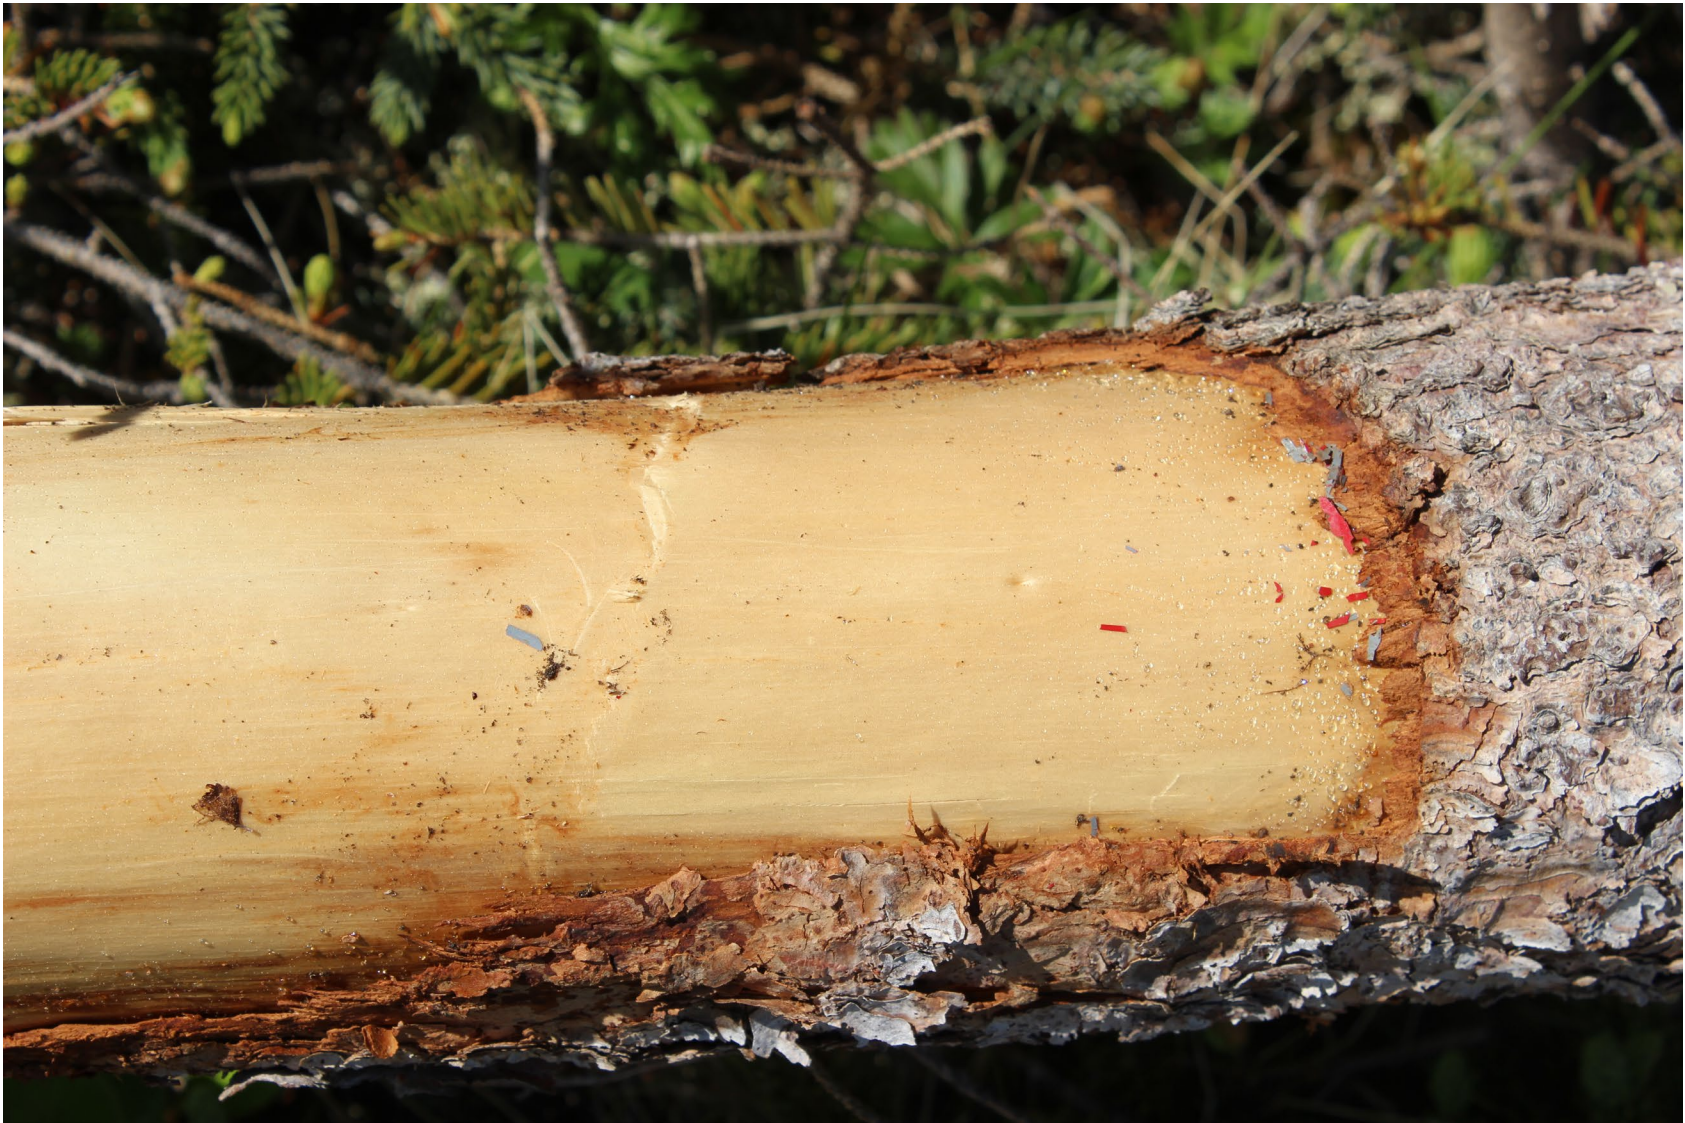
**Photograph 3 - View of the impact damage and red paint fragments.**

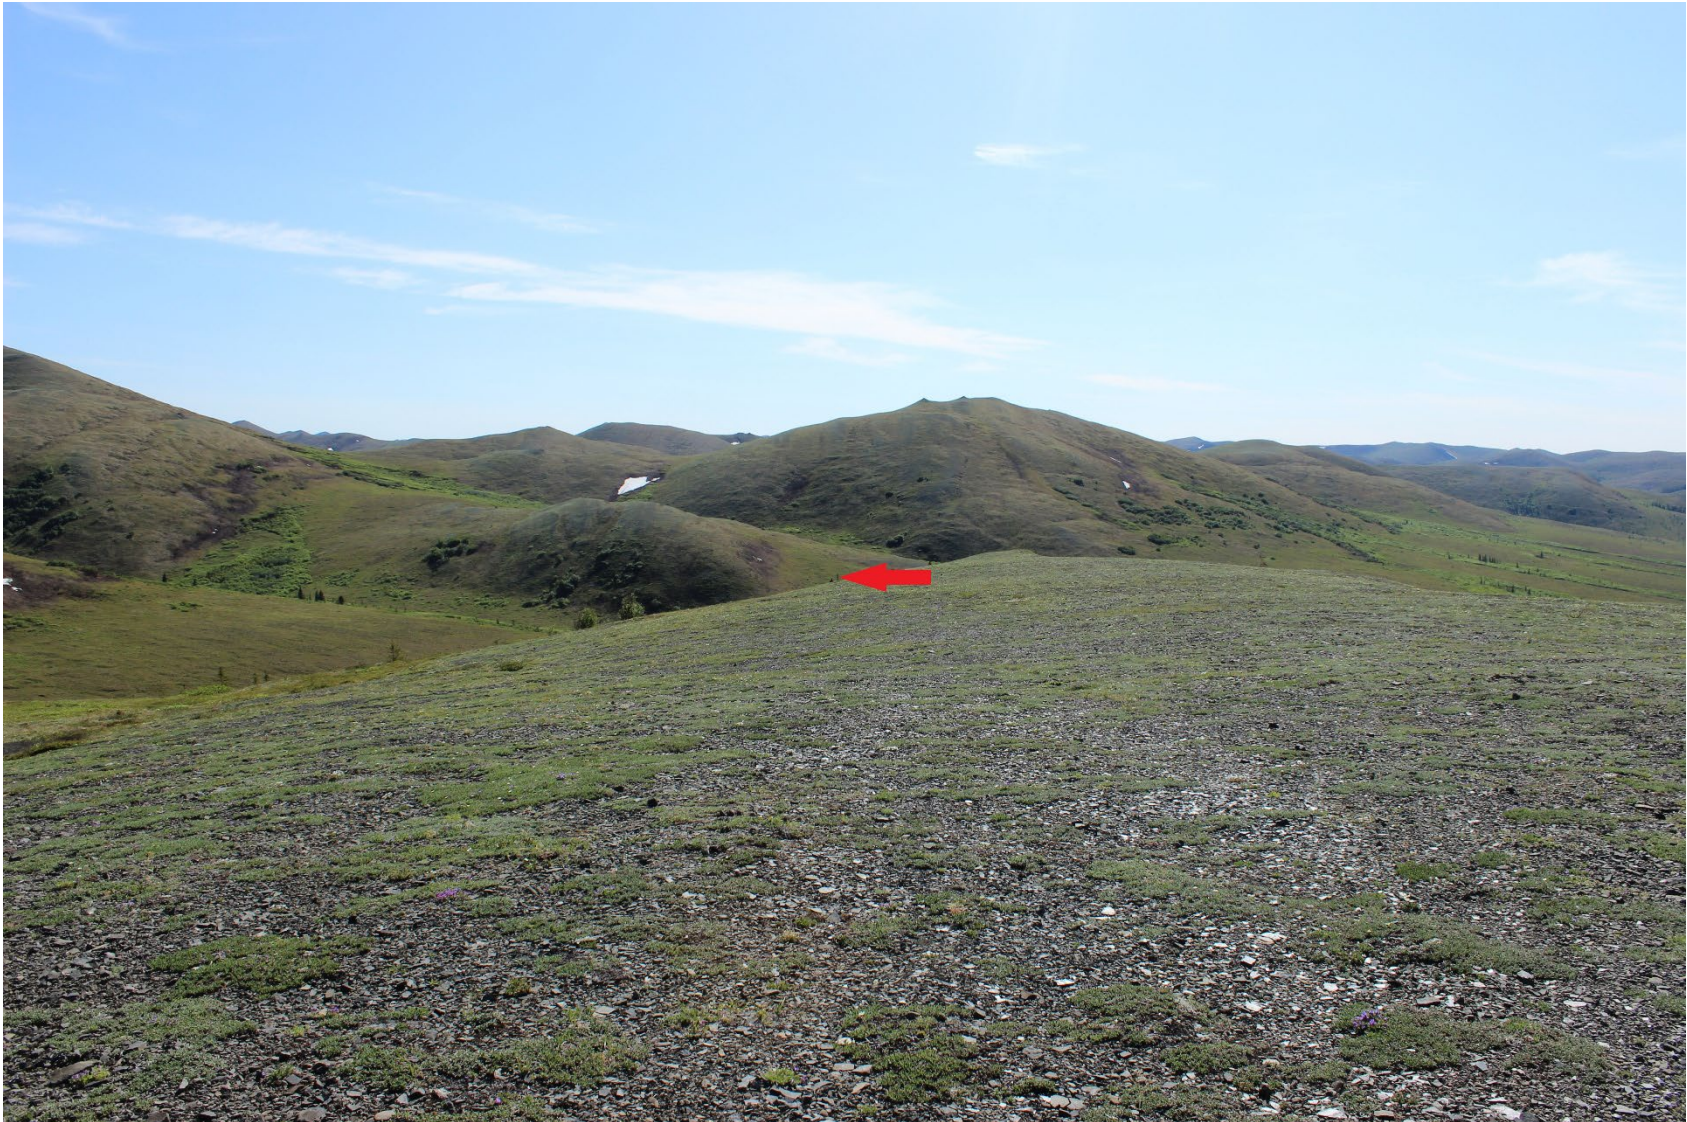
**Photograph 4 - View from the airstrip from the beginning towards the departure end. The red arrow indicates the location of the tree that was struck.**

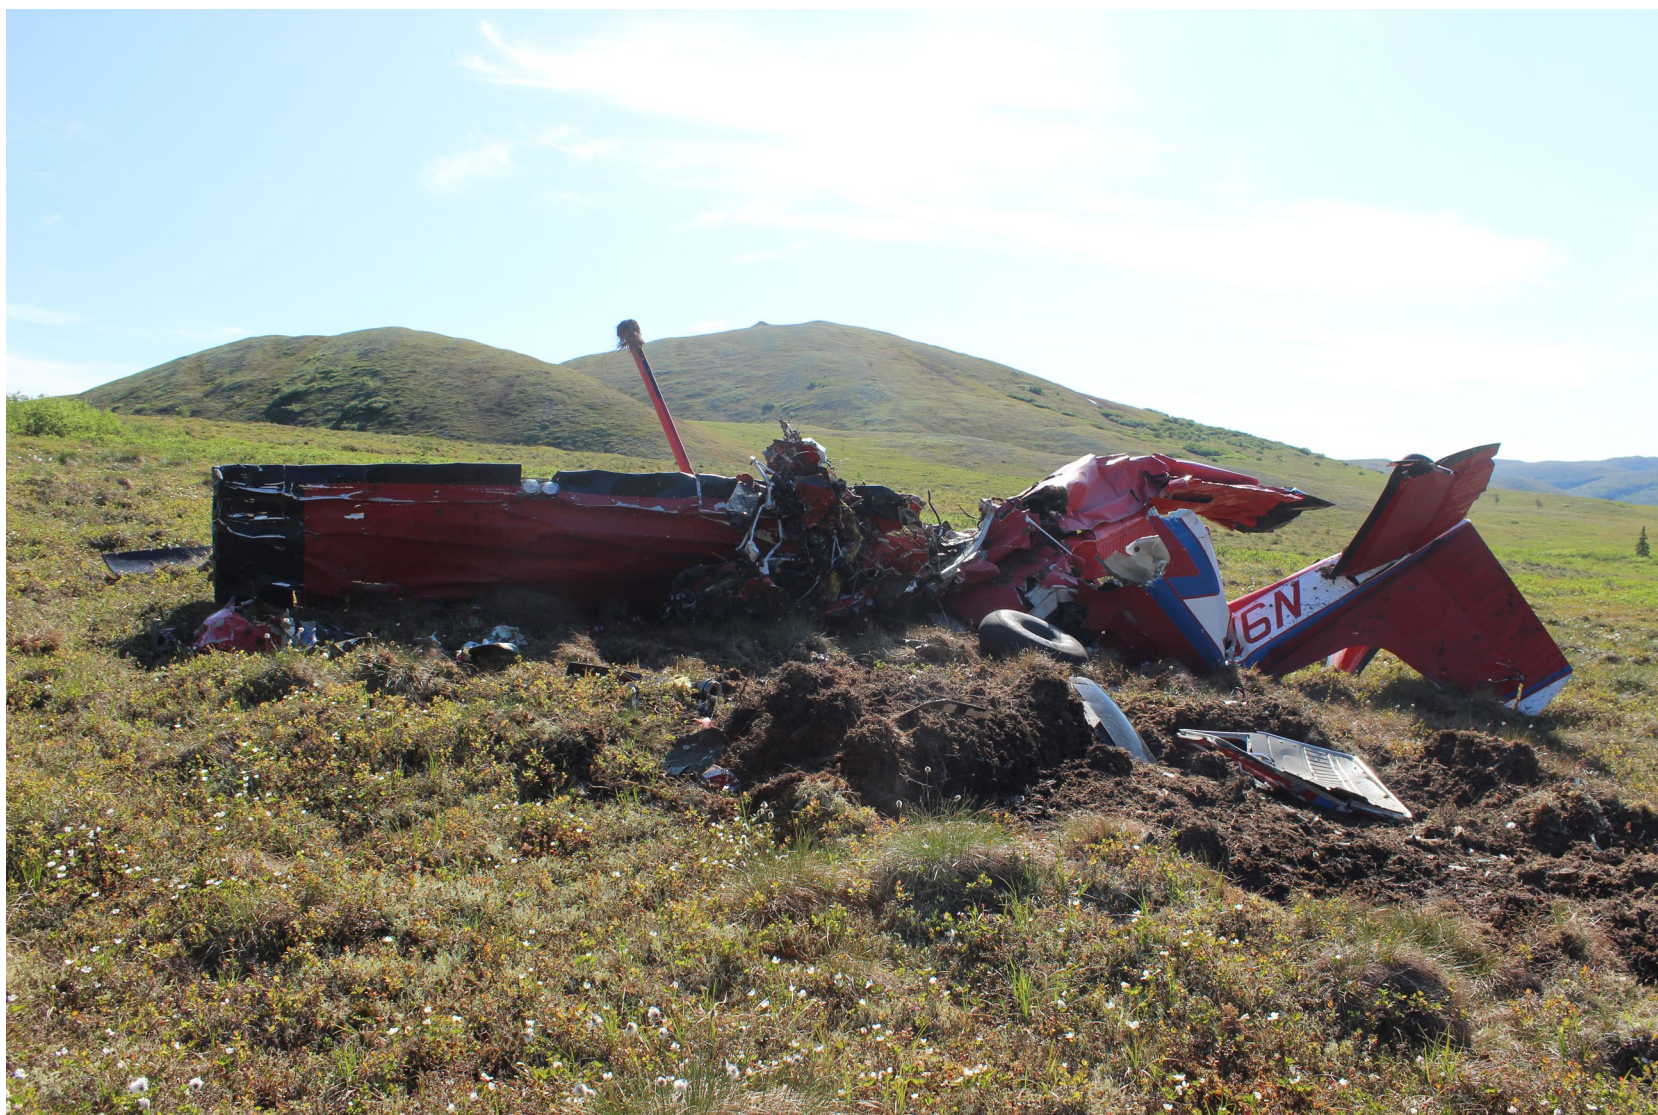
**Photograph 5 - View of the main wreckage where it came to rest.**

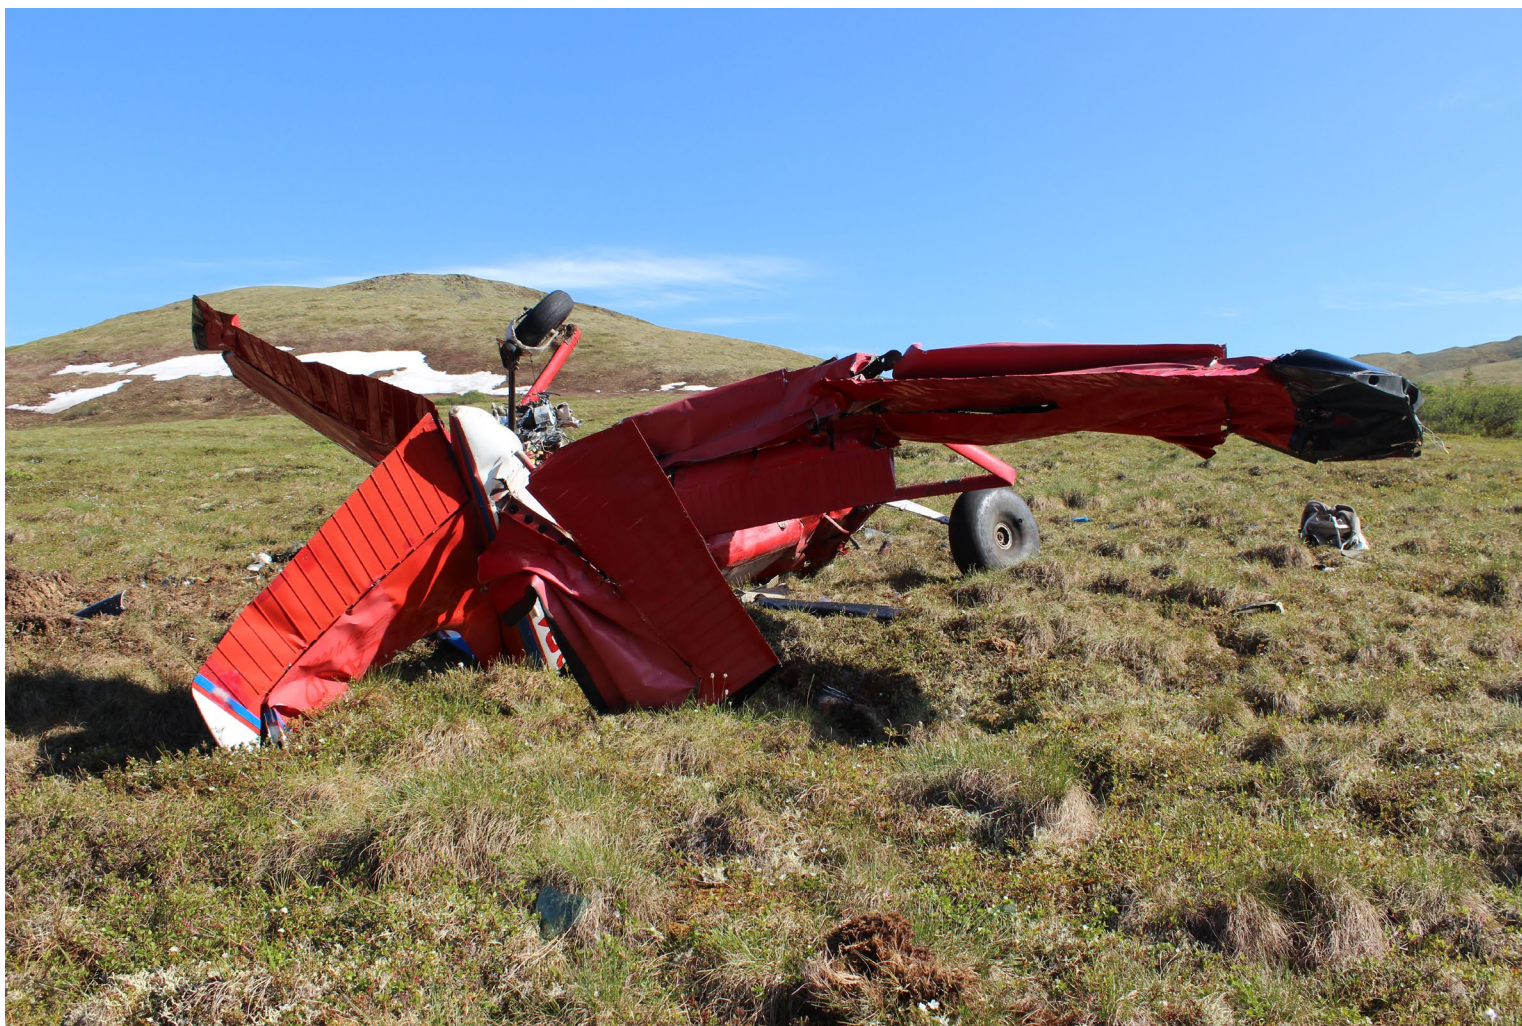
**Photograph 6 - Rear view of the wreckage and the left horizontal stabilizer.**

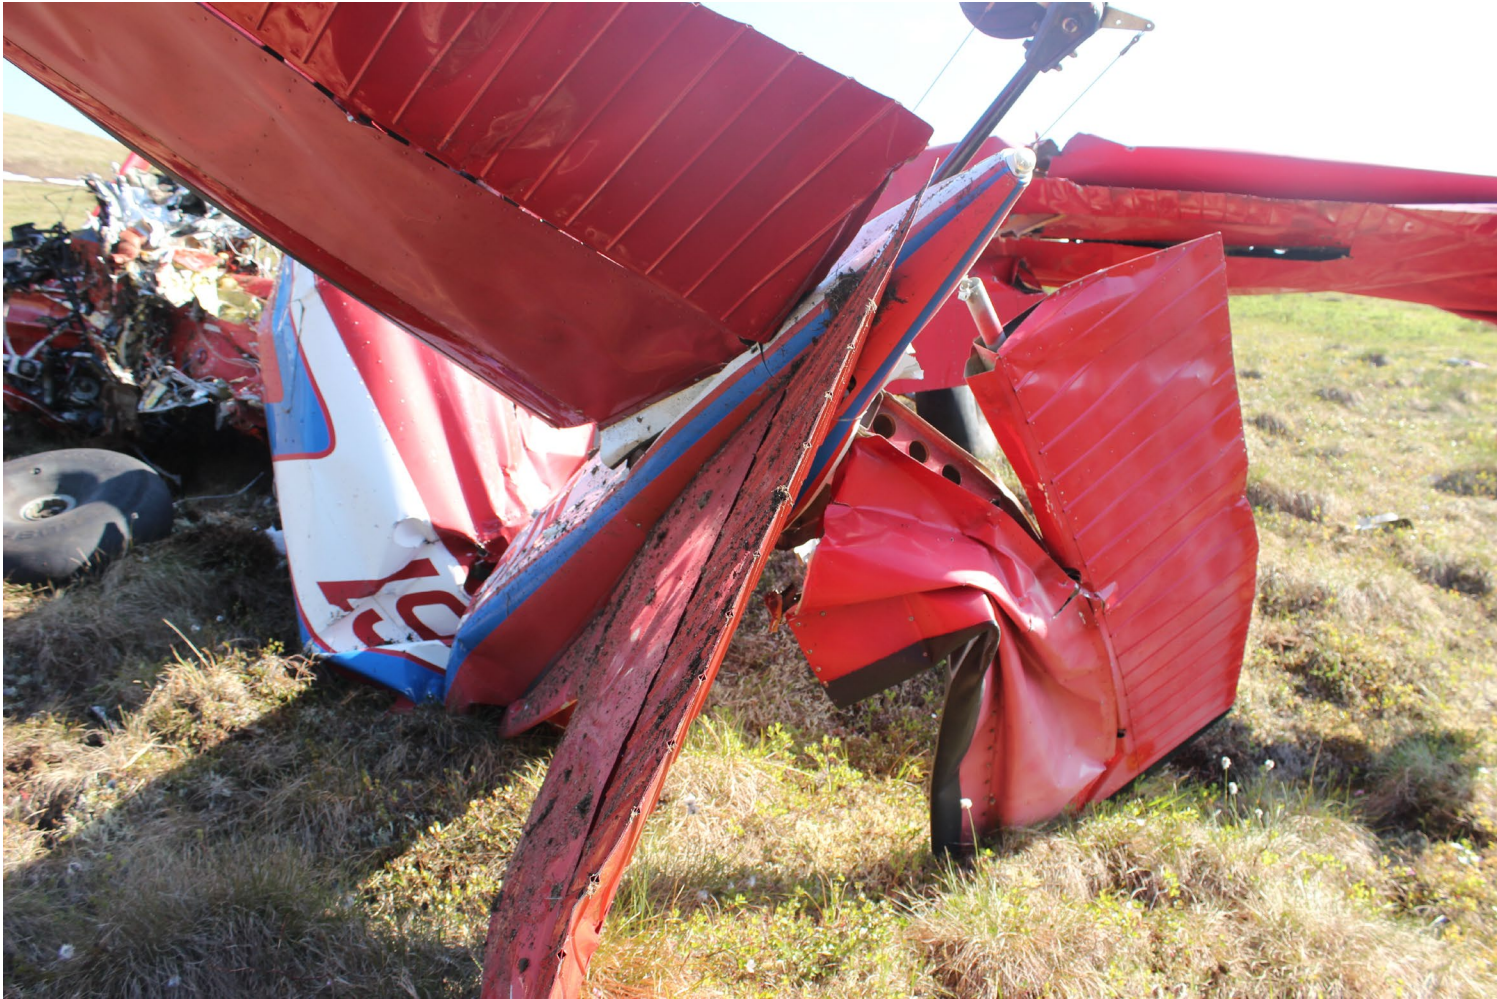
**Photograph 7 - View of the horizontal stabilizers and rudder.**

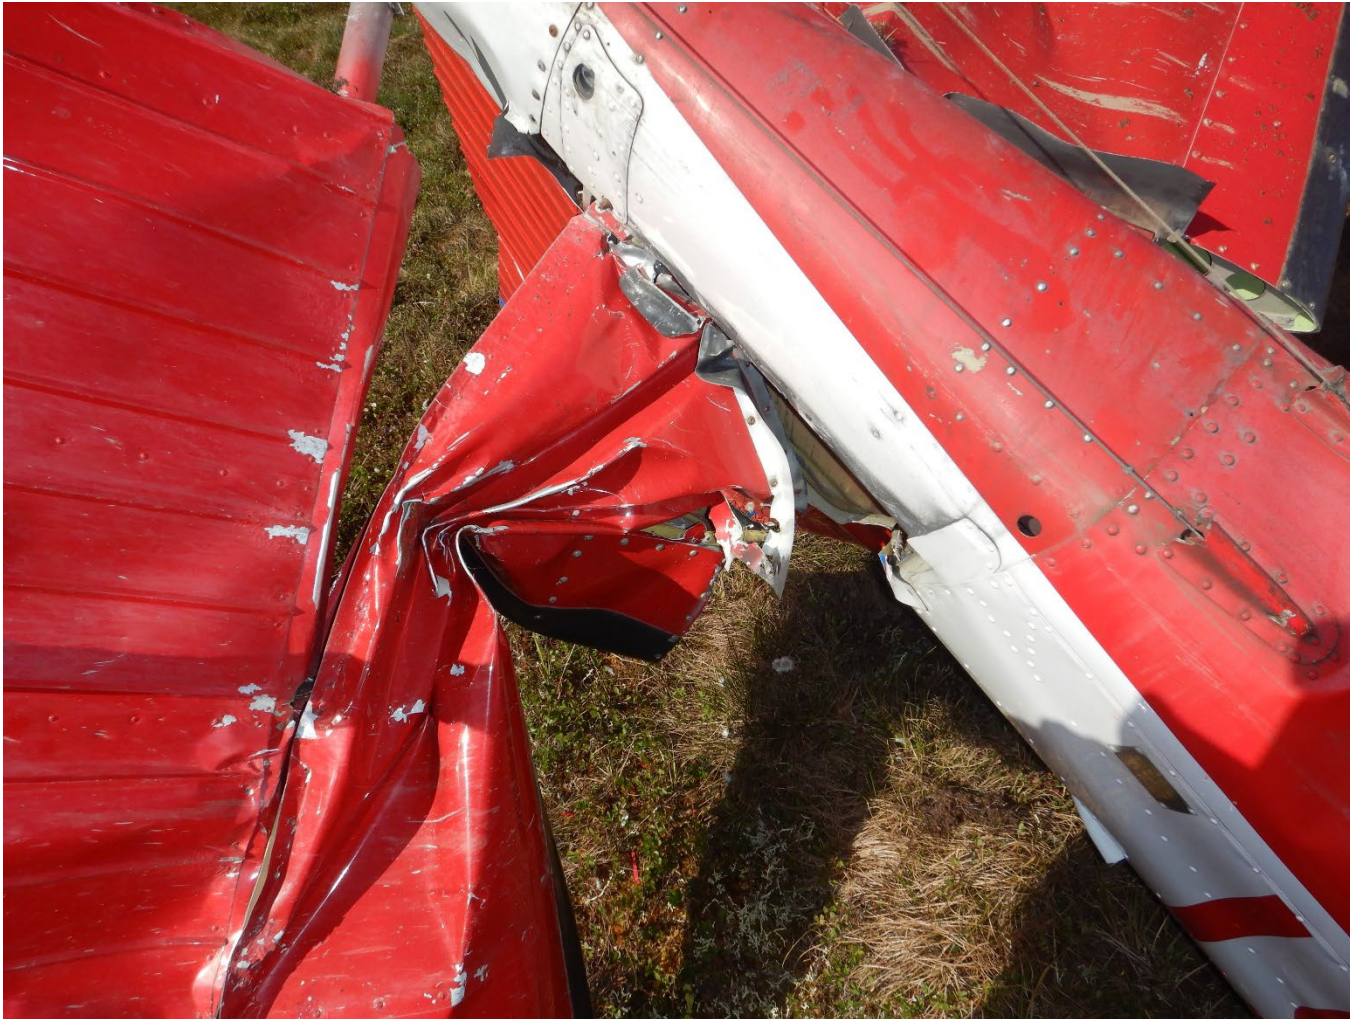
**Photograph 8 - View of the leading edge damage to the left horizontal stabilizer (Courtesy of Textron Aviation)**

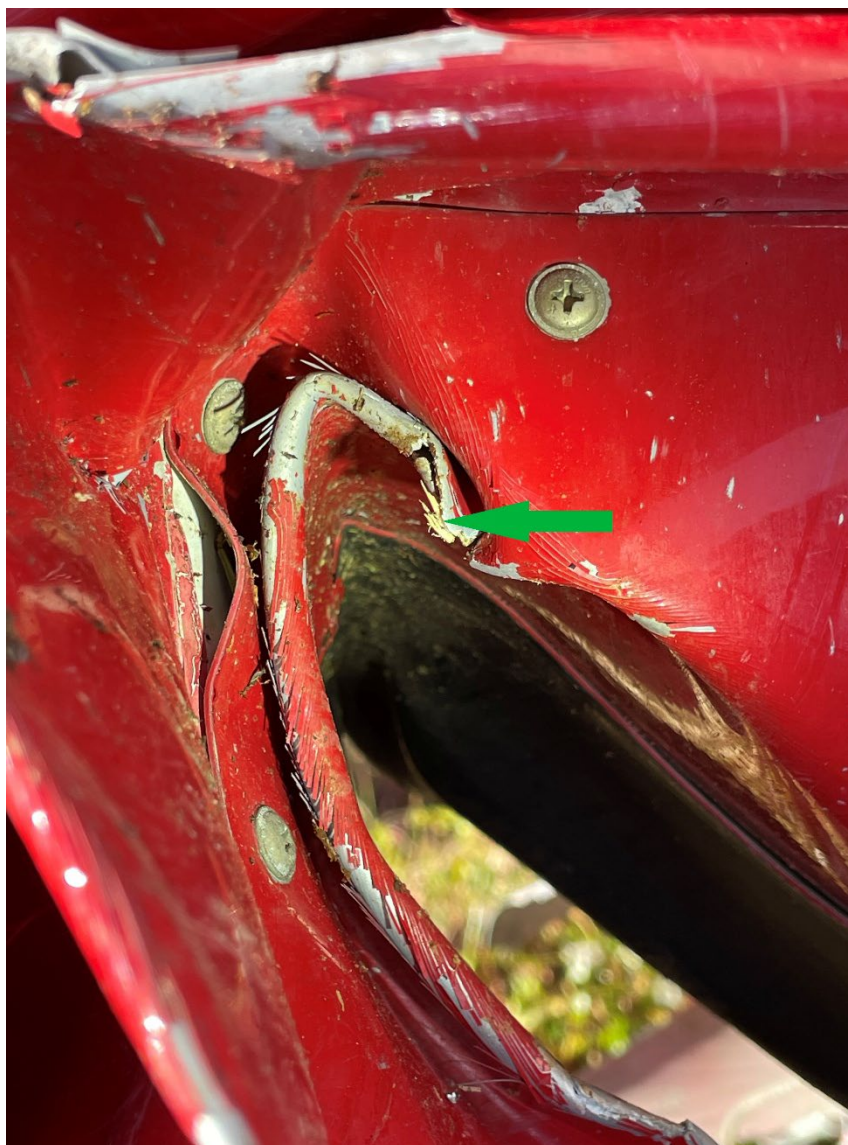
**Photograph 10 - View of tree sap and embedded tree fibers in the leading edge of the horizontal stabilizer.**
