# National Transportation Safety Board

ANC23FA042

## **AIRFRAME AND ENGINE EXAMINATION**

Location: Shaktoolik, Alaska  
Date: June 16, 2023  
Time: 1135 AKDT  
Airplane: Cessna 180A, N91361

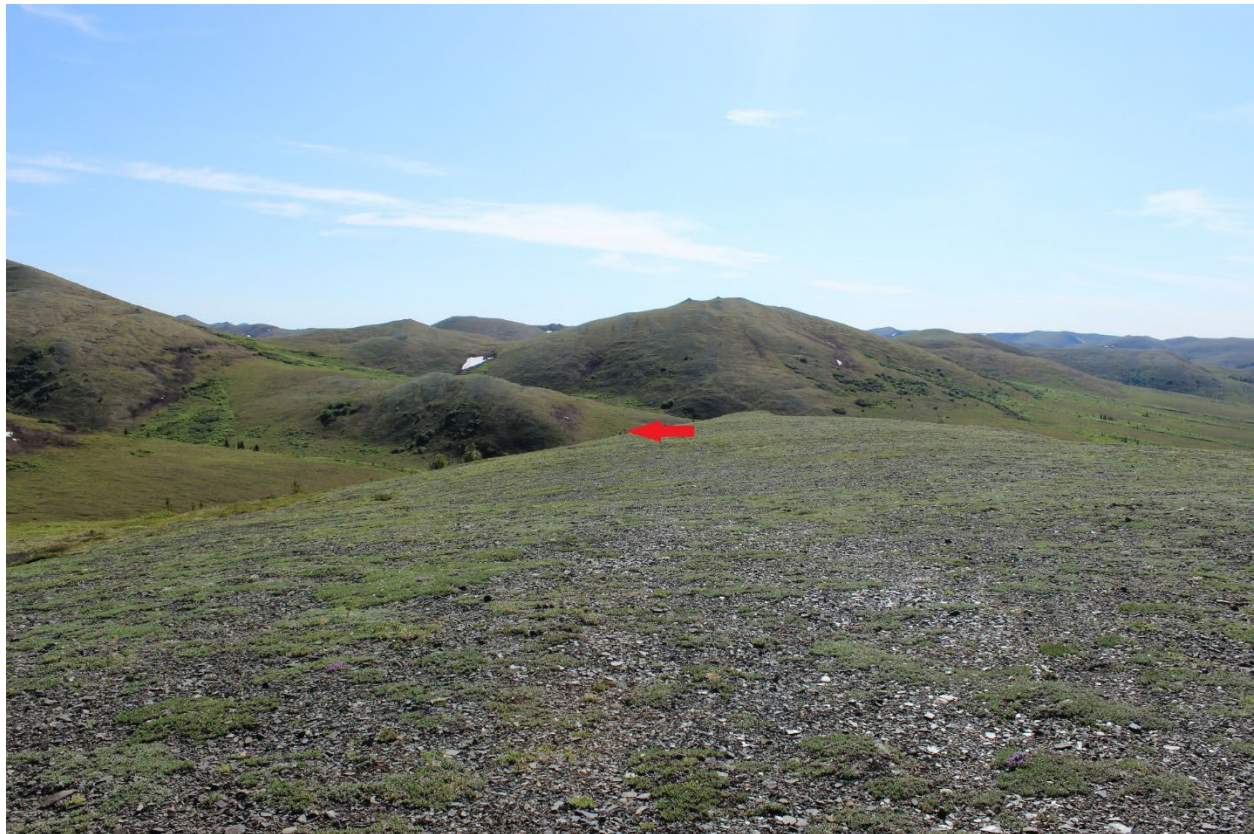
**Photograph 1 - View from the airstrip from the beginning towards the departure end. The red arrow indicates the location of the tree that was struck.**

The airplane took off on a downward sloping mountain top airstrip. The aircraft struck a group of three small trees located on the left side of the ridgeline about 2/3 of the distance from the beginning of the strip to the end. The largest one was approximately 4 inches in diameter at the base and 12 ft tall. The impact mark observed on the tree was approximately 4 ft from the ground. The only impact signature on the aircraft that was consistent with tree impact signatures was located on the left horizontal stabilizer approximately 1 ft outboard from the stabilizer root. The aircraft then continued down the slope and off the left side of the mountain. It

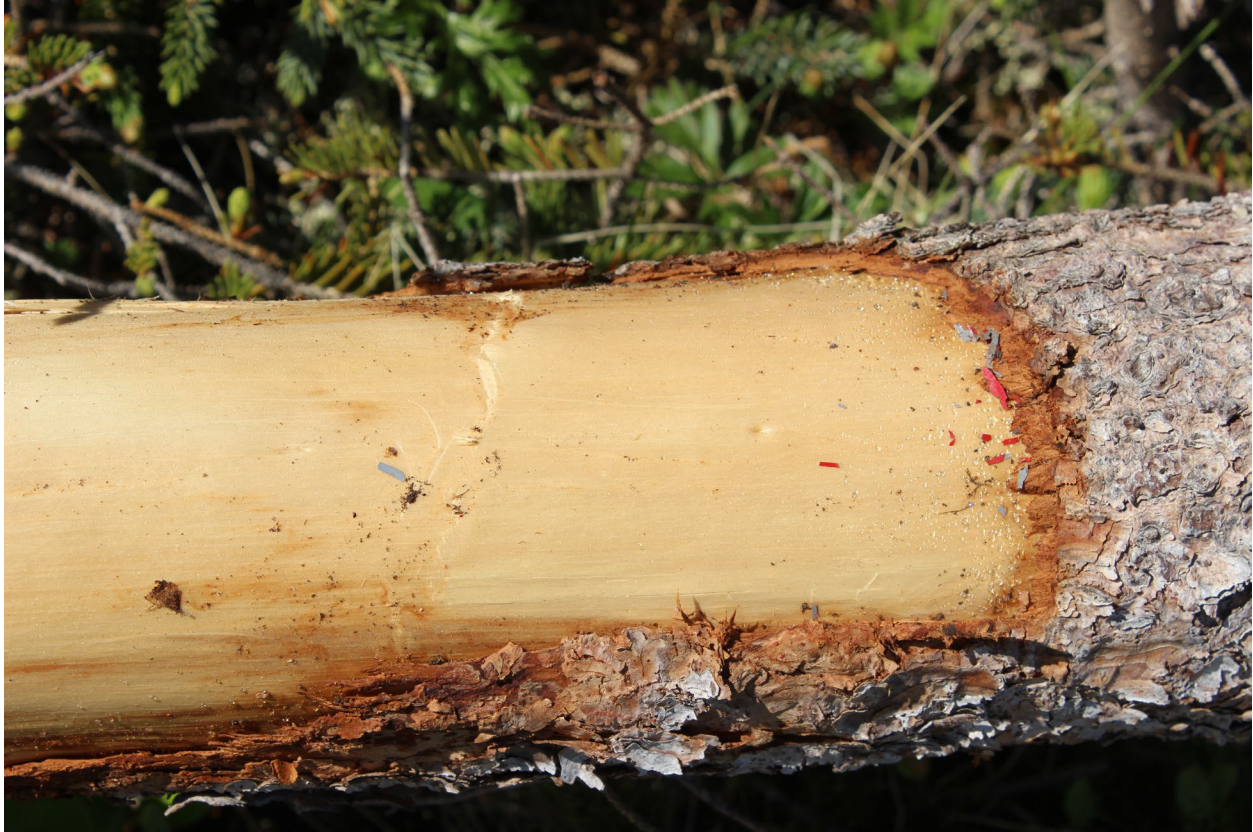
impacted rolling tundra 300 ft below the tree impact point in a steep nose-down, wings level attitude. The wreckage was oriented on a magnetic heading of 072°.

**Photograph 2 - View of the impact damage and red paint fragments.**

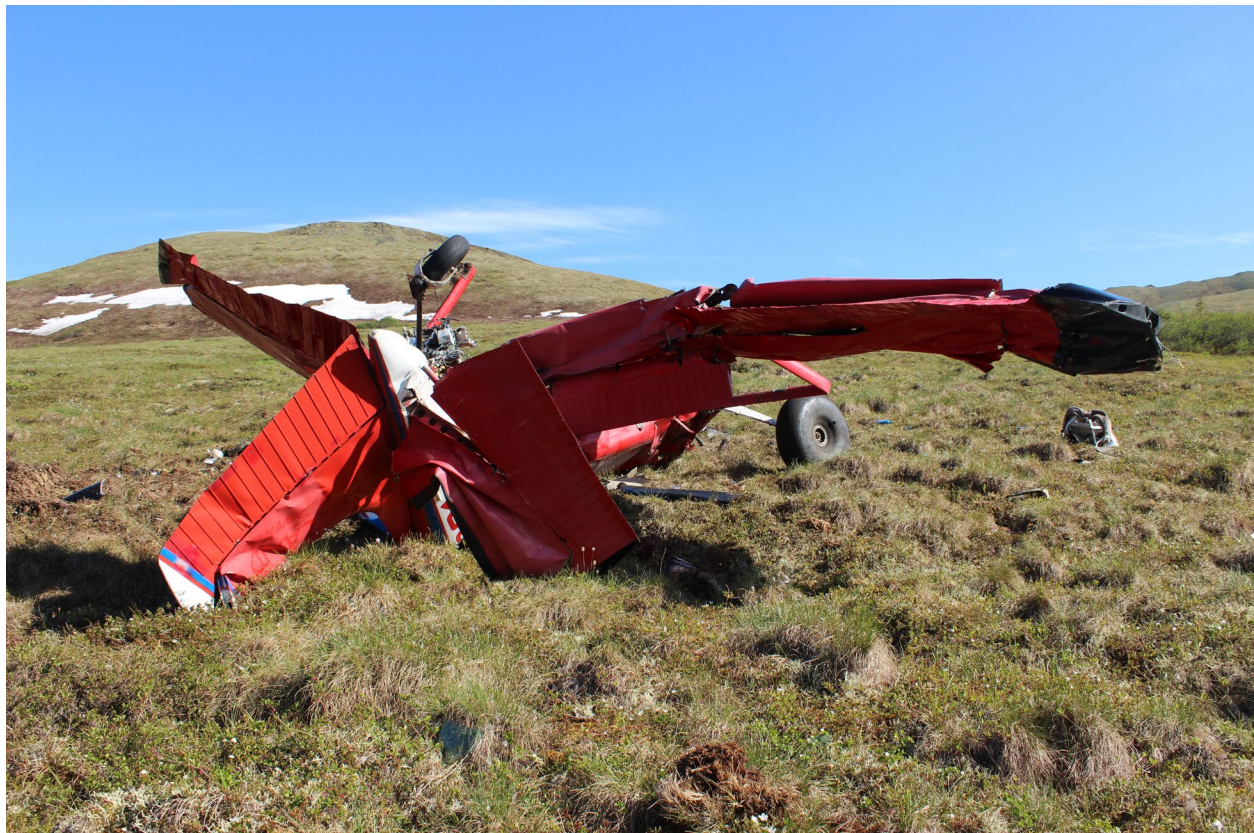
**Photograph 3 - Rear view of the wreckage and the left horizontal stabilizer.**

The aft portion of the fuselage partly separated at the baggage compartment and buckled near fuselage station 140 and came to rest inverted to the fuselage. The left horizontal stabilizer sustained an impact mark and aft crushing about 1 ft outboard of the stabilizer root. Tree sap and embedded tree fibers were present. The impact displaced the leading edge of the stabilizer aft approximately 14 inches. The

left elevator torque tube impact fractured from the elevator aft bellcrank. The root of the stabilizer was pulled outward from the fuselage. The horizontal stabilizer jack screw attach points were separated from the stabilizer but remained attached to the jackscrews via attach hardware. The right horizontal stabilizer and elevator did not exhibit leading edge impact signatures, and the elevator remained attached.

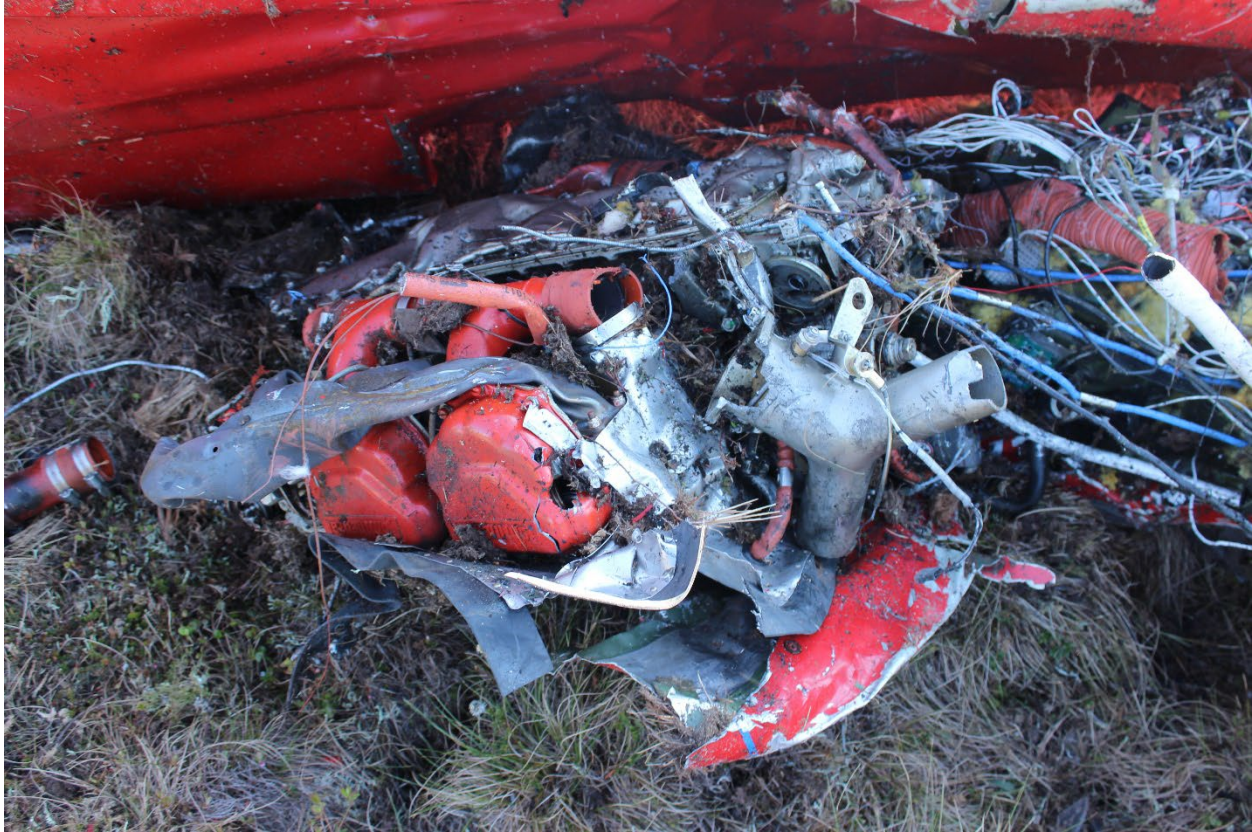
The engine was separated and located forward of the initial ground impact point and behind the left wing. It came to rest upside down; the oil pan was crushed upward.

**Photograph 4 - View of the engine where it came to rest.**
