# National Transportation Safety Board

ANC23FA045

## **ENGINE EXAMINATION**

Location: Old Harbor, Kodiak AK  
Date: July 2 2023  
Time: 1510L  
Airplane: Piper PA-32-300

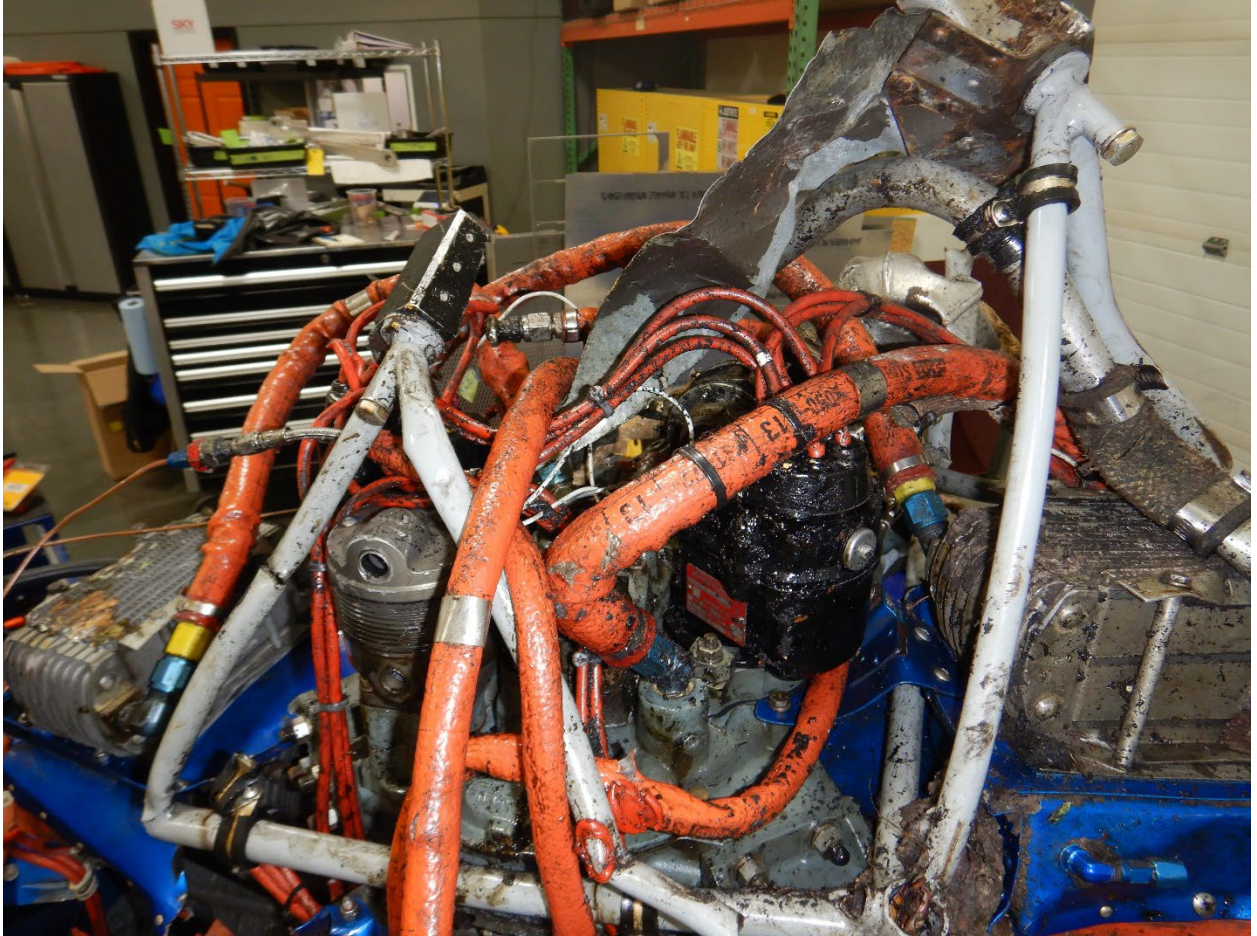
**Figure 4. Accessory gear box on rear of engine.**

Drivetrain continuity from the propeller to the accessory case was confirmed by the vacuum pump moving when rotating the propeller. Valves moved equal distance.

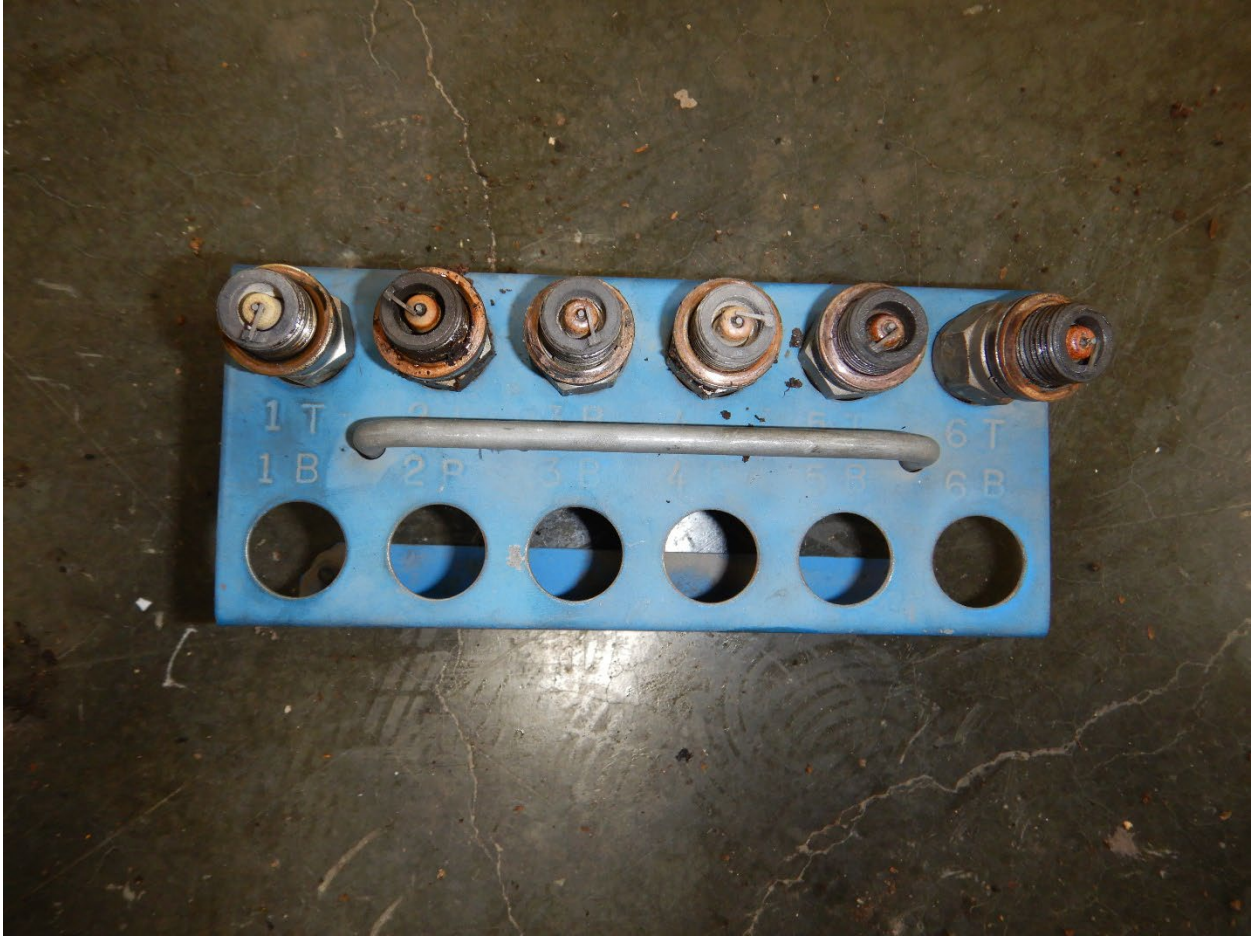
Spark plugs were in used but good condition. All spark plug wires were secure.

**Figure 5. Top row of spark plugs removed from engine.**

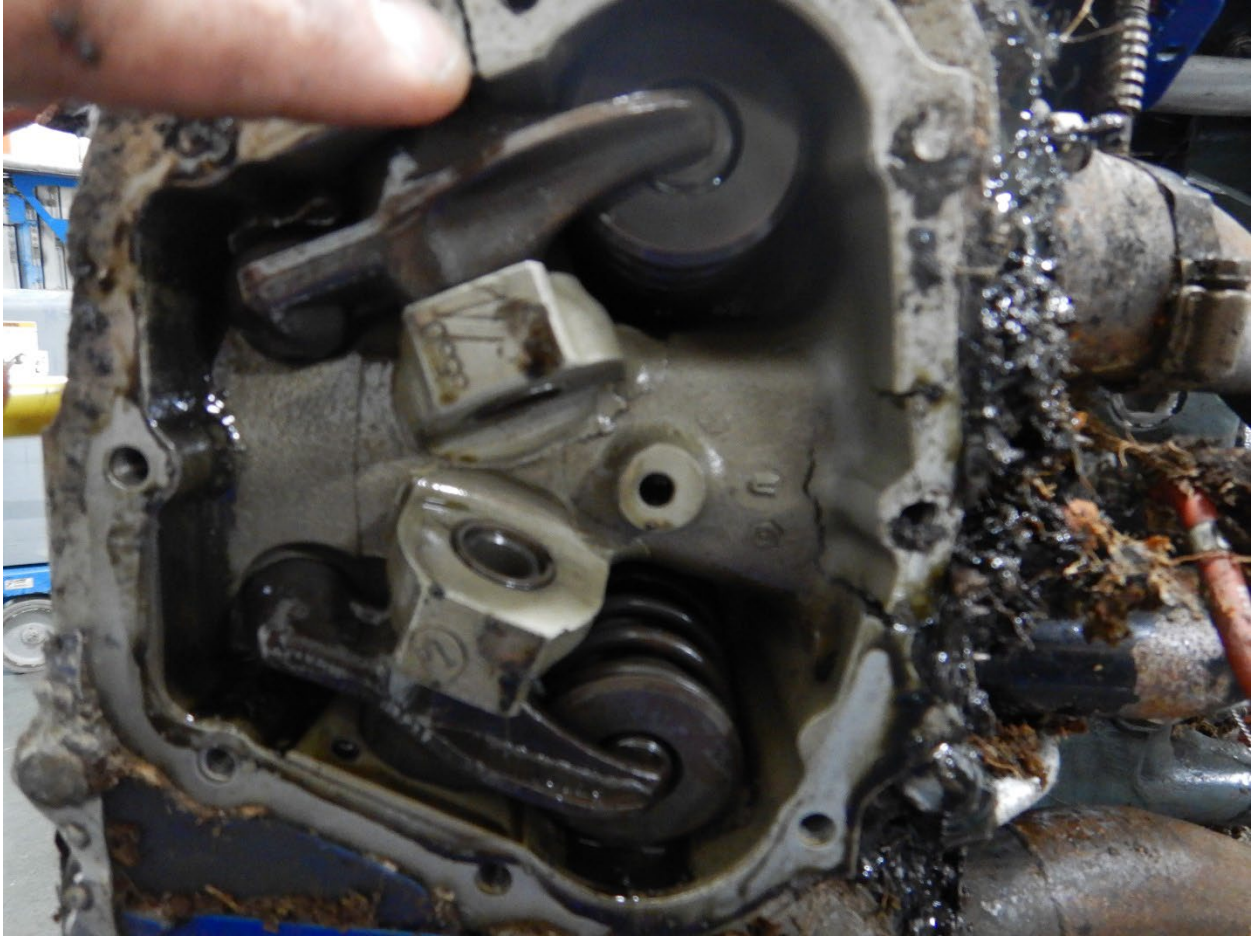
#6 0/80 - Cylinder cracked.

Borescope cylinders with low compression and found all cylinders in good over all conditions with signs of cracking from impact forces and debris sucked in from the air intake.

**Figure 6. View of cracks in cylinder.**

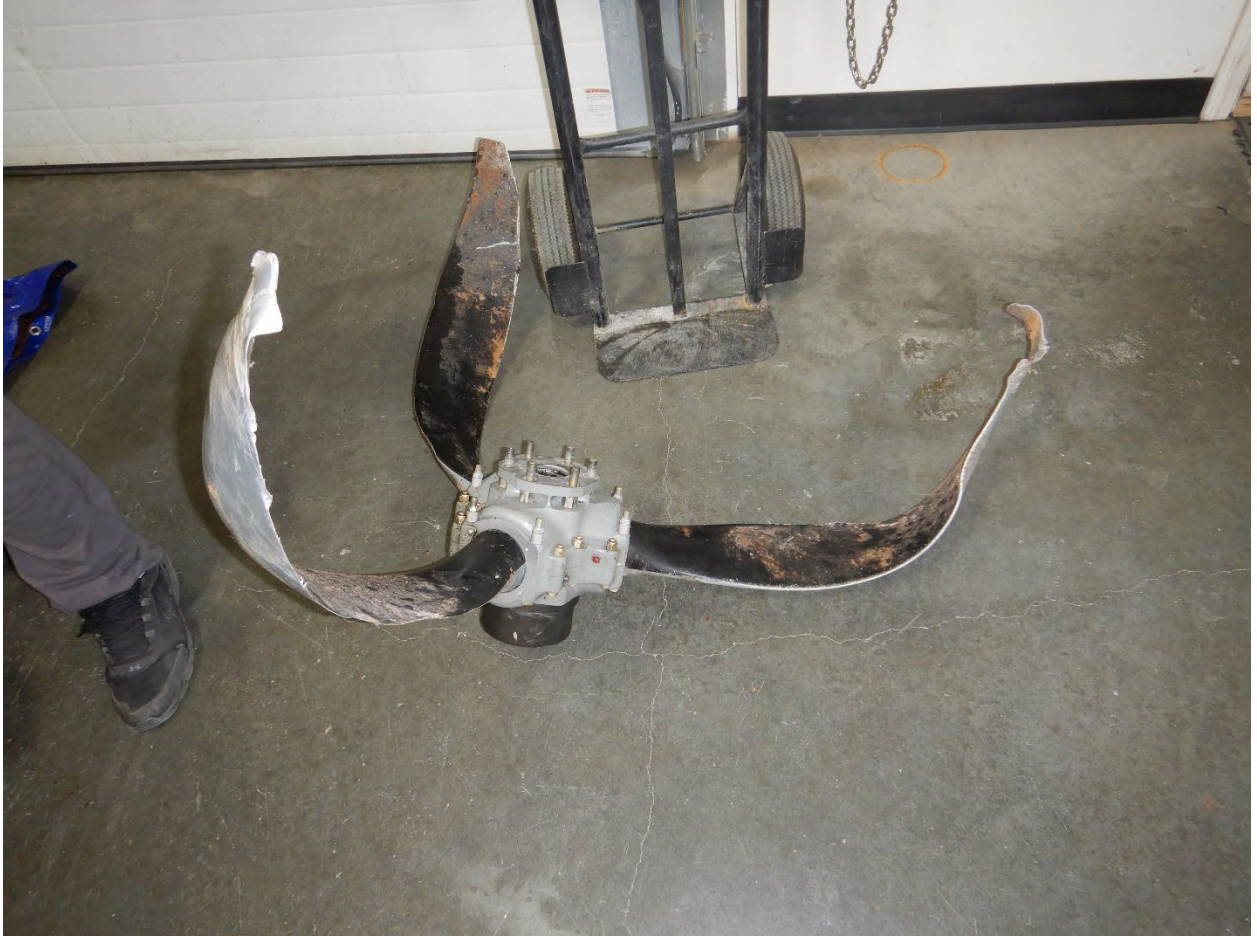
All three propeller blades were curled back and had nicks, dents and cuts into the leading edges of the propeller. All propeller blades had rotational scoring. The propeller hub had oil in it. Propeller attachment nuts were all safety wired.

**Figure 8. Propeller assembly after removal from engine.**
