# National Transportation Safety Board

ANC23FA056

## **Wreckage Examination**

Helicopter: N311MH Bell 206-L4

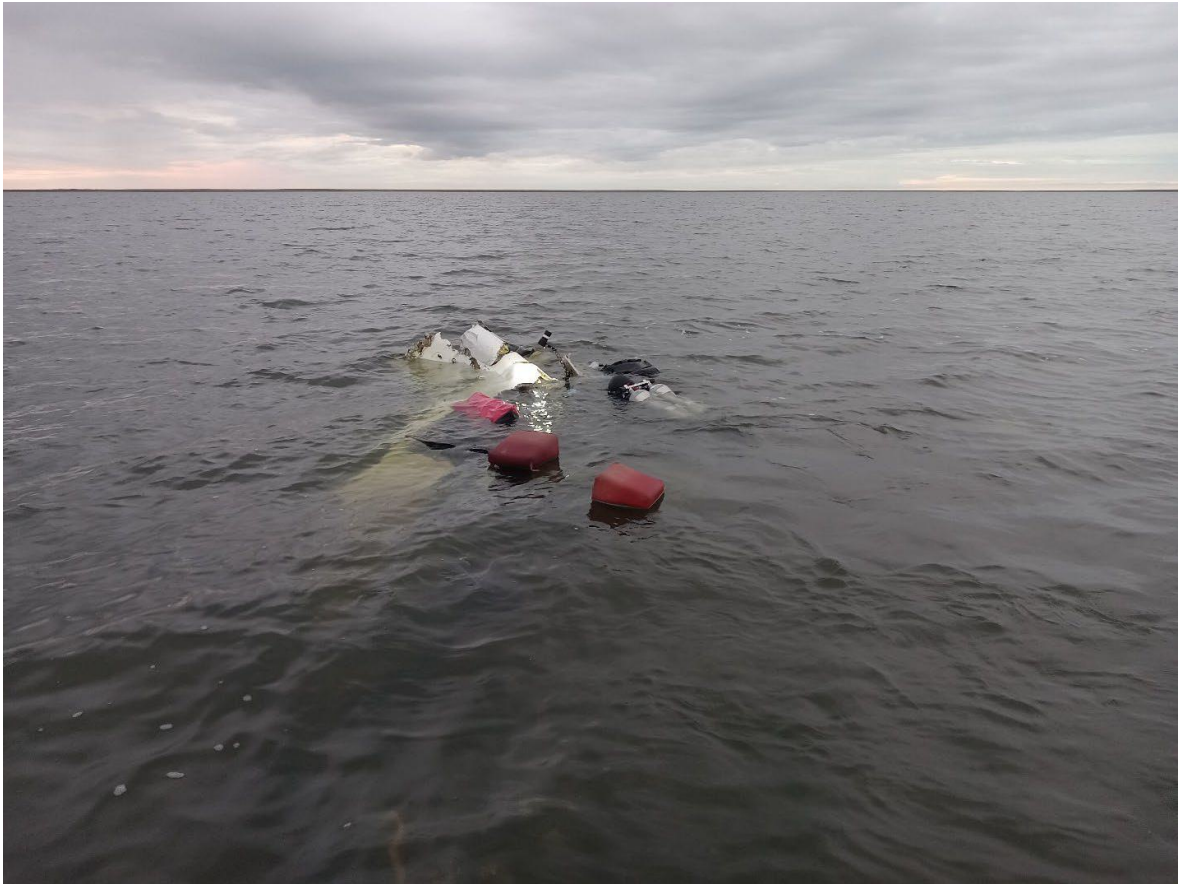
The accident site is in the middle of a large lake in about 6 feet of water. N70.66114 W158.564989. Underwater visibility was very poor. The bottom of the lake had a thick, muddy sediment layer about 2 feet deep. The helicopter was about 2 miles from the last automatic location sent by a Honeywell Sky Connect system. Along the same reported heading.

**Figure 4 View of accident helicopter at accident site.**

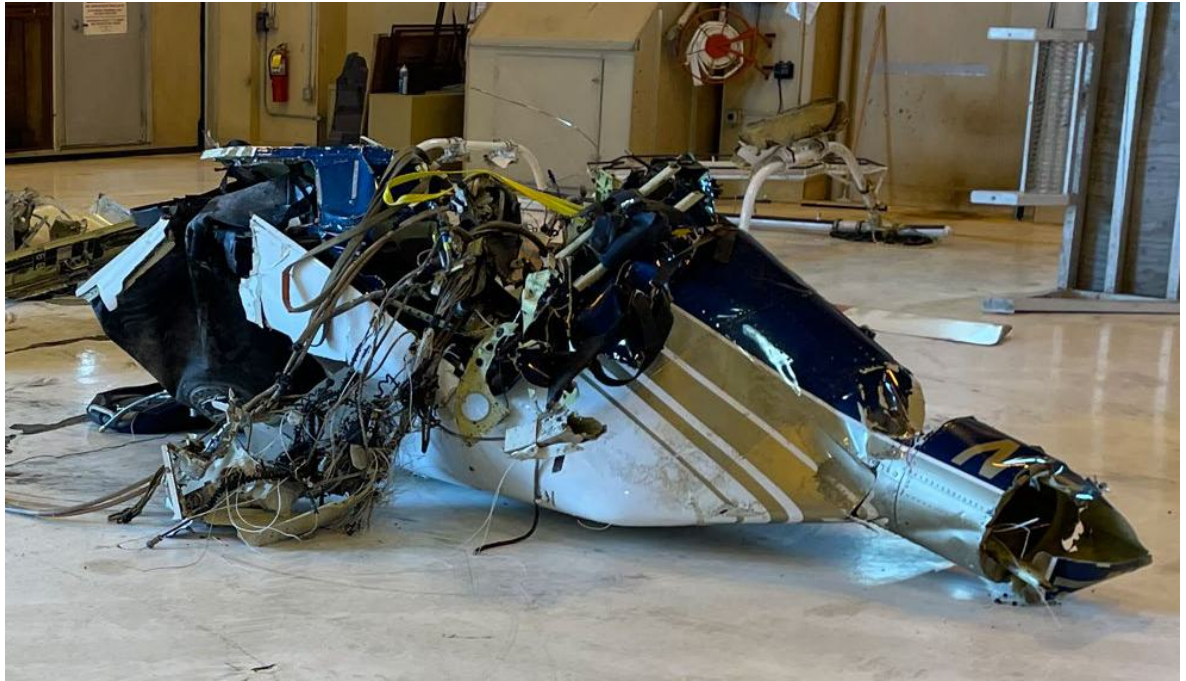
The fuselage was fragmented from impact forces with the water. All observed fractures were consistent with overload forces from impact. The nose, instrument panel, pilot door were not recovered. Evidence of front to rear crushing consistent with frontal water impact forces was observed at the cockpit seat structure, copilot door, and right cabin door. The aft fuselage was relatively intact but heavily damaged from impact forces. The four tailboom attachment bolts and nuts were all solidly attached. The tailboom exhibited an impact overload fracture just aft of the intercostal support at the forward end of the tailboom.

**Figure 7 Left side of accident helicopter fuselage.**

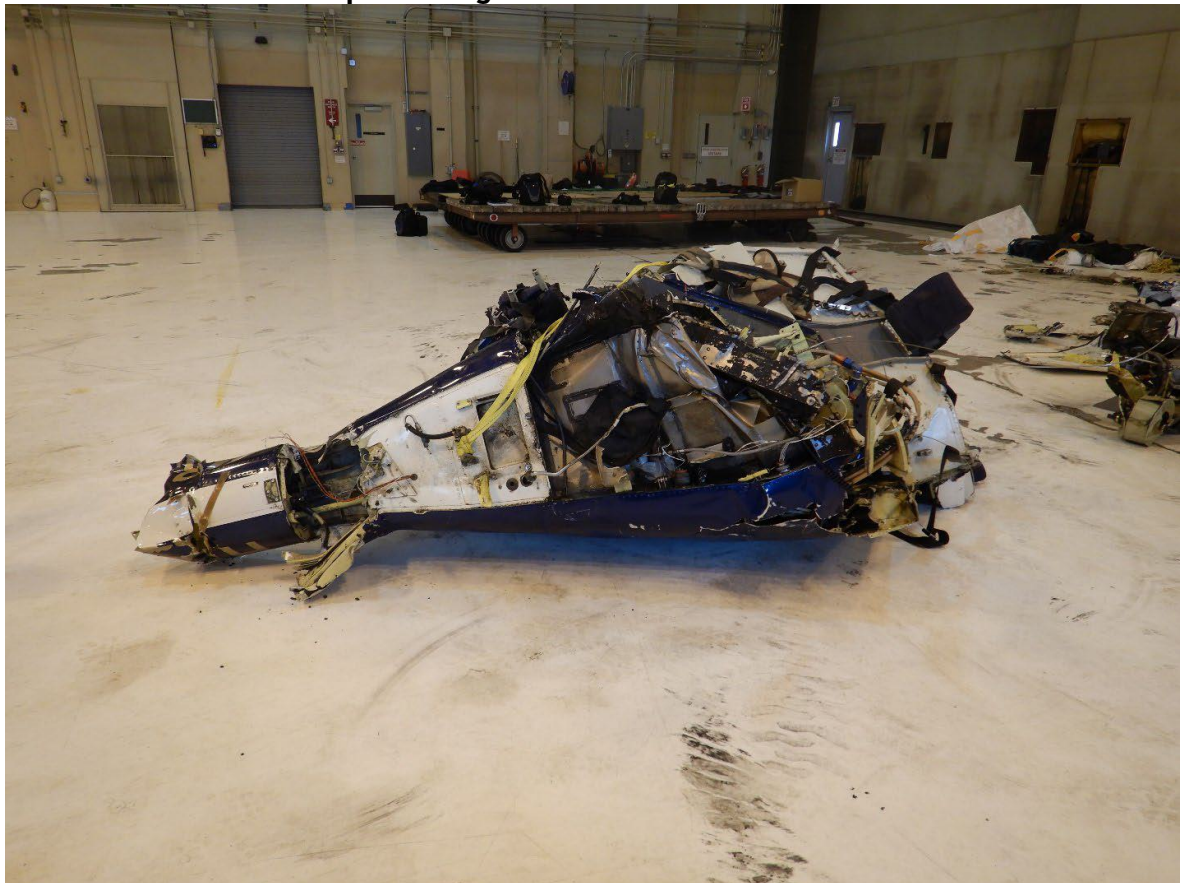
**Figure 8 Top view of accident helicopter fuselage.**

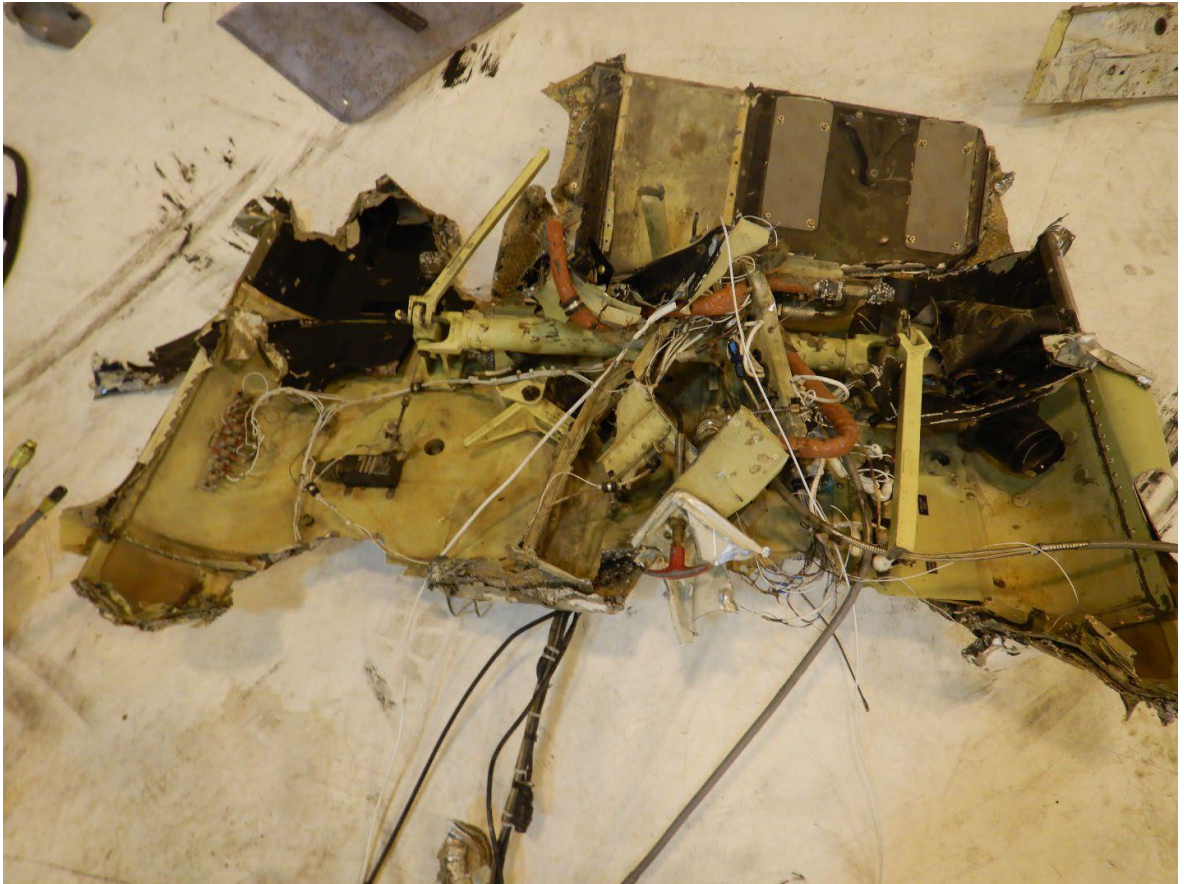
**Figure 9 View of accident helicopter's cockpit floor and seat location.**

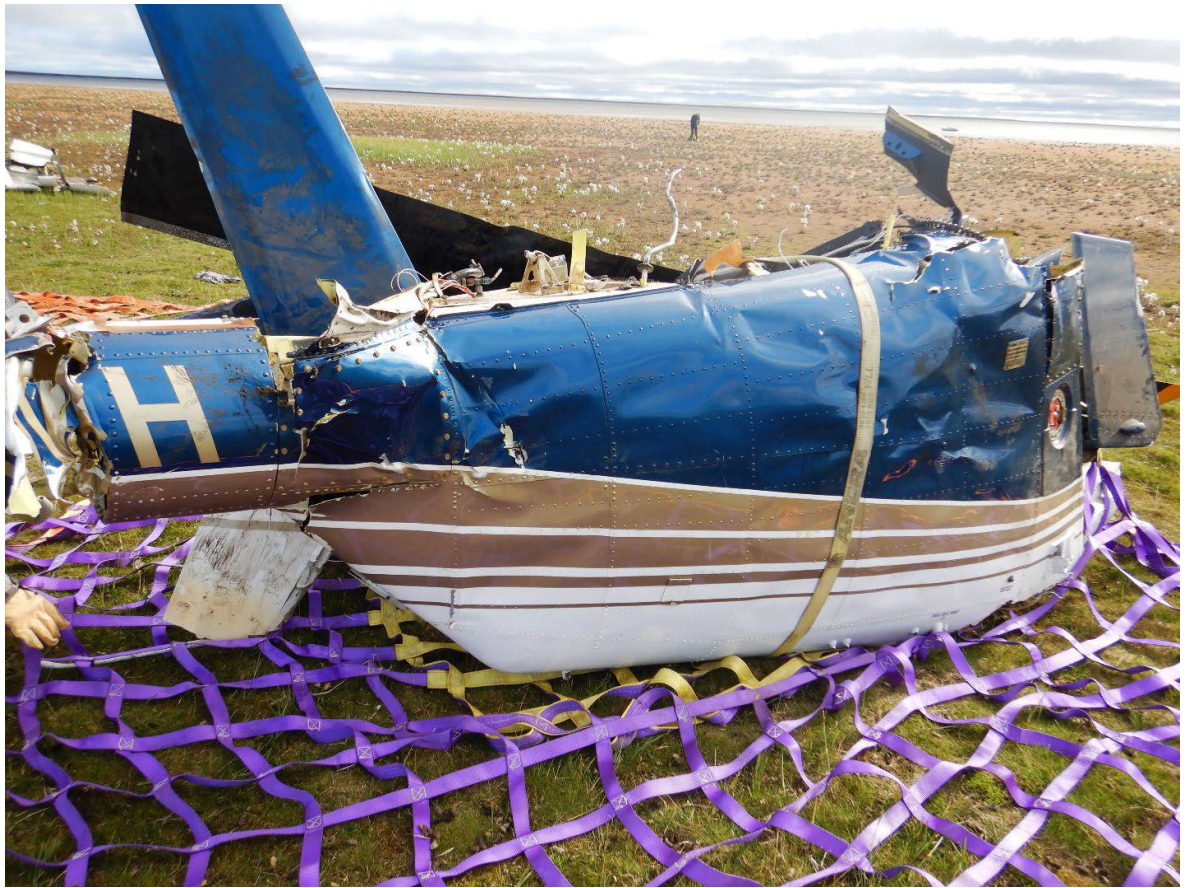
**Figure 10 Right side view of accident helicopter fuselage.**

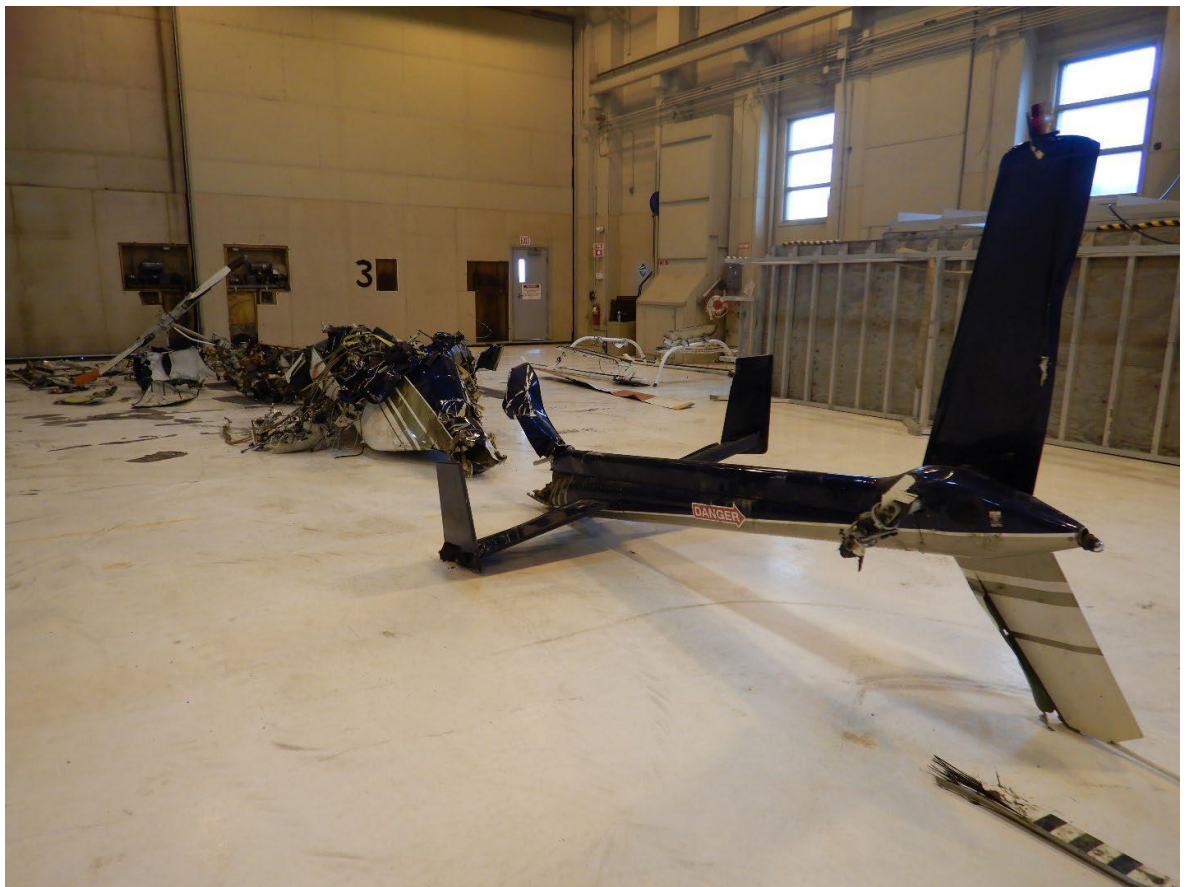
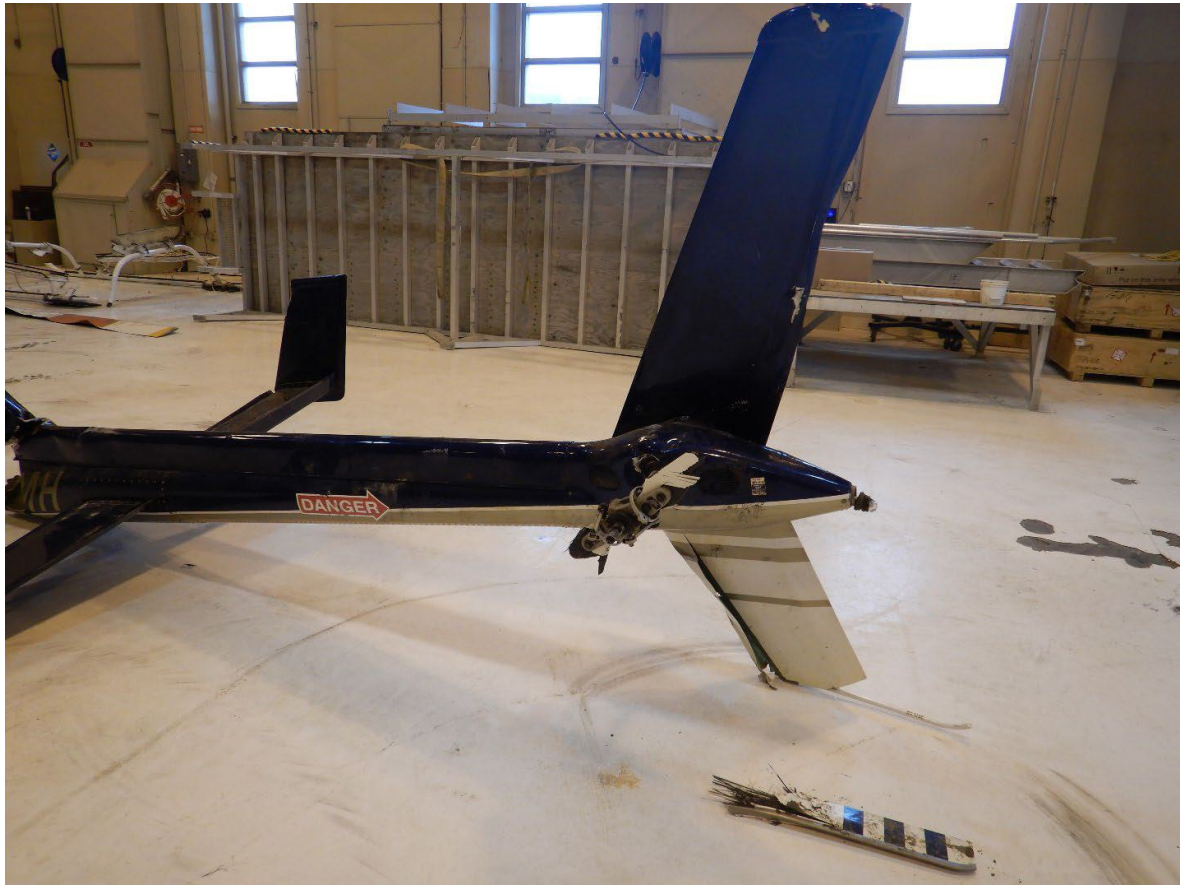
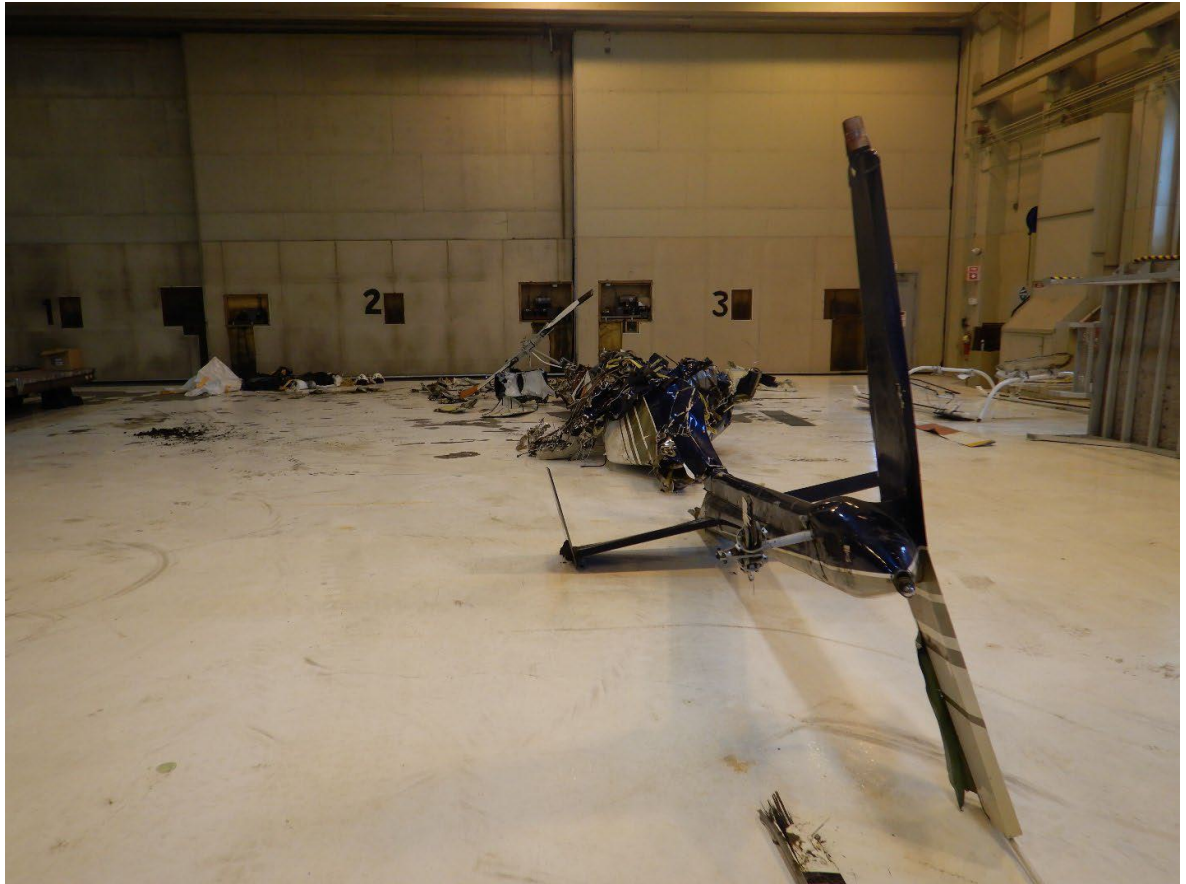
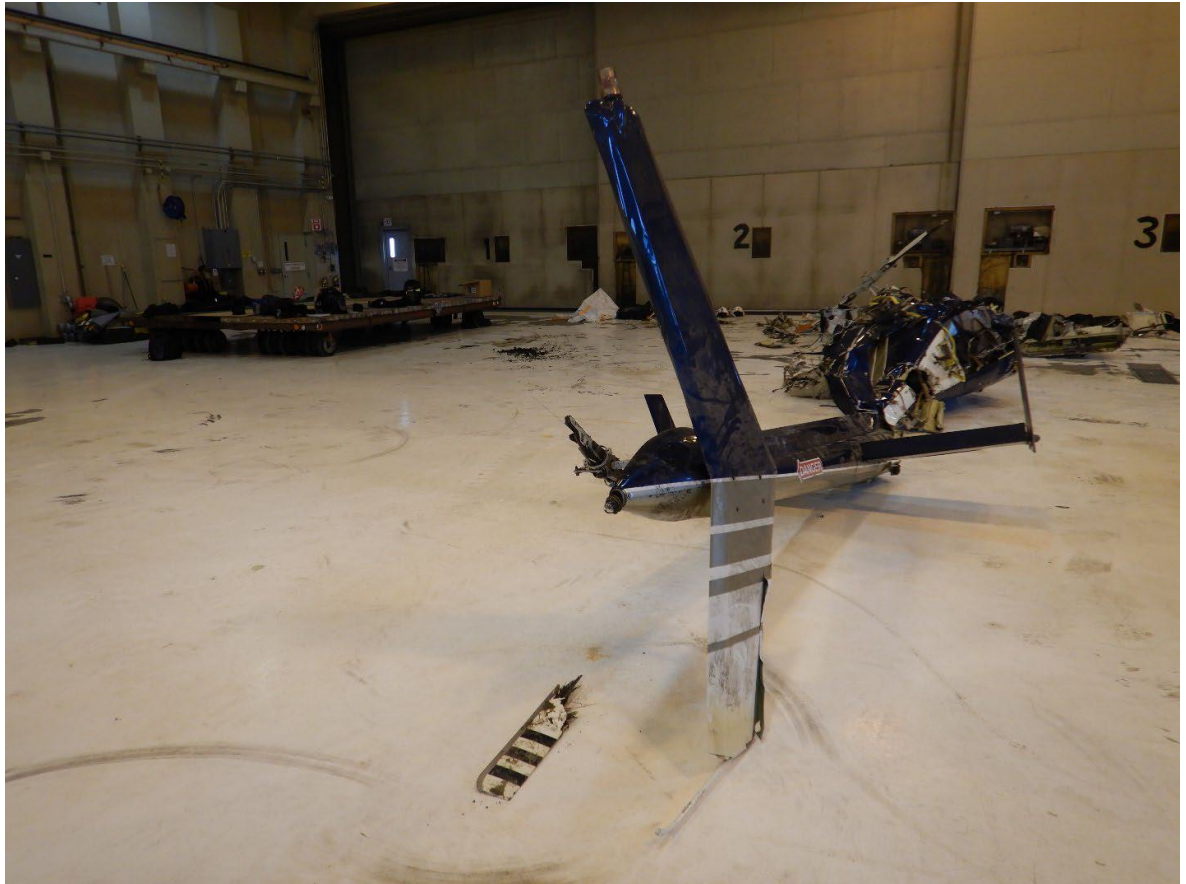
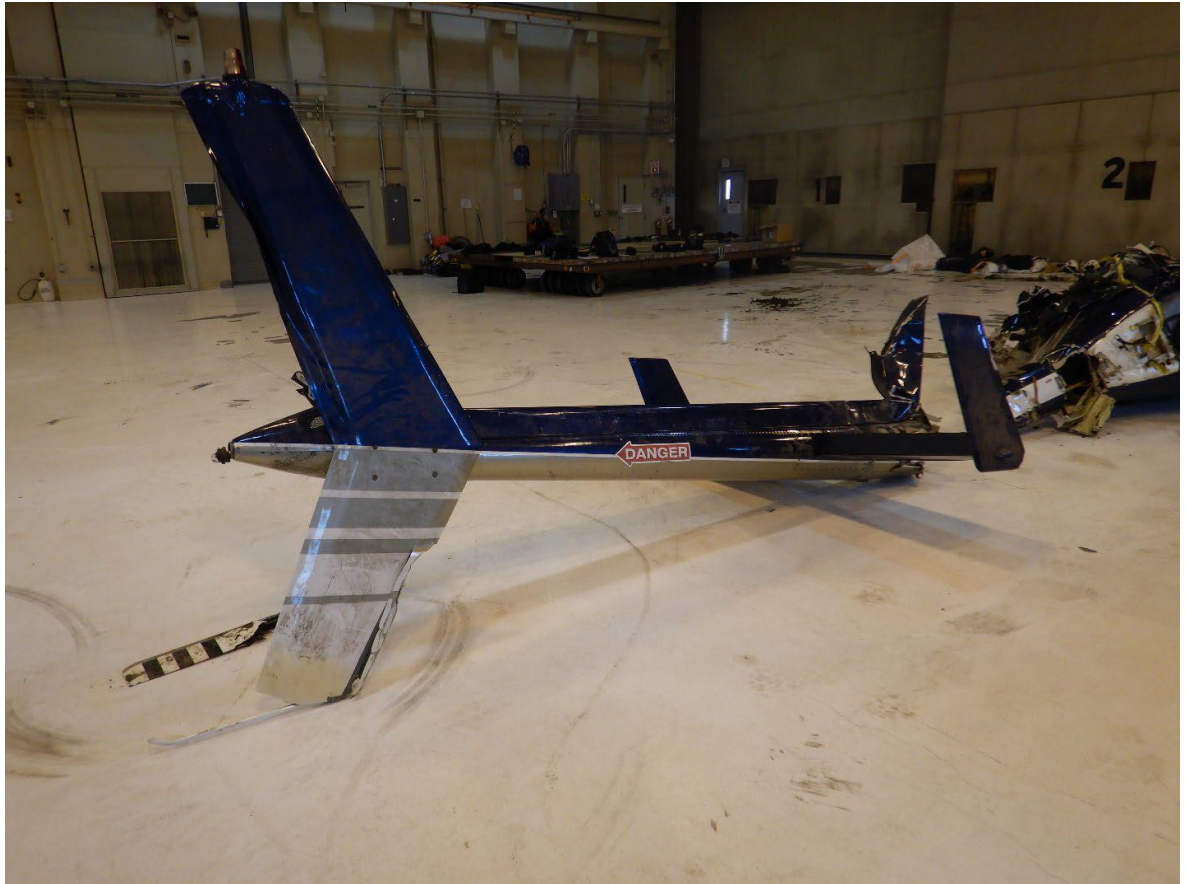
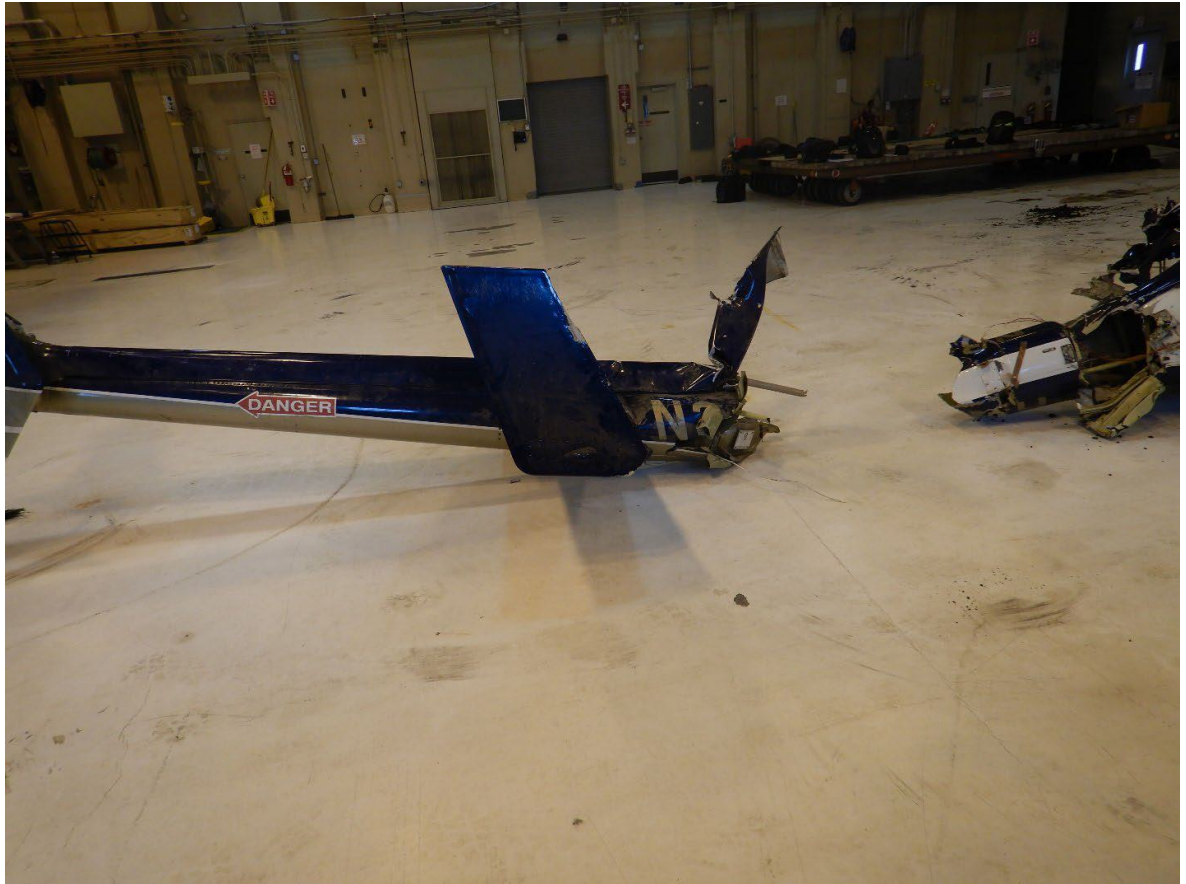
No pre-impact anomalies were observed in the tail rotor, elevator flight controls or tail rotor driveshaft system and all observed fractures were consistent with overload impact forces. Except for a fractured tail rotor control tube found impaled into the floor of the forward cockpit area, all control tubes, bellcranks, and pedals were missing from the cockpit to the aft fuselage area above the cabin forward facing seats. The forward fractured long tail rotor control tube was manipulated by hand and free tail rotor blade pitch change movement was observed. The steel forward shaft under the engine remained connected to the system through the Thomas

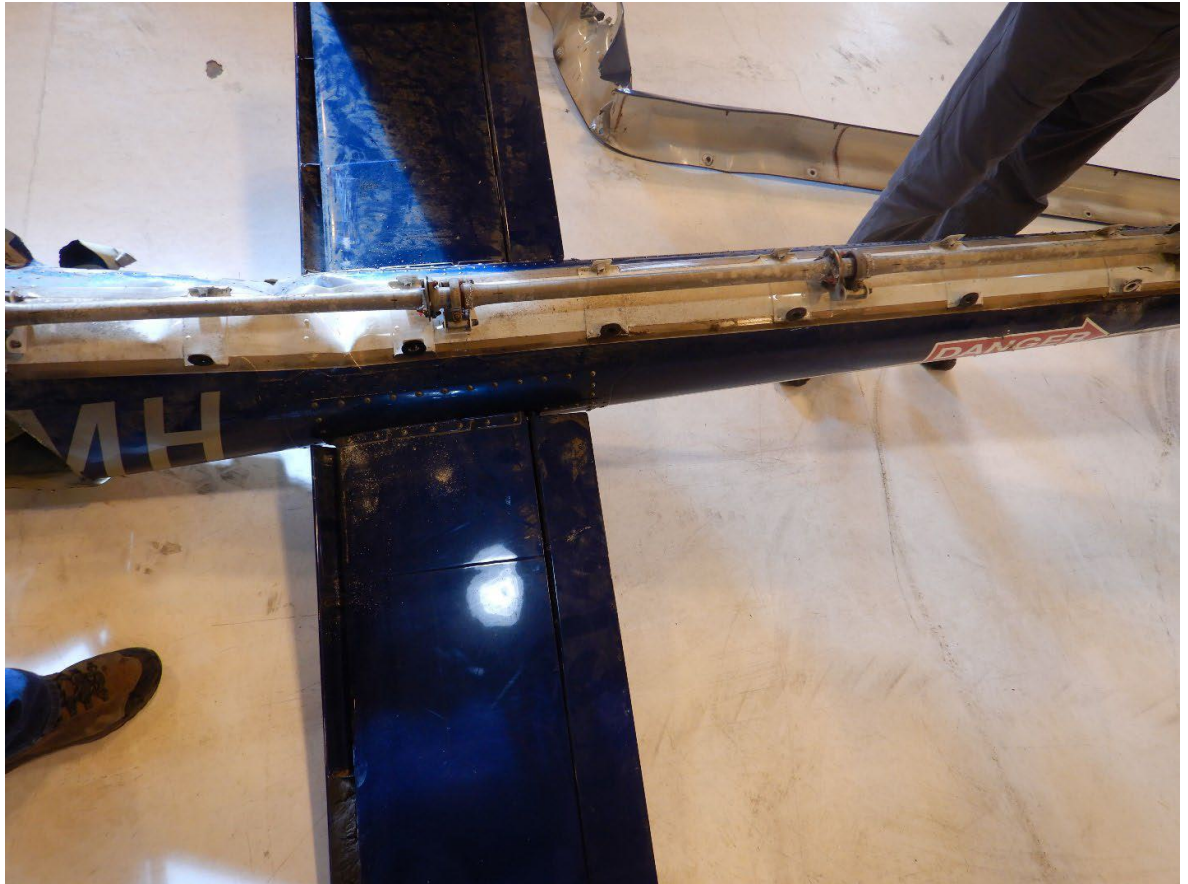
coupling (flexible steel plates) and rotated freely by hand through the freewheeling unit. The aft splined end of the steel shaft was disconnected from the oil cooler shaft splines consistent with airframe fracturing at impact. Both oil cooler shaft bearings rotated freely, the oil cooler cage was distorted from impact forces and both sets of male splines at the forward and aft end of the oil cooler were intact. The first tail rotor driveshaft on the tailboom was fractured from overload impact forces just forward of where the tailboom was fractured. All driveshaft segments on the tailboom rotated freely by hand and corresponding rotation to the tail rotor blades through the tail rotor gearbox was observed. No unusual noises were heard when the tail rotor gearbox was rotating. All Thomas couplings and hanger bearings on the tailboom were intact. Tail rotor gearbox support fractures were observed at both the left forward and left aft locations where the gearbox attaches consistent with overload forces. No chips were observed on the tail rotor gearbox chip detector. Remnants of oil were observed in the gearbox.

**Figure 20 View of tail rotor driveshaft.**

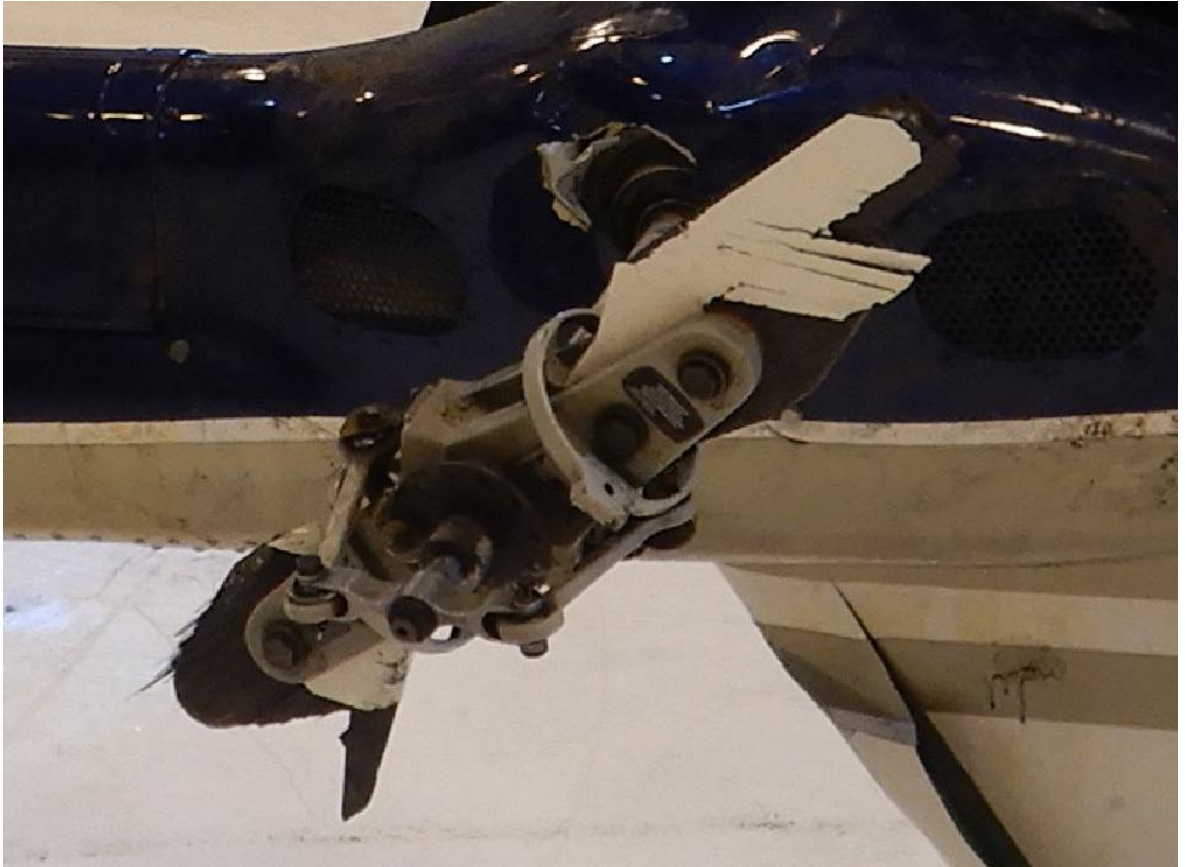
**Figure 21**View of tail rotor.

Both tail rotor blades were fractured chordwise in overload consistent with power applied at impact. One tail rotor blade fractured at approximately 6" from its base. The other blade was fractured near its base was not recovered.

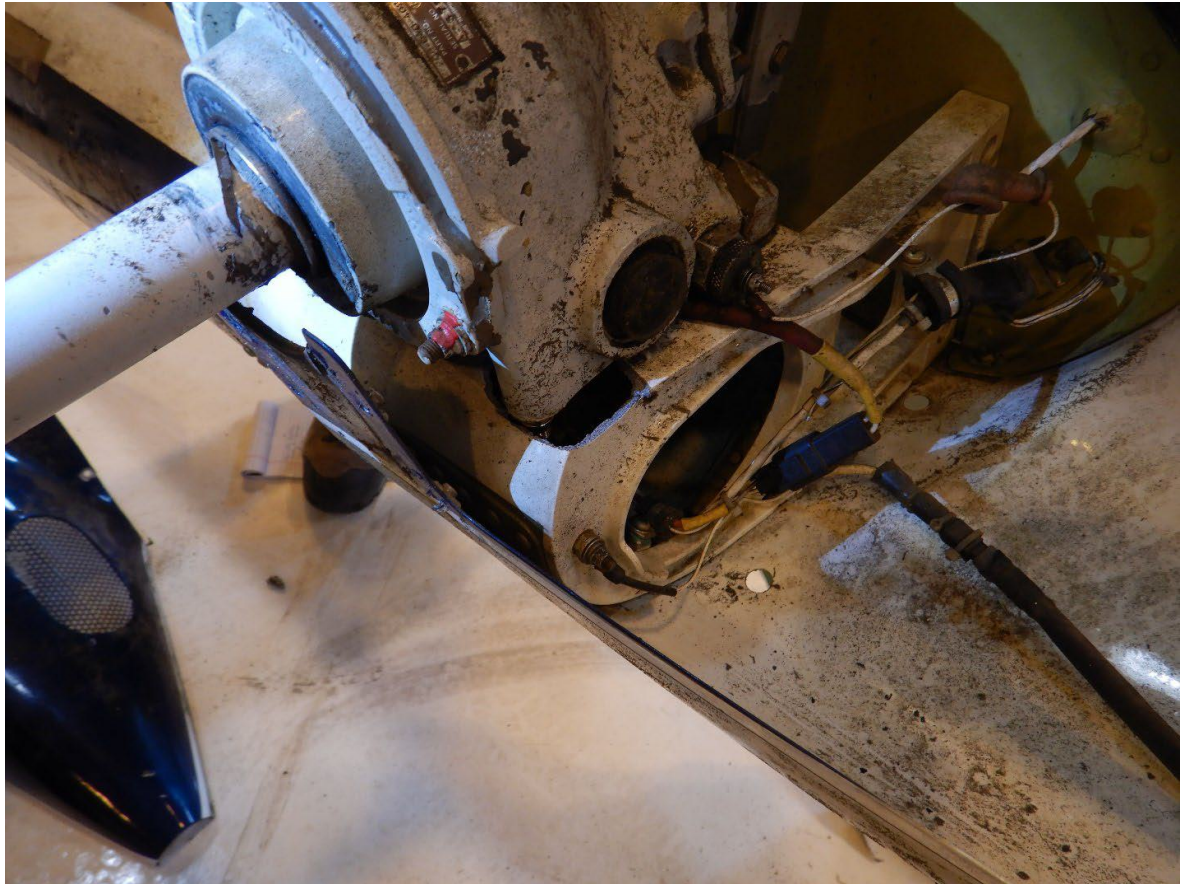
**Figure 24 View of impact fractures on the tail rotor gear box.**

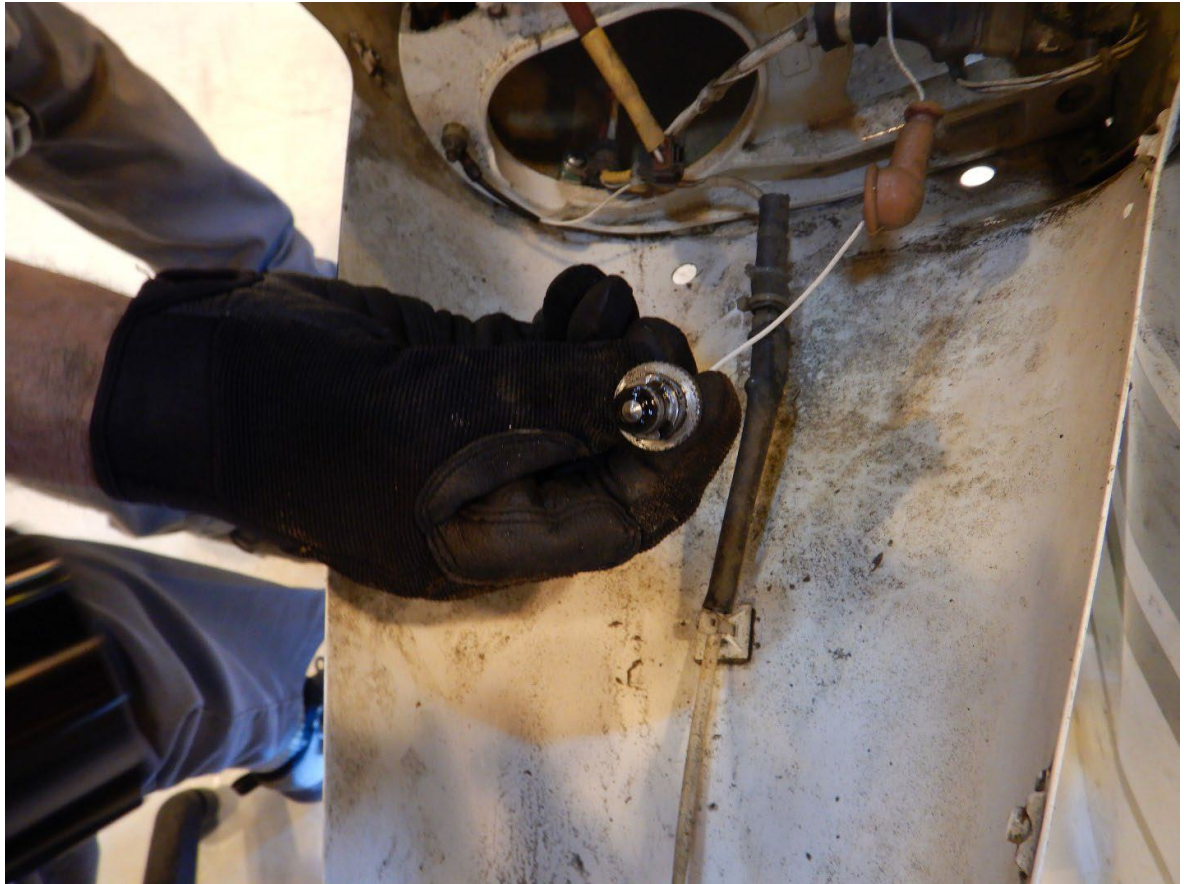
**Figure 25 View of tail rotor chip detector.**

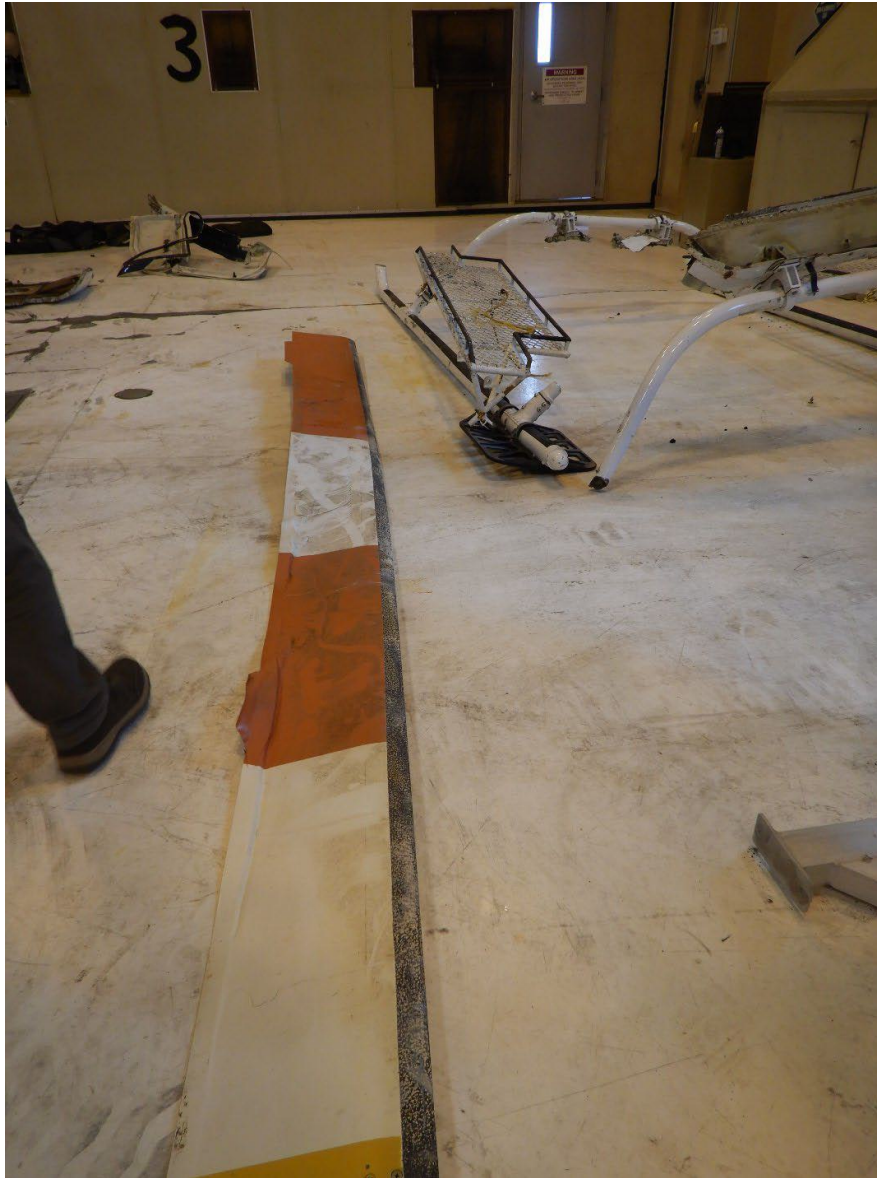
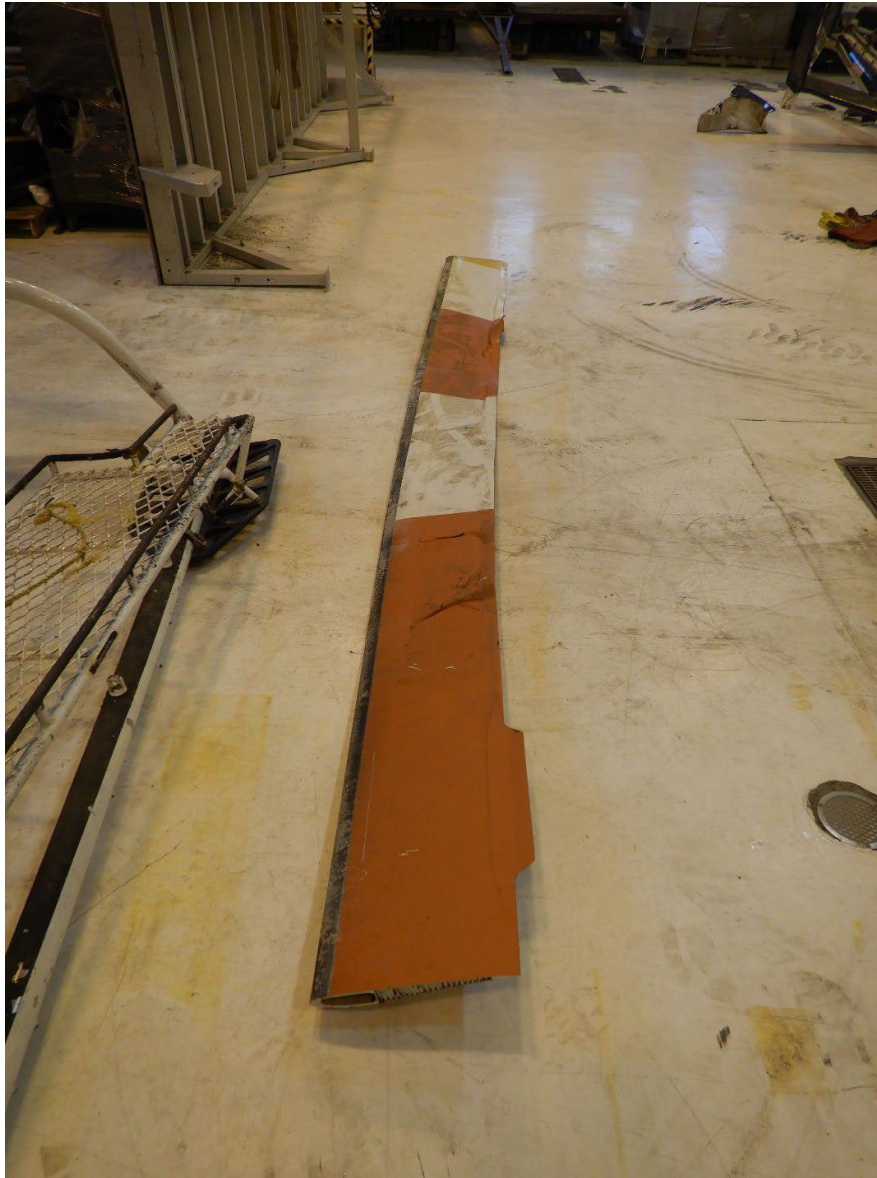
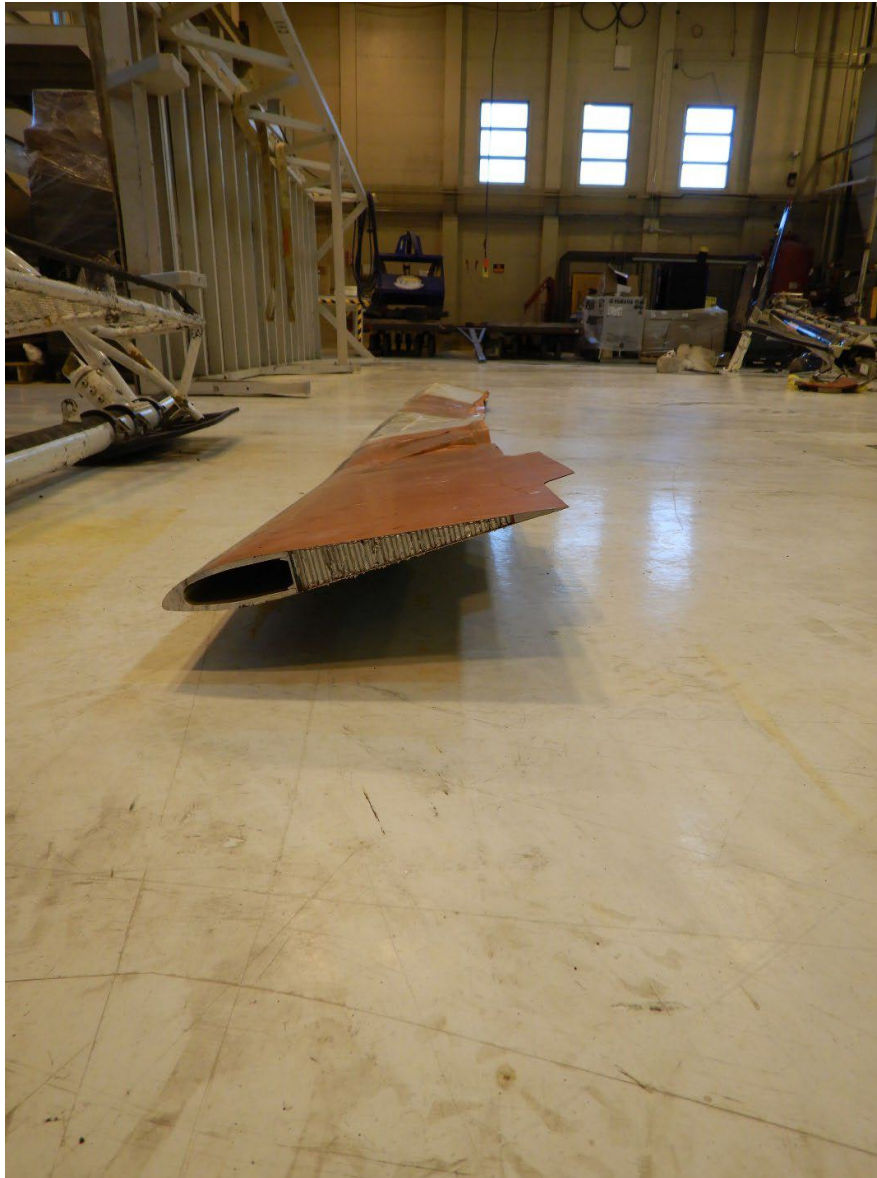
No pre-impact anomalies were observed in the main rotor hub and blades. Both blades remained connected to the hub at the blade grips. The blade grips and pitch horns all remained intact and attached. One blade was fractured at the outboard doublers consistent with impact forces as the first blade made contact with the water surface, under power. Outboard sections of this blade were not recovered. The other blade was cut during recovery approximately  $\frac{1}{4}$  of the way from the blade grip. This blade was relatively intact from root to tip with a slight bend opposite direction of rotation from impact forces while rotating.

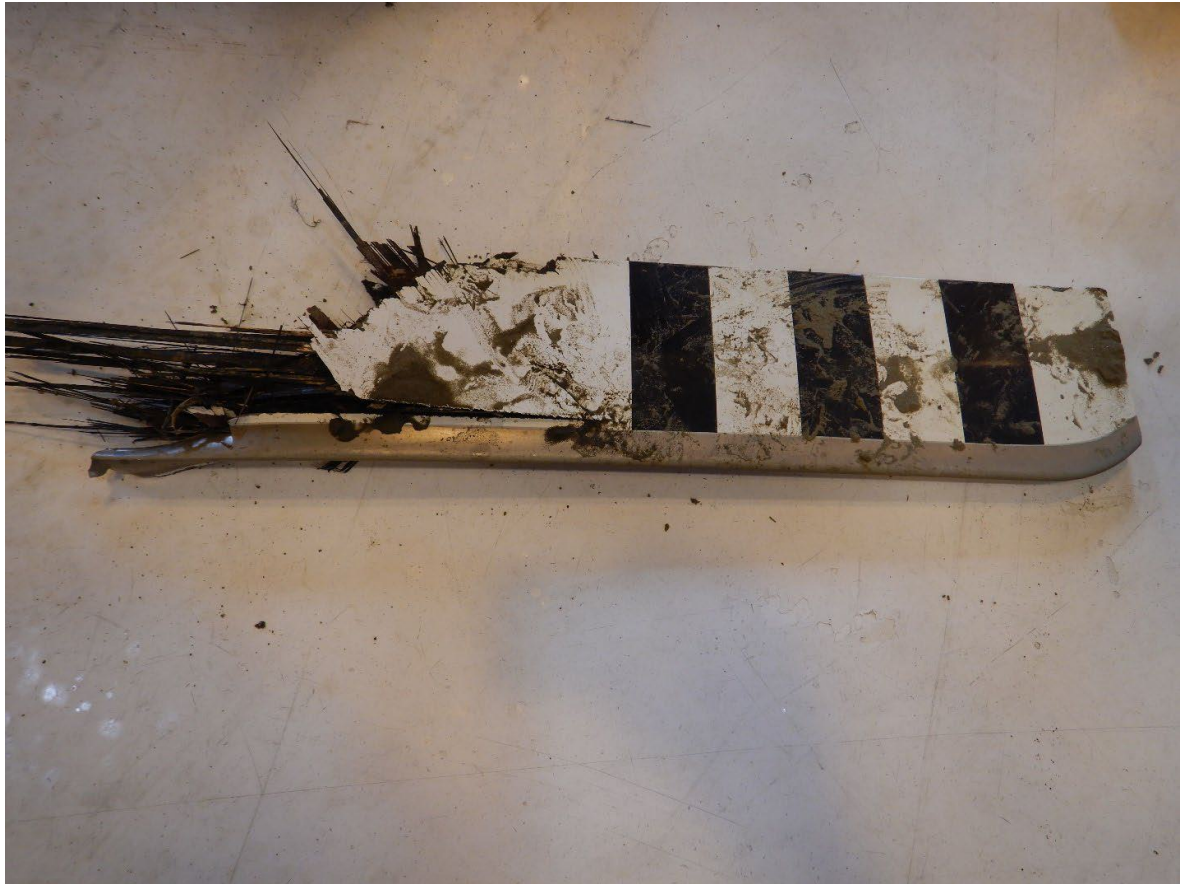
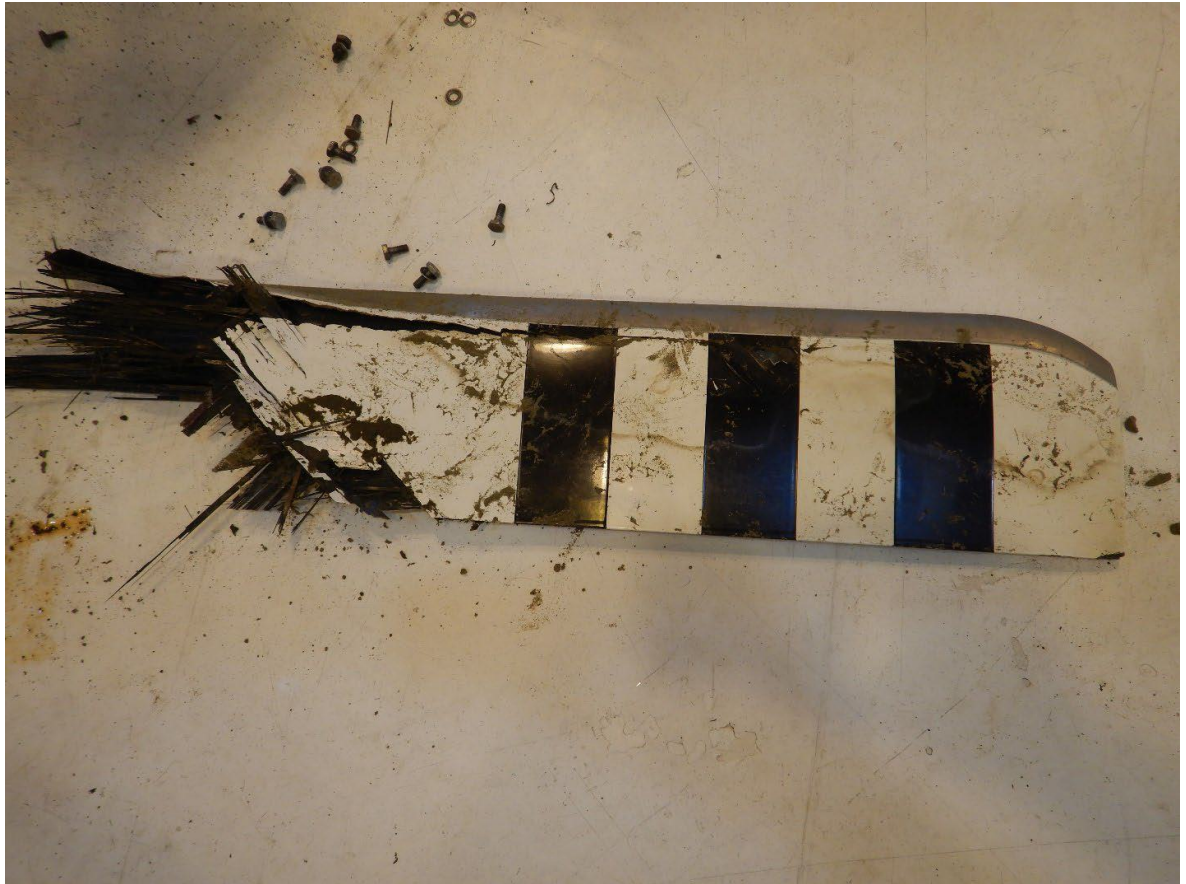
**Figure 29 View of side A of the recovered tail rotor blade.**

**Figure 30 View of side B of the recovered tail rotor blade.**

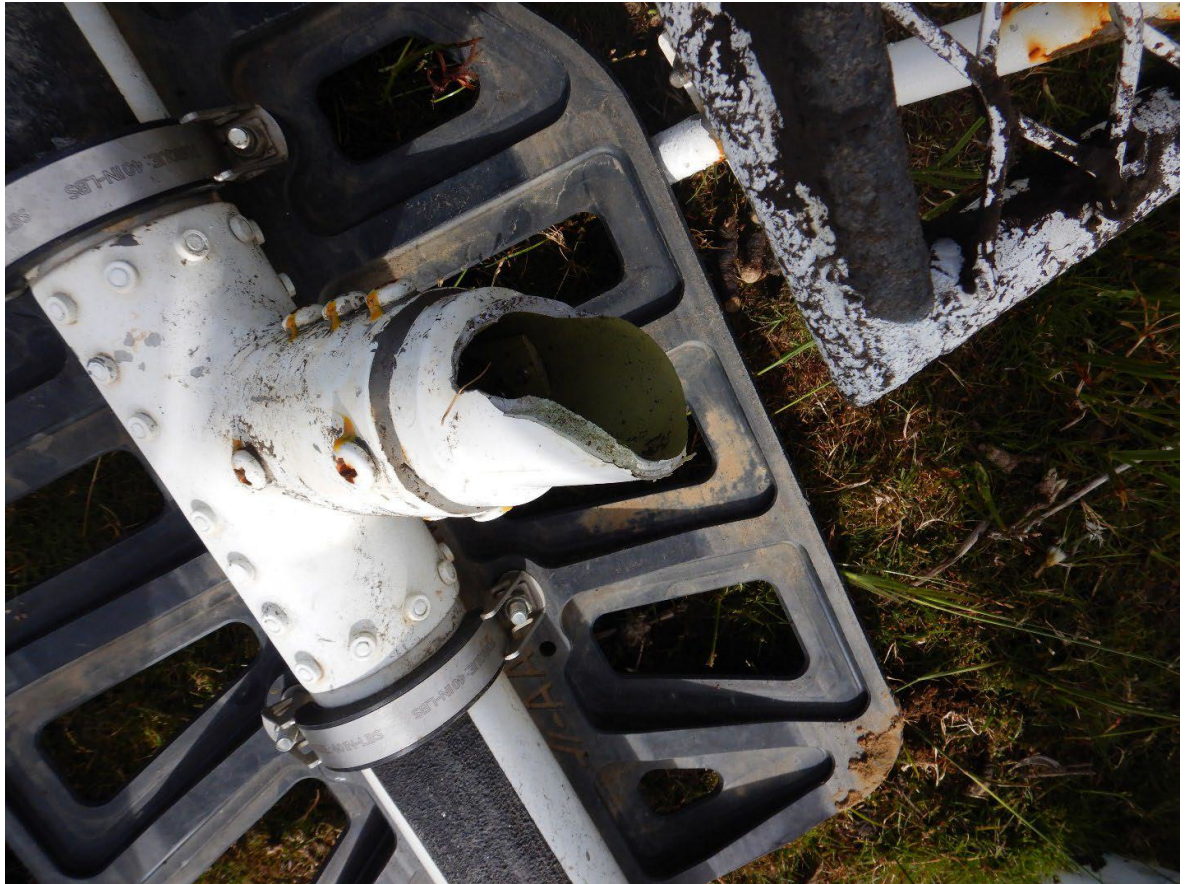
No pre-impact anomalies were found in the landing gear and all fractures were consistent with overload fractures. The landing gear was found close to the main wreckage in the lake.

**Figure 39 View of the fracture between the left landing gear skid and the rear crossover tube.**
