# National Transportation Safety Board

ANC23FA056

## **Wreckage Examination**

Helicopter: N311MH Bell 206-L4

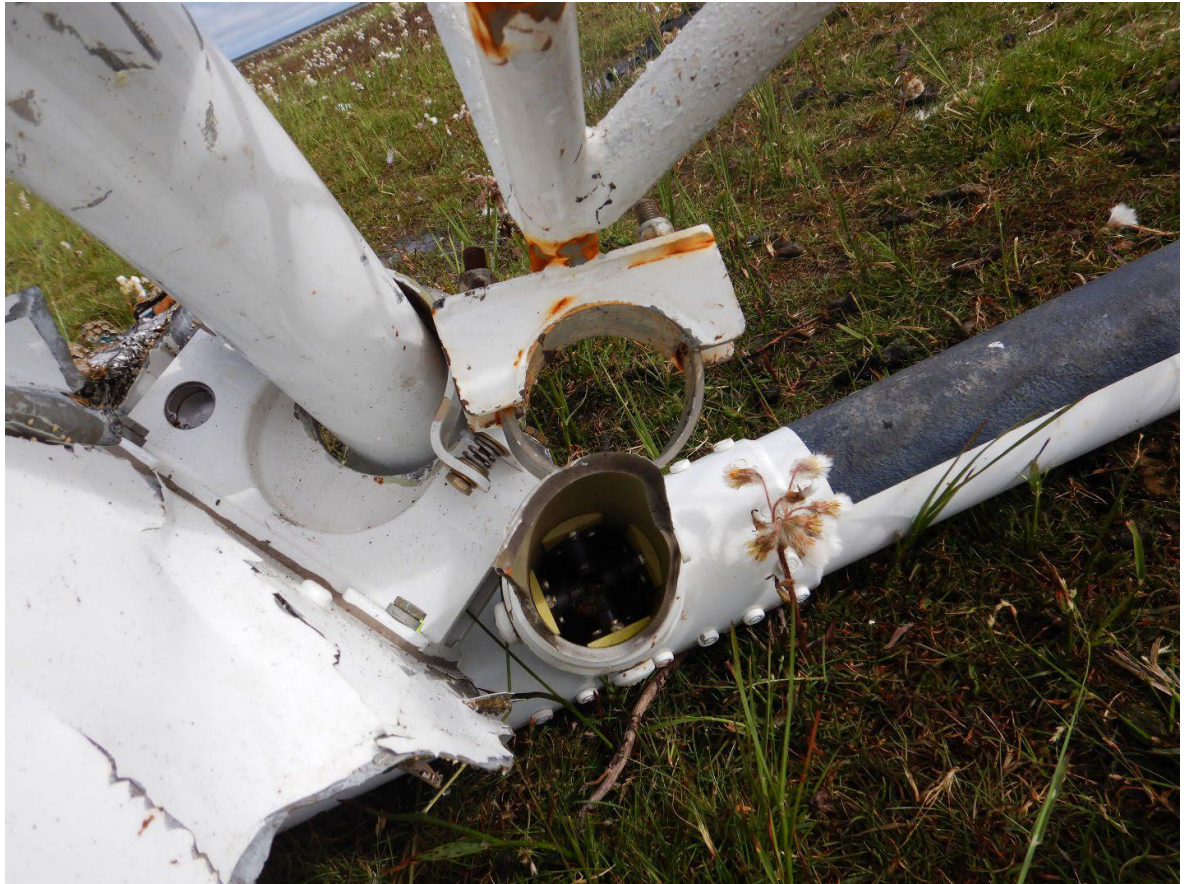
No pre-impact anomalies were found in the landing gear and all fractures were consistent with overload fractures. The landing gear was found close to the main wreckage in the lake.

**Figure 40 View of the fracture between the right landing gear skid and the front crossover tube.**

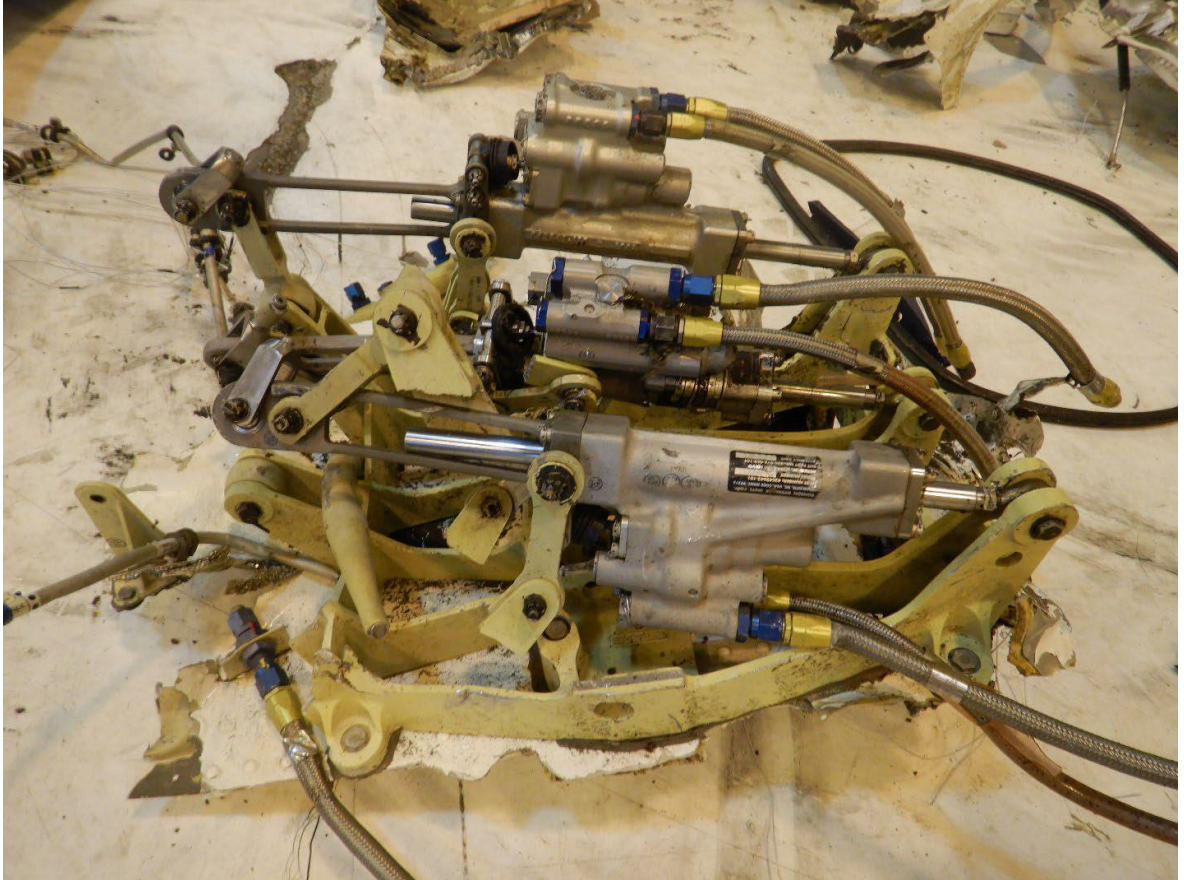
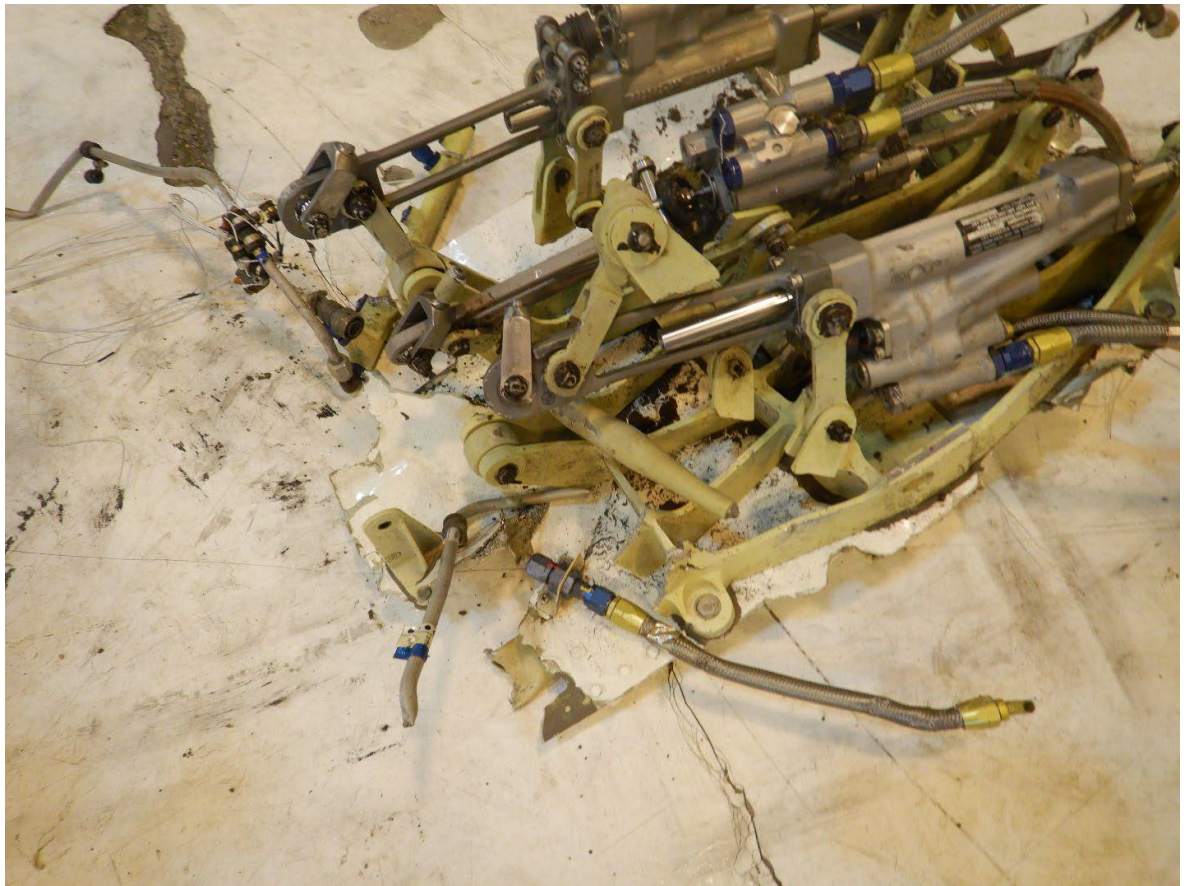
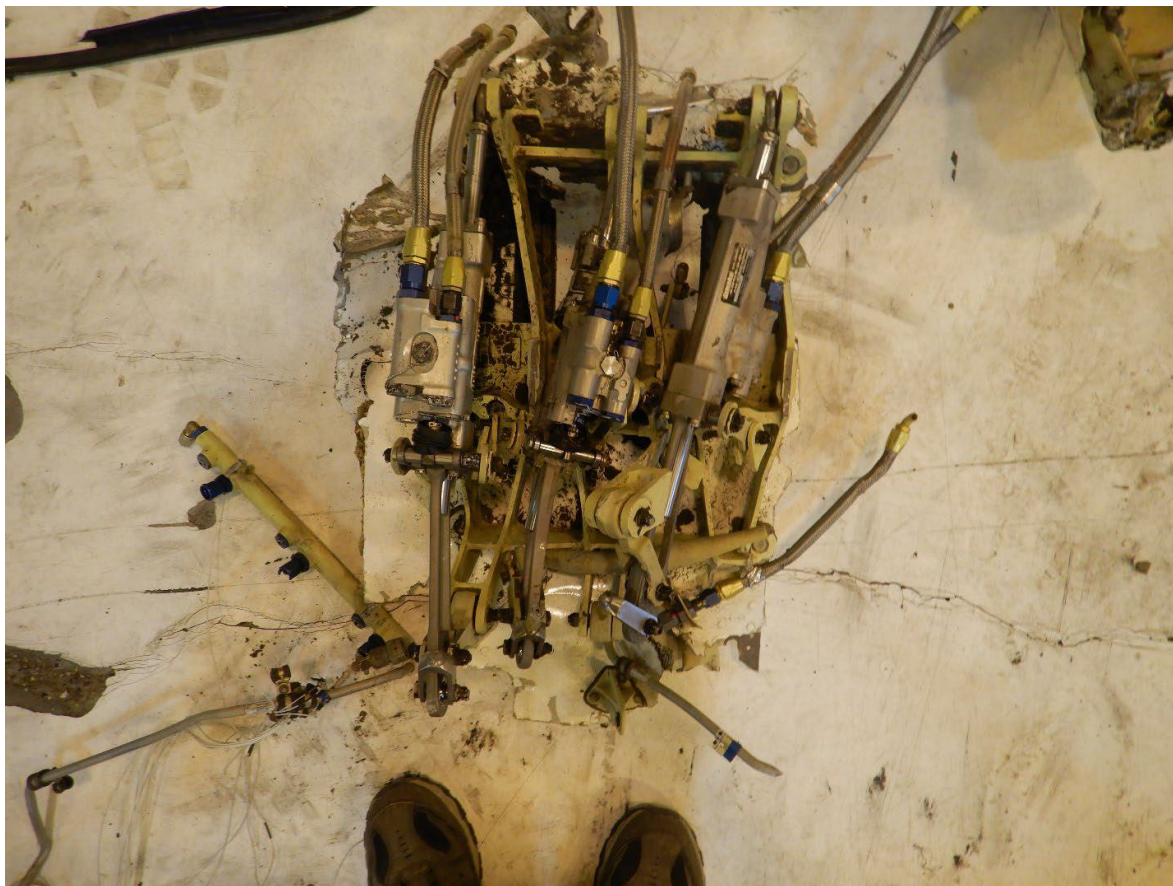
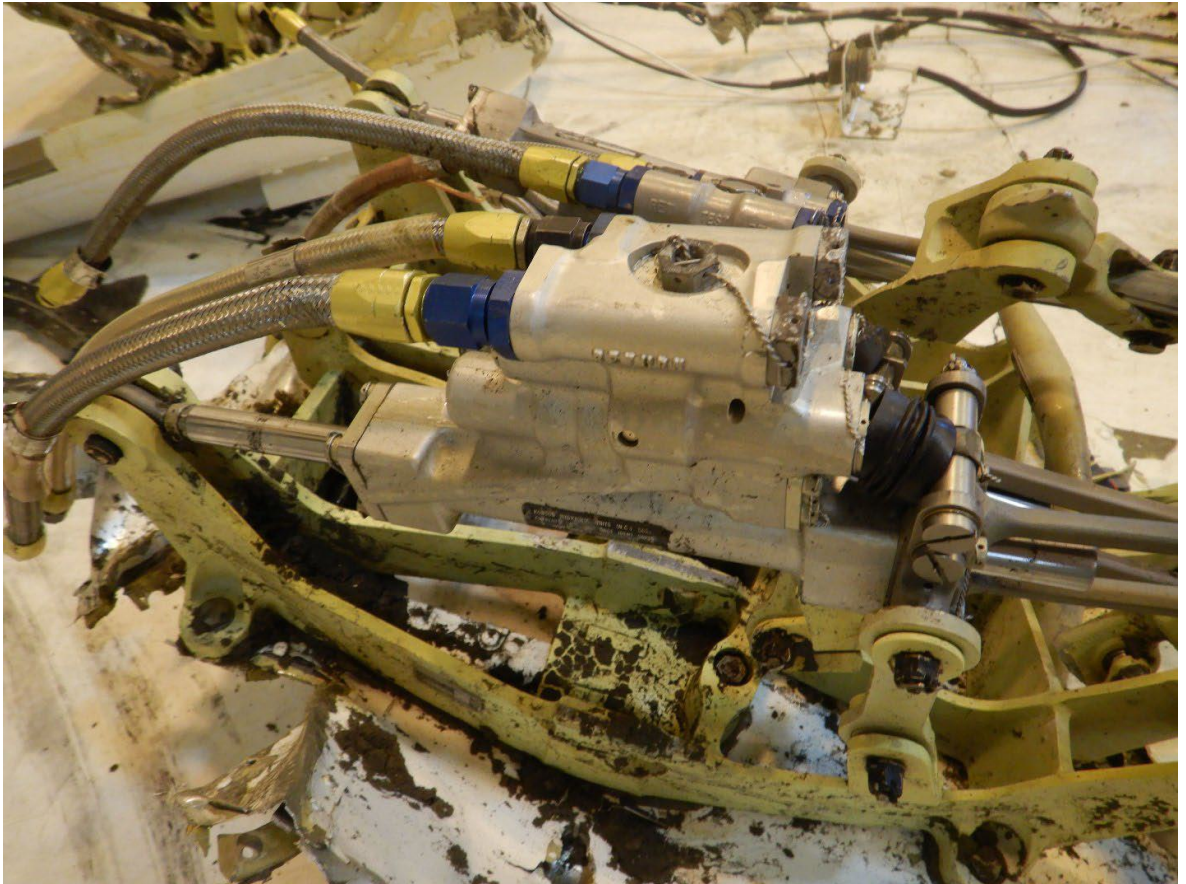
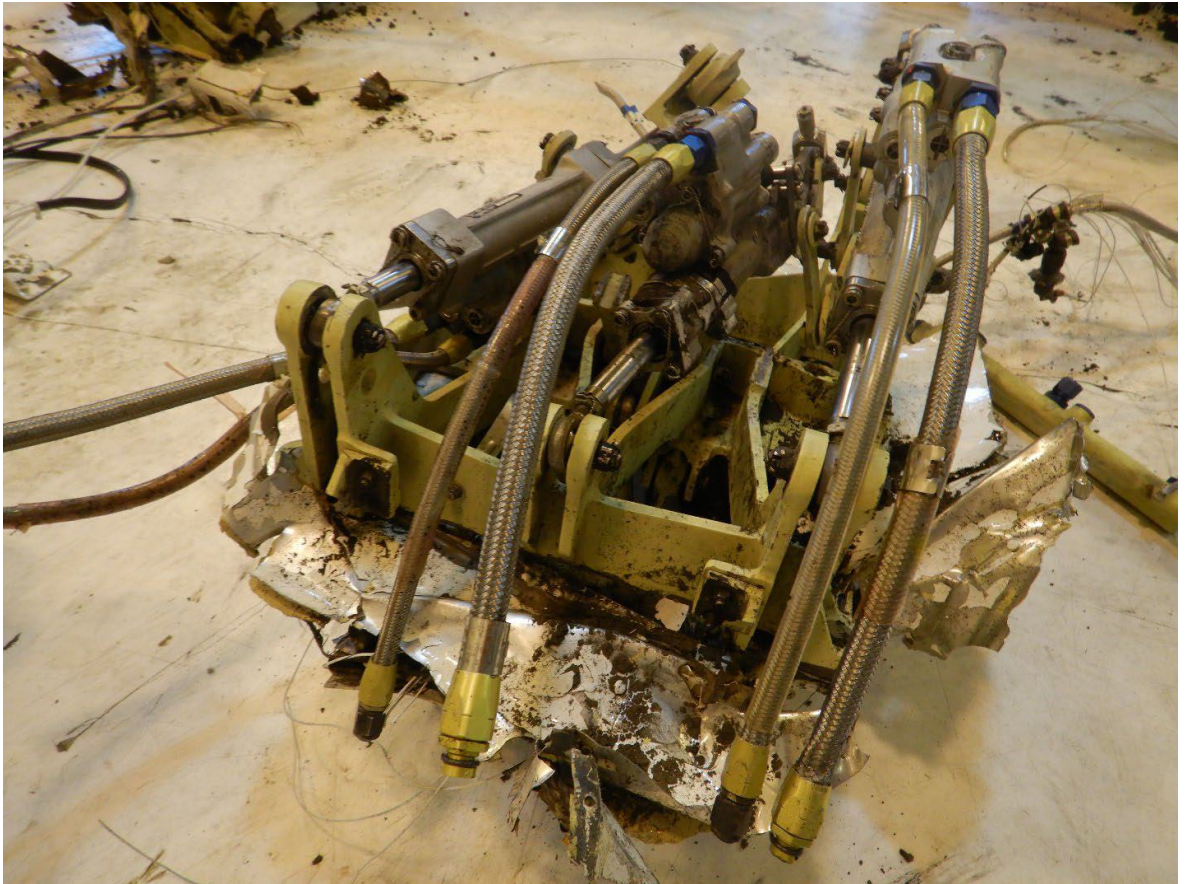
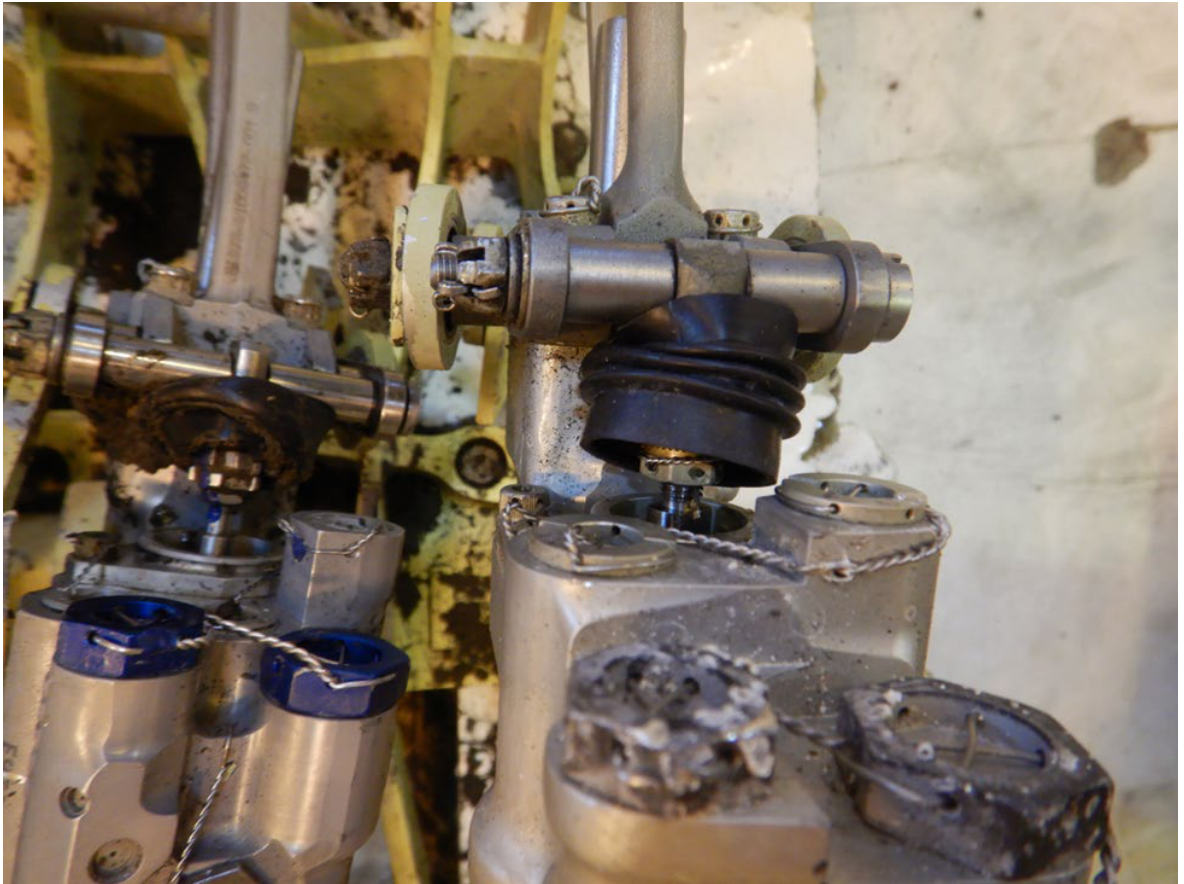
No pre-impact anomalies were observed in the main rotor flight controls and hydraulics and all observed fractures were consistent with overload forces at impact. Most of the main rotor flight controls were missing and not recovered and all fractures were consistent with overload at impact. The forward and mid-fuselage were highly fragmented and several parts of the fuselage, including the vertical tunnel (broom closet), where the controls transit, were not recovered. The collective stick, cyclic stick, and anti-torque tail rotor pedals were not recovered. The cyclic stick was fractured at its base consistent with overload forces. The three main rotor servos were found impact damaged but relatively intact. All three servo bodies were able to be moved by hand through their respective servo pistons. The servo support remained attached to fractured roof structure. The servo manifold exhibited several fractured lines consistent with overload fractures. The connection from the servo input valve lever arms to their respective wiredrive assemblies were all intact with no evidence of joint looseness observed. The outer ring rotating swashplate rotated freely by hand. The swashplate support was fractured near its base as result of the mast bending just above the transmission top case from impact forces. One main

rotor pitch change link (PCL) was fractured consistent with overload forces in the middle of the link and at the bottom of the link near the bottom clevis insert. This PCL was associated with the main rotor blade that fractured from water impact forces. The other PCL was bent but not fractured.

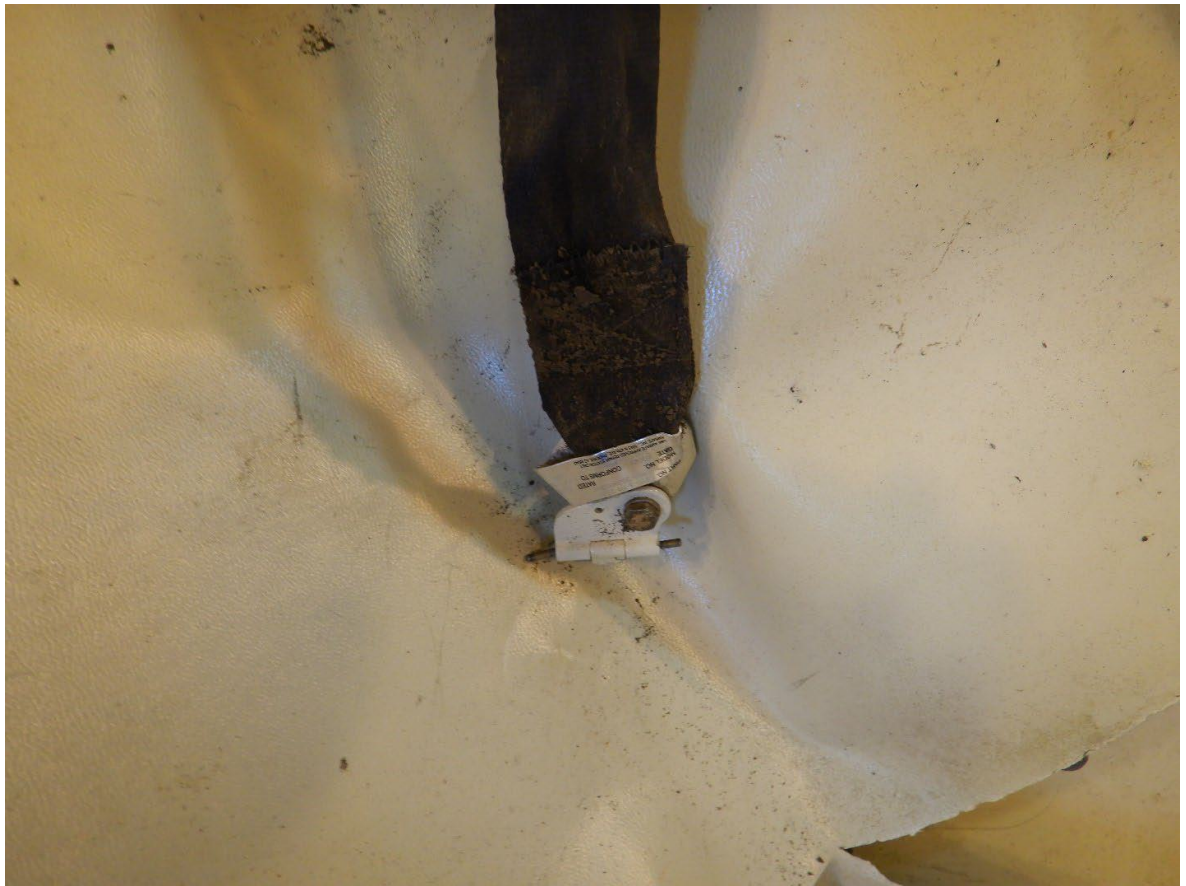
**Figure 48 Broken seat belt attachment.**

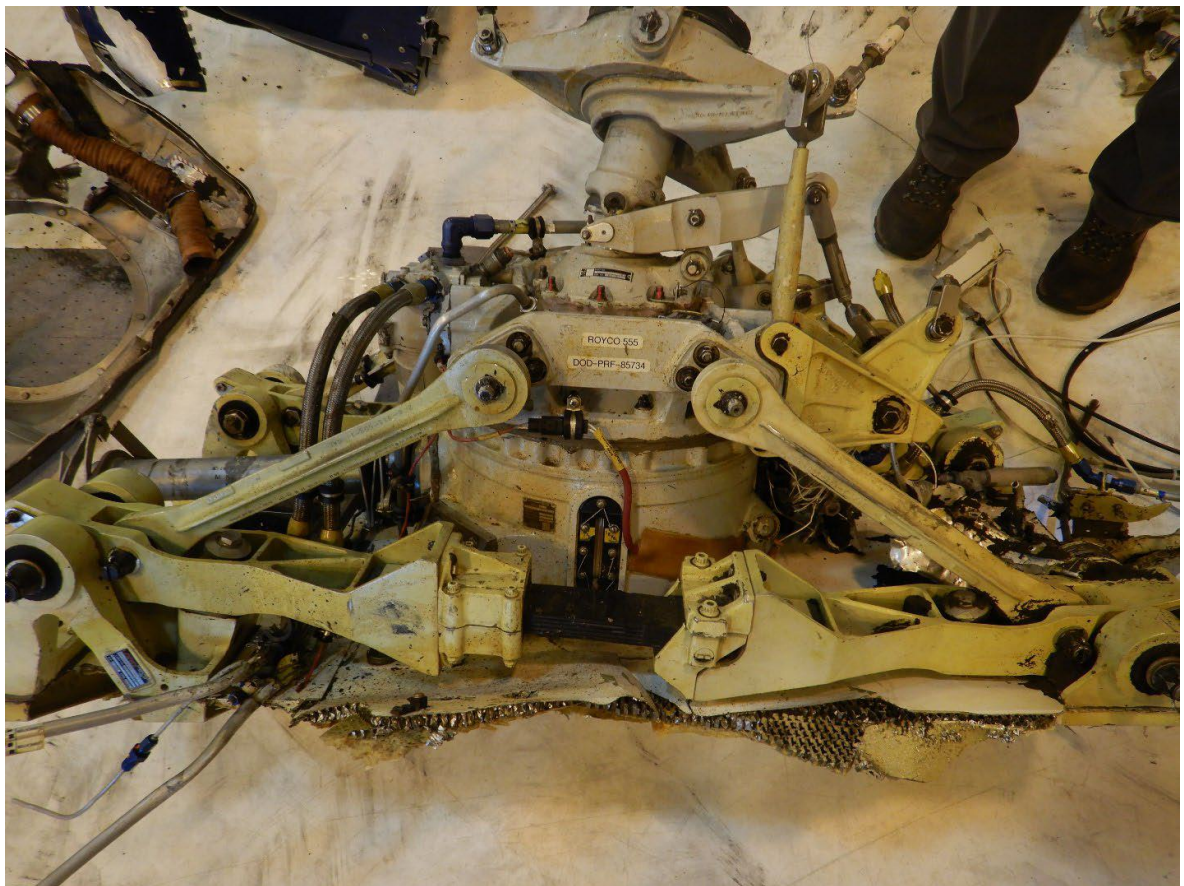
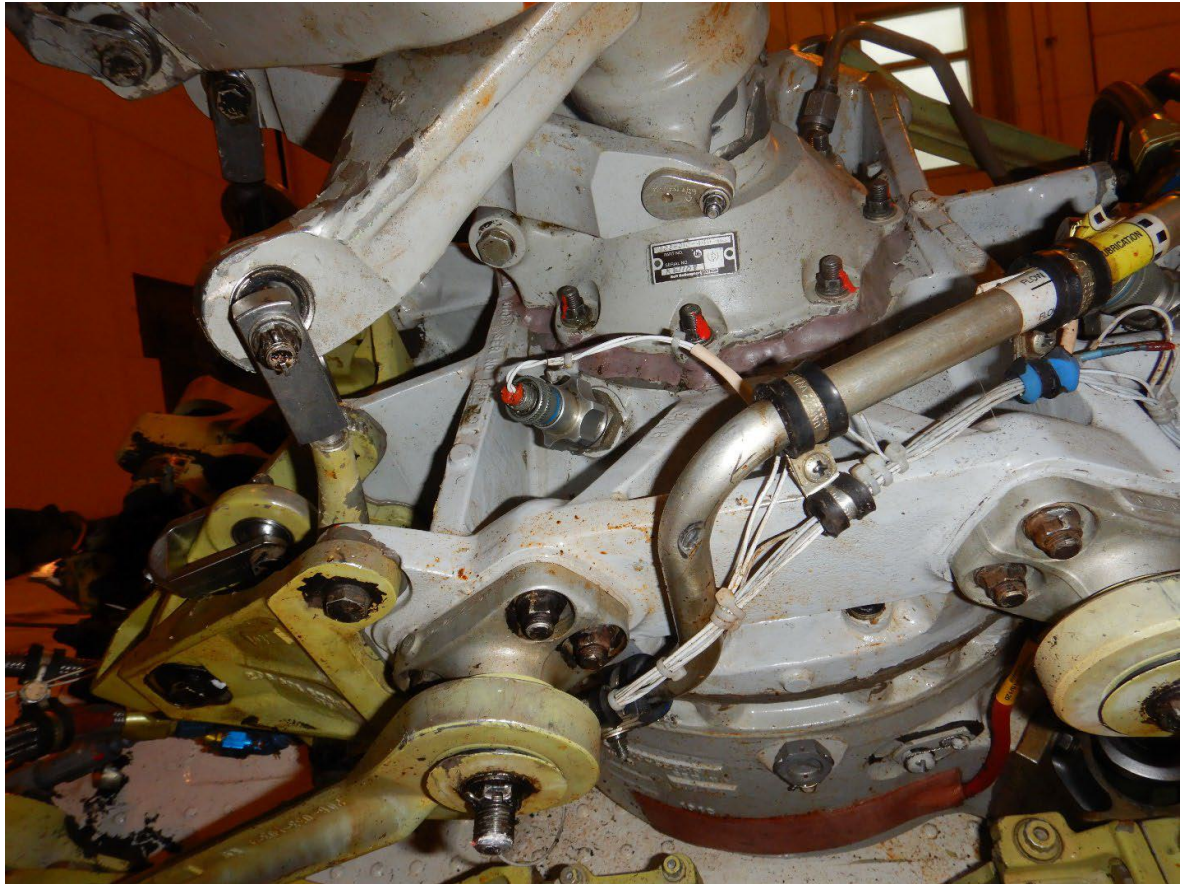
No pre-impact anomalies were observed in the main drive system and all fractures were consistent with overload forces. The main transmission remained mounted through all four intact pylon support links to the nodal beam supports. The roof structure was fractured surrounding the nodal beam supports from impact forces. Both chip detectors were removed for inspection and found to be clean with no debris. The main rotor blades were turned by hand and free movement with no unusual noises was observed at the KaFlex driveshaft, demonstrating main transmission drive continuity. The KaFlex main driveshaft remained connected at its forward end to the main transmission. Minimal rotational scoring was observed on the aft engine end exterior of the KaFlex shaft. The mast had contact marks from hard main rotor hub static stop contact and the mast was bent at this location. The freewheeling unit (FWU) exhibited a fractured outer race shaft assembly ("stub" shaft) that drives the FWU consistent with a sudden stoppage of main rotor while the engine was supplying power through its gearbox.

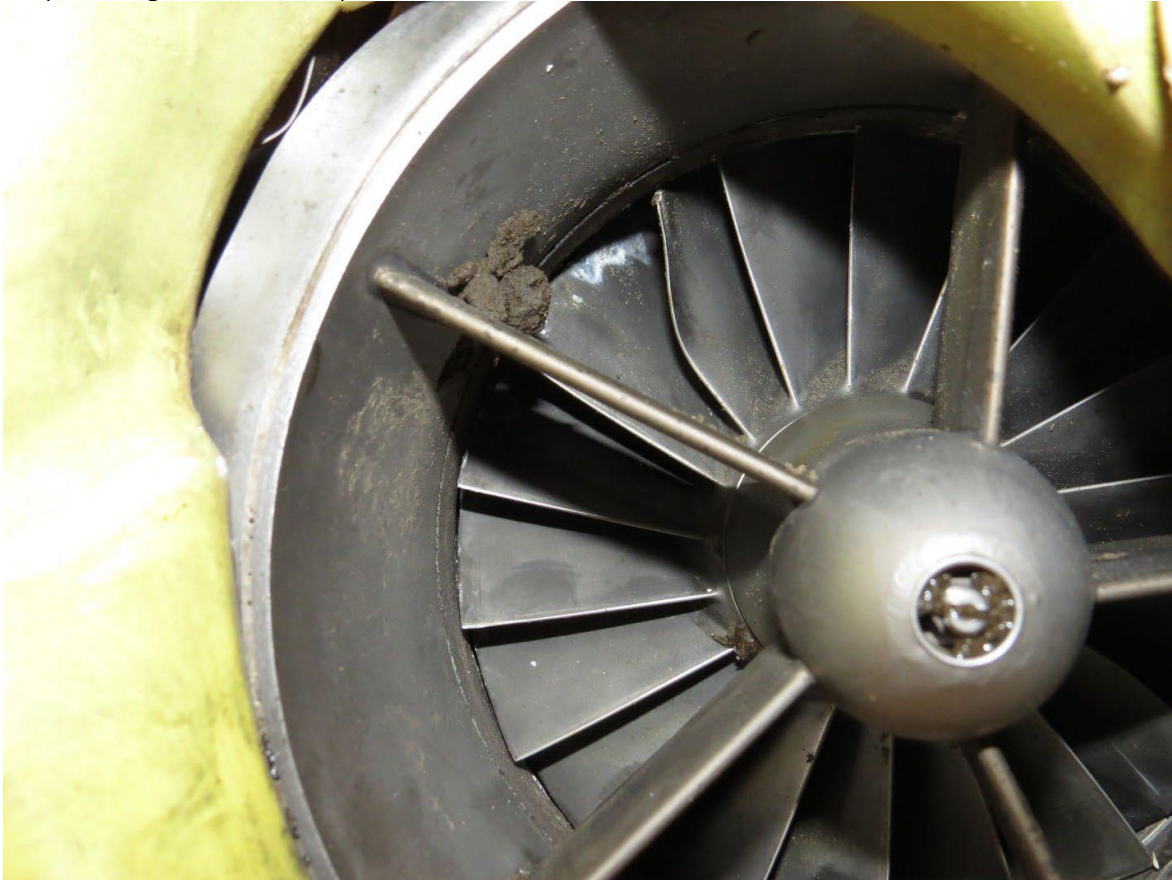
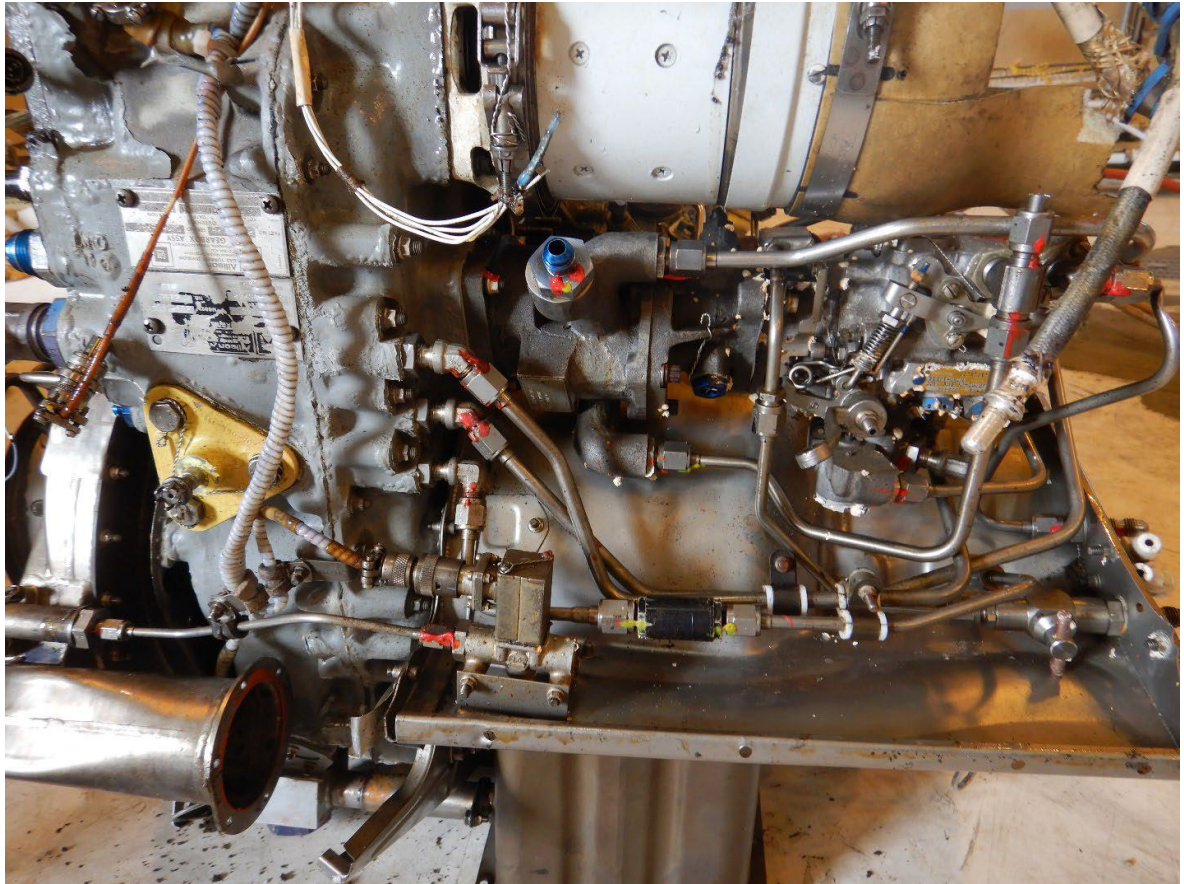
There was no visible evidence of pre-impact fire, damage, or malfunction of the engine. Both N1 and N2 rotors were continuous, could be rotated by hand, & were smooth and quiet. The output shaft assembly, which is part of the freewheel installation, was fractured forward of its spline connection with the power takeoff gearshaft in the engine gearbox (Figure 62). The compressor impeller contained 2 blades approximately 180° apart that were heavily bent opposite the direction of rotation (Figure 61). Cockpit controls to the Power Turbine Governor (PTG) & Fuel Control Unit (FCU) were not recovered. The FCU pointer indicator was in the 100 (max) position. Both controls were checked to confirm full stop to stop travel of their input drive arms. Clean, clear fuel was detected & drained at the inlet of the fuel spray nozzle. Primary oil lines: supply, scavenge, vent, pressure, & torquemeter hoses were securely connected to the engine gearbox. Oil was present in the supply & scavenge hoses to the aft firewall immediately forward of the airframe oil tank & cooler compartment. Only the lower portion of the oil tank was recovered & the oil cooler assembly was distorted from impact forces. The engine oil filter & magnetic chip

detectors were clean of ferrous metal & related debris. Clean but somewhat darkened oil was observed in the engine pressure filter housing. All available evidence & observations suggests the engine was producing power & responding to throttle inputs.

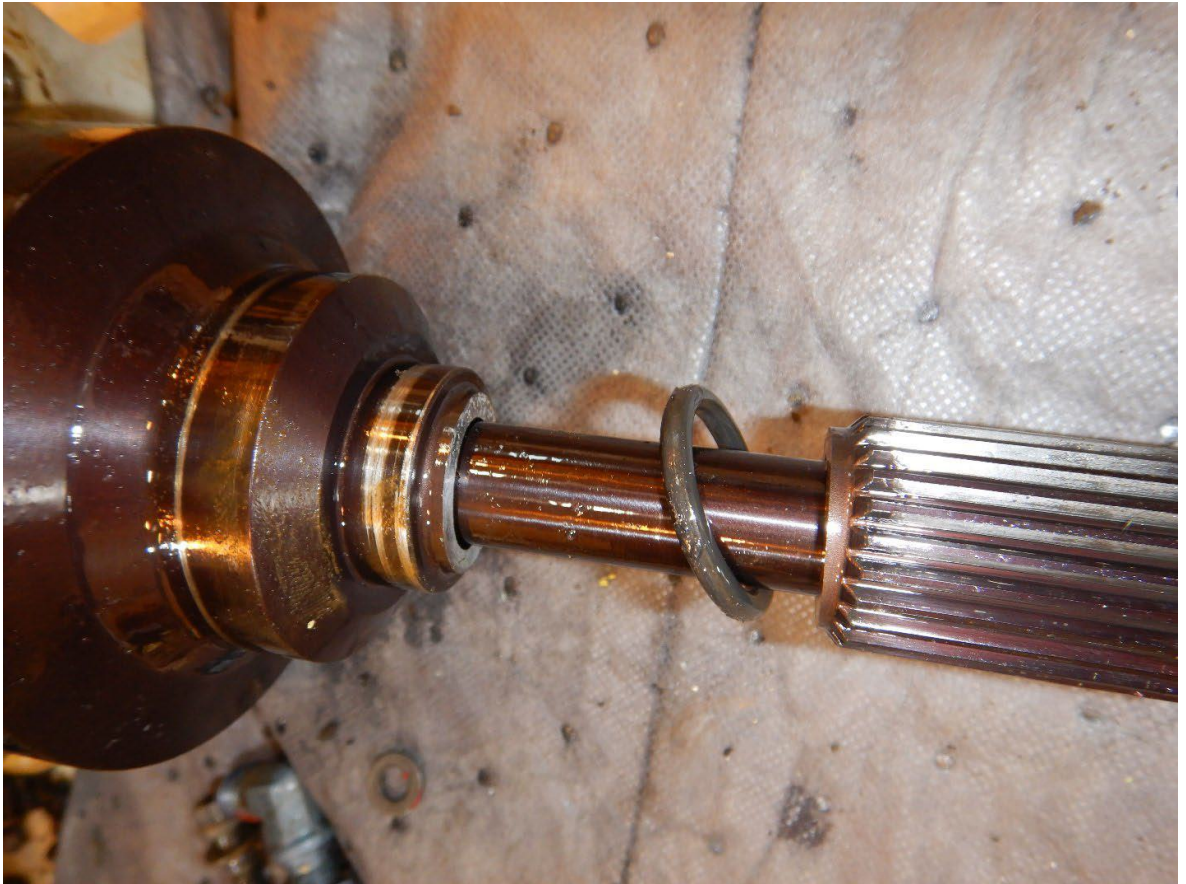
**Figure 62 The output shaft assembly.**
