# National Transportation Safety Board

ANC23FA074

## VIDEO STUDY

October 19, 2023

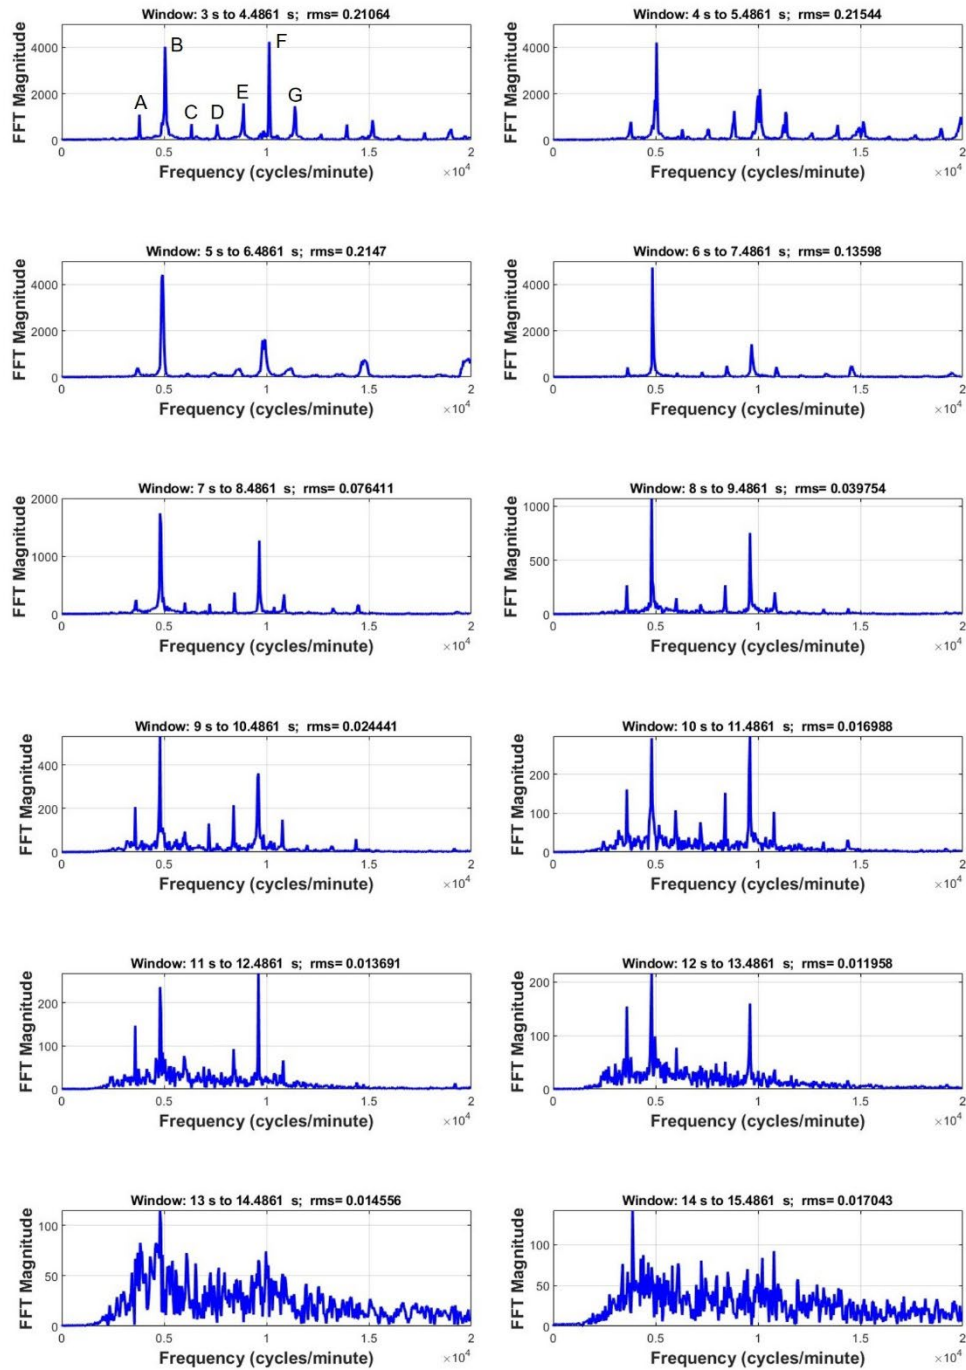
Figure 1 shows the computed sound spectra. Table 1 lists the frequencies of some of the spectral peaks seen in Figure 1. The airplane propeller had two blades so that the propeller blade passage frequency (BPF) of 5046 cpm indicates an engine speed of  $5046/2=2523$  rpm. In a four-stroke engine, each cylinder fires once per two engine revolutions. At an engine speed of 2523 rpm, the cylinder firing frequency and its harmonics are  $N \times 2523/2 = N \times 1261.5$  where N is the number of a harmonic. For example, the 3<sup>rd</sup> harmonic frequency is  $3 \times 1261.5 = 3784.5$  cpm. This frequency agrees well with the frequency listed in Table 1, considering that the frequency resolution of the FFT algorithm was 40 cpm.

Figure 1 shows a slight decrease of the propeller BPF as time advances. It is due to the Doppler effect caused by the increasing speed of the airplane away from the camera as it was taking off. Past time 13 seconds, the characteristics of the sound spectrum change, however the spectra show that the engine speed remained at about 2500 rpm. The spectrum in the window starting at time 13 seconds includes the propeller BPF frequency just under 5000 cpm. The spectrum in the window starting at time 14 seconds includes the peak at 3 × cylinder firing frequency near 3795 cpm.

**Figure 1.** Sound spectra in windows with starting times from 3 through 14 seconds

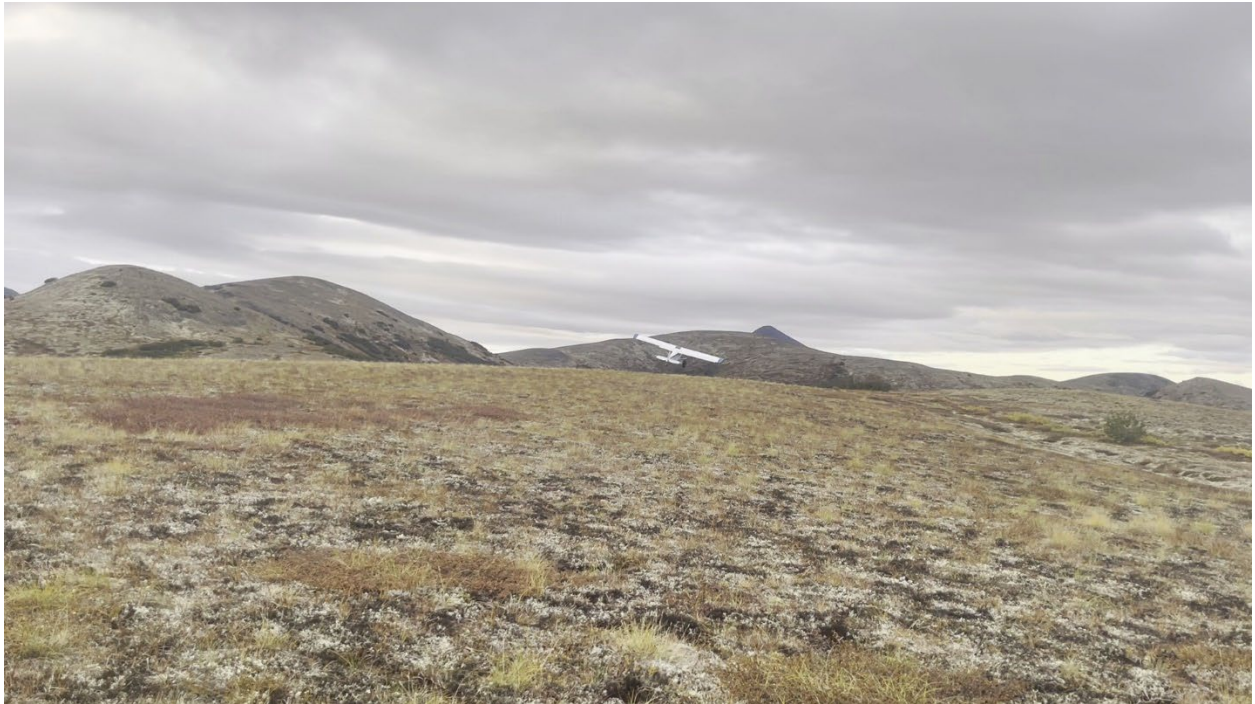
Shortly after liftoff, the airplane underwent a pitch and bank transient that peaked at about video time 13 seconds. Figure 2 shows the airplane at that time. It was desirable to estimate the maximum nose-up pitch angle of the airplane to determine whether the angle was large enough to cause the cargo in a cargo pod to shift toward the tail of the airplane and change the dynamic characteristics of the airplane.

The wireframe model was superimposed on the video frame shown in Figure 2 and then scaled and rotated until it optimally aligned with the image of the airplane in the video frame. The pitch and roll angles of the wireframe model when it was optimally aligned were the optimal estimates of the angles of the accident airplane at the time when the video frame was recorded.

For the purpose of the analysis, the pitch angle of the airplane was defined as zero when the bottom of the wing airfoil was horizontal. The estimated airplane nose-up pitch angle was  $16.2^\circ$ . The estimated right-wing-down bank angle was  $16.6^\circ$ . The bottom of the cargo pod that was mounted under the fuselage sloped up by  $13^\circ$  toward the tail of the airplane when the airplane pitch angle was zero. Consequently, at time 13 seconds, when the airplane nose-up pitch angle was  $16.2^\circ$ , the bottom of the cargo pod sloped down toward the tail by  $16.2^\circ - 13^\circ = 3.2^\circ$ . If the uncertainty of the estimation is accounted for, the estimated slope can be specified as  $3^\circ \pm 1.5^\circ$ .

**Figure 2.** Airplane at video time 13 seconds
