# National Transportation Safety Board

ANC23FA074

## **ONSCENE EXAM REPORT**

Location: St Marys, Alaska  
Date: September 12, 2023  
Time: 2047 LCL  
Airplane: Piper PA18-150, Reg: N109T

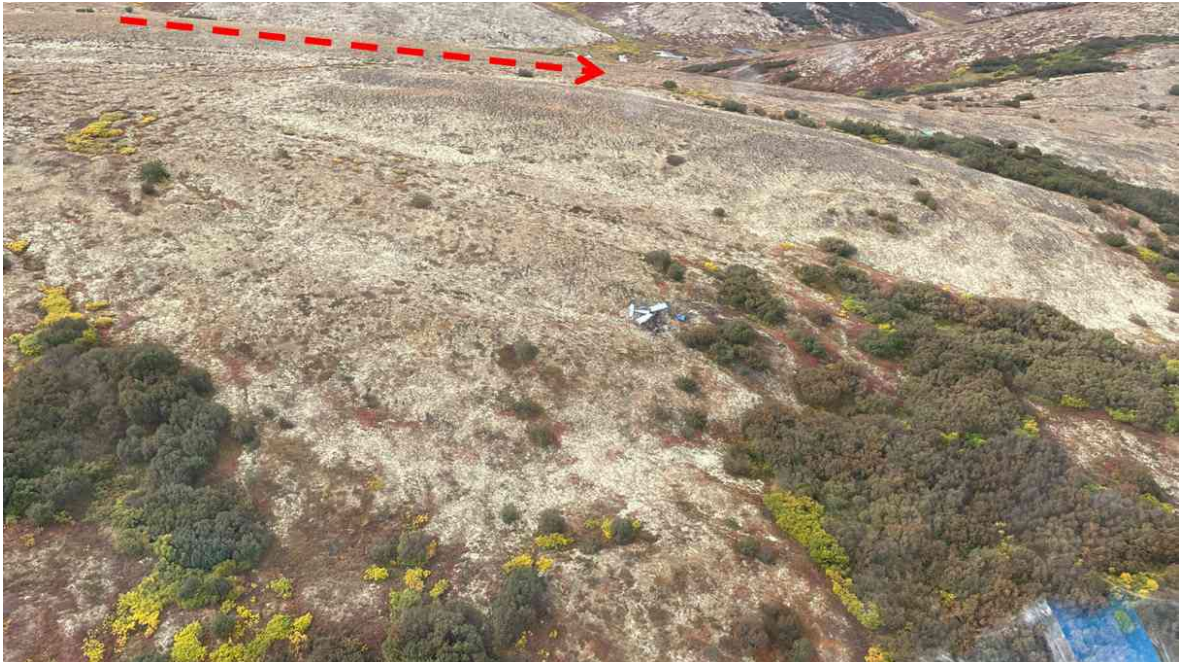
**Figure 1 - Accident site with runway and takeoff location indicated in red**

The airplane came to rest on a 30° slope, at an elevation of 1,210 ft, about 600 ft east of the departure end the north runway. The surrounding area consisted of rolling hills, covered in moss and grass, and distributed with low-lying shrubs and bushes (see figure 1).

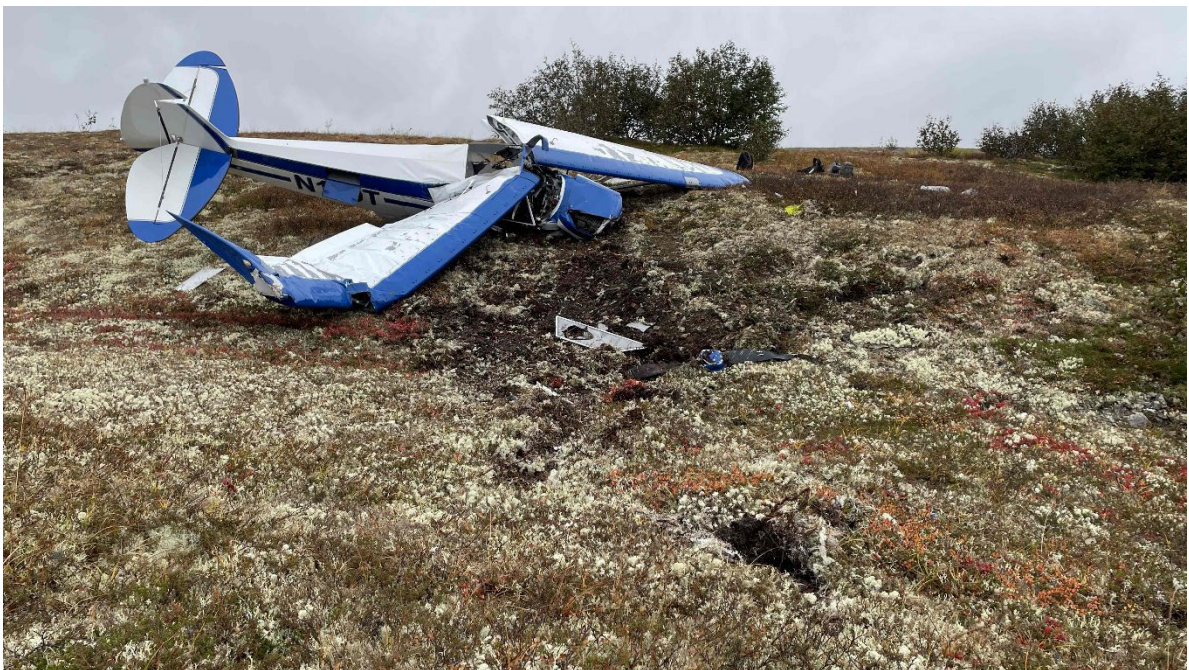
**Figure 2 - Airplane at accident site**

impact was about 20 ft below the main wreckage and consisted of a divot in the soil that contained blue and white paint fragments. About 5 ft further uphill in a west direction was the right wing landing light assembly, and right window frame. A further 5 ft uphill was a large divot in the soil that matched the general dimensions of the main landing tire. Adjacent to this hole was the propeller (see figure 2).

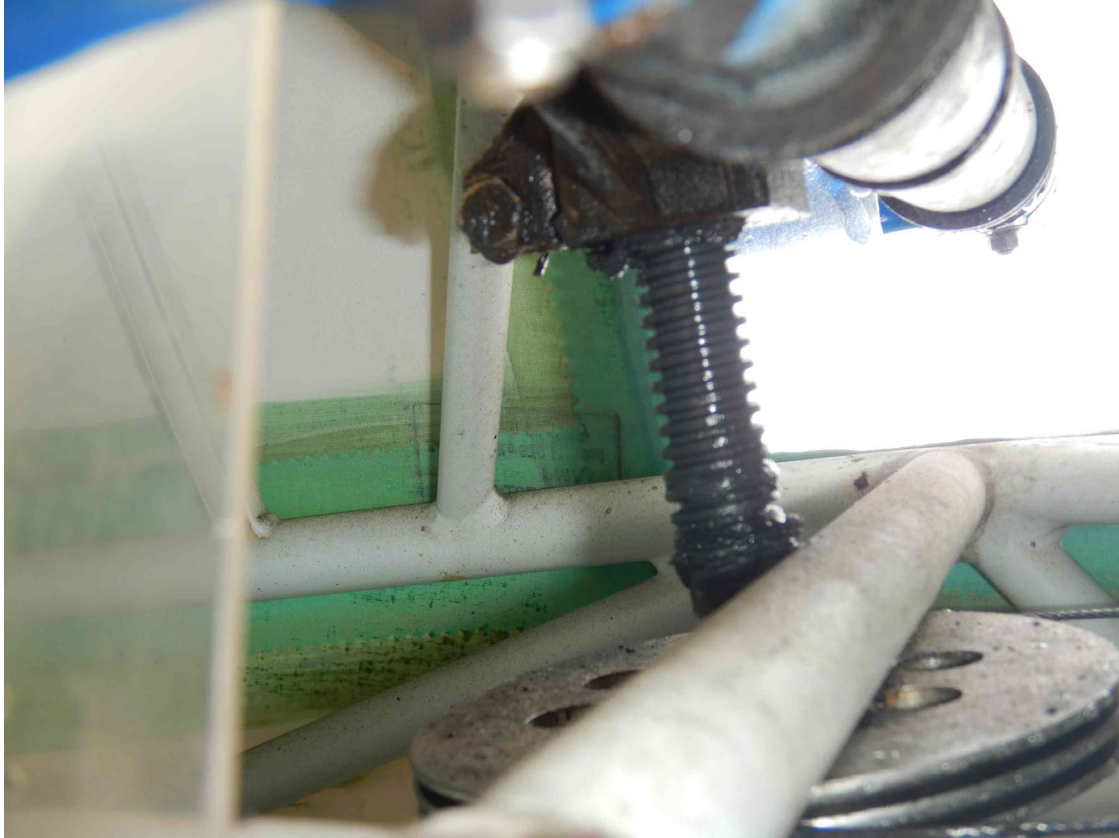
**Figure 3 - Pitch trim jackscrew**

The vertical and horizontal stabilizer remained firmly attached to the tail section and did not appear to have sustained any damage. The vertical stabilizer pitch trim actuator jackscrew shaft showed 13 exposed threads below the control surface (see figure 3), which correlated to a partial nose down trim position. According to Piper, 17 visible threads would correlate to full nose down trim (4°), and no threads visible would correlate to full nose up trim (-2.5°).

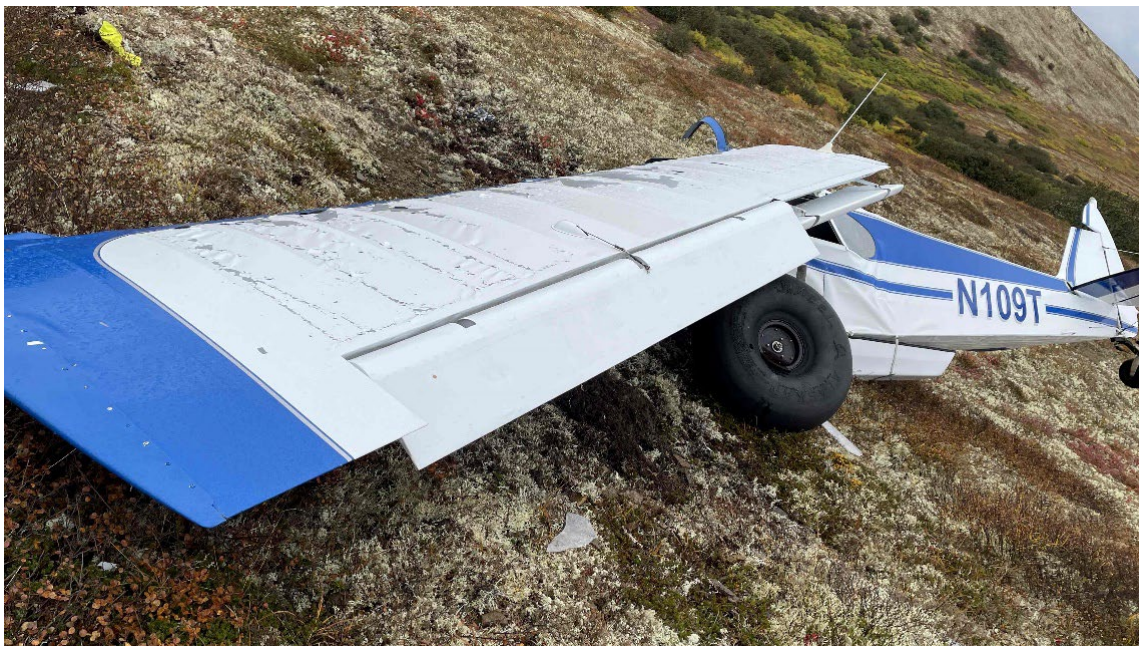
**Figure 4 - Left wing**

The left wing was largely intact and remained connected by its main spar and lift struts to the fuselage (see figure 4). The aft spar attachment fitting had pulled away from the fuselage and exhibited fresh and bright granular surface features at the fracture. Leading edge tip damage was present, and paint fragments had delaminated from most of the top wing skin surface.

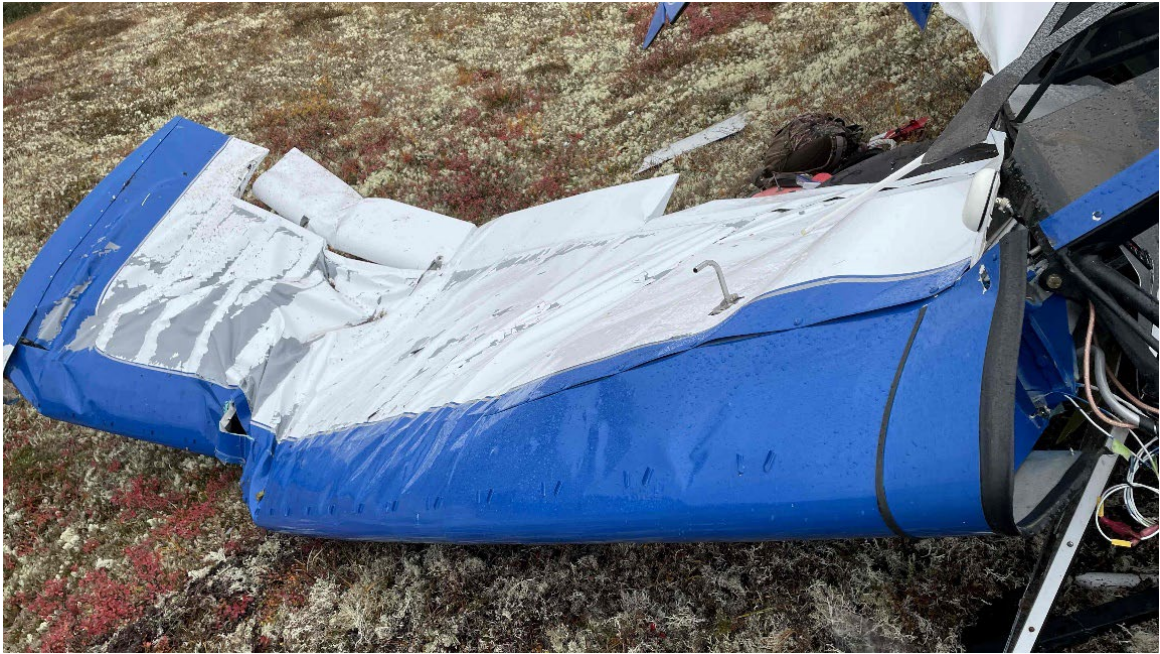
**Figure 5 - Right wing**

The right wing sustained leading edge damage at the tip and had bent up about 20° at the outboard 1/3 of its span (see figure 5). It remained attached to the fuselage by both the main and aft spar along with the lift struts. Similar paint damage was observed. The antler rack remained attached in the same manner as observed in the pre-flight photo, and there was no evidence it was impinging on the aileron cables within the strut (see figure 11).

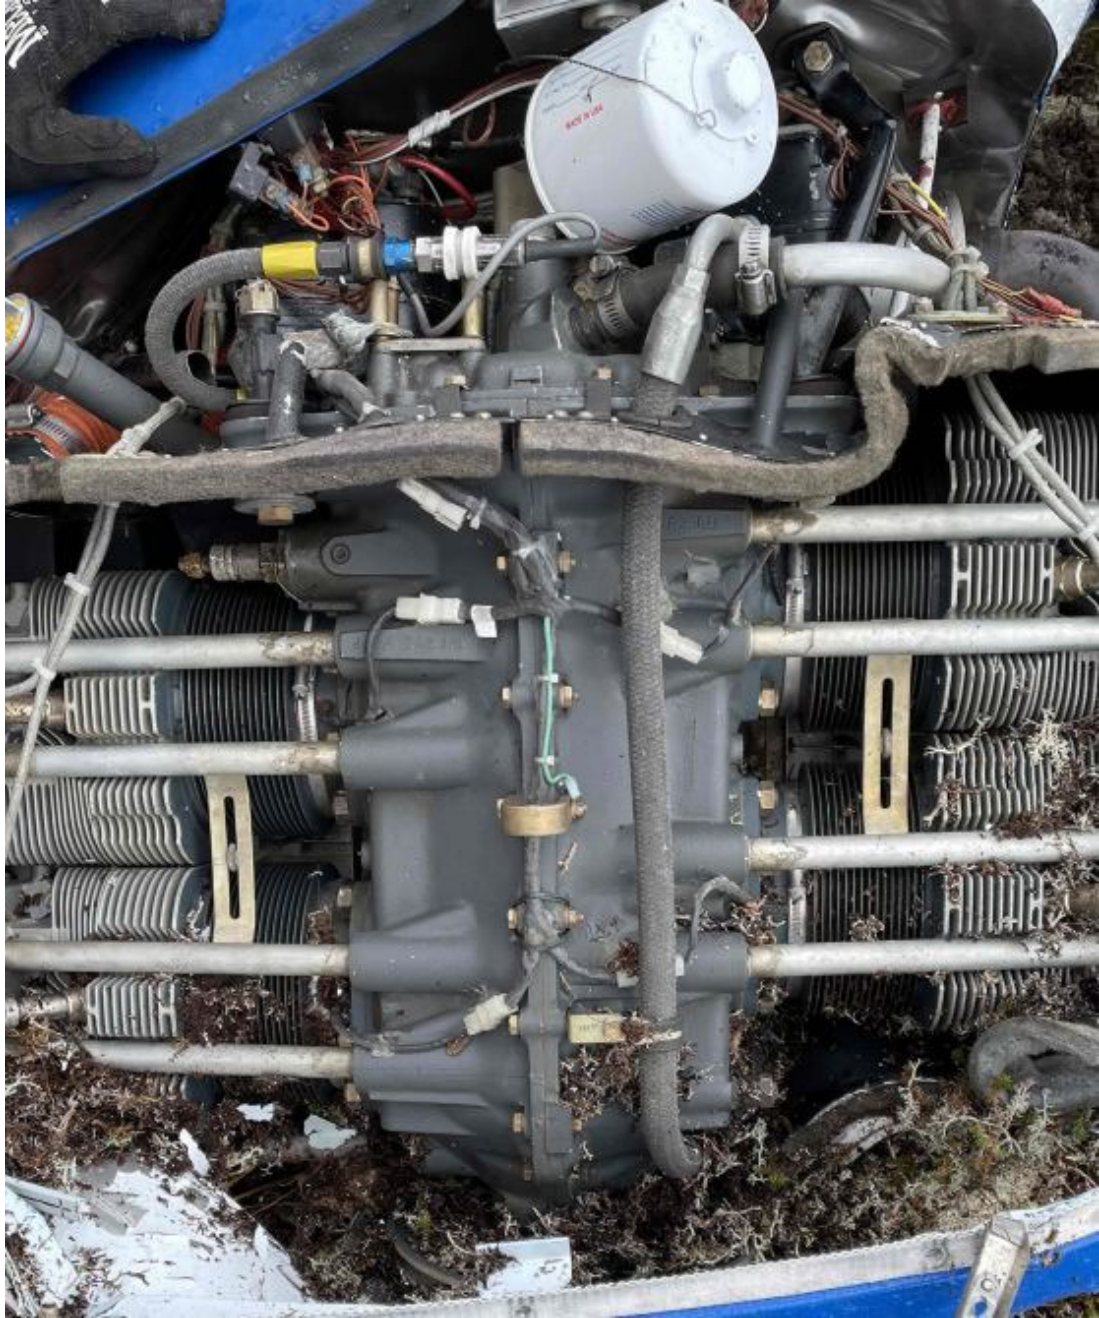
**Figure 6 - Engine**

The engine sustained minimal damage during the accident sequence and remained partially attached to the firewall by its bent and fractured mount (see figure 6).

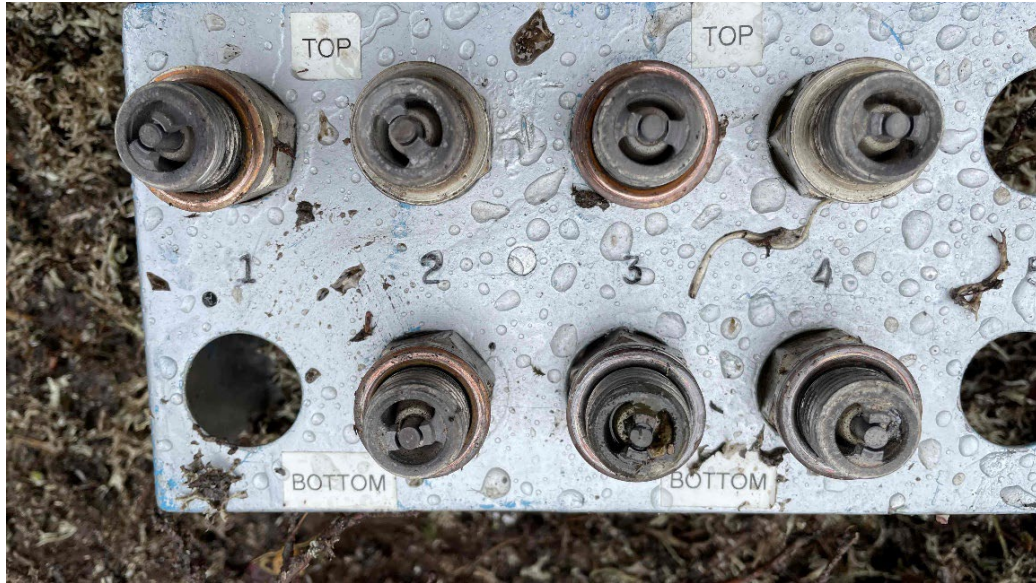
**Figure 7 - Spark plugs**

All top spark plugs (and lower plugs for cylinder 2,3,4) were removed and examined. Their electrodes remained mechanically intact, coated in light grey deposits, and displayed normal wear signatures when compared with the Champion Spark Plugs AV-27 Check-A-Plug chart (see figure 7). The lower plugs for cylinders number 3 and 4 displayed evidence of lead deposits within the ceramic cavity, however the deposits did not appear to be fouling the electrode. The exhaust pipes exhibited light grey deposits and were free of oil residue.

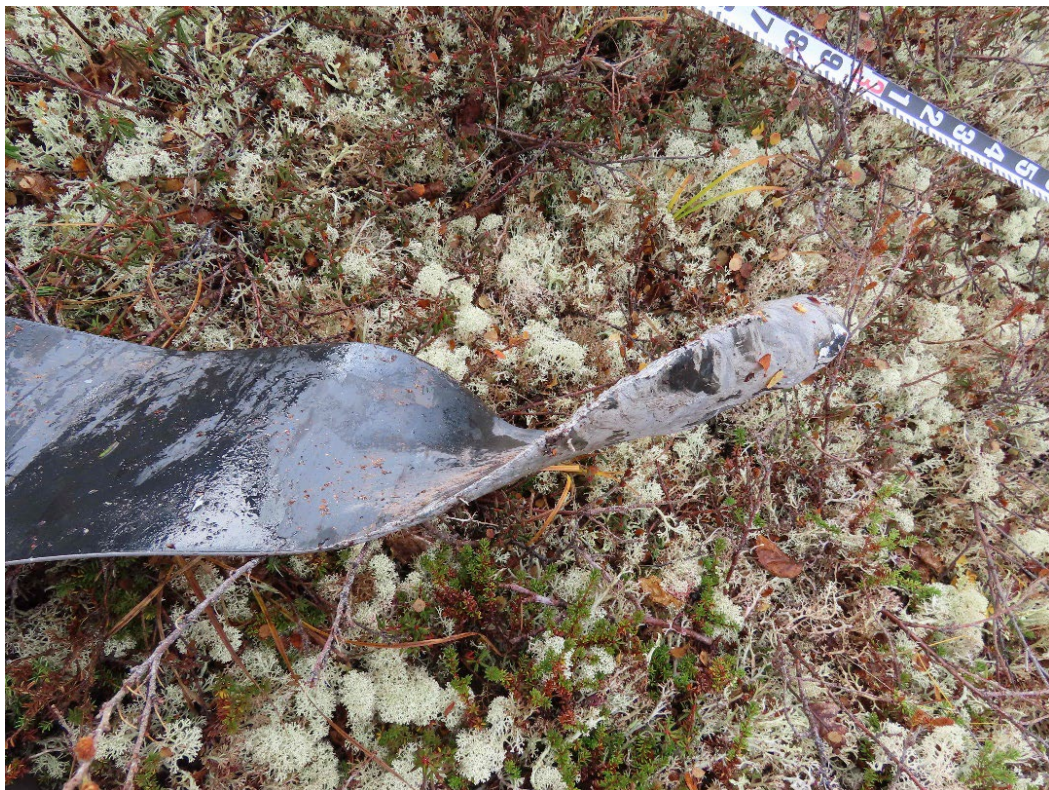
**Figure 8 - Propeller tip**

The propeller had detached from the crankshaft flange. Each blade exhibited similar damage including twist, leading edge nicks and dents (see figure 8), trailing edge S-bending, and chordwise scratches. One blade tip had torn away at an angle of about

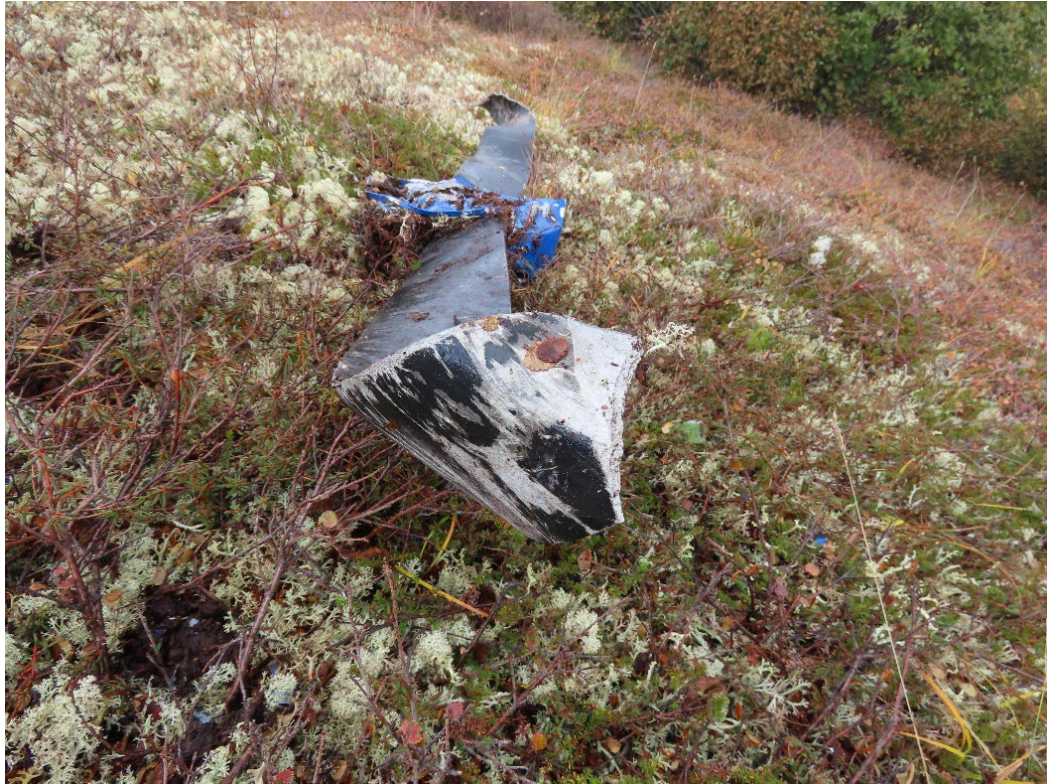
**Figure 9 - Propeller tip**

30° relative to the chord (see figure 9) and exhibited granular and jagged surface fracture features.

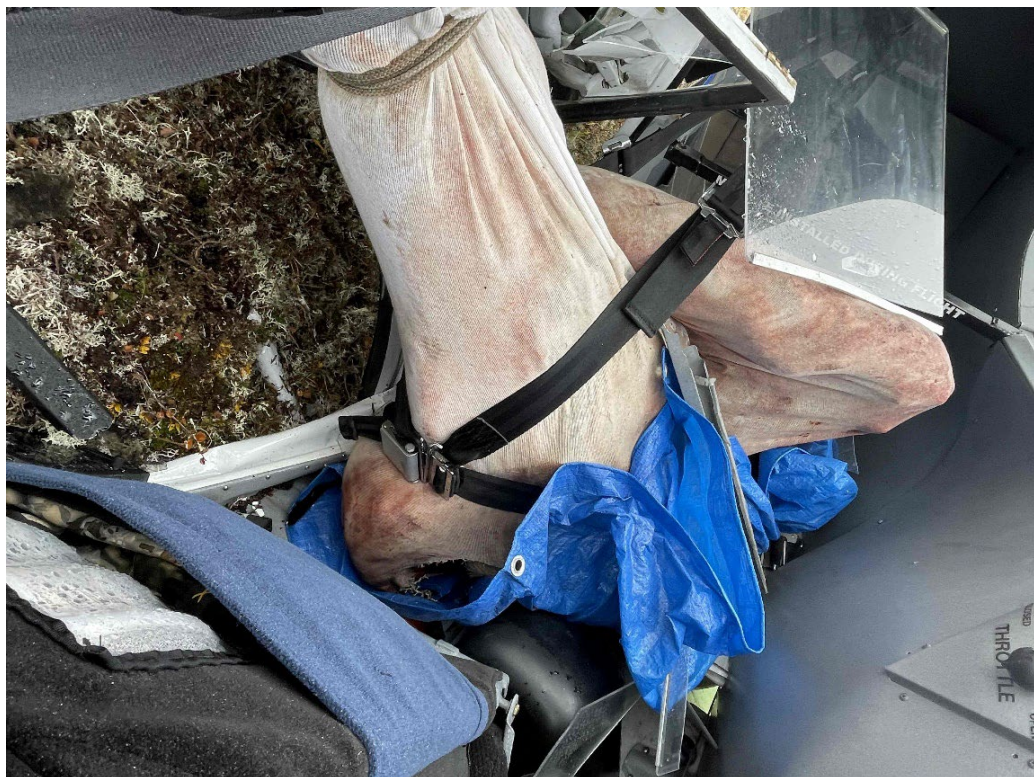
**Figure 10 - meat in rear cabin**

Review of video footage taken during the accident takeoff indicated that the hind quarter in the rear seat area was sitting upright behind the pilot. At the accident site, the hind quarter remained securely tied to the upper fuselage frame and secured with the aft seatbelts. The rib section was similarly secured with the seat belt. The meat appeared to have moved forward with the buckled airframe and was resting on top of the aft flight control stick base (the aft control stick was not installed) (see figure 10). The meat was not touching the pilot's seat.
