# National Transportation Safety Board

ANC23FA074

## ENGINE EXAMINATION

Airplane: Piper PA18-150, Reg: N109T

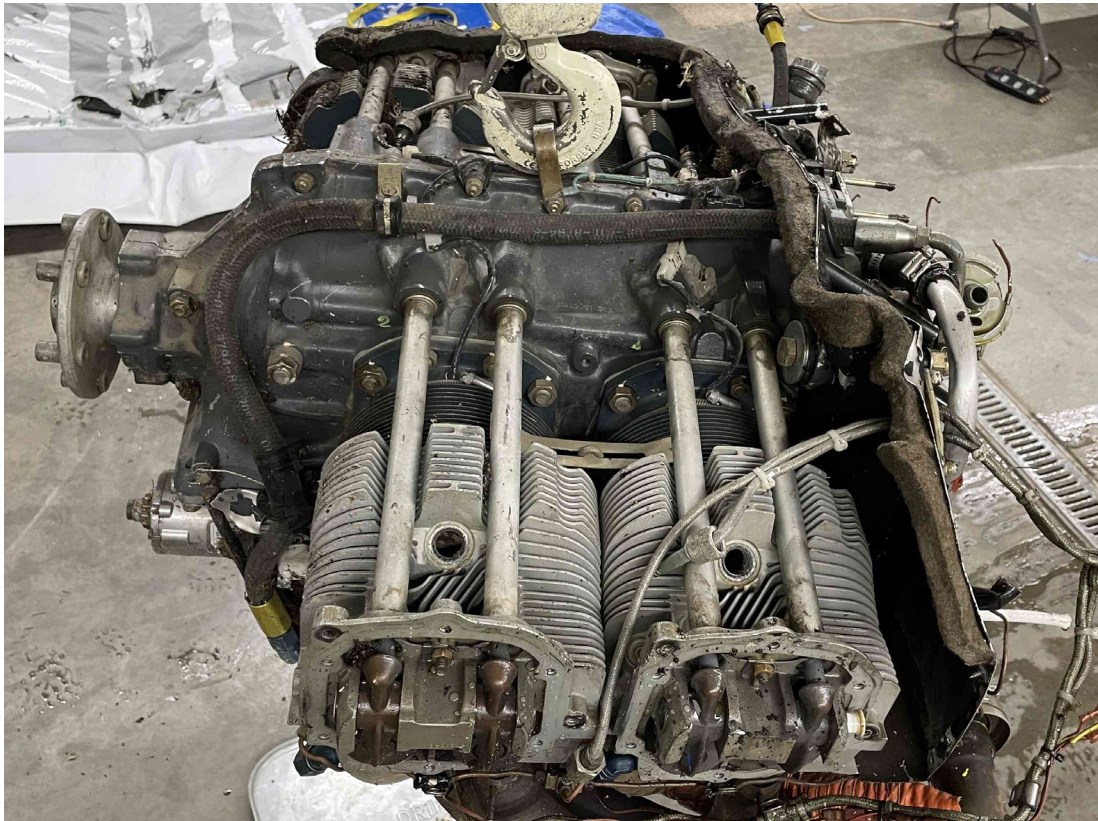
The engine was intact and showed minimal signs of impact damage (see figure 1). The crankshaft could be rotated smoothly by hand at the crankshaft flange. There was

**Figure 1- Engine before disassembly**

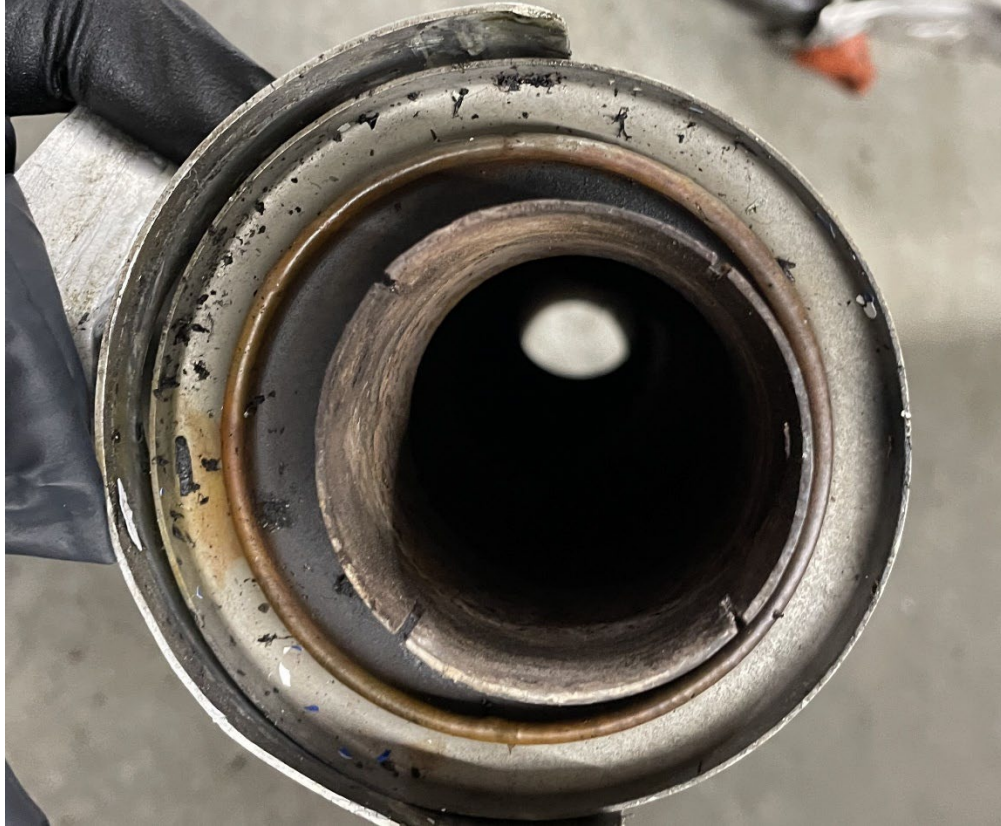
The exhaust tubes sustained crush damage but remained attached to their respective cylinder heads. The muffler was removed and internally inspected, and there was no evidence of either internal gas path blockage or exhaust gas leakage, and the inner surfaces were coated in light grey deposits consistent with normal operation (see figure 2). The induction tubes were intact and remained firmly attached to both the cylinder heads, and their lower their flexible couplings at the sump.

**Figure 2 - Exhaust muffler gas path**

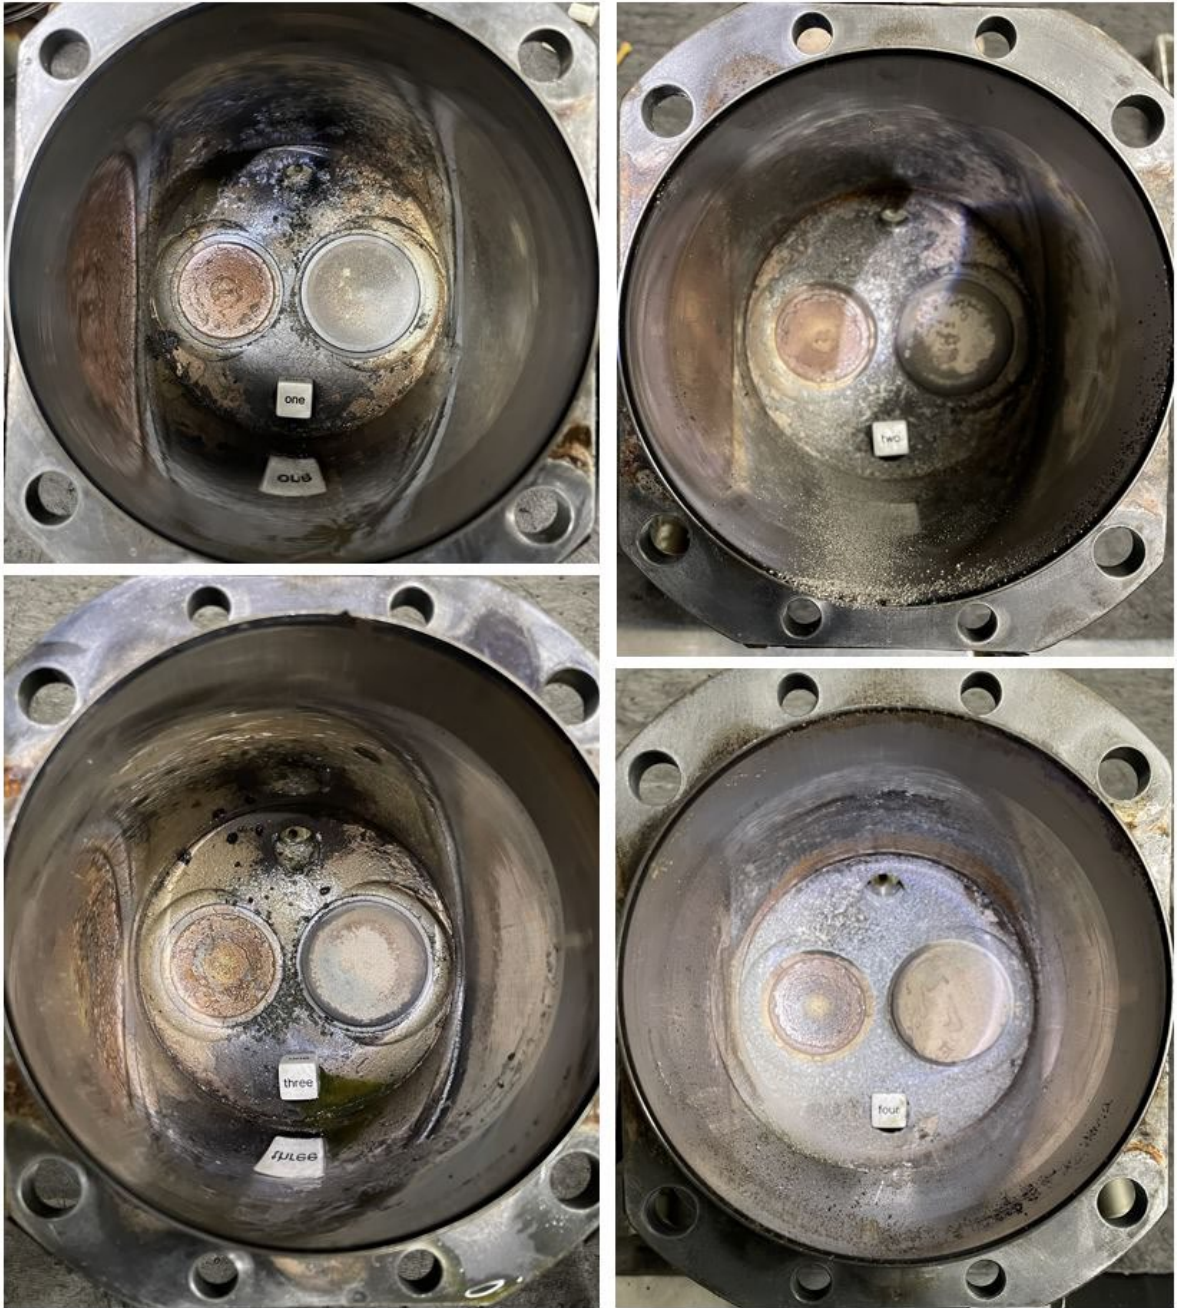
Each cylinder head assembly was then removed and disassembled. The pushrods were all straight, and their tubes and seals appeared undamaged. All four cylinder head crowns were coated in light grey deposits and there was no evidence of piston head to valve contact.

All the exhaust and inlet valve faces displayed dark to light deposits, all in concentric patterns, with no evidence of hot spots, chips, or material loss (see figure 3).

**Figure 3 - Cylinder head crowns**

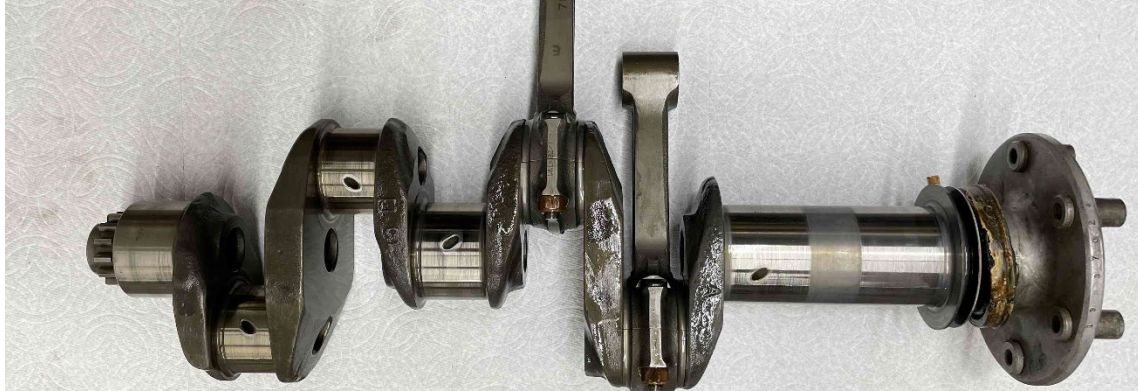
The pistons and their associated connecting rod assemblies were removed from the crankshaft. All bearing surfaces were intact and clean with no evidence of thermal damage (see figure 4). The cylinder bores were bright and displayed light crosshatching signatures.

**Figure 4 - Crankshaft**

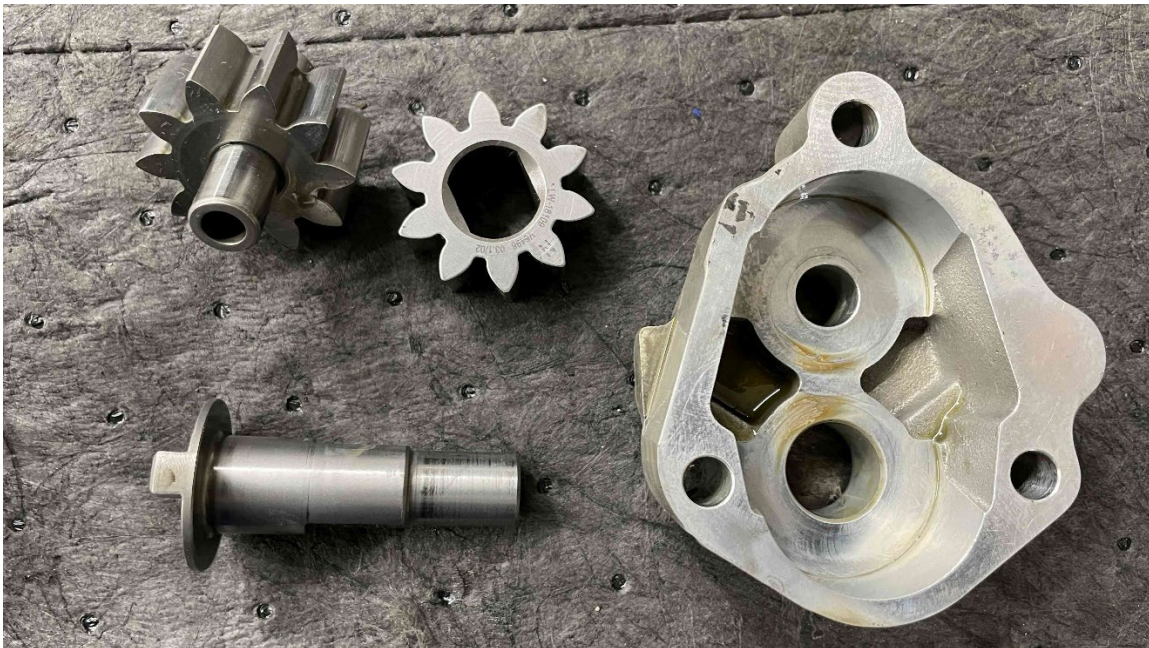
The accessory case was removed; all timing gears were intact and undamaged. The oil pump input shaft could be rotated freely by hand. The pump gears were undamaged and coated in a light sheen of oil. The pump cavity walls were free of gouges (see figure 5). The oil filter was removed and opened, the paper element was coated in oil and free of debris (see figure 6).

**Figure 5- Oil pump**

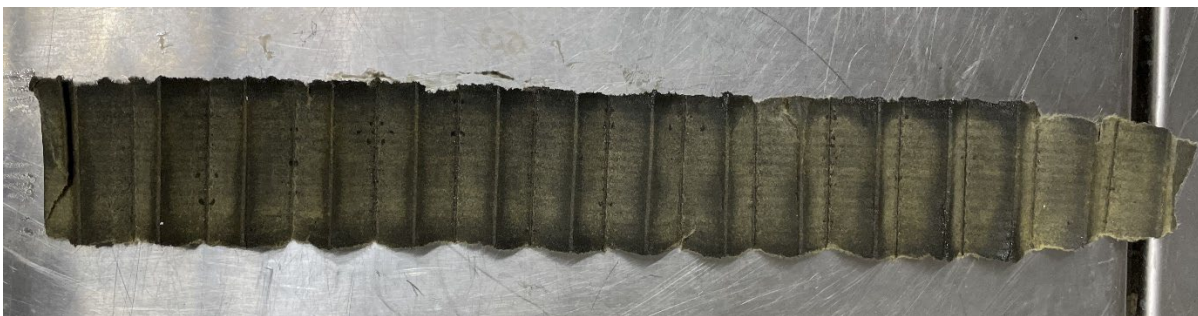
**Figure 6 - Oil filter element**

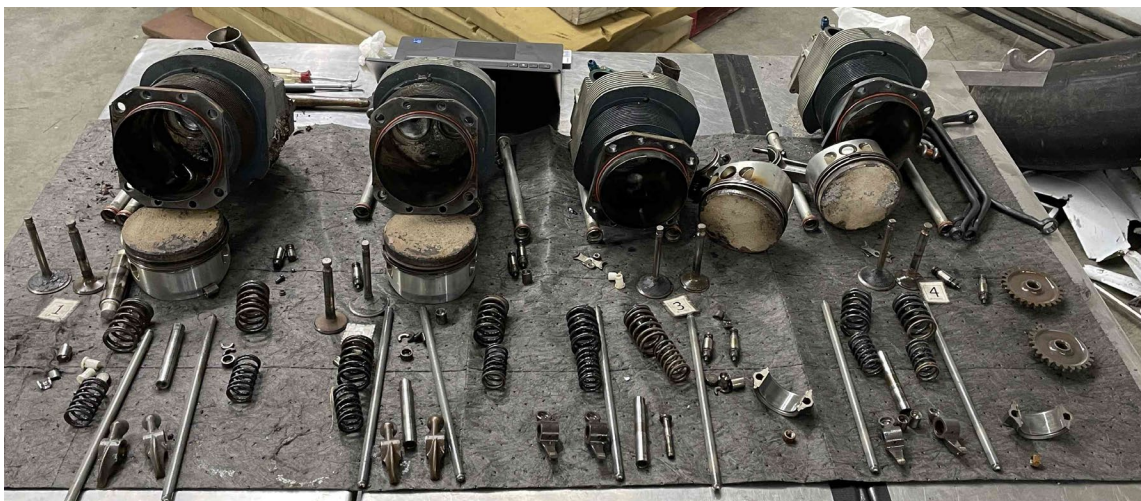
The crankcase was opened and the crankshaft, camshaft, tappets and associated bearing surfaces were examined. The tappets moved smoothly within their bores,

and the faces were smooth to the touch, with no evidence of spalling or wavy patterns (see figure 7).

**Figure 7 - Engine cylinder head assemblies**

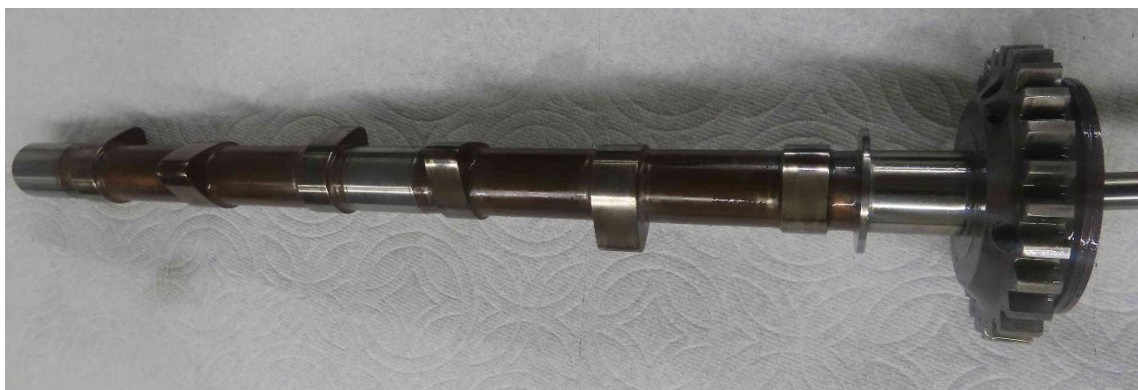
The camshaft bearing surfaces were smooth and the lifting surfaces were smooth to the touch, with no spalling (see figure 8).

**Figure 8 - Camshaft**
