# National Transportation Safety Board

ANC23LA002

## **WRECKAGE EXAMINATION**

Location: Cordova , AK  
Date: October 16, 2022  
Time: 1427 Local  
2227 Zulu  
Airplane: Piper PA-32-300 N3423W

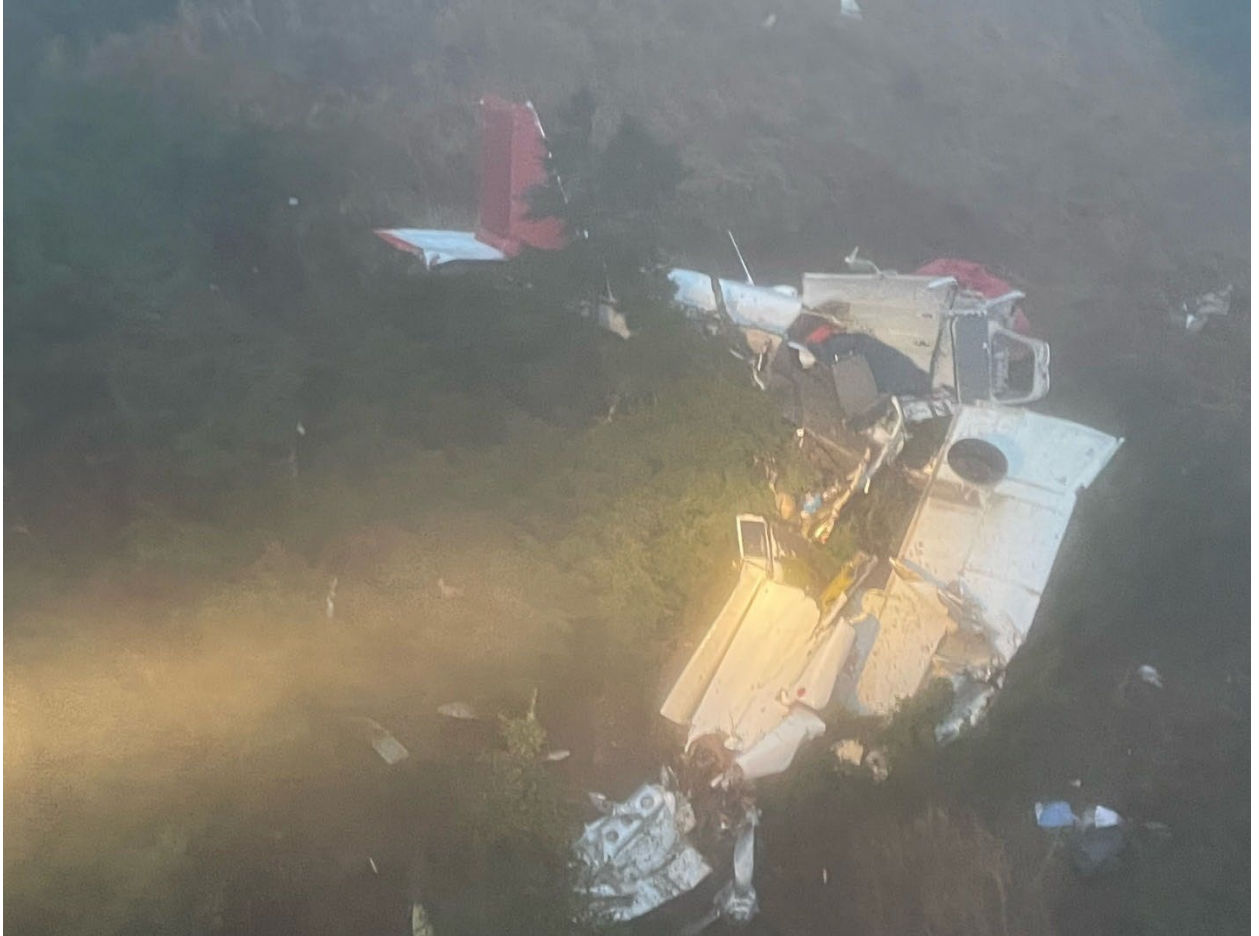
**Figure 1. Accident airplane at accident site looking up terrain. Photo courtesy of the Coast Guard.**

The airplane impacted the side of a mountain in steep terrain at about 1866 ft MSL.

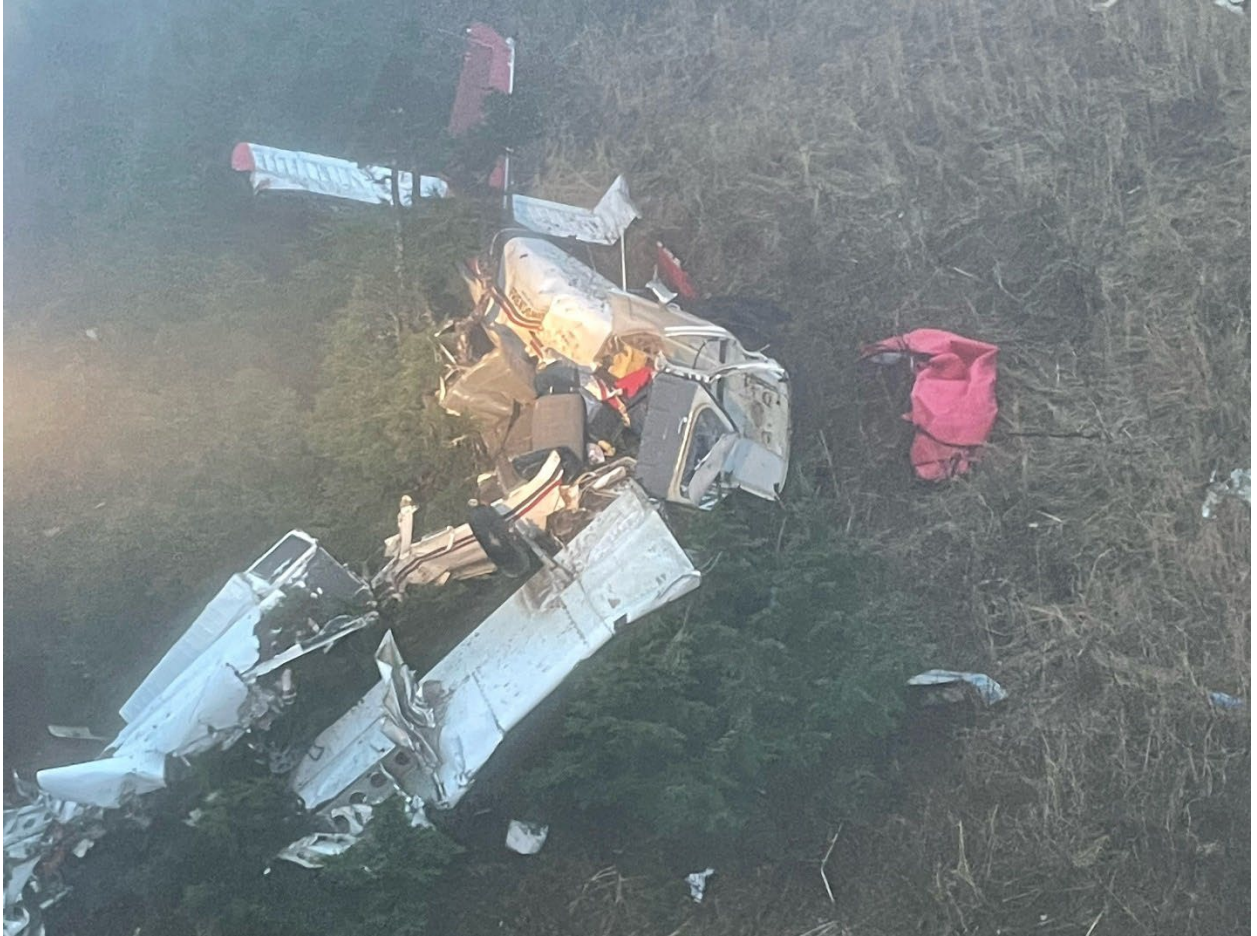
**Figure 2. Accident airplane at the accident site looking along the side of the mountain. Photo courtesy of the Coast Guard.**

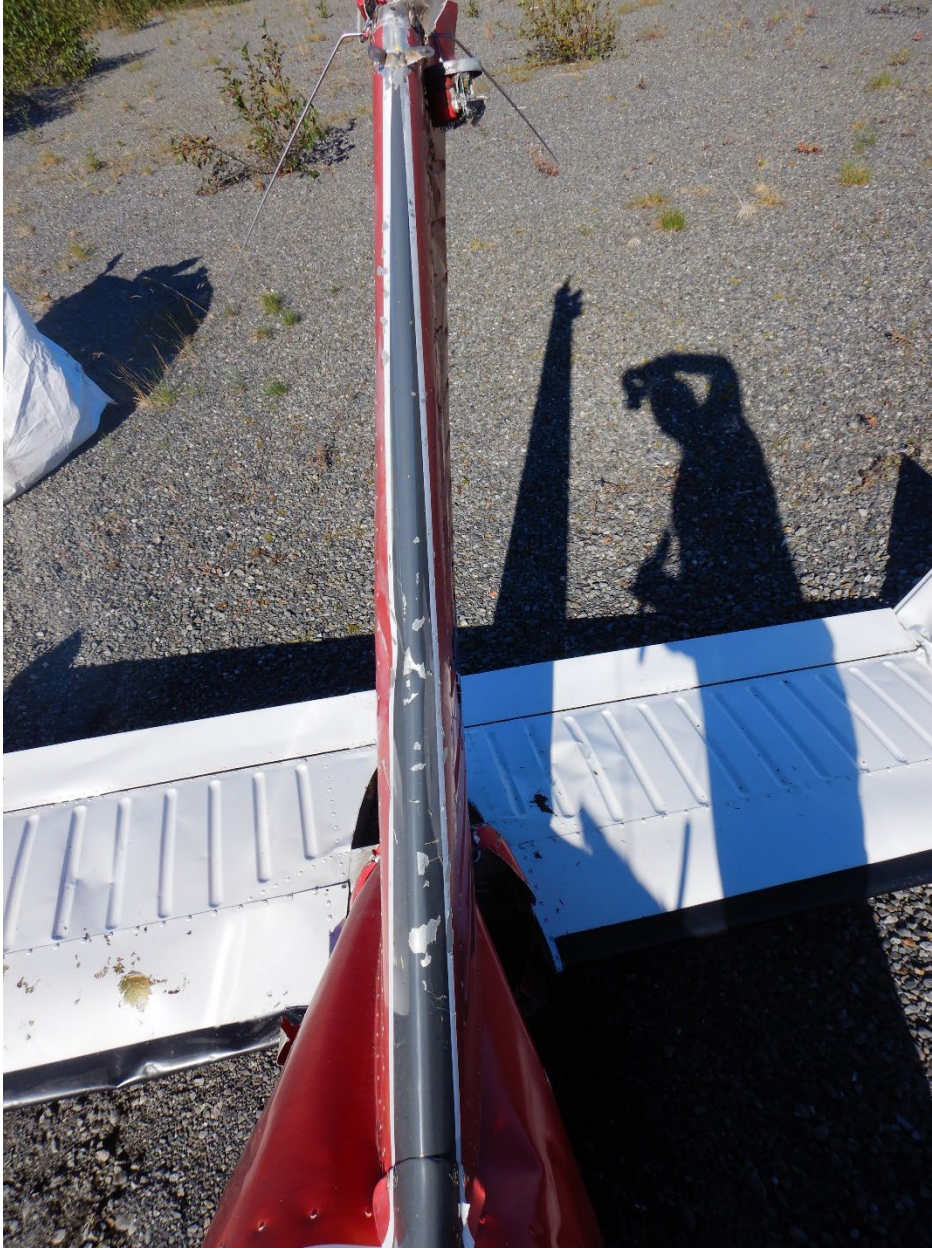
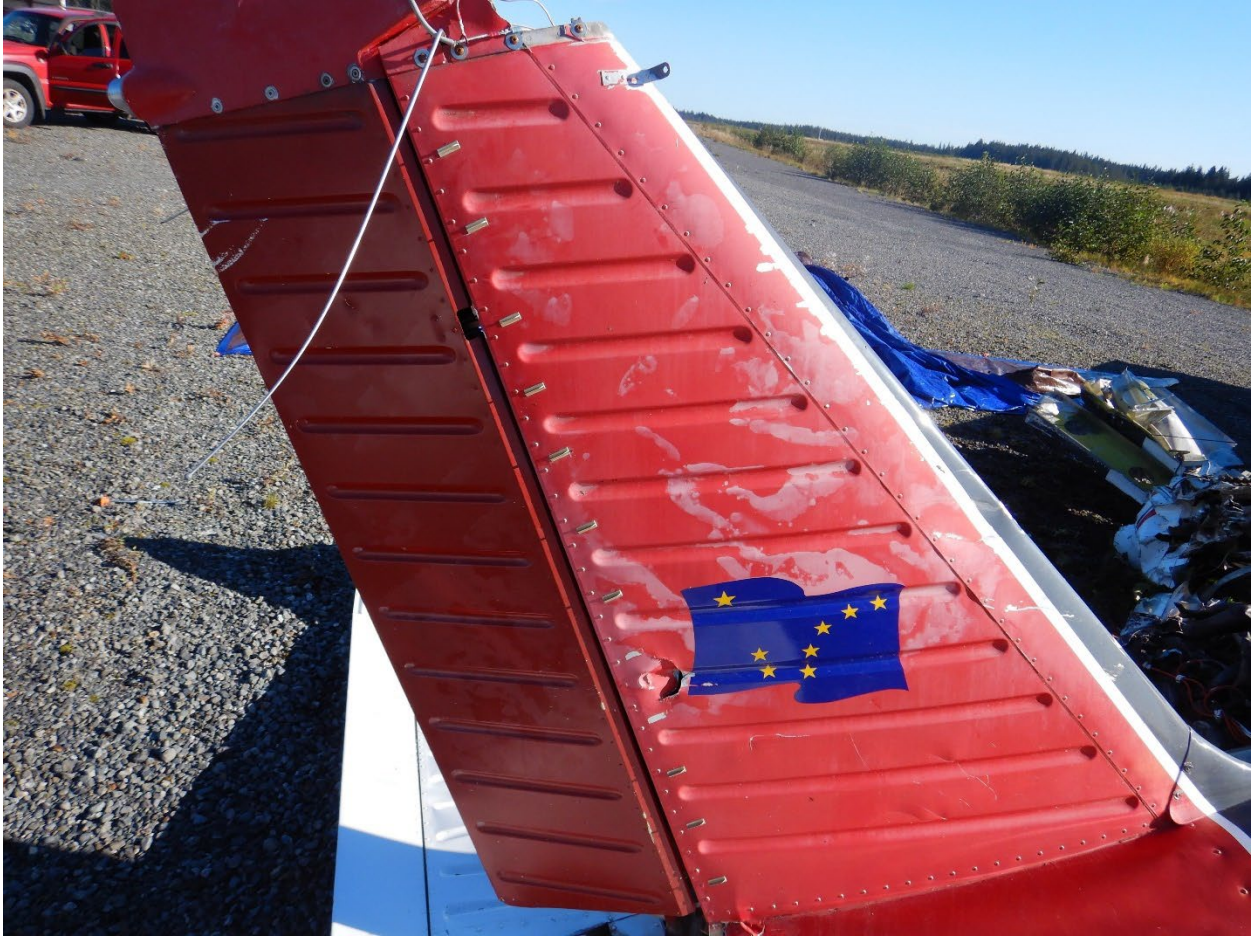
Vertical stabilizer had minor impact points along the leading edge with horizontal scratches along the sides starting at the leading edge (*figure 6,7*). The tip cap of the vertical stabilizer was impact separated (*figure 8*).

**Figure 6. View of leading edge of the vertical stabilizer.**

**Figure 7. View of the right side of the vertical stabilizer and rudder.**

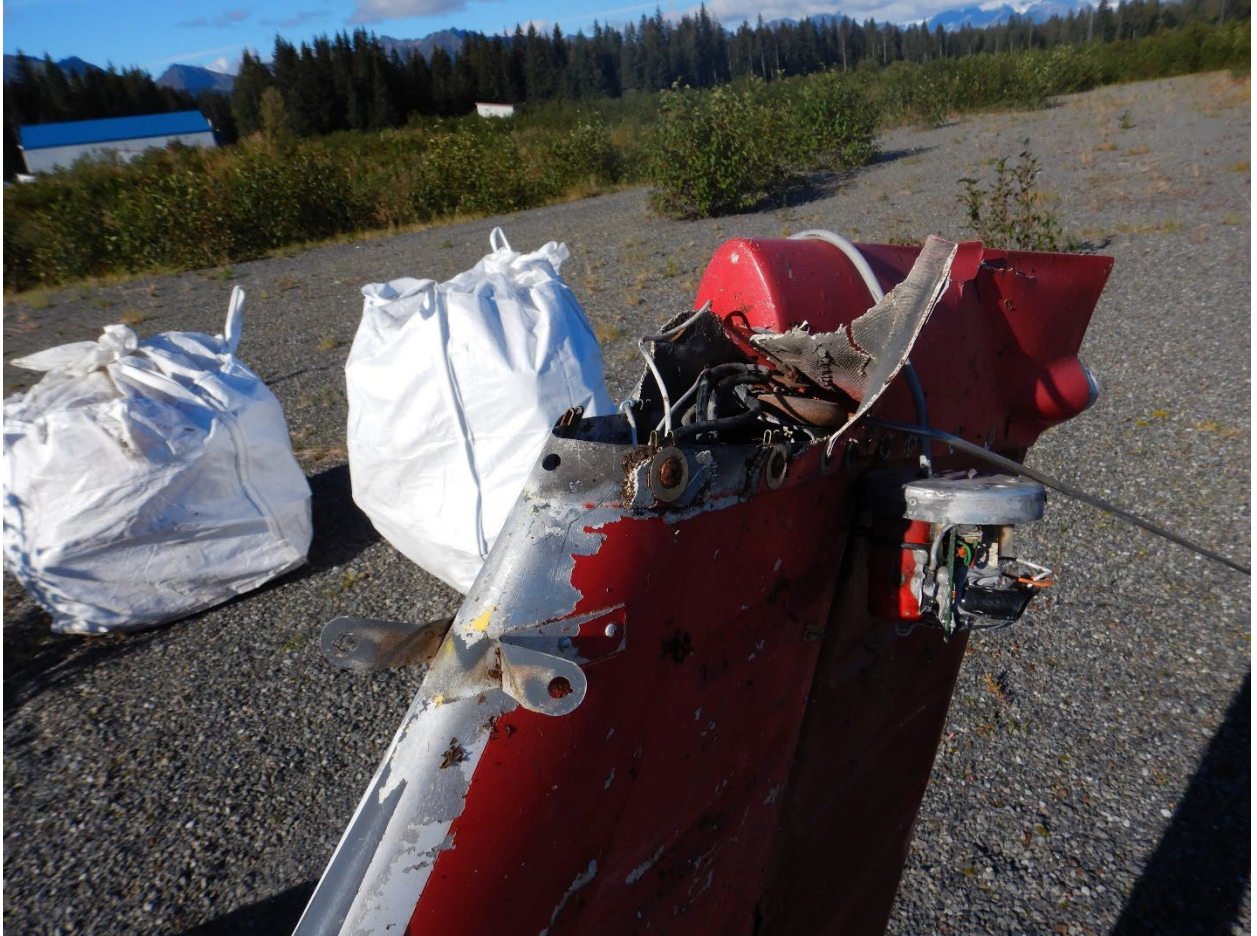
**Figure 8. View of the upper portion of the vertical stabilizer and rudder.**

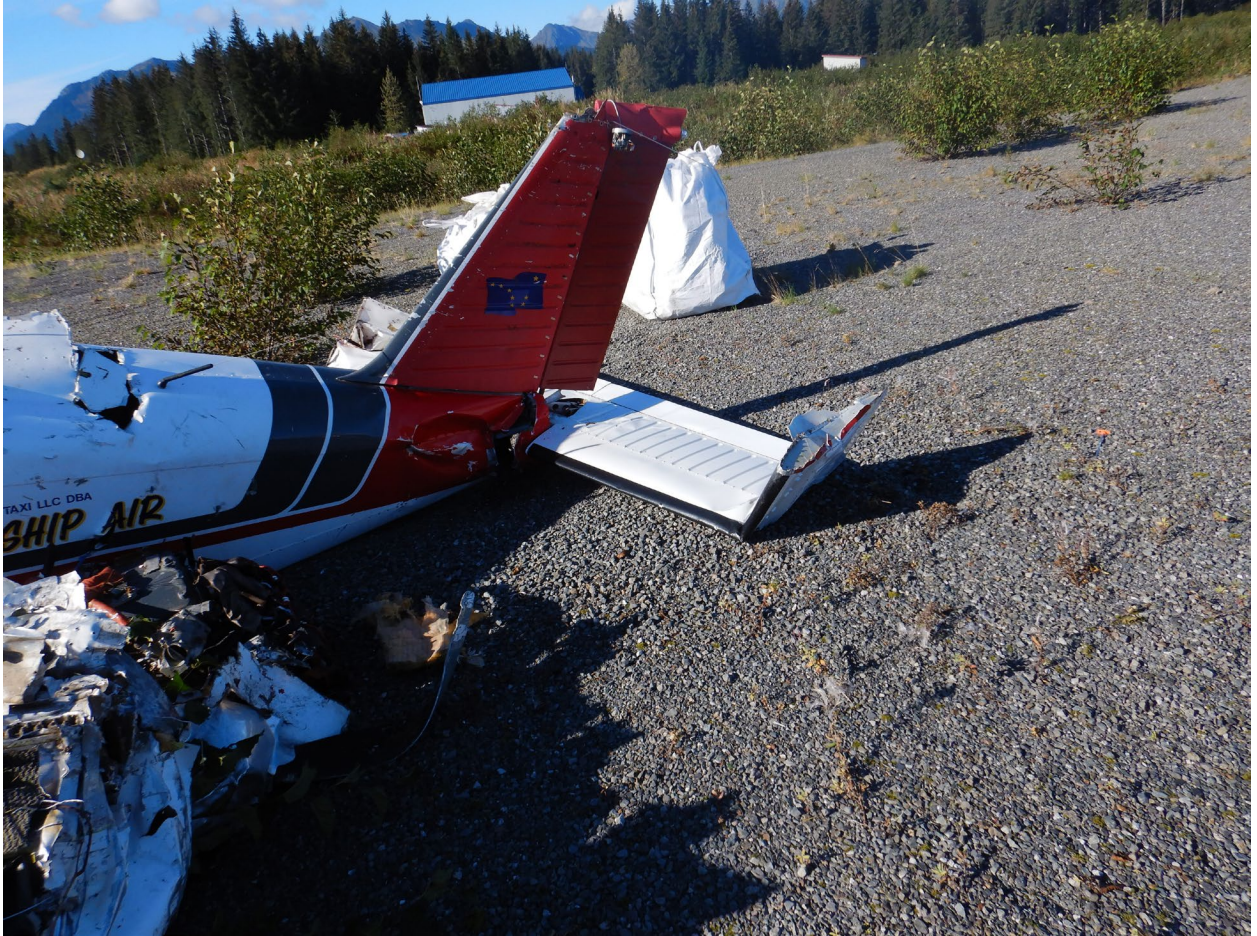
Elevator was attached at all attachment points and moved freely. Left side of the elevator at about 32" and 43" outboard there were quarter size impacts to the leading edge (*figure 14*). At about 48" outboard the left elevator was bent upward at about 80° along a rivet line (*figure 10*). The left cap showed signs of impact damage. Right side of the elevator's leading edge had impacts starting at about 48" outboard with a large impact centered on the tip cap (*figure 14*). Starting at about 48" outboard, at a rivet line the right elevator is bent upward about 90° (*figure 11*). Elevator control cable continuity established from the elevator to the break in the fuselage about 5.5 ft into the airplane from the beginning of the lower baggage compartment wall (*figure 18,19,20*).

**Figure 10. View of the left side of the empennage and damage to the left side of the elevator.**

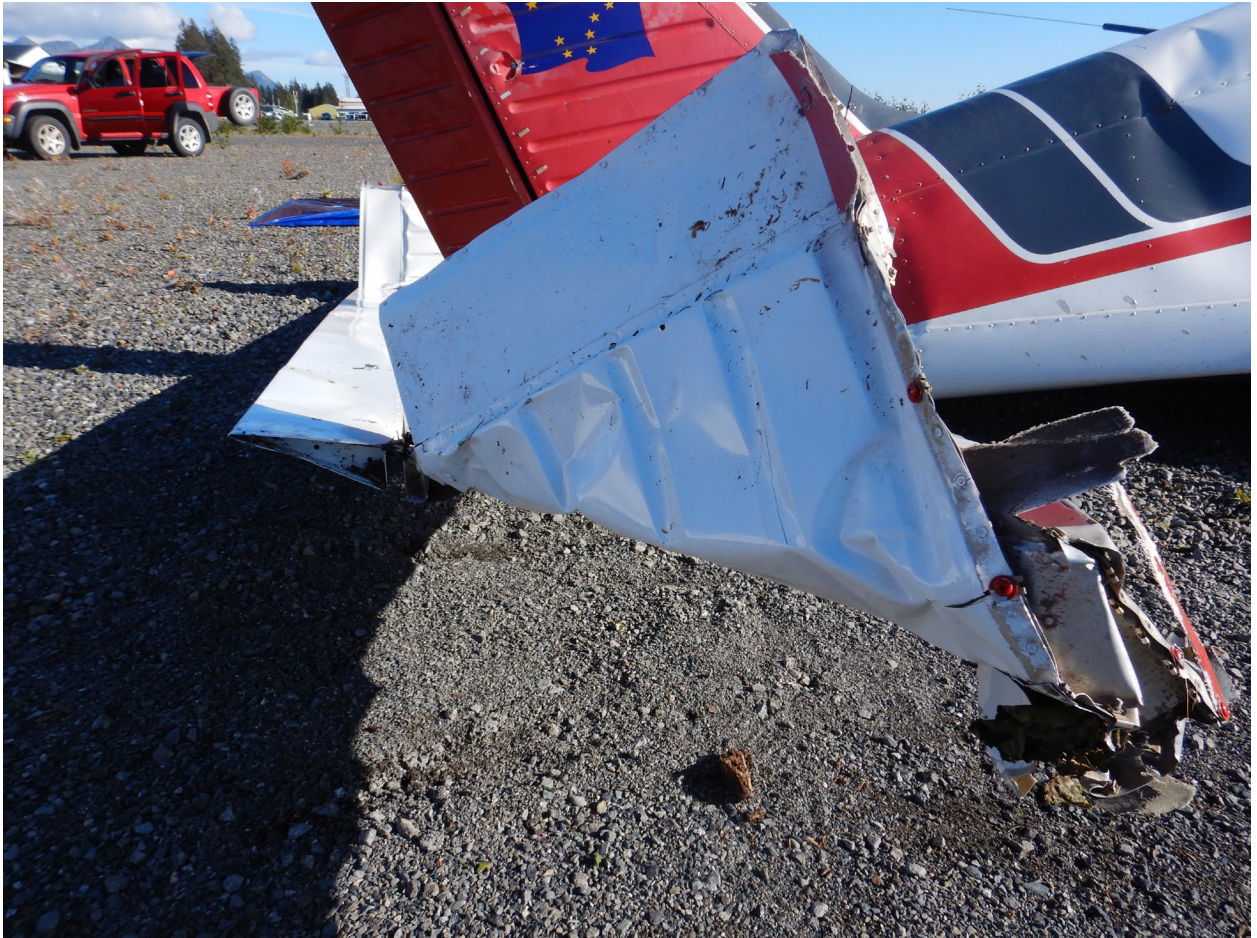
**Figure 11. View of the damage to the right side of the elevator.**

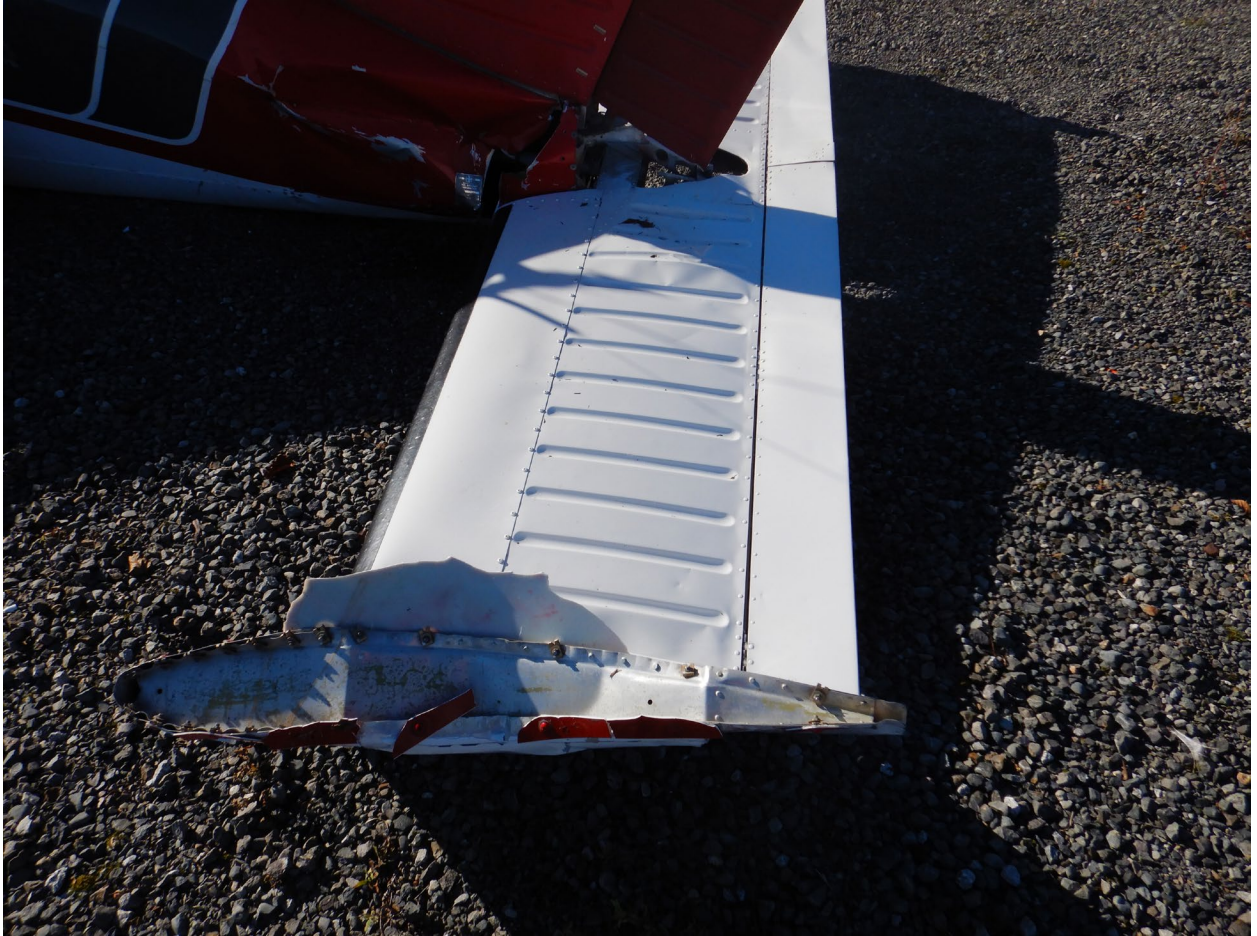
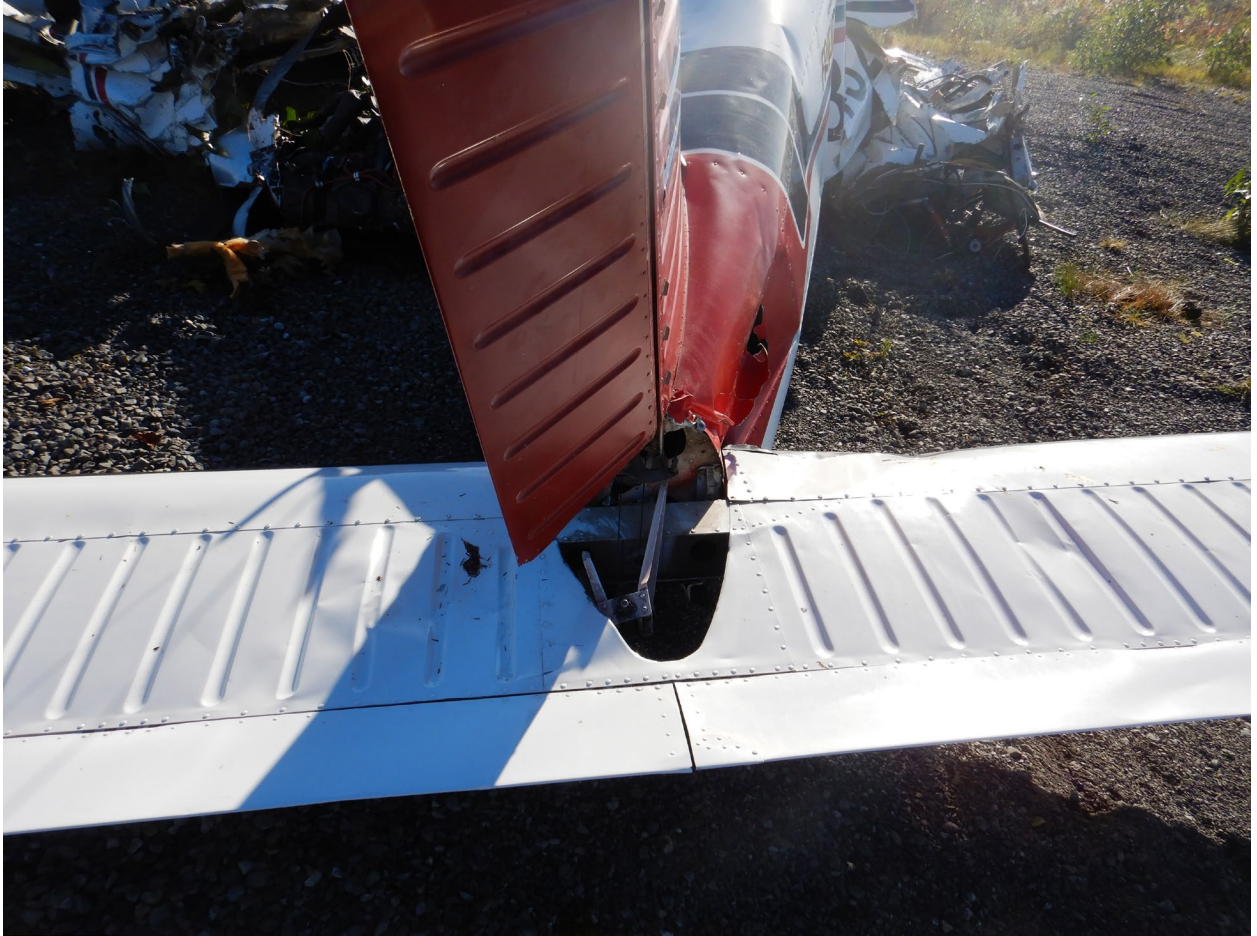
Trim tab was relatively undamaged and was attached to all attachment points (*figure 12, 15*). Some movement of the trim tab was possible but was limited by

impact damage to the trim cable assembly. Trim tab control continuity was established from the trim tab to the break in the fuselage about 5.5 ft into the airplane from the beginning of the lower baggage compartment wall (*figure 18,19,20*). The right trim tab control assembly attachment bracket near the trim tab was still attached, the left side bracket was impact damaged with 45° shear lips and all clean breaks.

**Figure 12. View of damage to left side of the elevator.**

**Figure 15. View of the trim tab and upper portion of the elevator.**

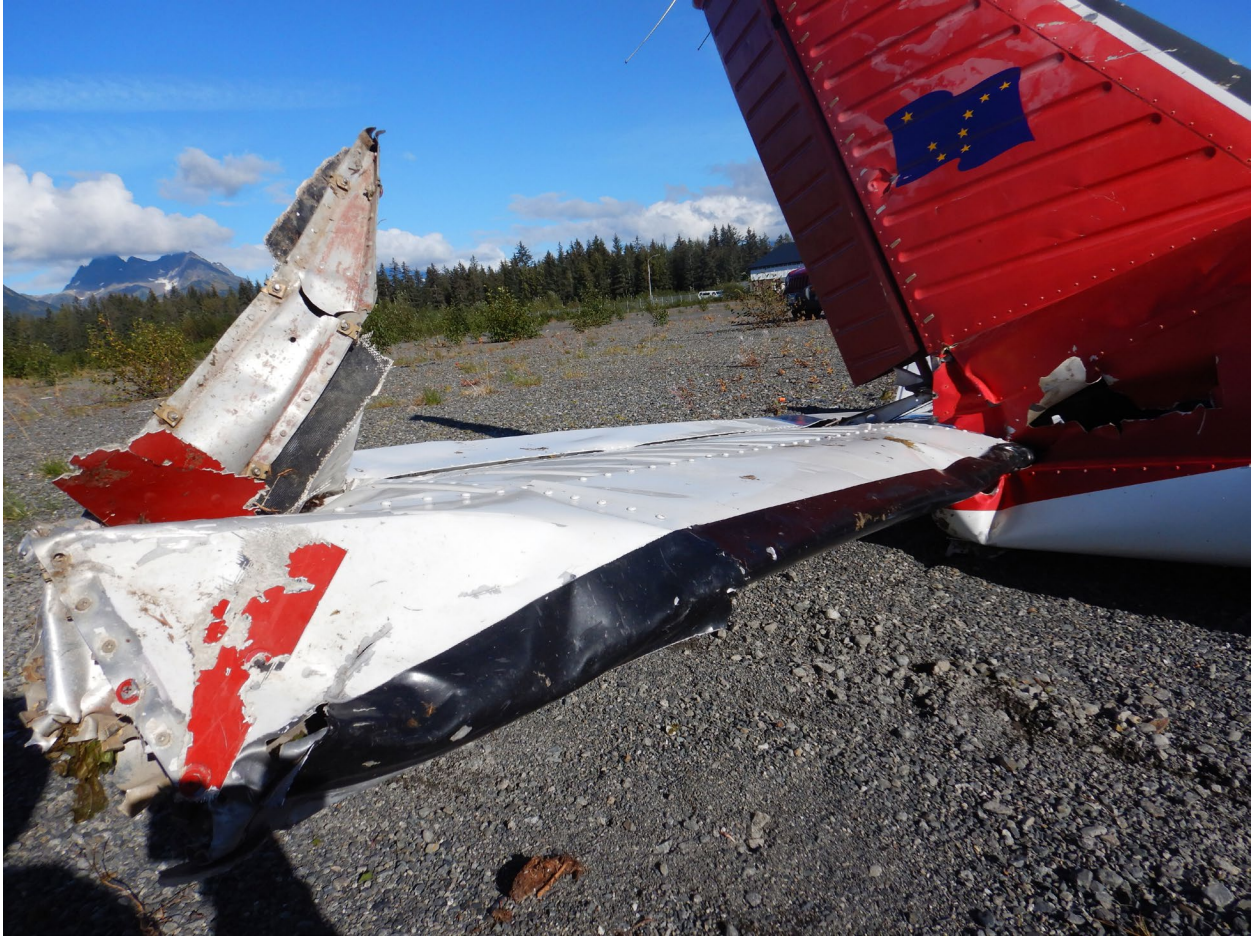
**Figure 13. View of damage to leading edge of the right side of the elevator.**

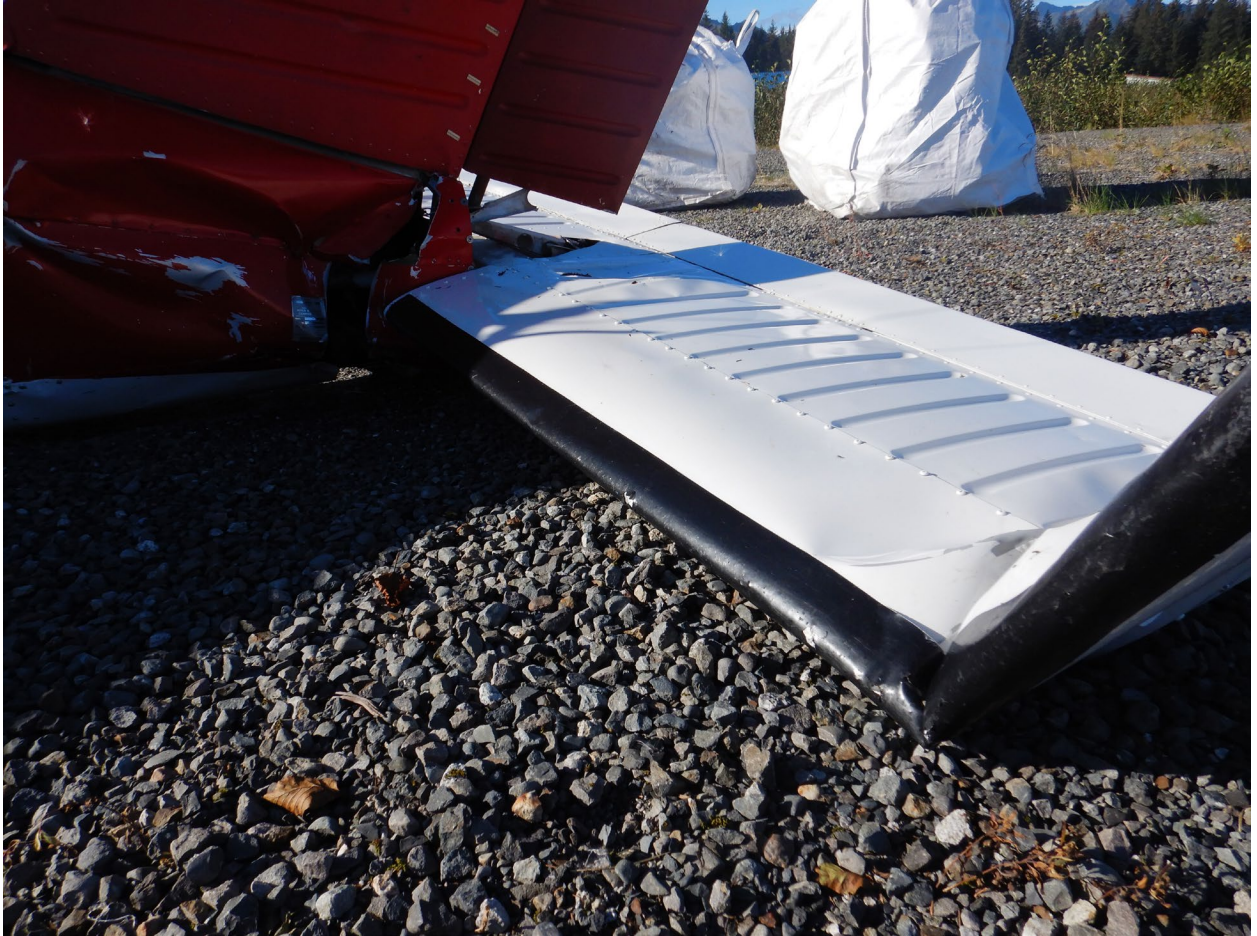
**Figure 14. View of leading edge of the left side of the elevator.**

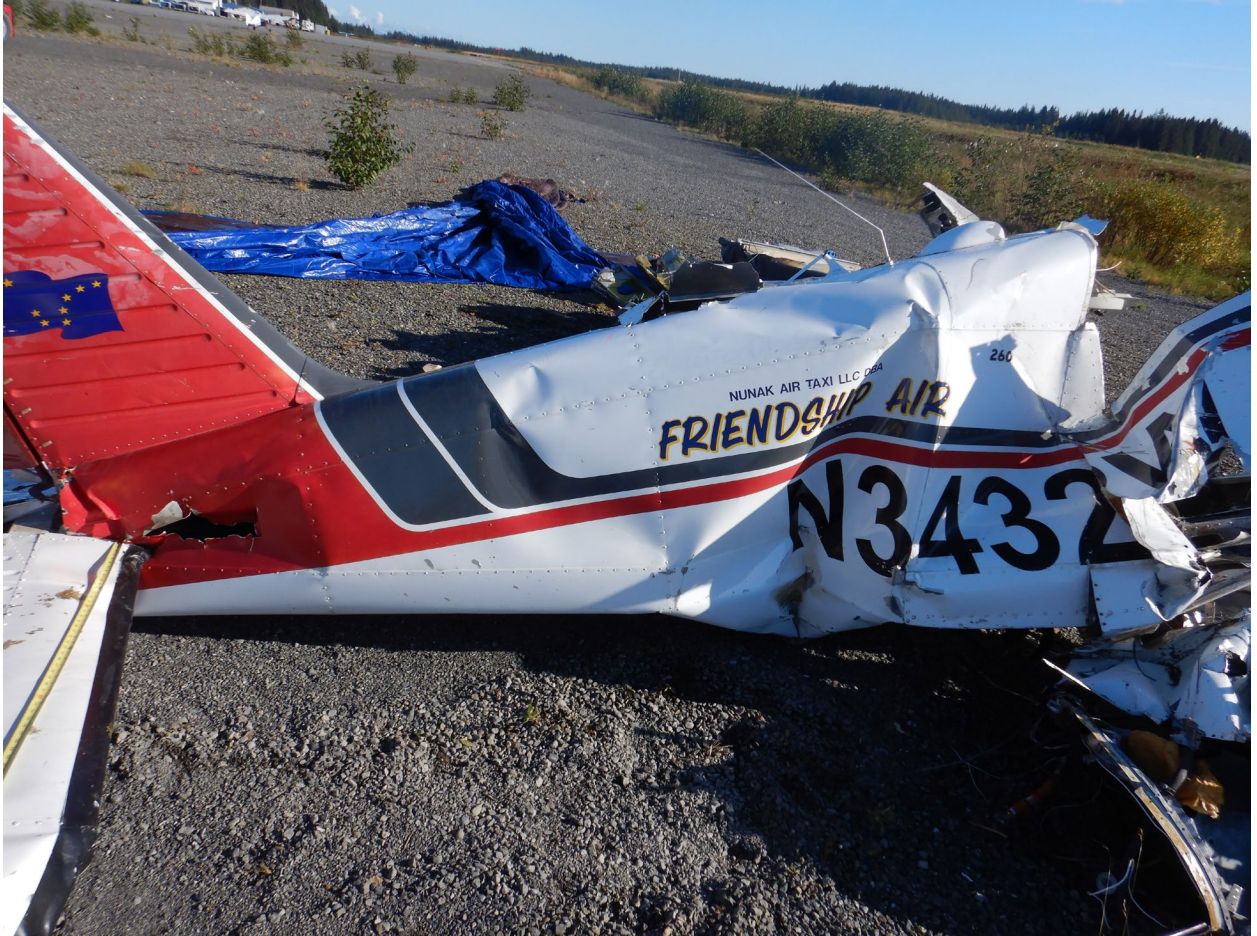
Visual inspection from the tail into the Empennage revealed all cables and pulleys in good condition. Both sides on the Empennage had impact damage from impact with the elevator. The right side of the empennage/fuselage had accordion impact damage at about a 45° angle (*figure 16*).

**Figure 16. View of the right side of the empennage and fuselage.**

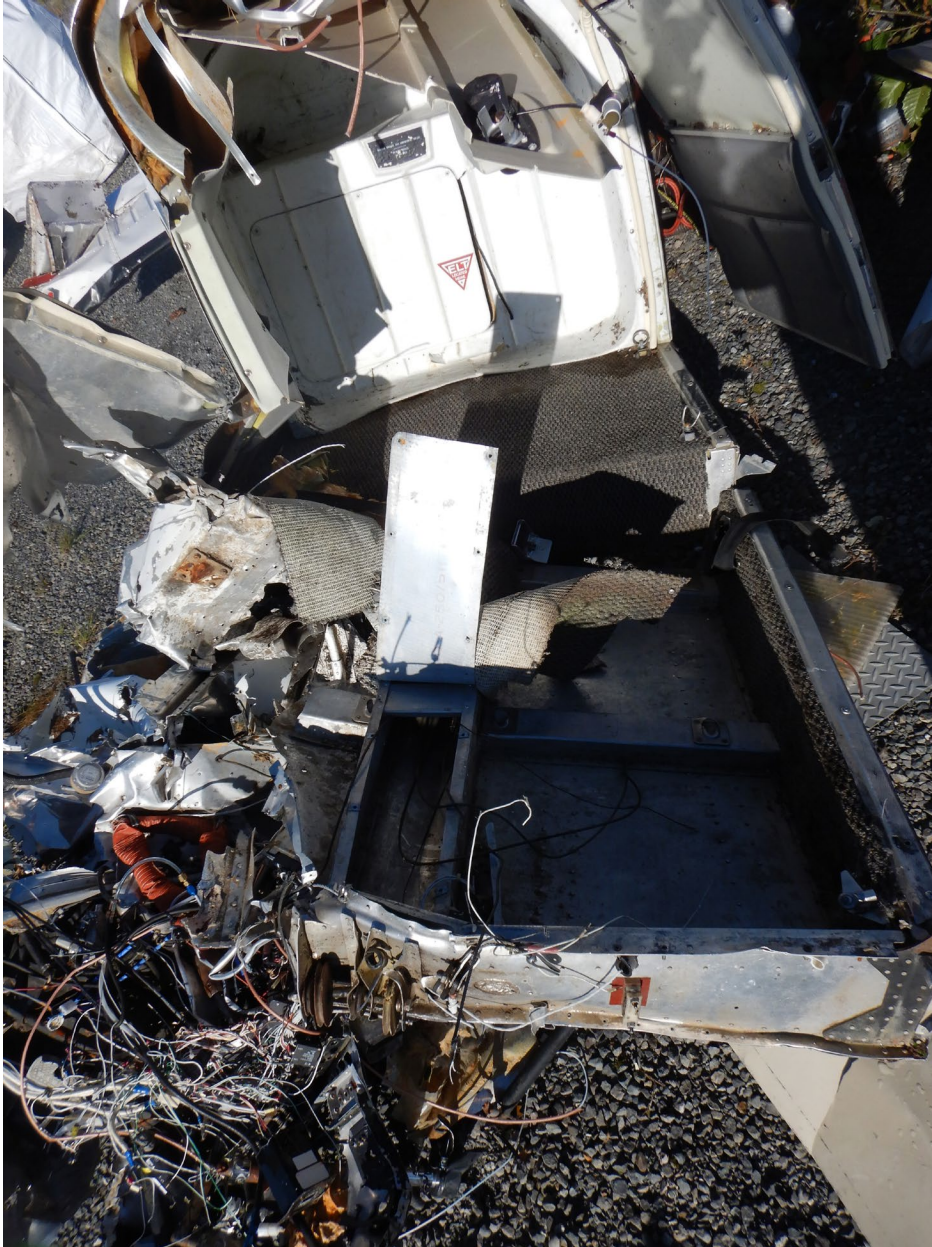
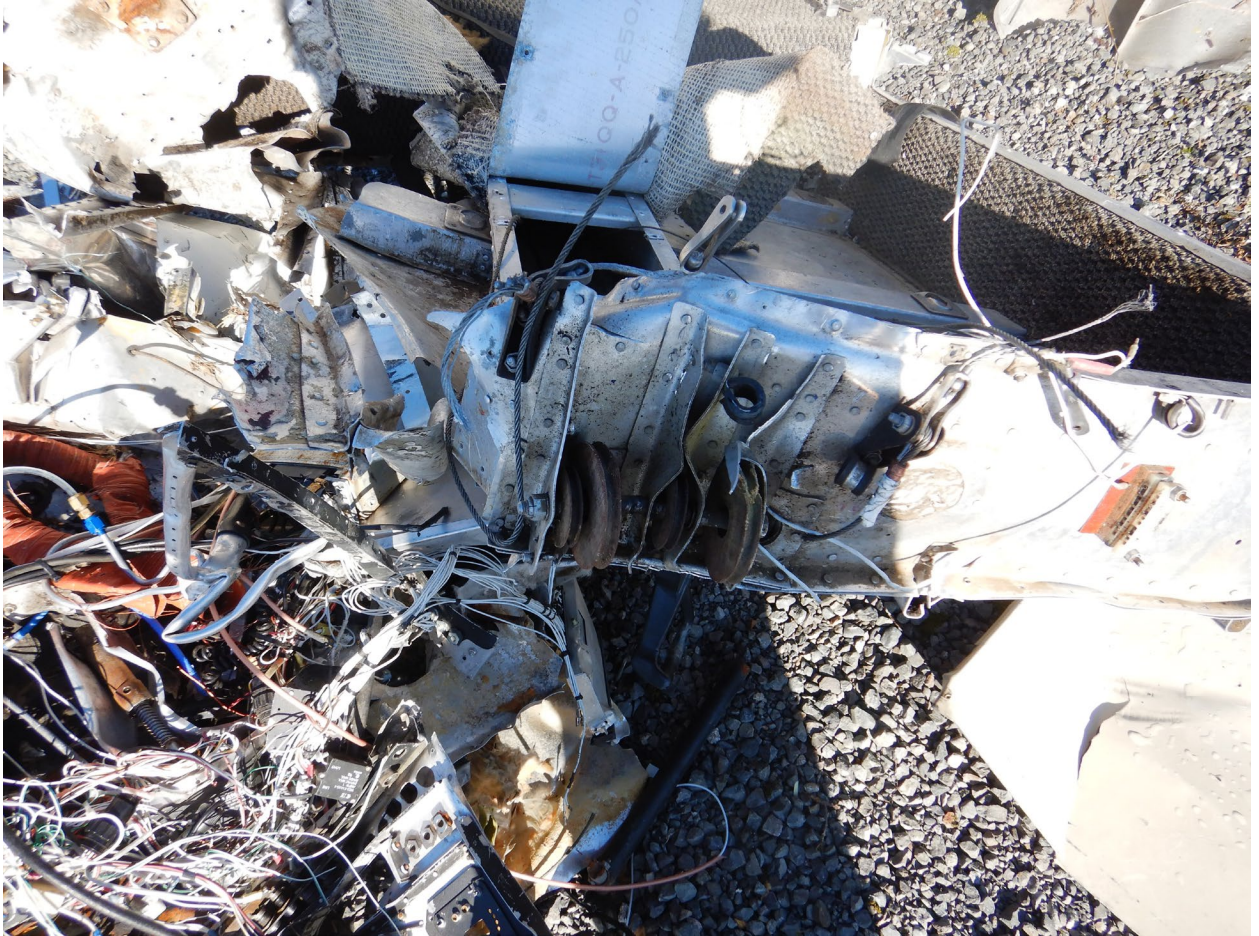
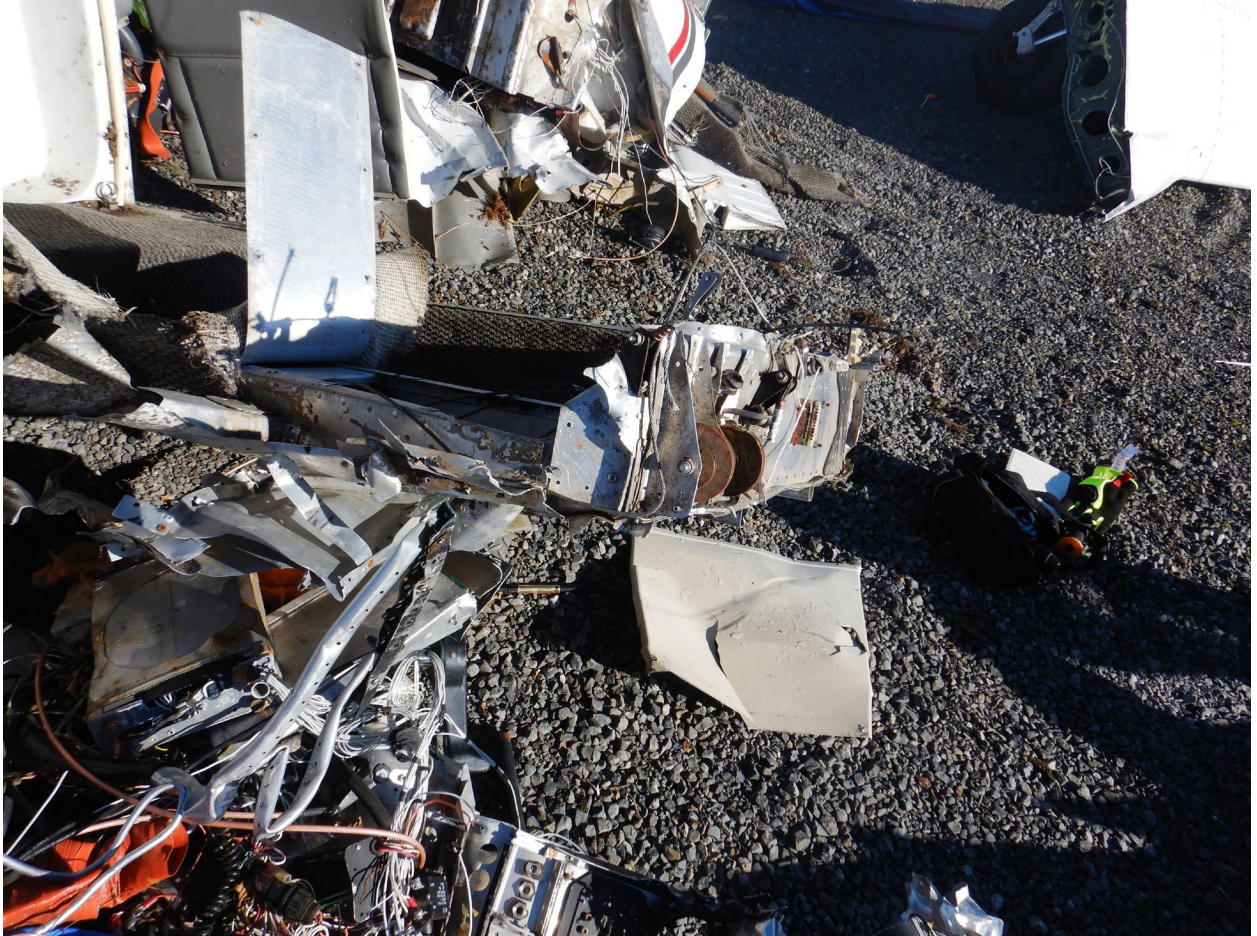
The rudder was attached to all attachment points and moved freely with minor impact damage to the fiberglass cap on top of the rudder. Rudder flight control cables were attached to the rudder with an overload break at pullies located about 5.5 ft into the airplane from the lower baggage compartment wall (*figure 18,19,20*).

**Figure 18. View of cabin floor about 5.5 ft from the baggage compartment wall.**

**Figure 19. View of flight control cable breaks along the floor about 5.5 ft from the baggage compartment wall.**

**Figure 20. Side view of the flight control cables about 5.5 ft from the baggage compartment wall.**

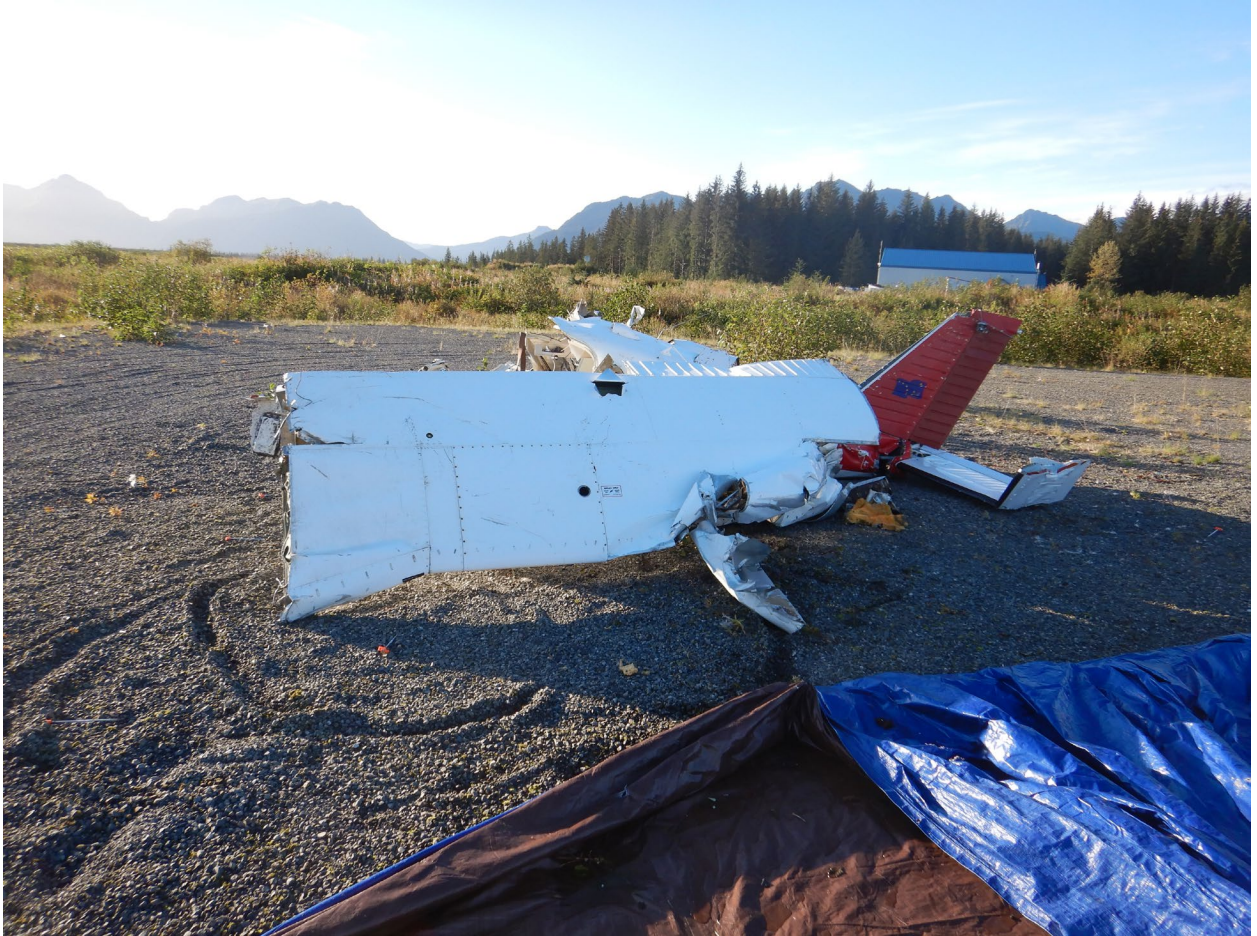
Left wing leading edge was impact damaged from the root to at about one foot outboard and significant impact damage about 67" outboard to the wing tip (*figure 21*). Fiberglass wing tip was impact separated. The left wing fuel cap was missing. Left aileron had a slight upward bend centered about mid span and was still attached to all attachment points. Left aileron control tube was still connected to the aileron and control cables. The cables pulled out into the upper wing surface near the wing root with broom strawing at the break in the cable from overload forces (*figure 24*). The left flap was impact separated from the left wing with the flap attachment portion still attached to the wing.

**Figure 21. View of left wing. Leading edge down.**

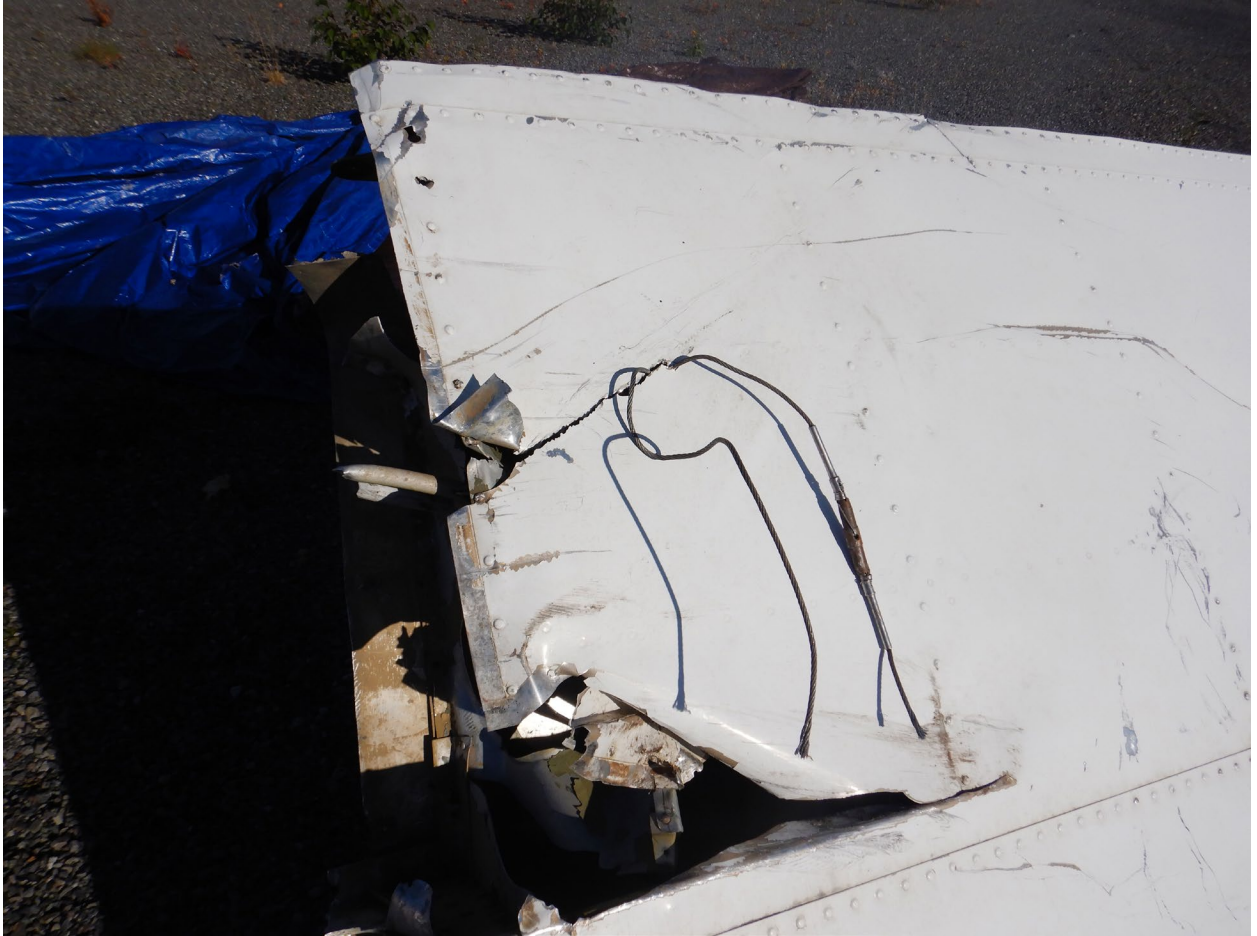
**Figure 24. View of left wing at the root. Flight control cables pulled through upper wing surface.**

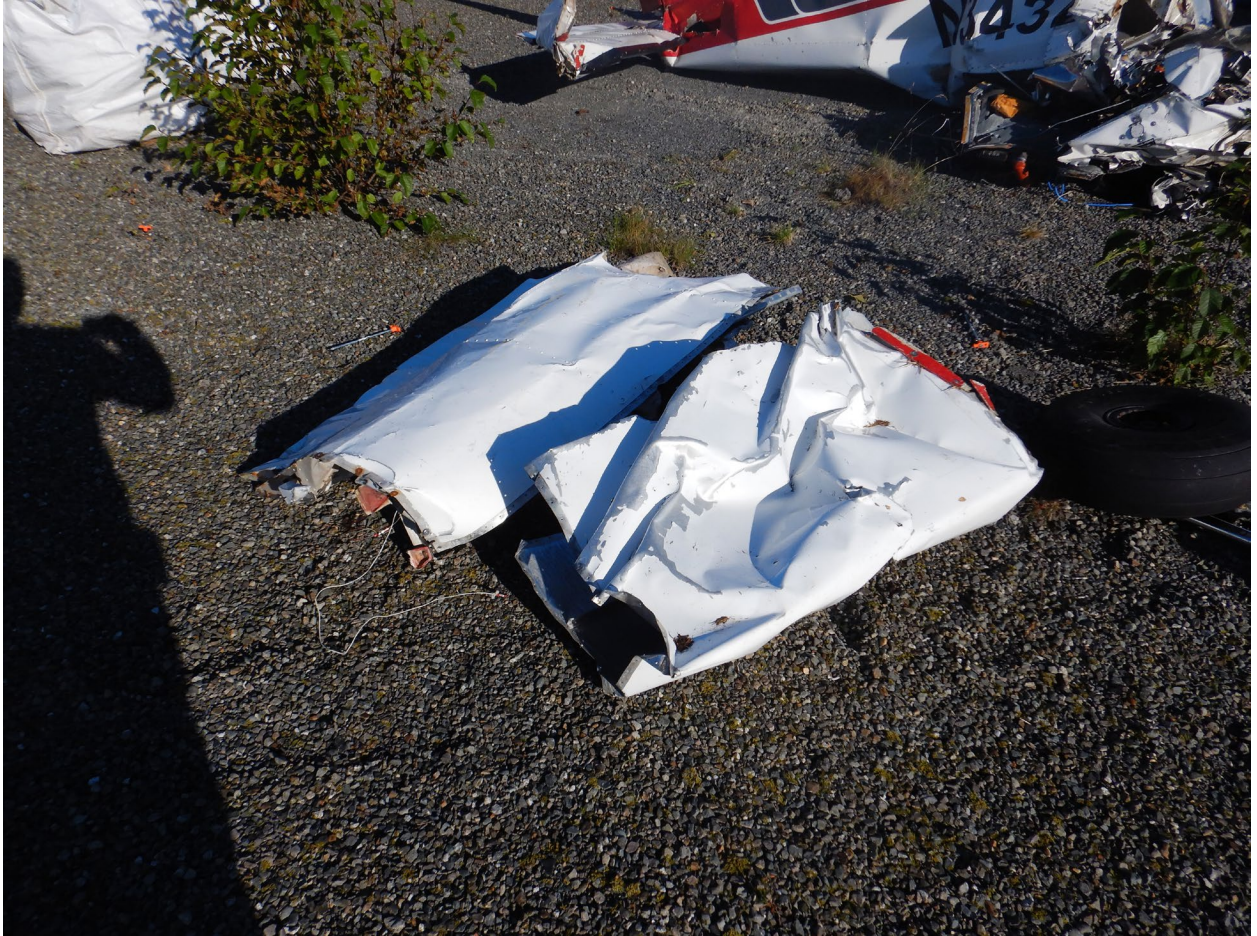
Right wing was impact separated from the fuselage. One section separated at the wing root (*figure 26,27*) and the other section was from the wing tip to about 62" in from the wing tip (*figure 25*). The fuel tank cap was still installed but the fuel tank had significant impact damage. Control cables for the right aileron were still attached from the aileron push tubes to a break under the flight controls in the cockpit from overload forces.

**Figure 25. View of outer right wing section.**
