# National Transportation Safety Board

ANC23LA002

## **WRECKAGE EXAMINATION**

Location: Cordova , AK  
Date: October 16, 2022  
Time: 1427 Local  
2227 Zulu  
Airplane: Piper PA-32-300 N3423W

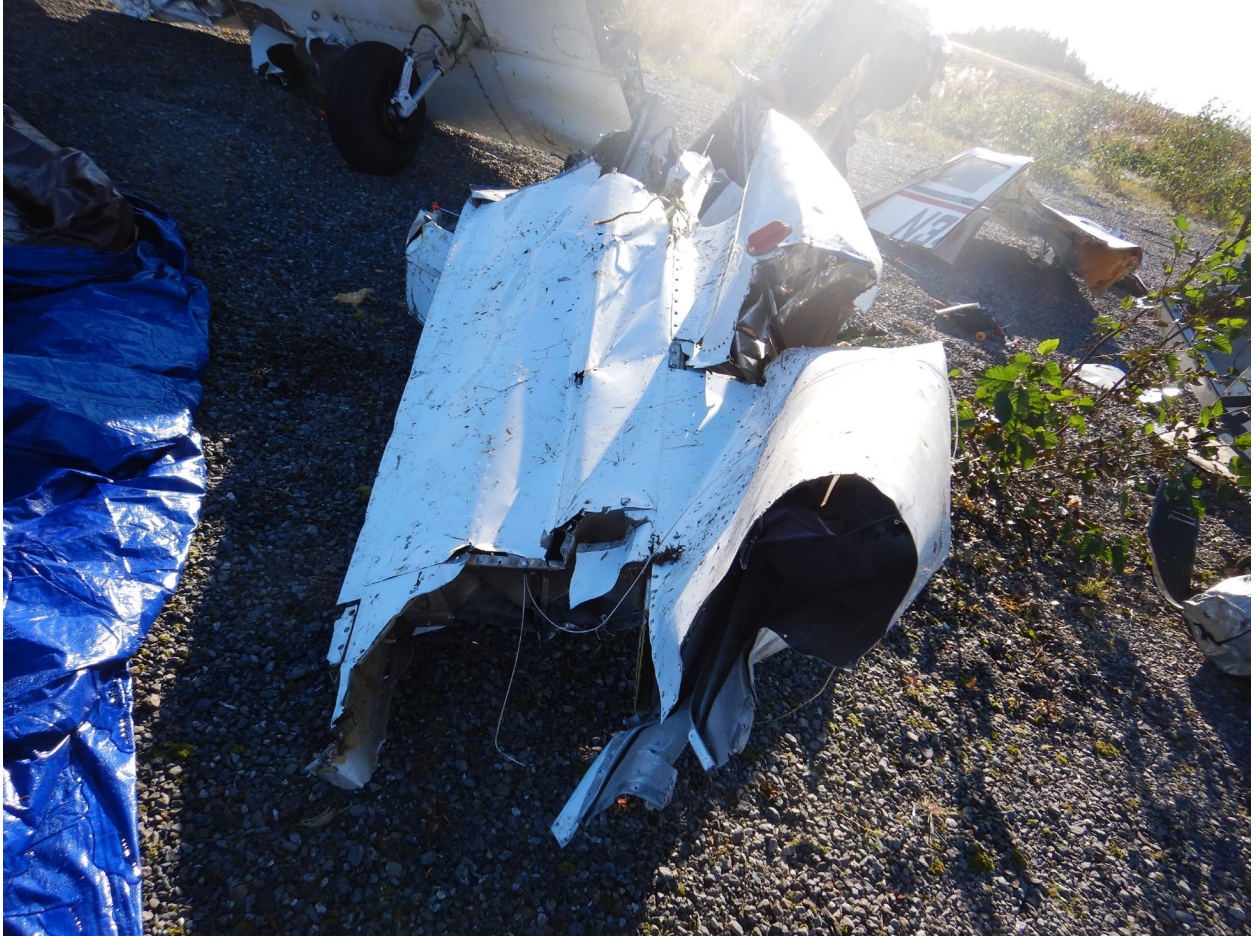
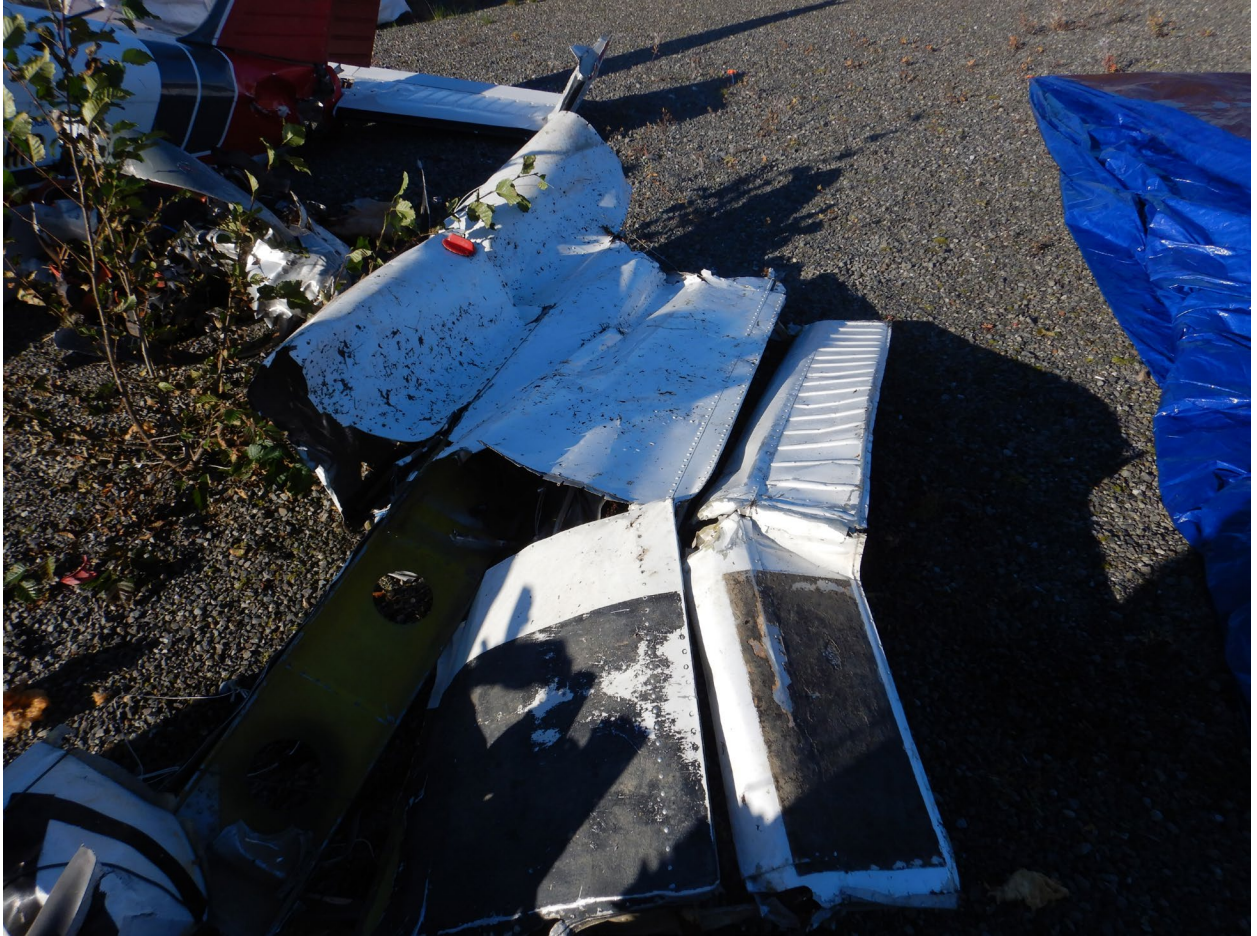
Right wing was impact separated from the fuselage. One section separated at the wing root (*figure 26,27*) and the other section was from the wing tip to about 62" in from the wing tip (*figure 25*). The fuel tank cap was still installed but the fuel tank had significant impact damage. Control cables for the right aileron were still attached from the aileron push tubes to a break under the flight controls in the cockpit from overload forces.

**Figure 26. View of inner right wing section.**

**Figure 27. View of right wing looking out from the wing root.**

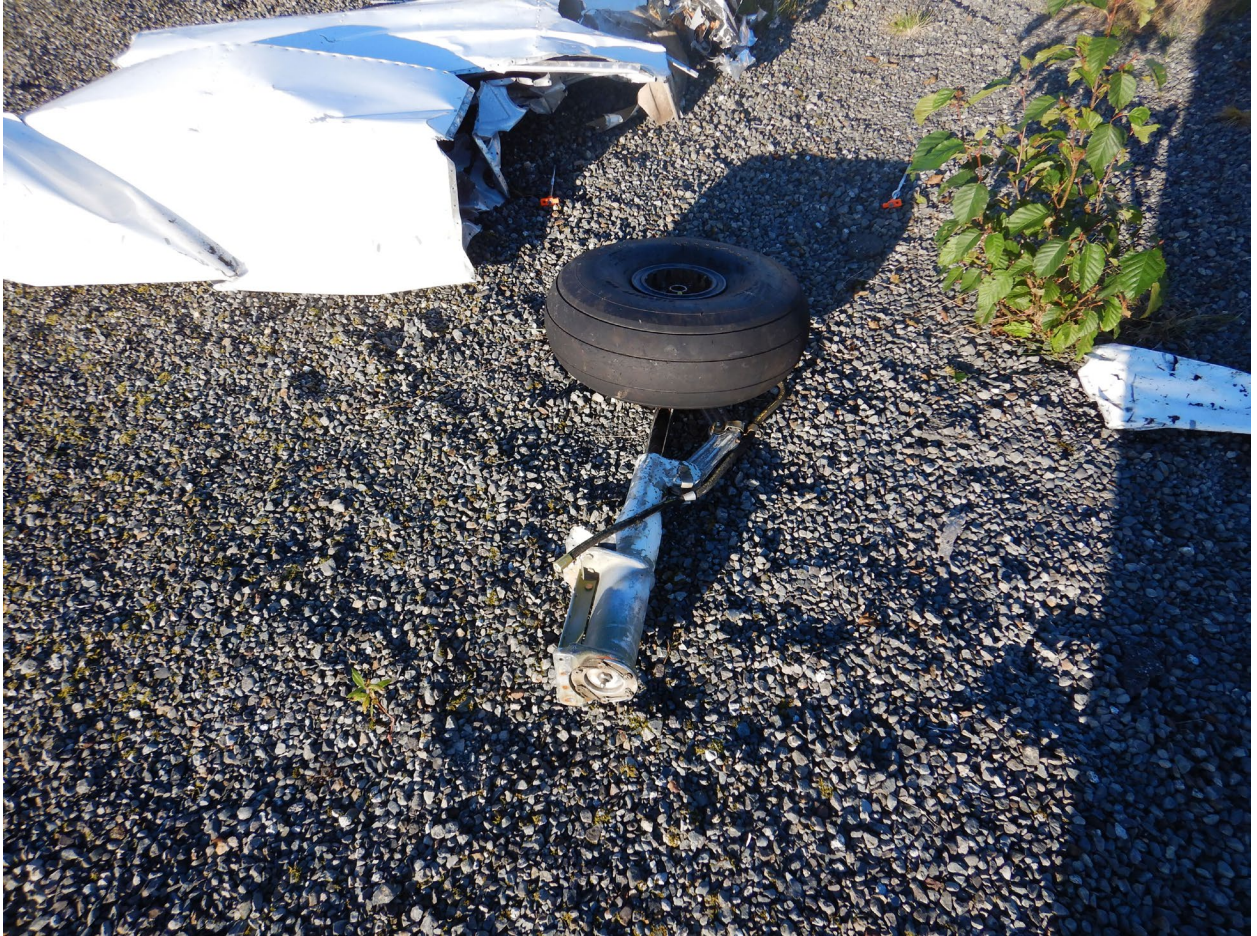
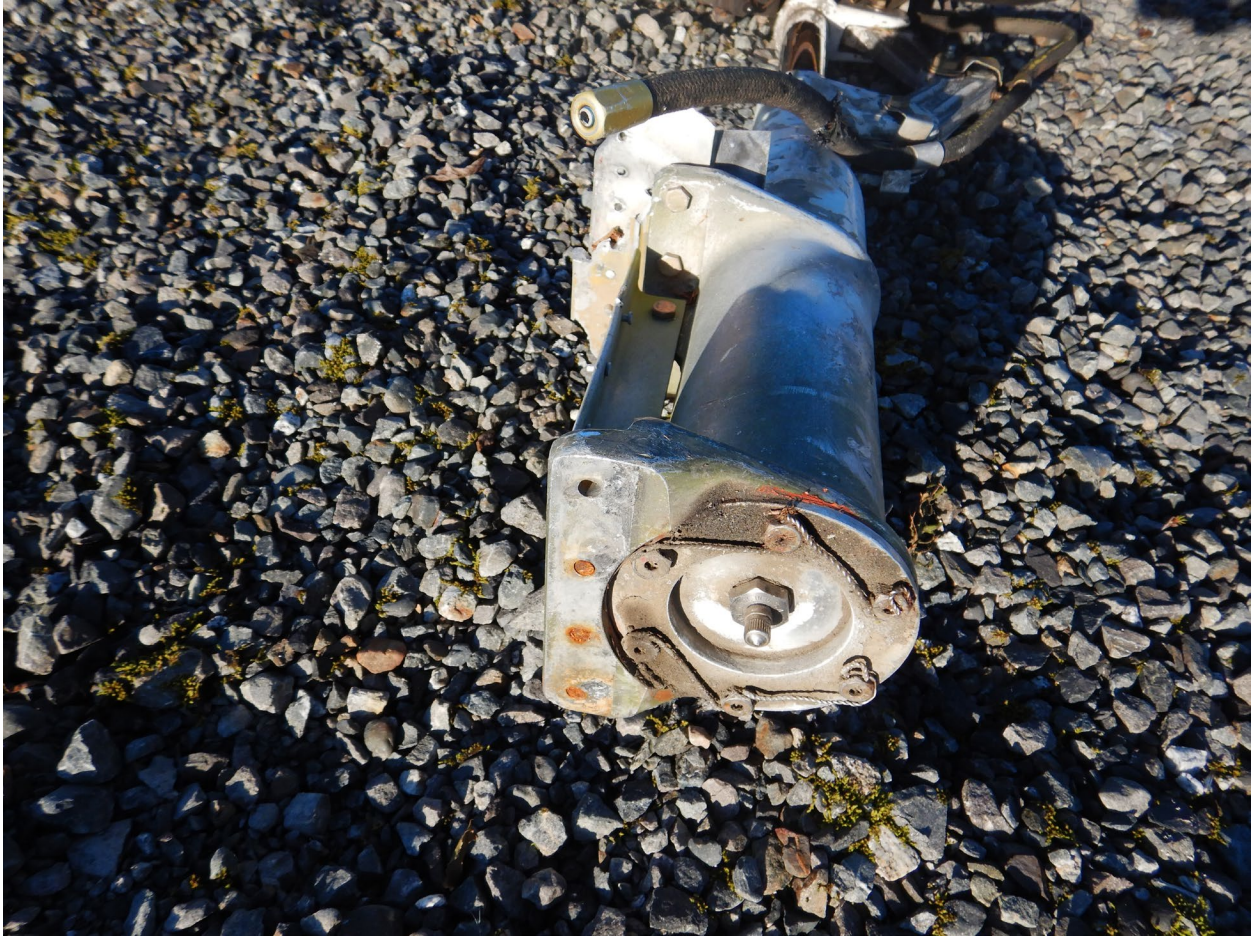
The left landing gear was still attached to the left wing, the right landing gear was impact separated from the right wing (*figure 28,29*). Both wheels turned freely.

**Figure 28. View of right landing gear assembly.**

**Figure 29. View of the right landing gear assembly looking down from the attachment point to the tire.**

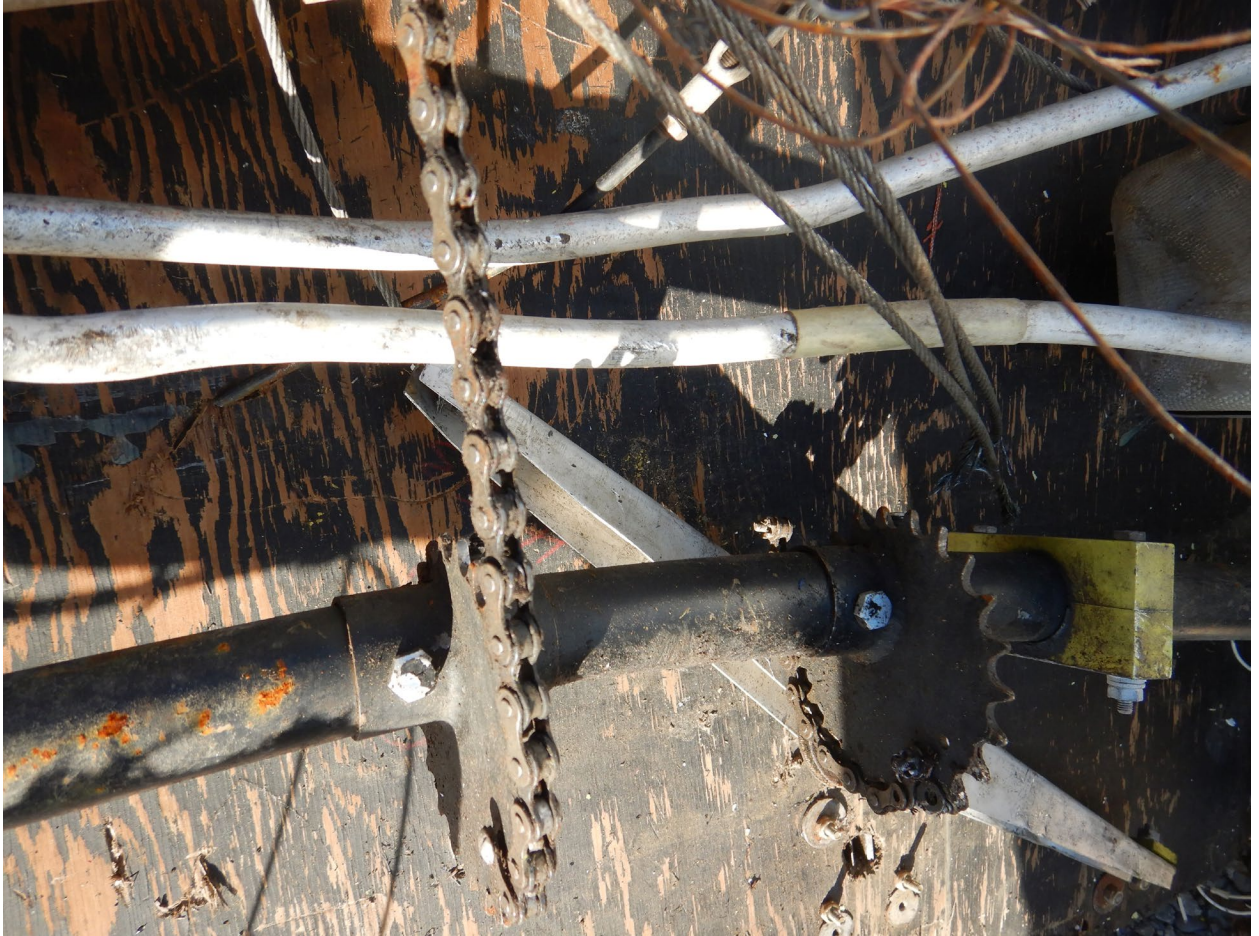
Cockpit had significant impact damage. The flight controls/cables were all impacted separated at the floor below the instrument panel (*figure 32*).

**Figure 32. View of control cable breaks under the floorboard near the instrument panel area.**

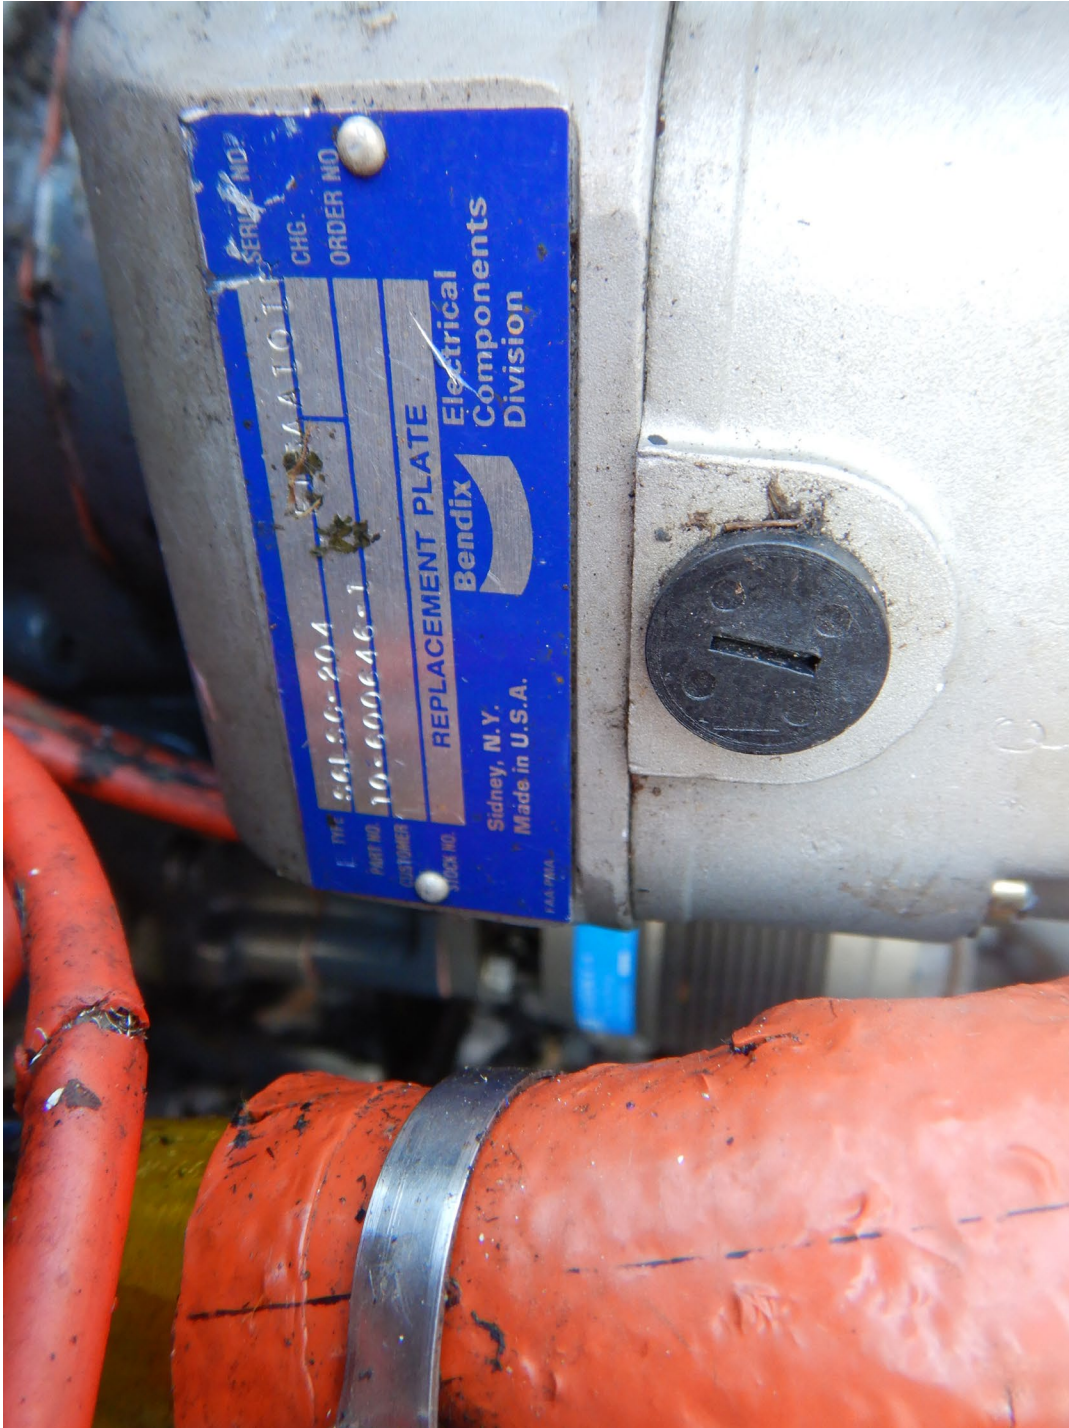
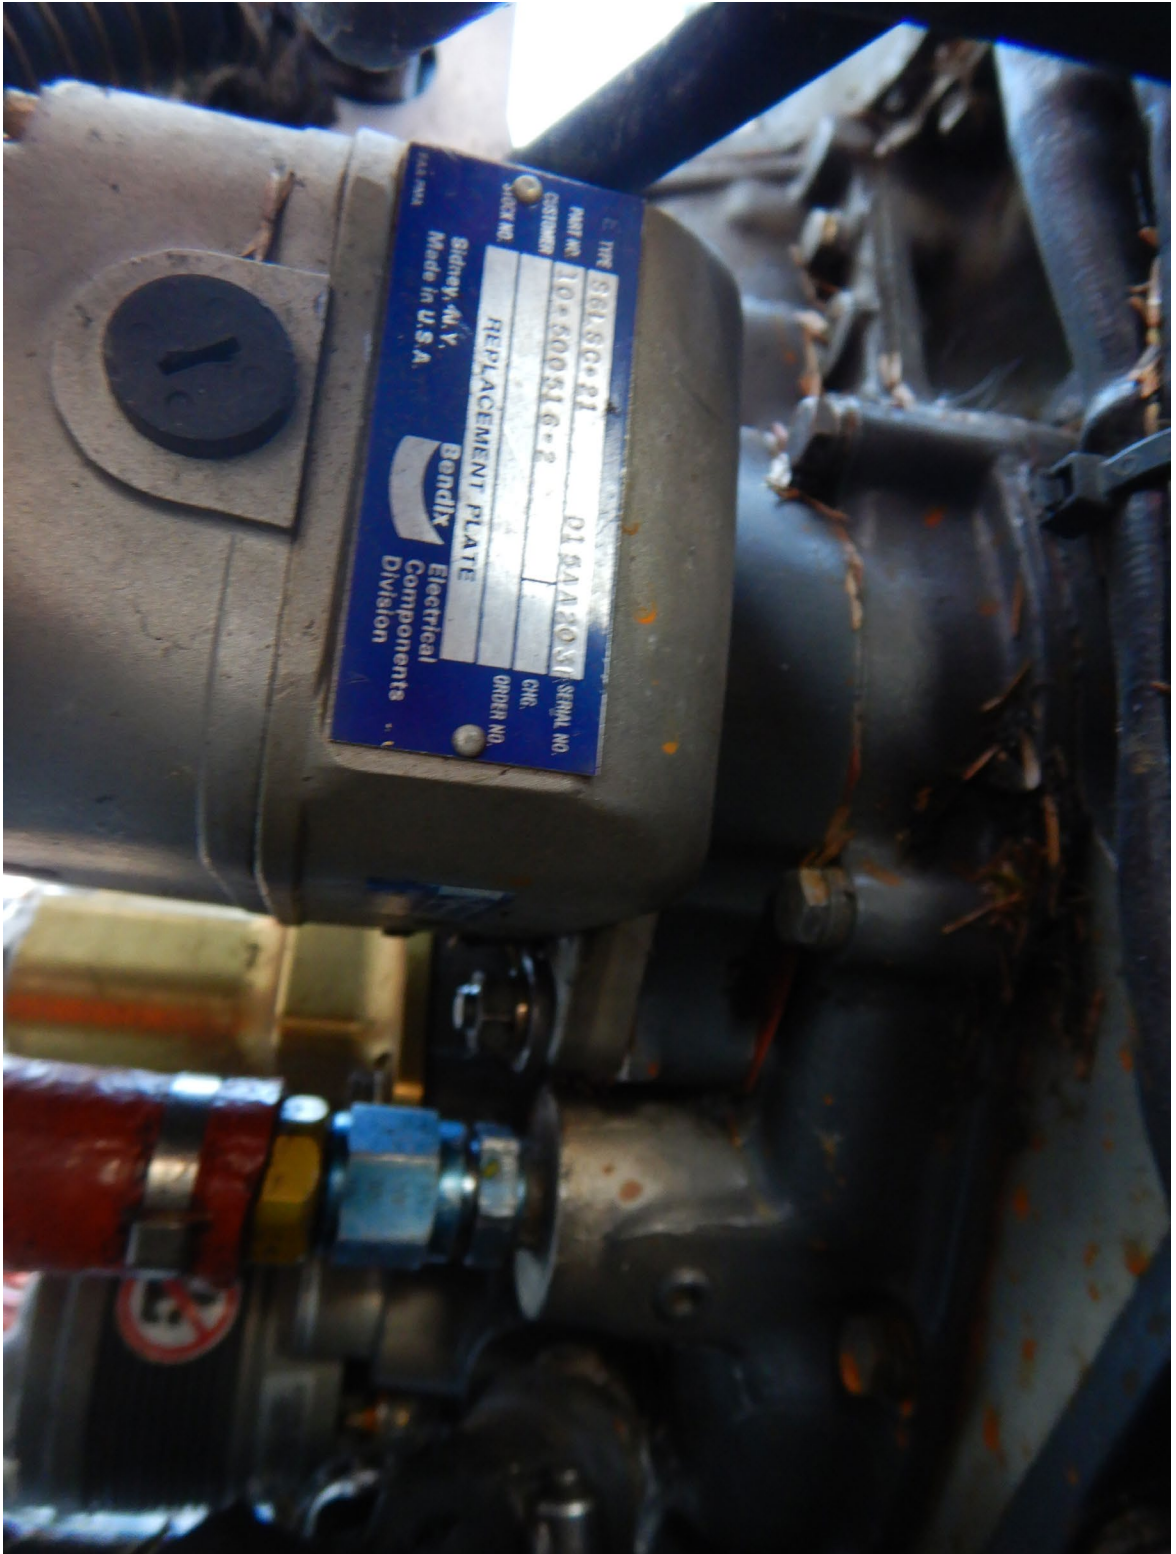
Engine could be rotated by hand. Limited by the ability of one person to lift and turn the engine with the propellers attached. Magnetos were securely attached to the engine (*figure 42, 43*). Removed the sparkplugs to inspect inside of the cylinders but due to broken intake and exhaust connections, water had entered into the cylinders. The engine internals were exposed to the elements for almost a year. The spark plugs and inside of the cylinders were rusted.

**Figure 42. View of the right engine magneto.**

**Figure 43. View of the left engine magneto.**

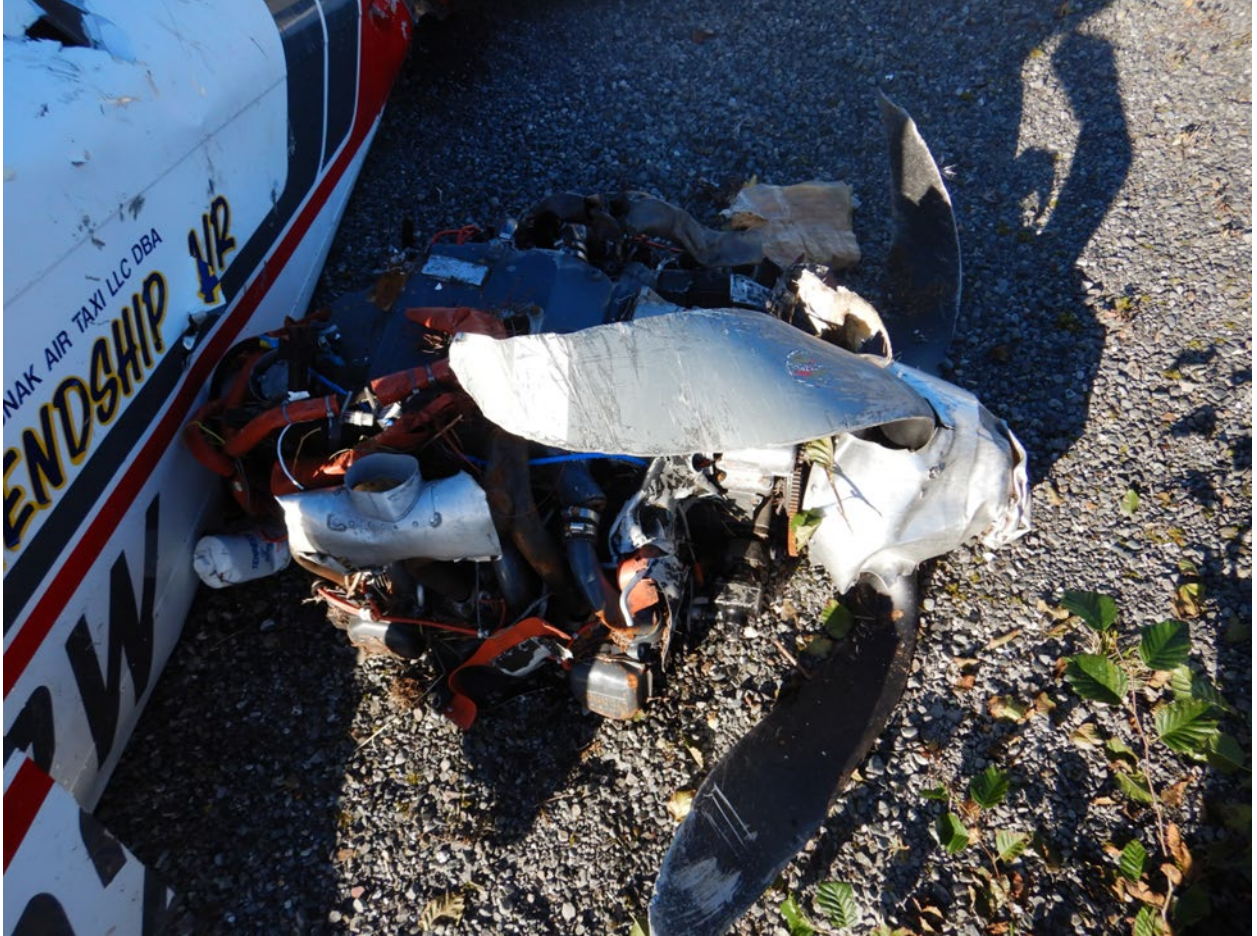
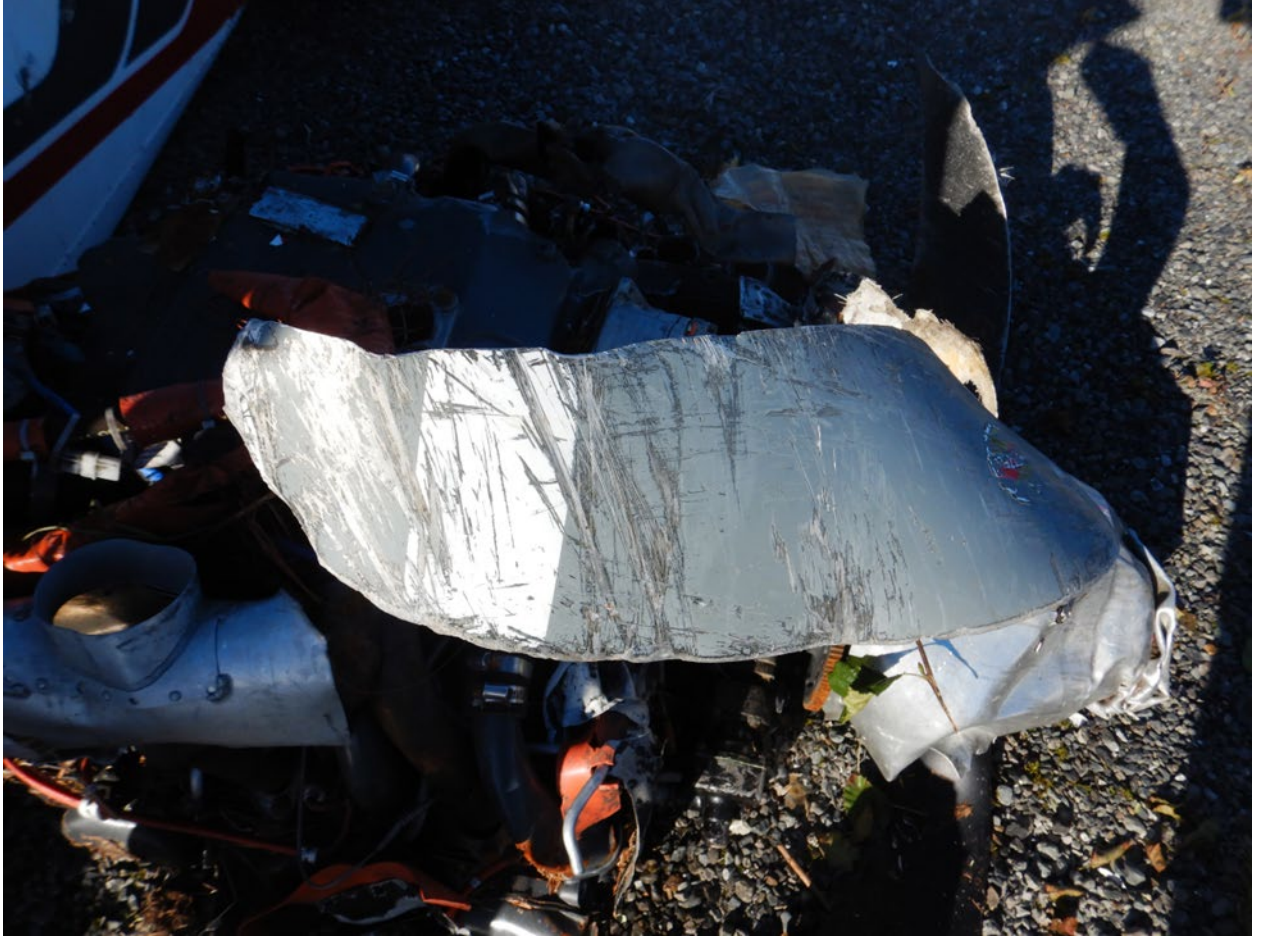
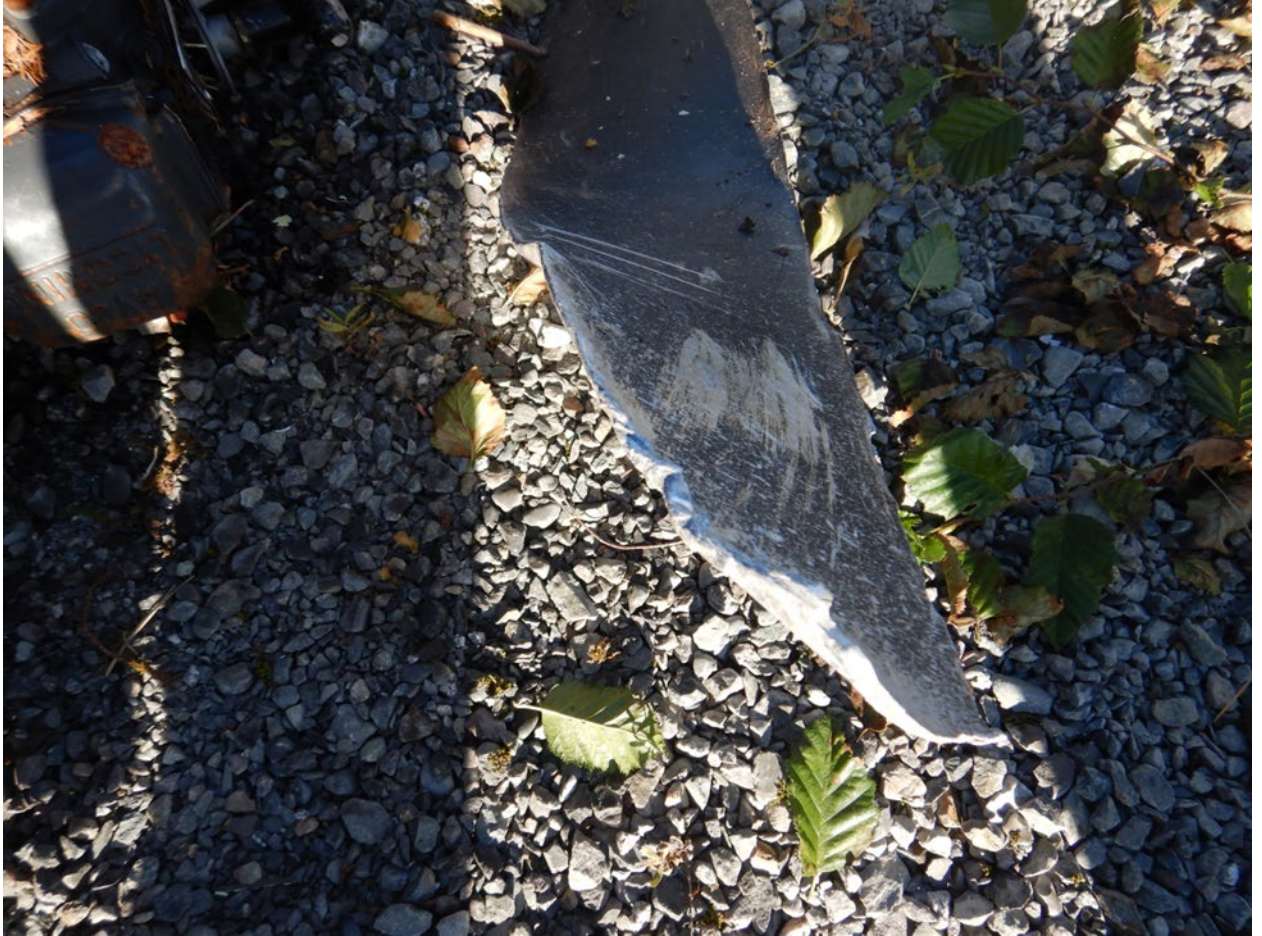
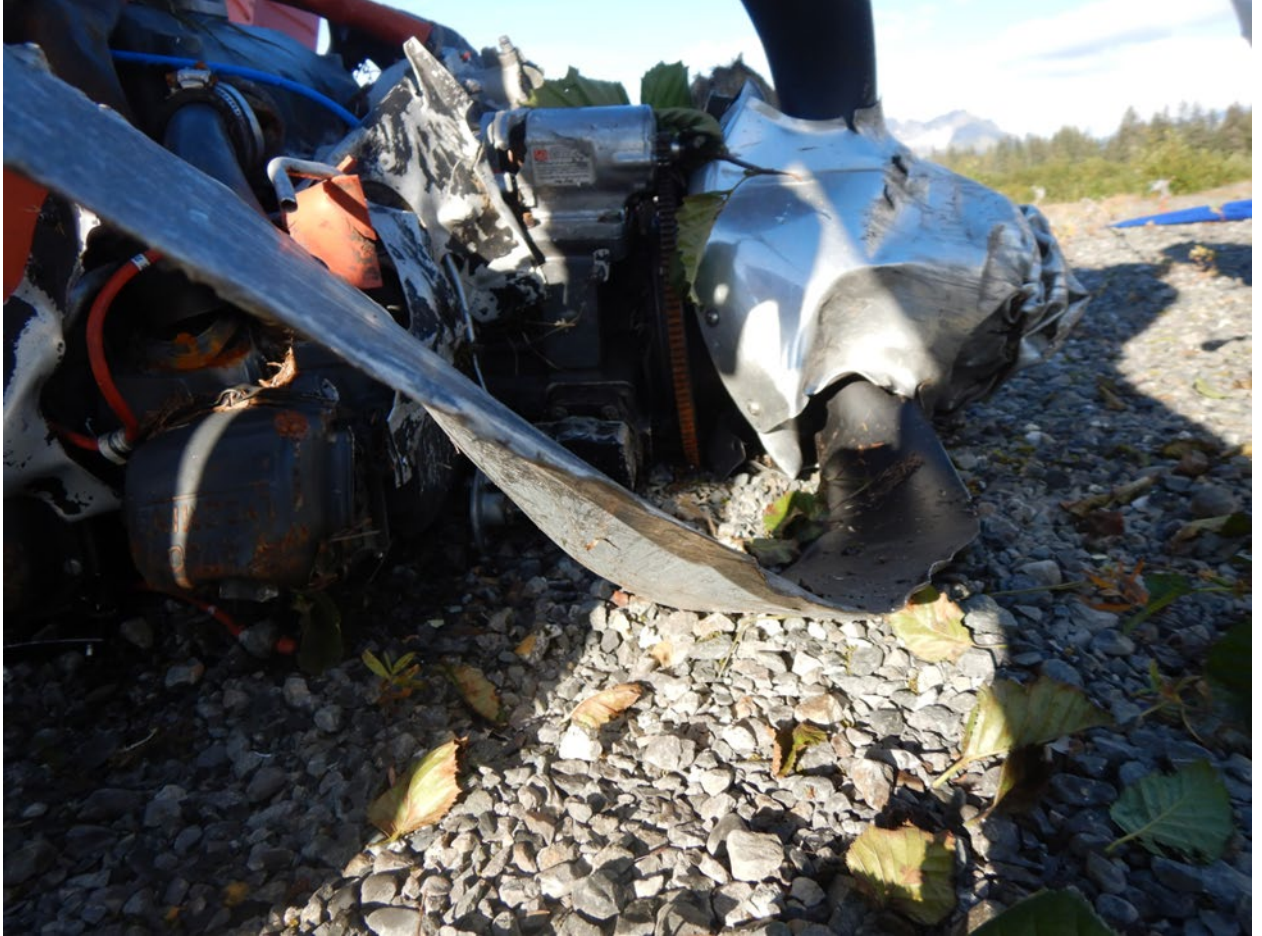
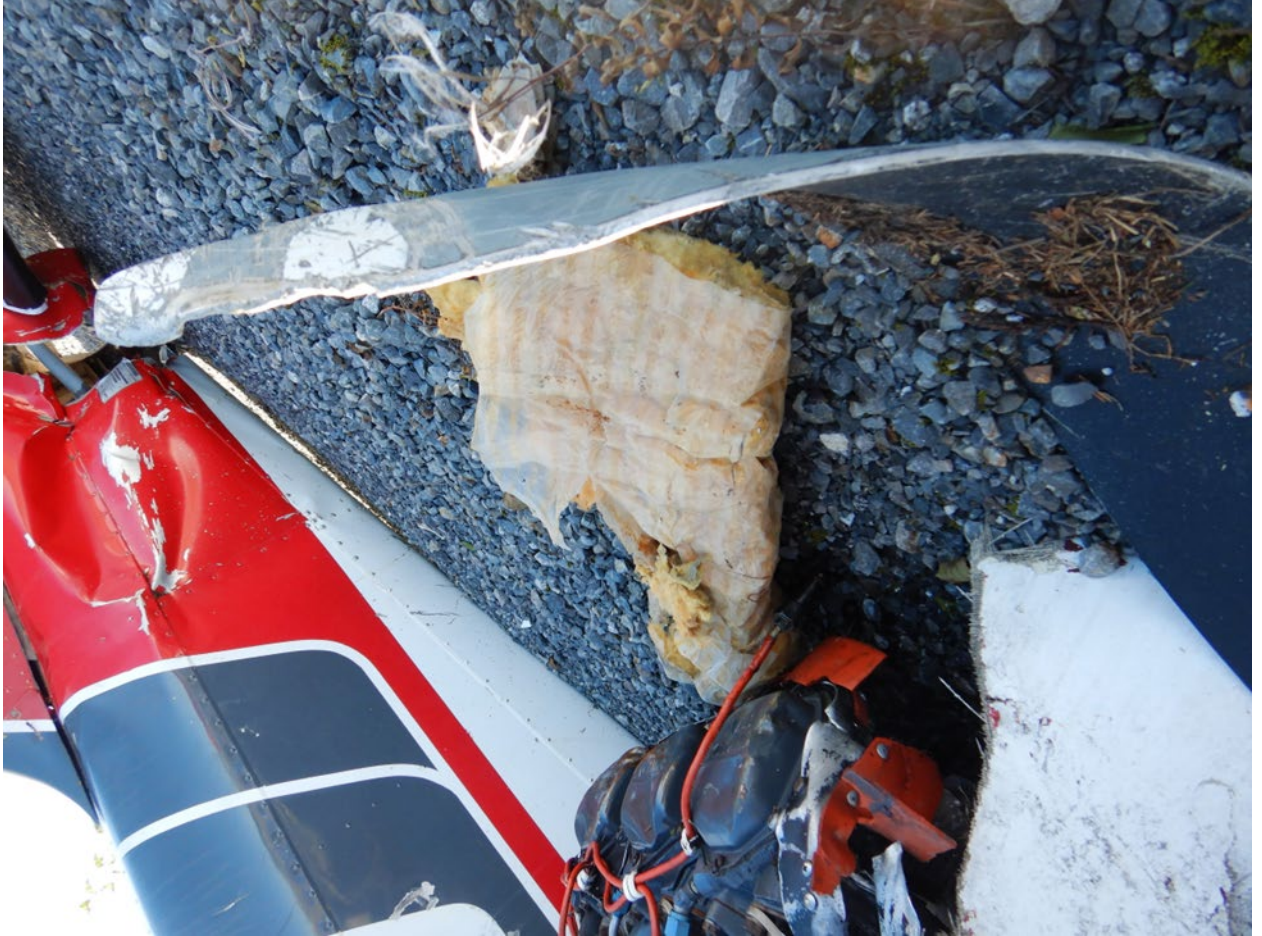
All three propeller blades had rotational scoring and bending of the blades indicating the engine was producing power at the time of impact (*figure 45-49*).
