## SERVICE BULLETIN

Service Bulletin No. 475C  
(Supersedes Service Bulletin No. 475B)  
Engineering Aspects are  
FAA Approved

SUBJECT: Crankshaft Gear Modification and Assembly Procedures

MODELS AFFECTED: All Lycoming direct drive piston aircraft engines (including VO-360 and IVO-360; excepting O-320-H, O-360-E, LO-360-E, TO-360-E, LTO-360-E, and TIO-541 series engines).

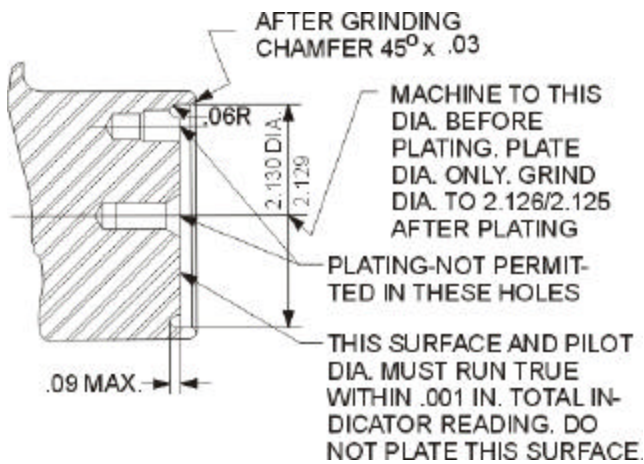
Figure 1. Details for Repairing Pilot Diameter of Crankshaft

3. Check the pilot diameter of the counterbore on the end of the crankshaft for size and evidence of damage. This diameter should not exceed 2.1262 inches when measured at any location. If found to be oversize, the crankshaft may be repaired as described in the following steps. Do not attempt to reuse a crankshaft with an oversize pilot diameter.

- a. After removing the dowel, machine the pilot diameter in the end of the crankshaft to 2.129/2.130 inch as shown in the illustration. See Figure 1. Also, cut the .09 deep x .06R undercut as shown.

- b. Chrome or nickel plate the surface of the pilot diameter with a firmly bonded deposit that is free of pin holes, blisters and any other imperfections that could impair the function of the parts.

- c. After plating, stress relieve the shaft by baking at 390° to 410°F for 3 to 5 hours.
  - d. Grind the plated pilot diameter surface to 2.125/2.126 inch. Note that the diameter must run true with rear main journal within .001 inch total indicator reading.

- e. Chamfer edge of pilot diameter  $45^\circ \times .03$  as shown in Figure 1.
4. If the dowel has been removed, check the condition of the dowel hole in the crankshaft. If out of round or oversize, ream as required for installation of an oversize dowel. Available oversize dowels and the corresponding size for reamed holes are shown in Table 1.
5. Install a new dowel in the crankshaft as shown in Figures 2 and 3. Insure that the correct dowel is installed.

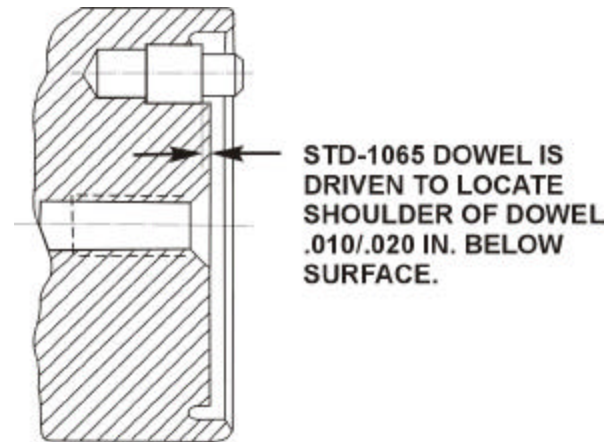
Figure 2. Section Thru End of Crankshaft Showing Driven Height of STD-1065 Dowel

2. Check the condition of the dowel in the end of the crankshaft. It should be perfectly smooth with no indication of nicks or deformation. If it is out of round, it should be removed and replaced with a new one. Replacement instructions are in paragraph 4. If dowel condition is acceptable, insure that it is installed as shown in Figure 2 or 3.

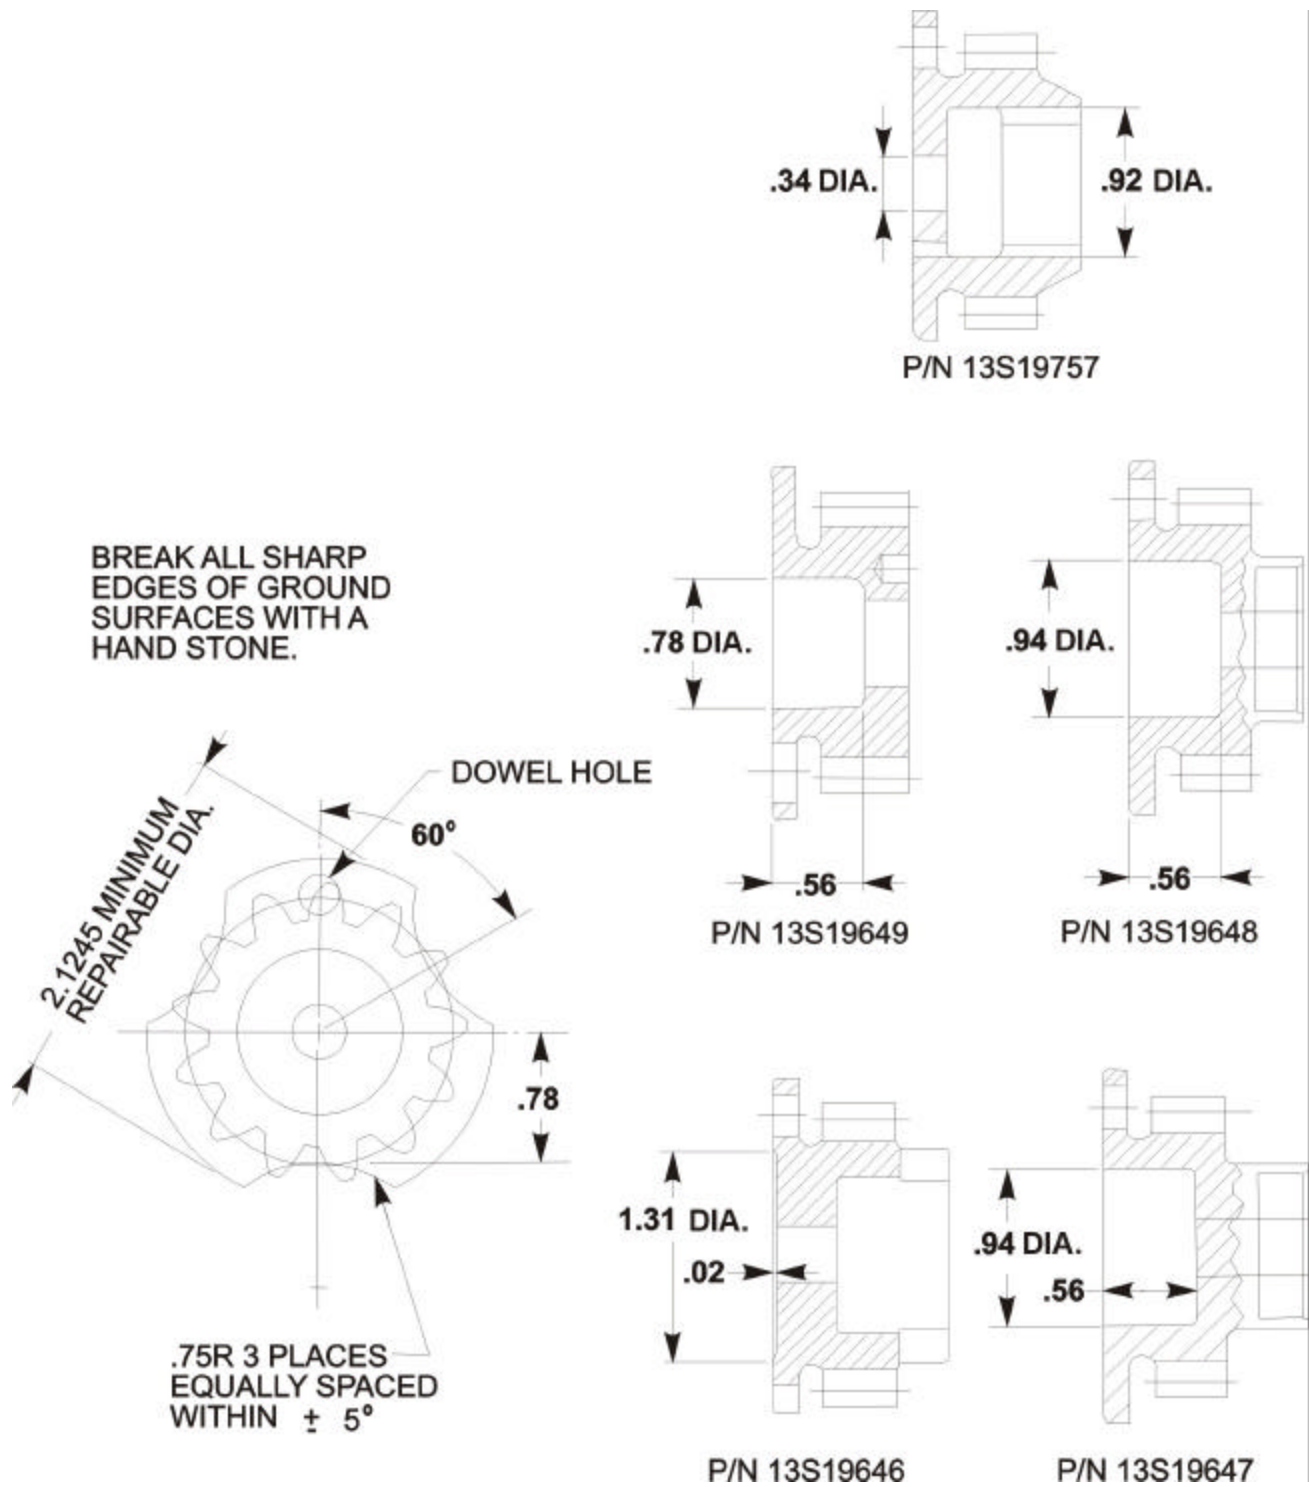
Figure 5. Details for Rework of Crankshaft Gears to Current Configuration

CRANKSHAFT GEARS FOR APPLICABLE ENGINES ARE NOW MANUFACTURED WITH THREE 3/4 INCH RADIUS SCALLOPS CUT INTO THE O.D. OF THE PILOT FLANGE AND A COUNTERBORE ON THE BACK SIDE OF THE GEAR. THESE ENLARGED SCALLOPS HAVE BEEN ADDED TO ALLOW INSPECTION OF THE GEAR AND CRANKSHAFT ASSEMBLY. SERVICEABLE GEARS MUST BE MODIFIED AS SHOWN IN FIGURE 5. PRIOR TO BEING REASSEMBLED ON THE CRANKSHAFT, OR A NEW GEAR THAT HAS BEEN MANUFACTURED TO THIS CONFIGURATION MUST BE INSTALLED. BEFORE MODIFYING THE GEAR, MEASURE THE DIAMETER OF THE PILOT FLANGE. IF IT IS LESS THAN 2.1245 INCH, IT SHOULD NOT BE RESUED. THE ORIGINAL 2.1250/2.1255 DIMENSION OF THE CRANKSHAFT GEAR MUST BE RESTORED WITH A FLASH COPPER PLATE OF UP TO .0005 INCH MAX.

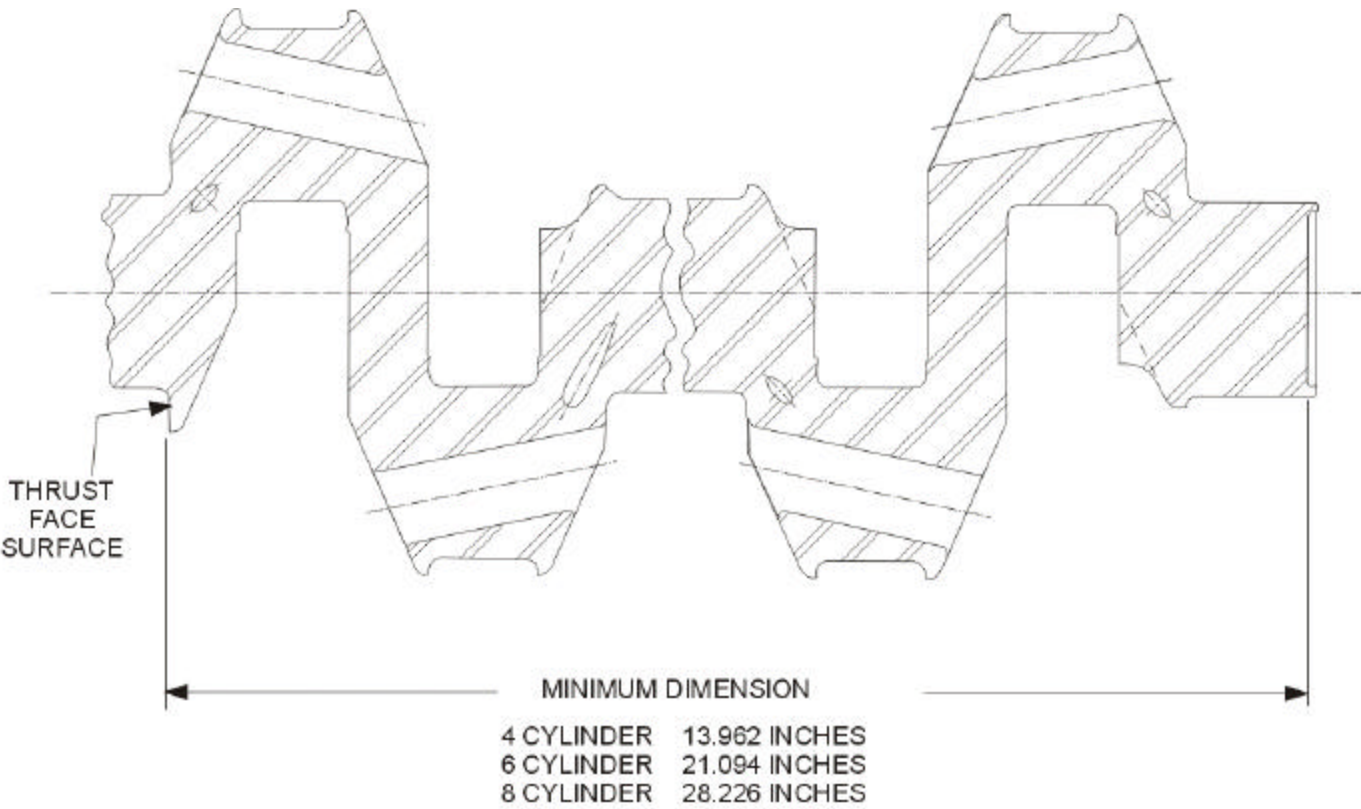
Figure 7. Minimum Dimension of Crankshaft

THE CRANKSHAFT COUNTERBORED GEAR MOUNTING FACE SHOULD BE CHECKED FOR DAMAGE. IF THE SURFACE REQUIRES REPAIR OTHER THAN SPECIFIED IN “CAUTION” ON PAGE 1, THE CRANKSHAFT SHOULD FIRST BE MEASURED AS SHOWN IN FIGURE 7. IF THE CRANKSHAFT MEASURES MORE THAN THE MINIMUM DIMENSION SHOWN IN FIGURE 7, THE SURFACE MAY BE REWORKED DOWN TO THE DIMENSIONS SHOWN. (DO NOT PLATE THIS SURFACE.) THE SURFACE MUST BE TRUE WITHIN .001 IN. TOTAL INDICATOR READING TO REAR MAIN BEARING AND THE SURFACE FINISH MUST BE HELD TO 45 TO 90 MICROINCHES.

INSURE MINIMUM DIMENSION IS MEASURED BETWEEN THRUST FACE SURFACE AND PILOT.
