# National Transportation Safety Board

ANC23LA013

## **ENGINE EXAMINATION**

Location: Wasilla, AK  
Date: January 13, 2023  
Time: 1545L  
1245Z  
Airplane: Taylorcraft BL-65

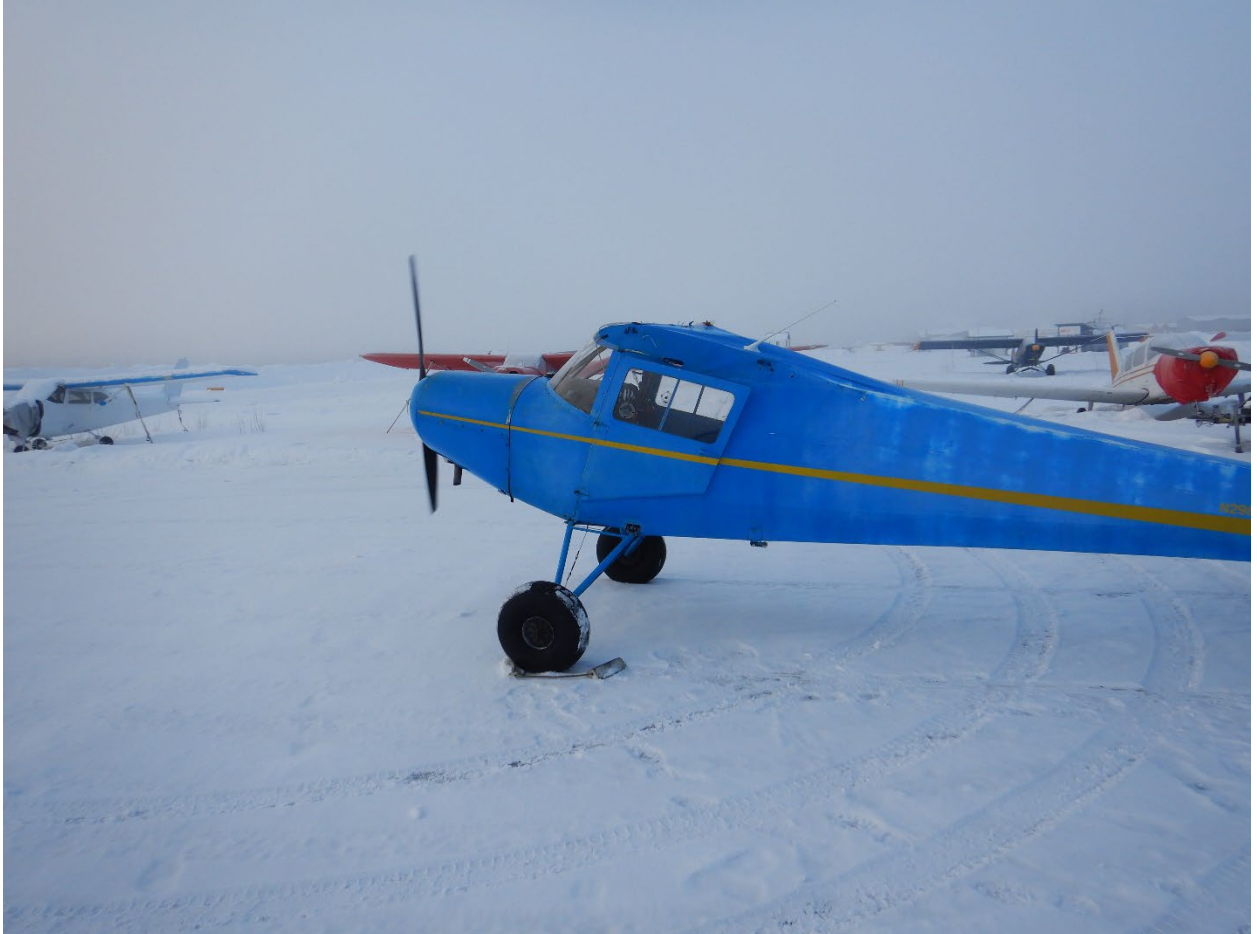
A serviceable propeller was installed, and the airplane engine was started. The engine started normally. The engine rpm was limited to 1200 rpm for safety concerns. The engine sounded normal and was left to run outside. (Figure 1)

**Figure 1** Accident airplane during engine run test.

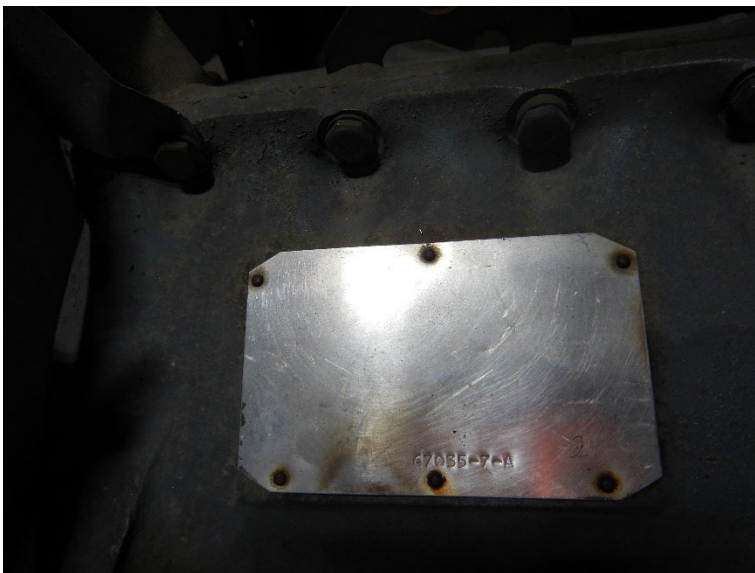
**Figure 2** Engine data tag.

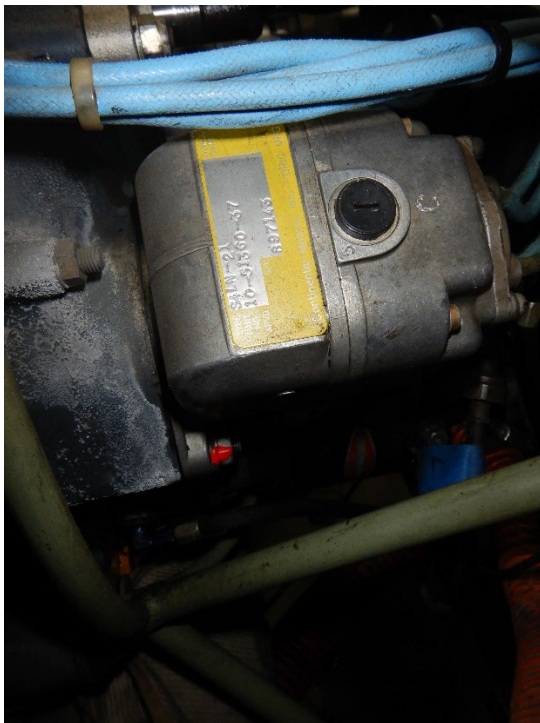
Magneto timing was at 24° for both magnetos, which is correct for this engine. Both Magnetos were securely fastened to the engine. (Figure 3 and 4)

**Figure 3 Left engine Magneto.**

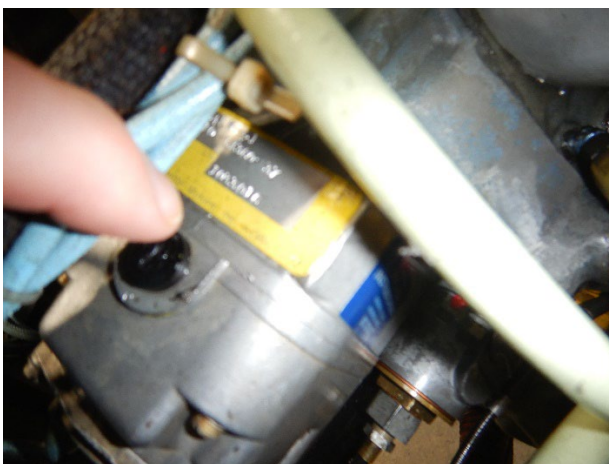
**Figure 4 Right engine Magneto.**

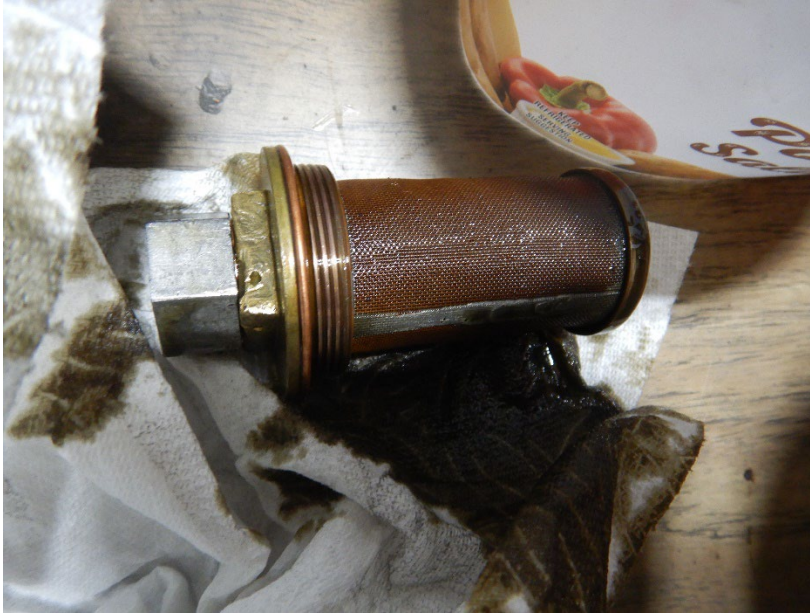
Engine oil screen was inspected, and no metal found.(Figure 5)

**Figure 5 Engine oil screen.**

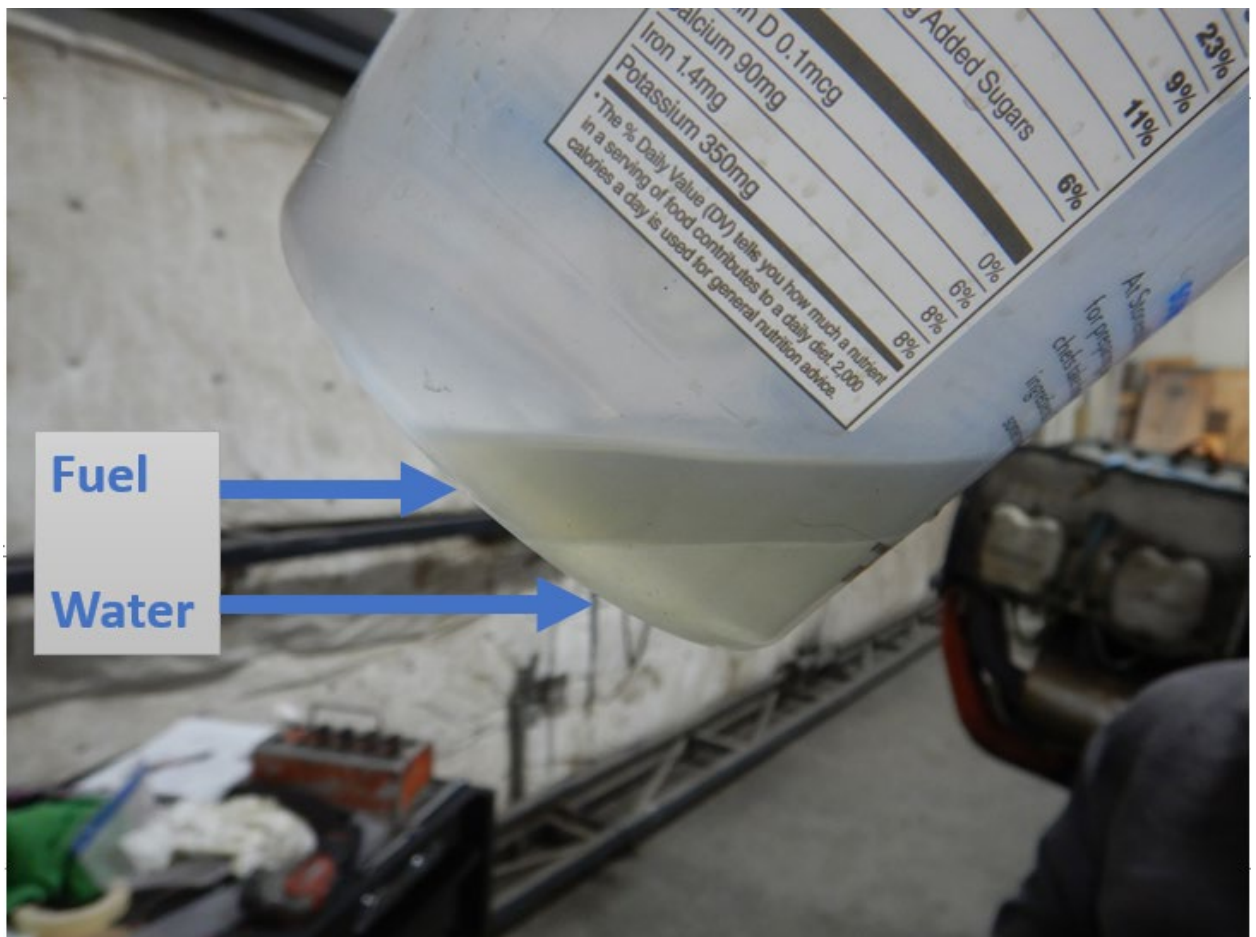
Gascolator was clean with a mixture of gas and water inside.

Carburetor was drained and water was found. The fluid from the carburetor was about 1/3 water. (Figure 6)

**Figure 6 Fluid drained from the Carburetor and Gascolator.**

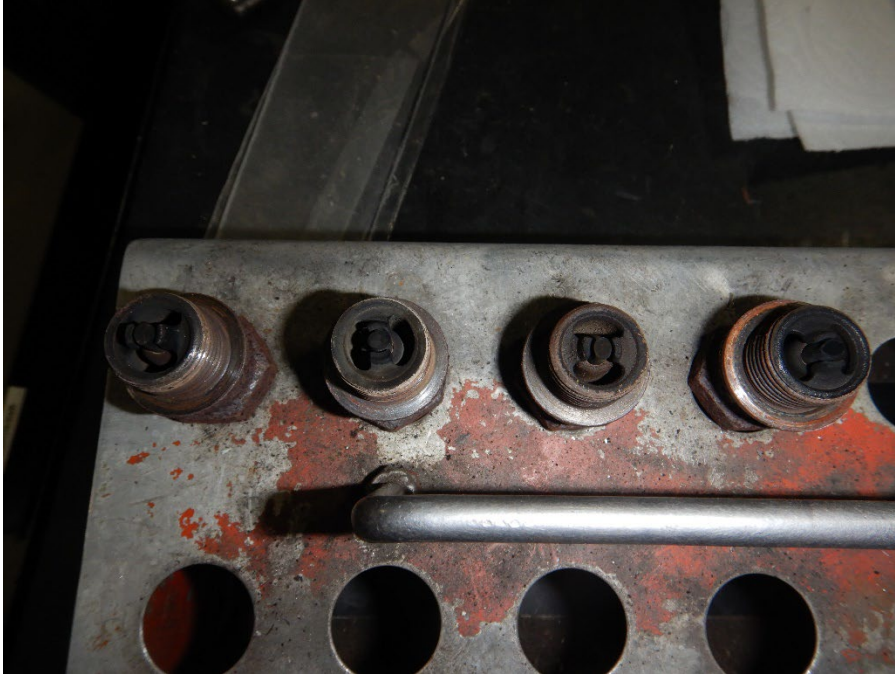
The top spark plugs were inspected and in serviceable condition. (Figure 7)

**Figure 7 Top sparkplugs from the engine.**

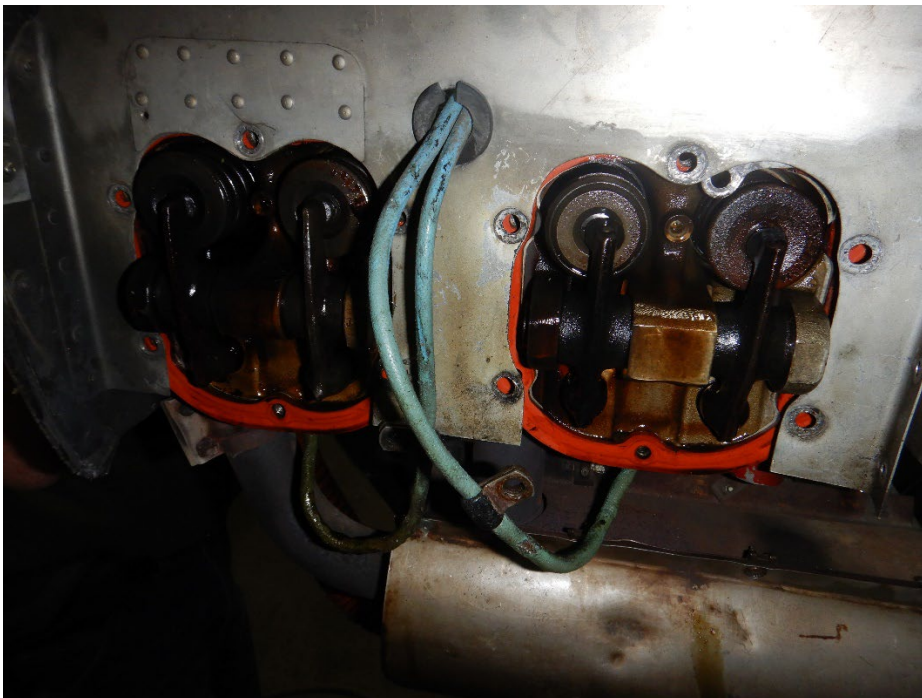
Valve covers were removed. Smooth valve action of equal movement was seen while turning the propeller.(Figure 8)

**Figure 8 Left side of engine, valve covers removed.**

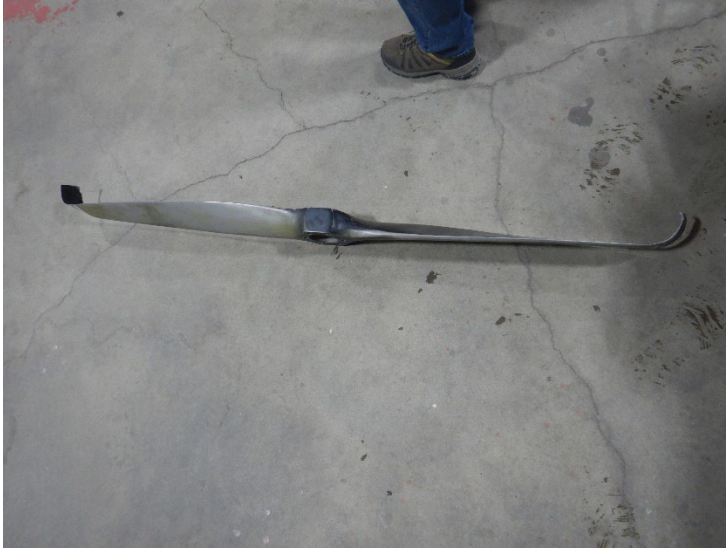
The propeller tips were curved in and rotational scars on both tips. (Figure 9 and 10)

**Figure 9 Accident airplane's propeller.**

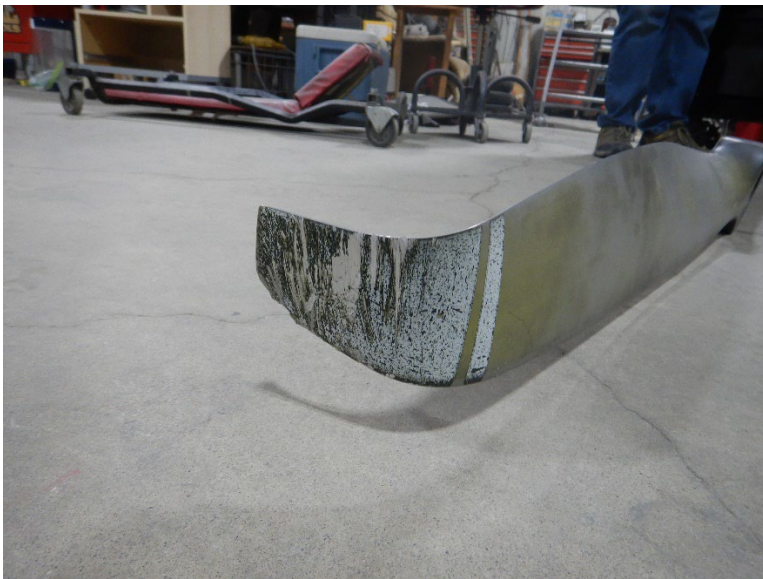
**Figure 10 Accident airplane's propeller tip.**
