# National Transportation Safety Board

ANC23LA024

## **ENGINE EXAMINATION**

Helicopter: N5688R Enstrom F-28C

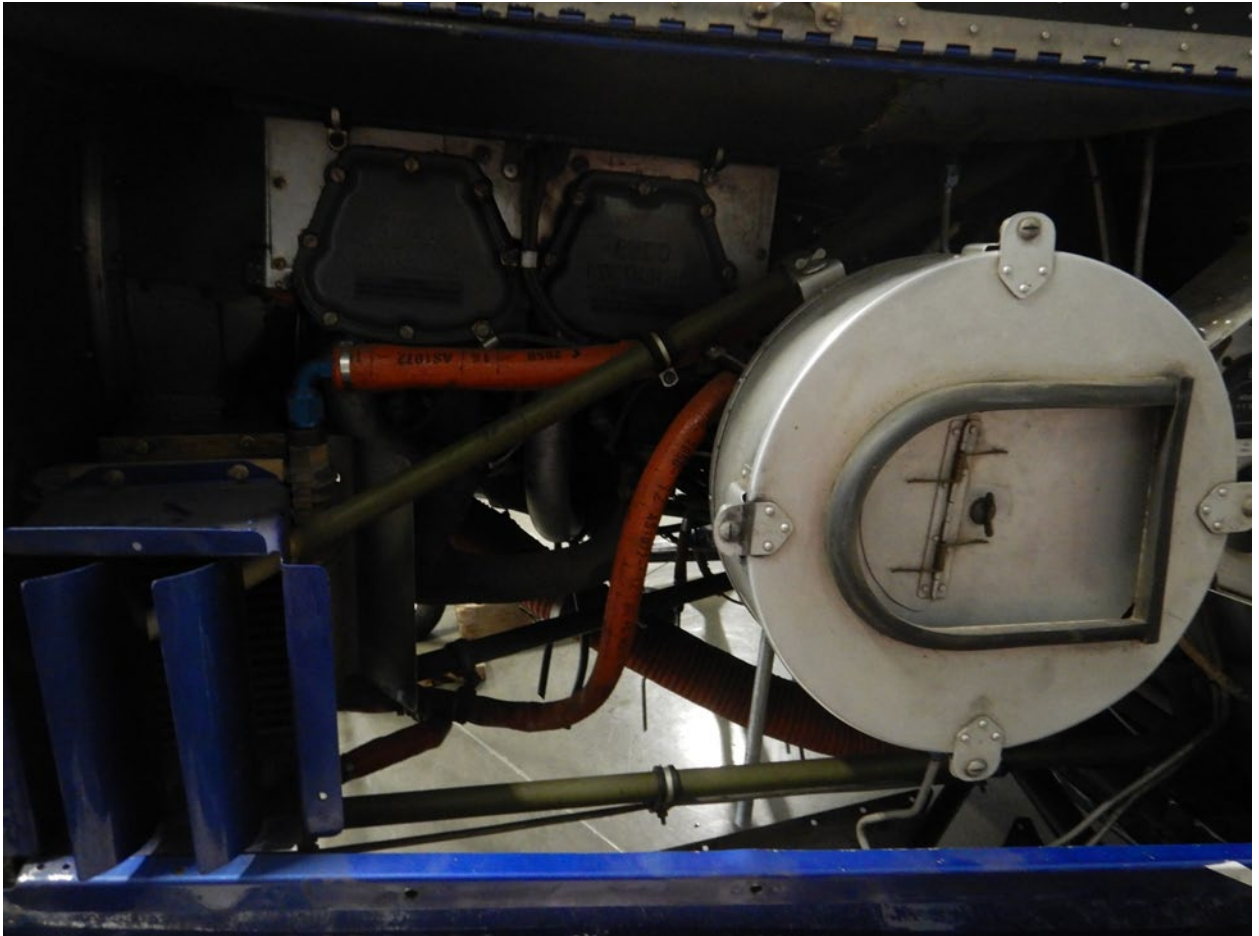
**Figure 1 Right side of engine**

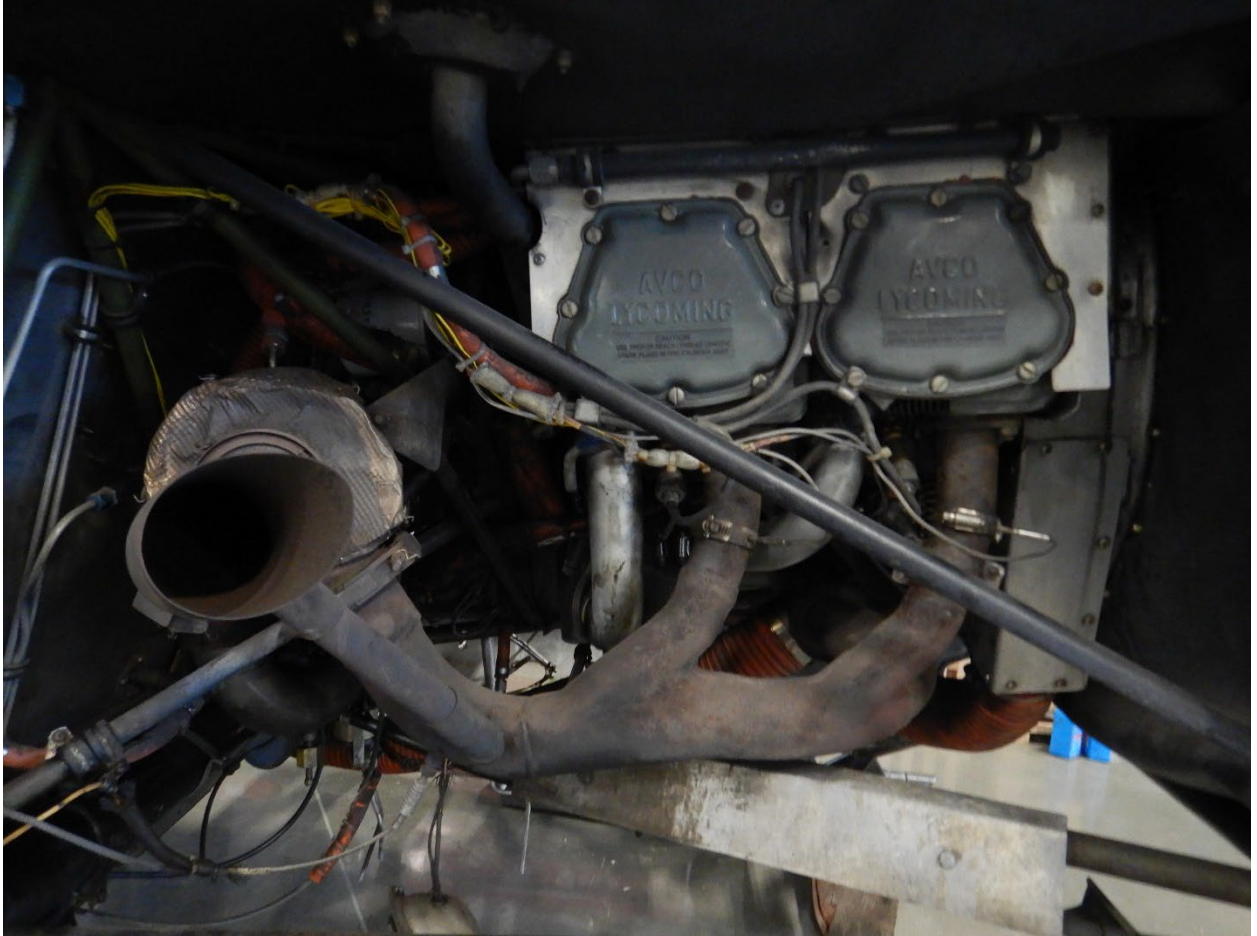
**Figure 2 Left side of engine.**

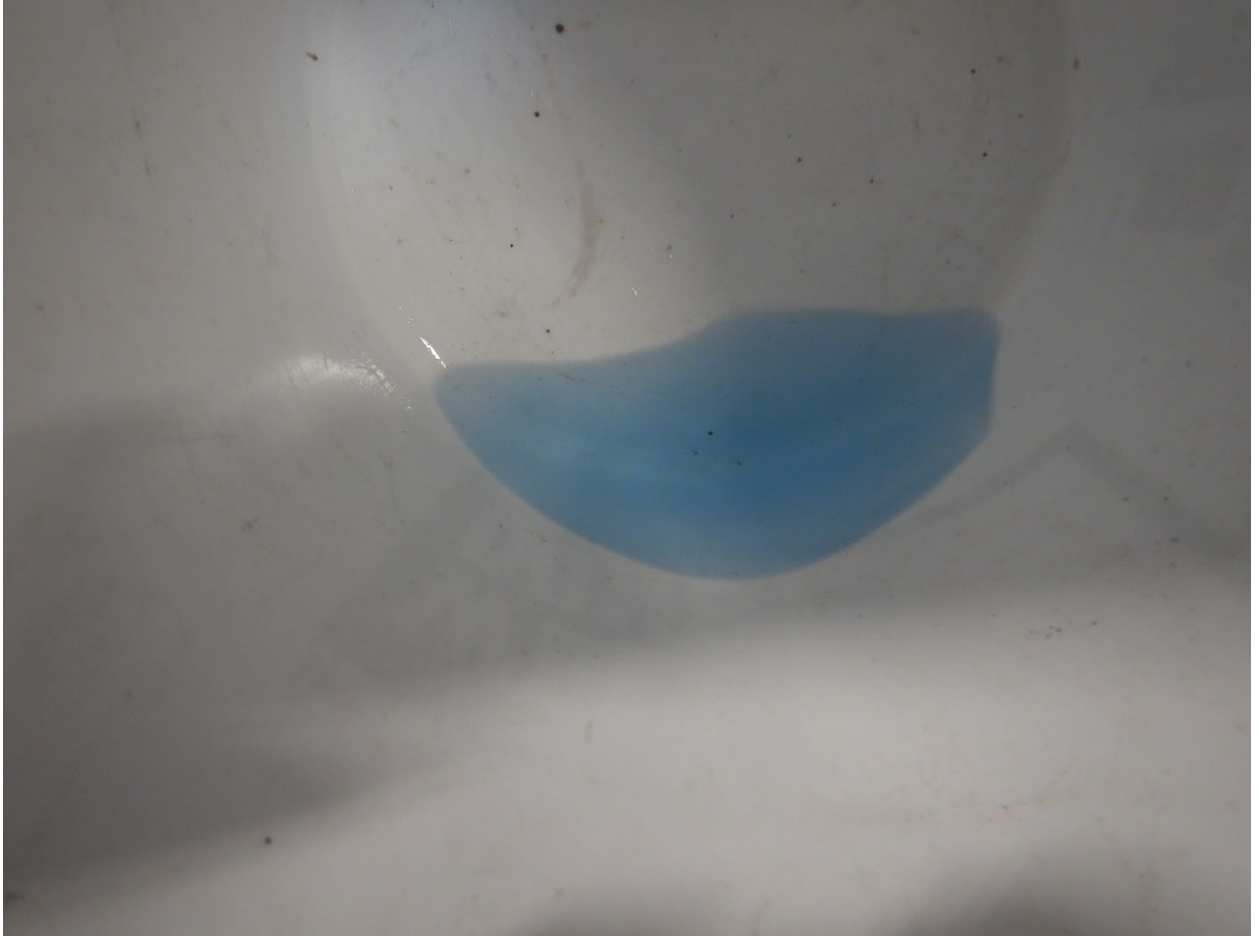
Fuel was drained from the gascolator. The fuel was blue in color and no evidence of water observed. The fuel screen in the gascolator was inspected and found in good condition.

**Figure 3 Fuel removed from gascolator**

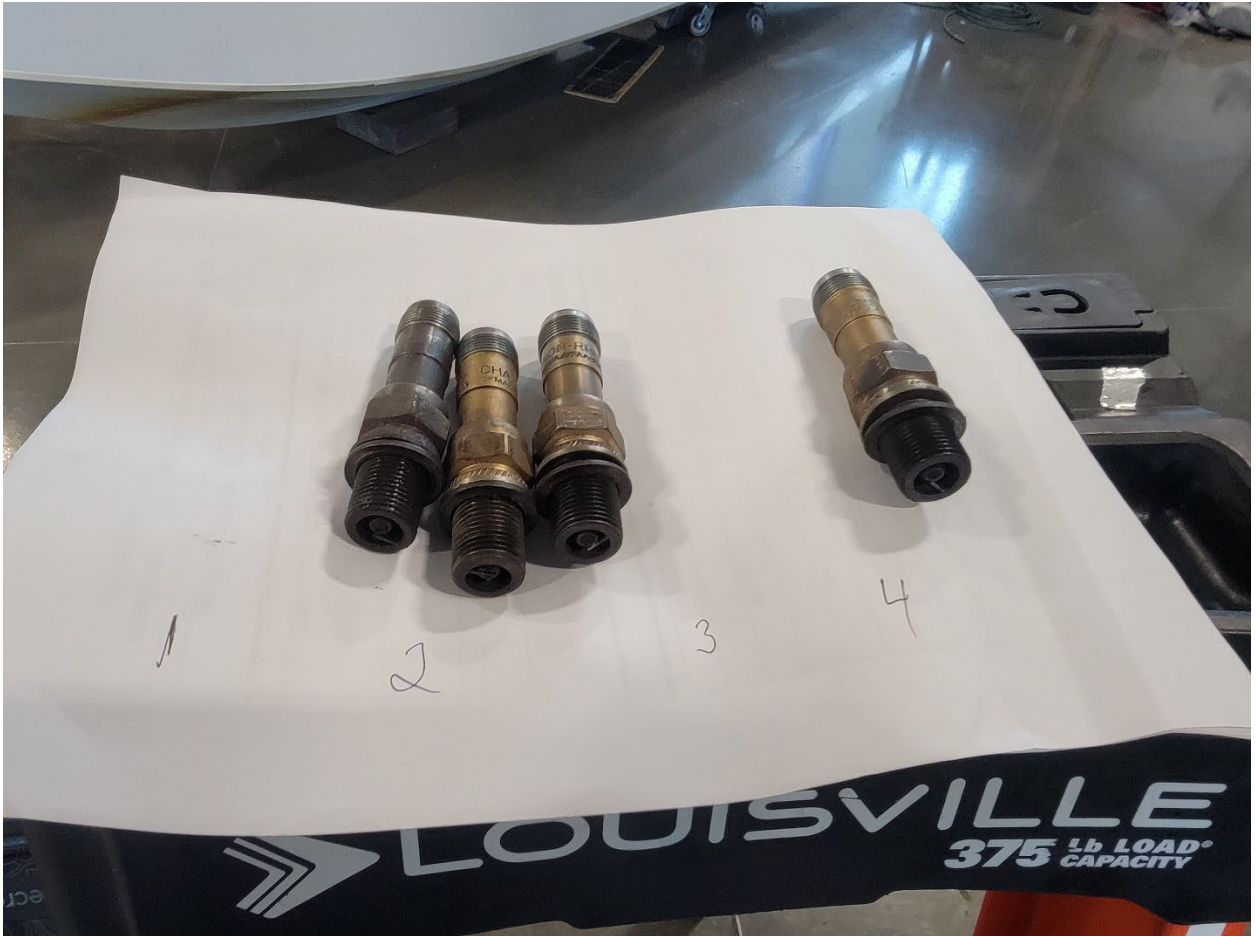
Spark plugs were secure, plug leads secure, no damage. Bottom spark plugs were in serviceable condition with normal electrodes.

**Figure 4 Spark plugs removed from the bottom side of the engine.**

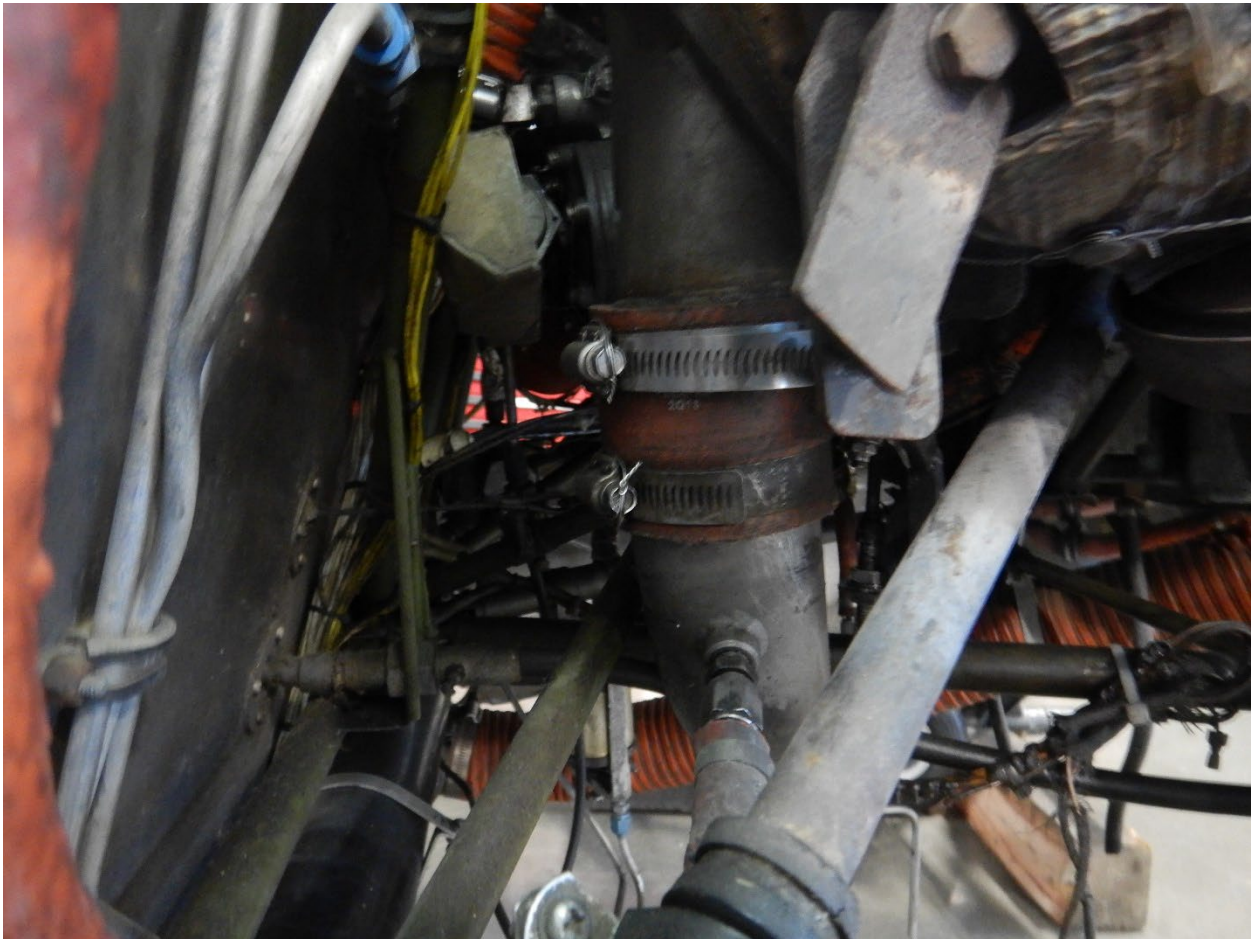
Turbo was inspected, all gaskets and hoses were secure and turbo fan moved freely.

**Figure 5 Hose connection to the engine turbo.**

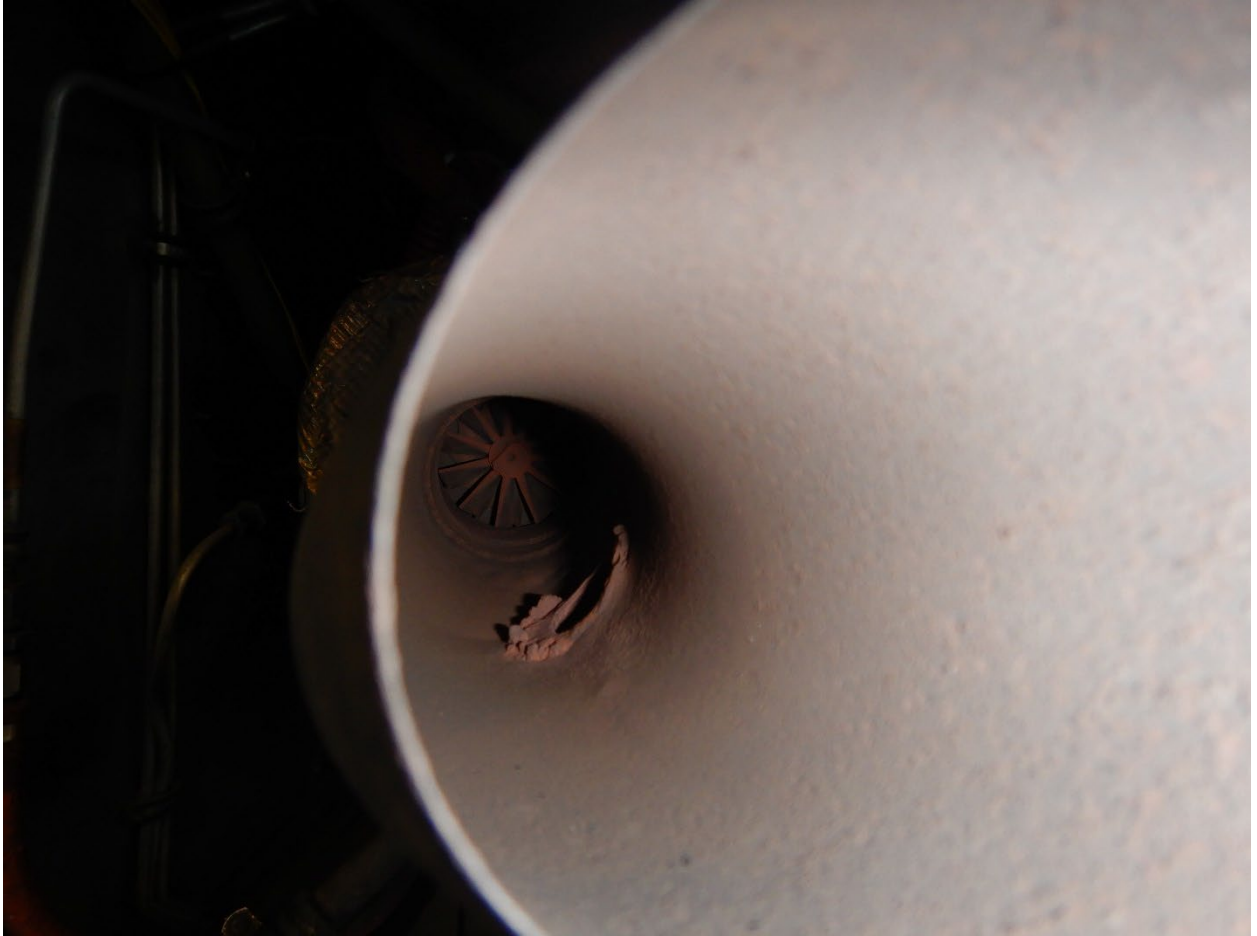
**Figure 6 View into the exhaust to the turbo fan.**

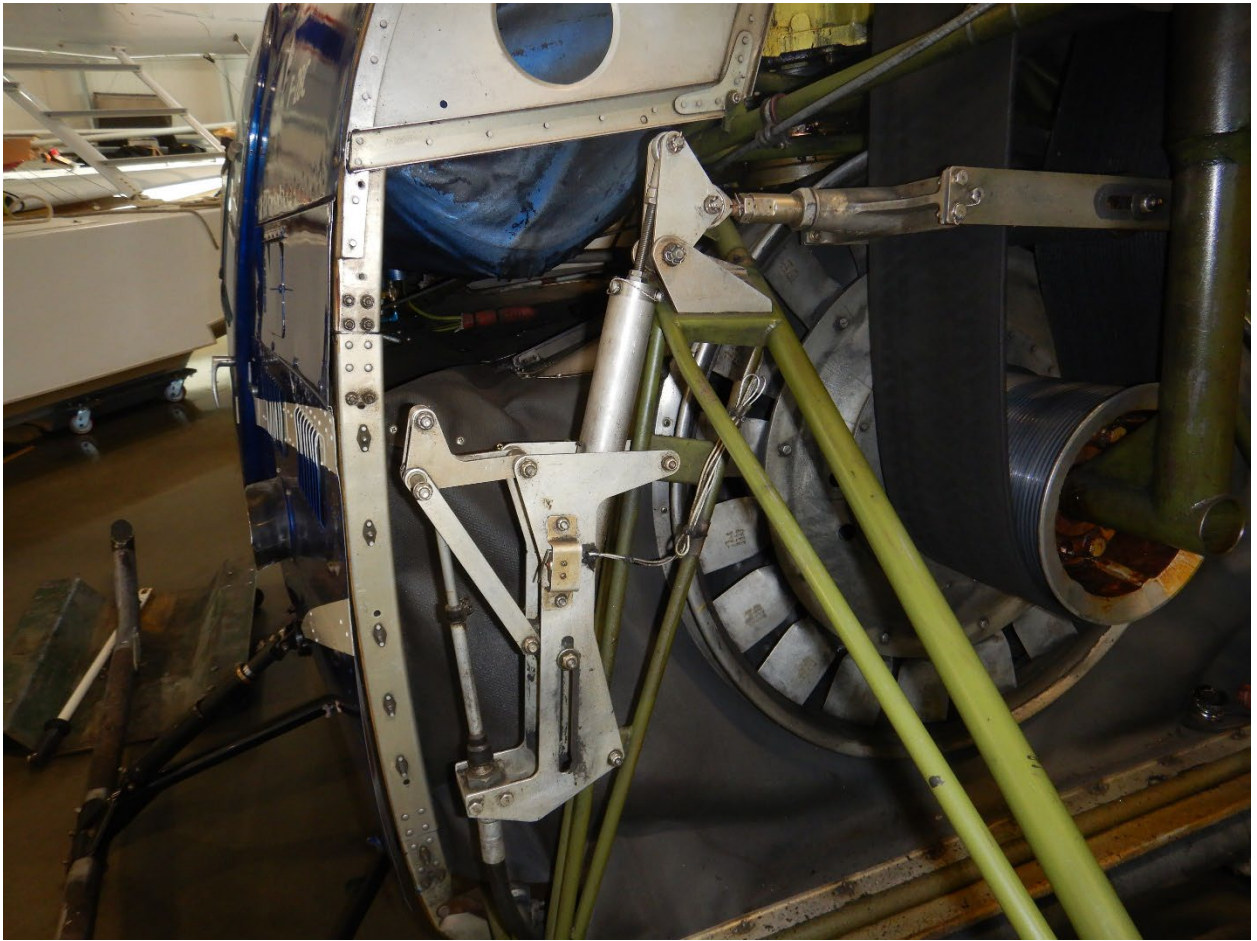
Main rotor blade belt tensioner operated normally. It was in the engaged position at the start of the examination. Belt was in good condition. After disengaging the belt tensioner, the main rotor transmission moved freely by hand.

**Figure 7 Belt clutch engagement system**

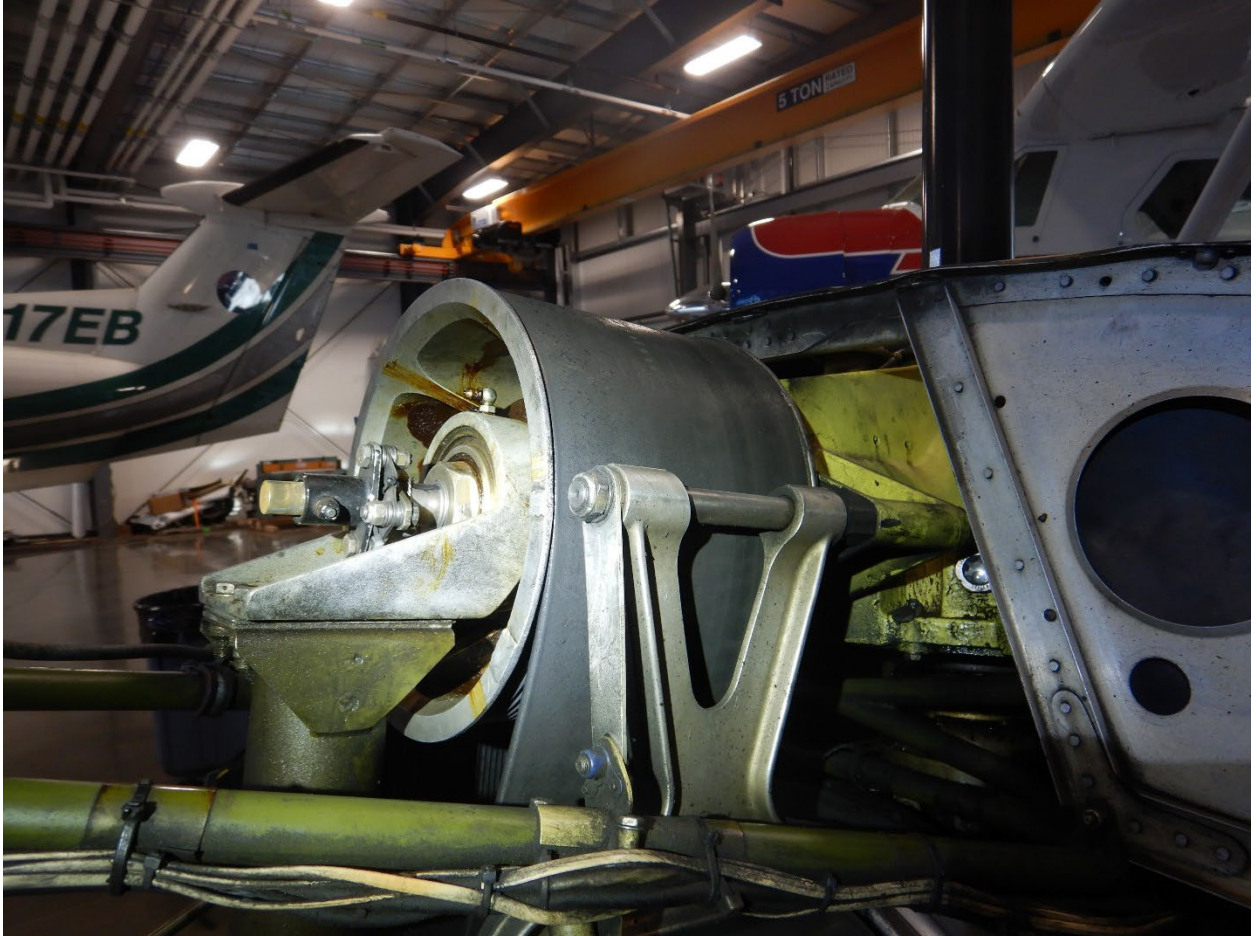
**Figure 8 Upper pulley/Over running clutch.**

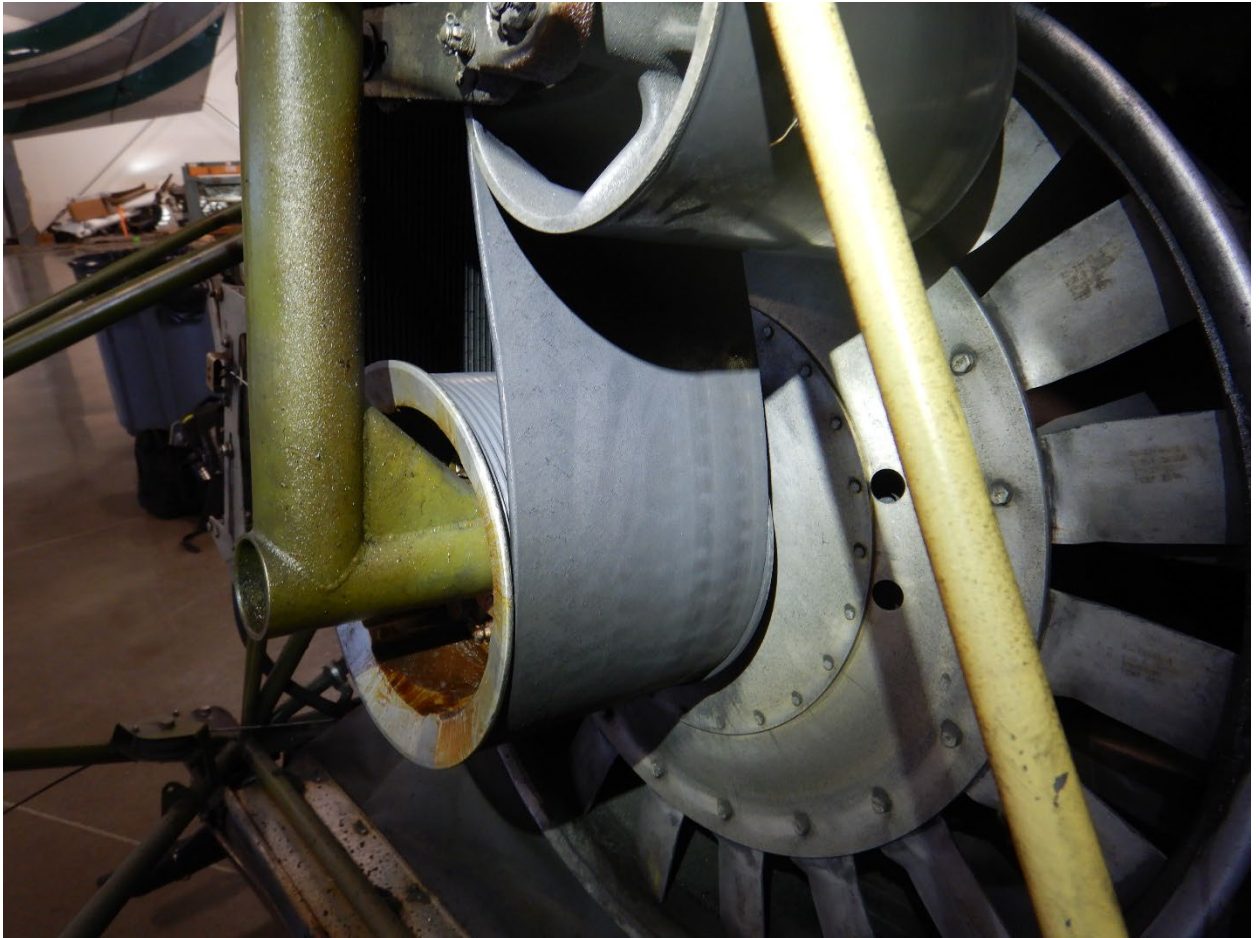
**Figure 9 Drive belt.**
