ANC23LA049

## INVESTIGATION PHOTOGRAPHS

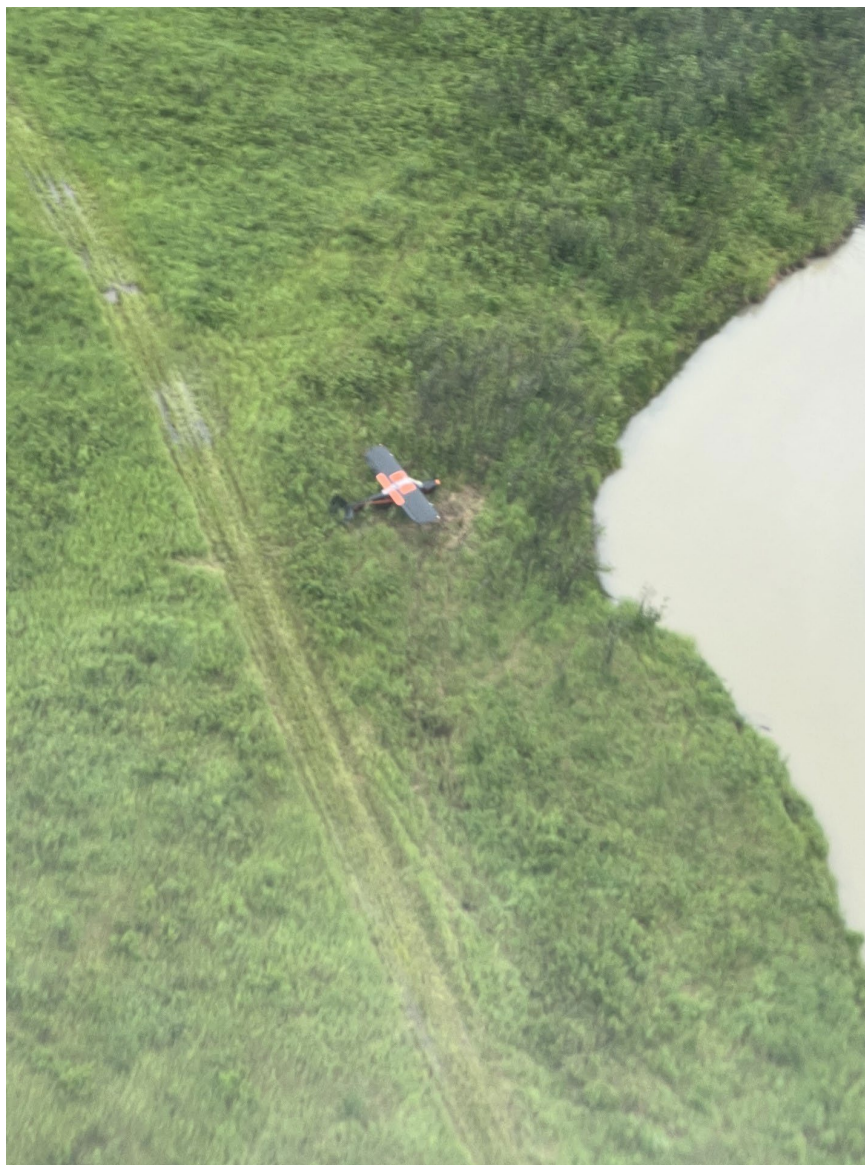
**Photograph 1 - Aerial view of accident site (Courtesy of FAA)**

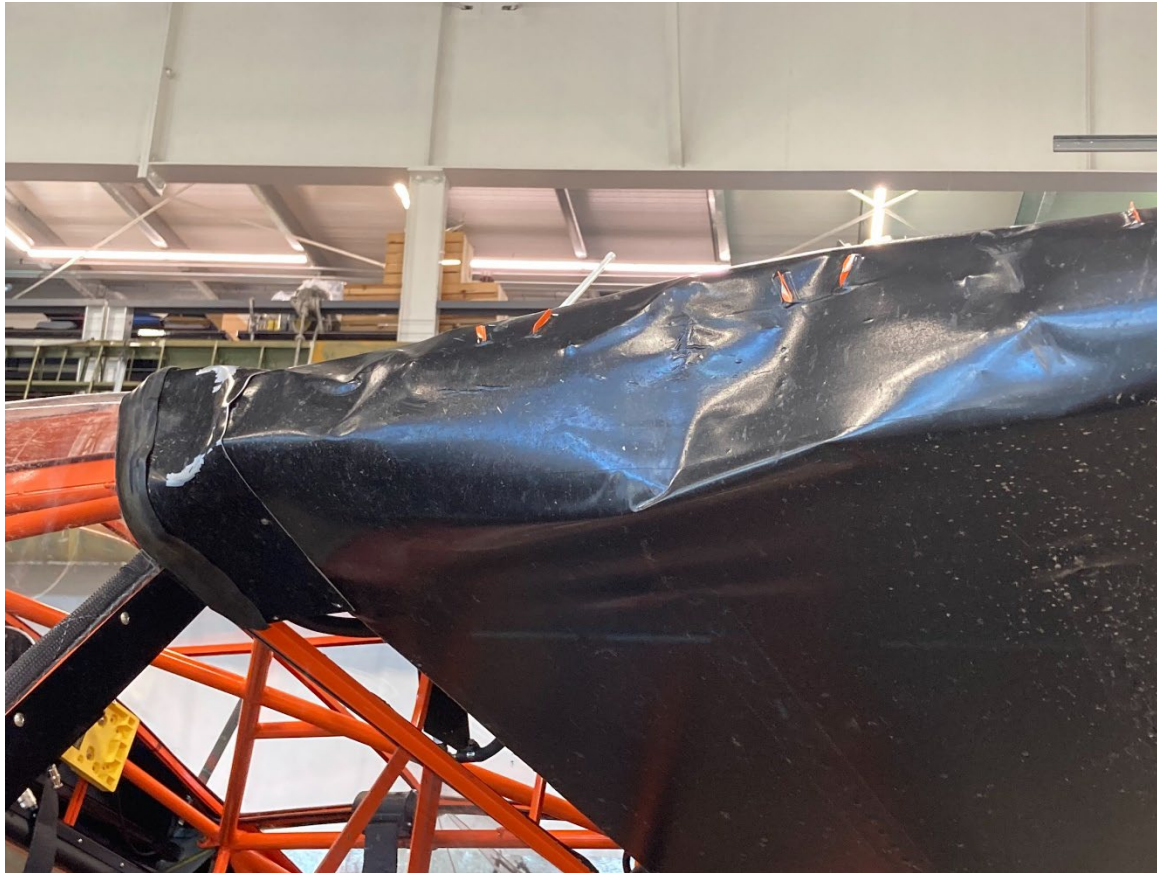
**Photograph 2 - View of left wing root (Courtesy of FAA)**

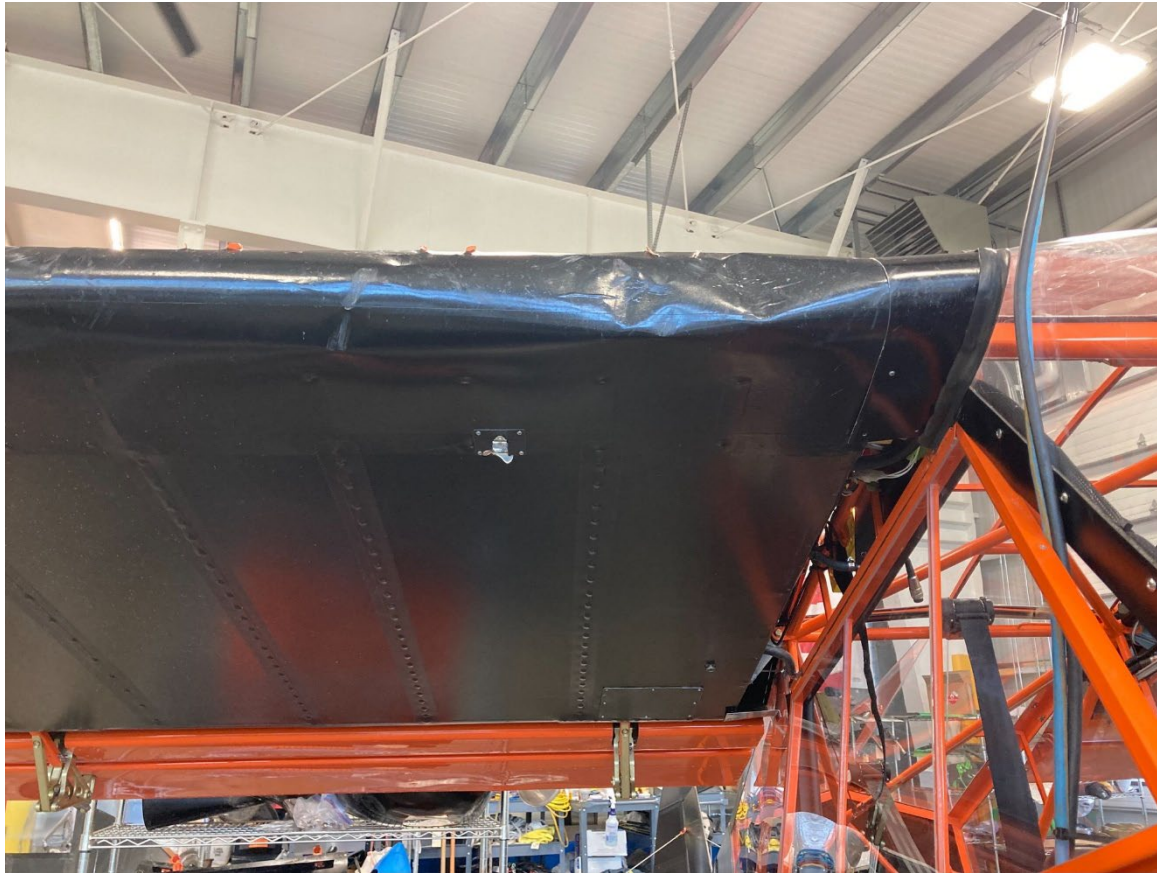
**Photograph 3 - View of right wing root (Courtesy of FAA)**

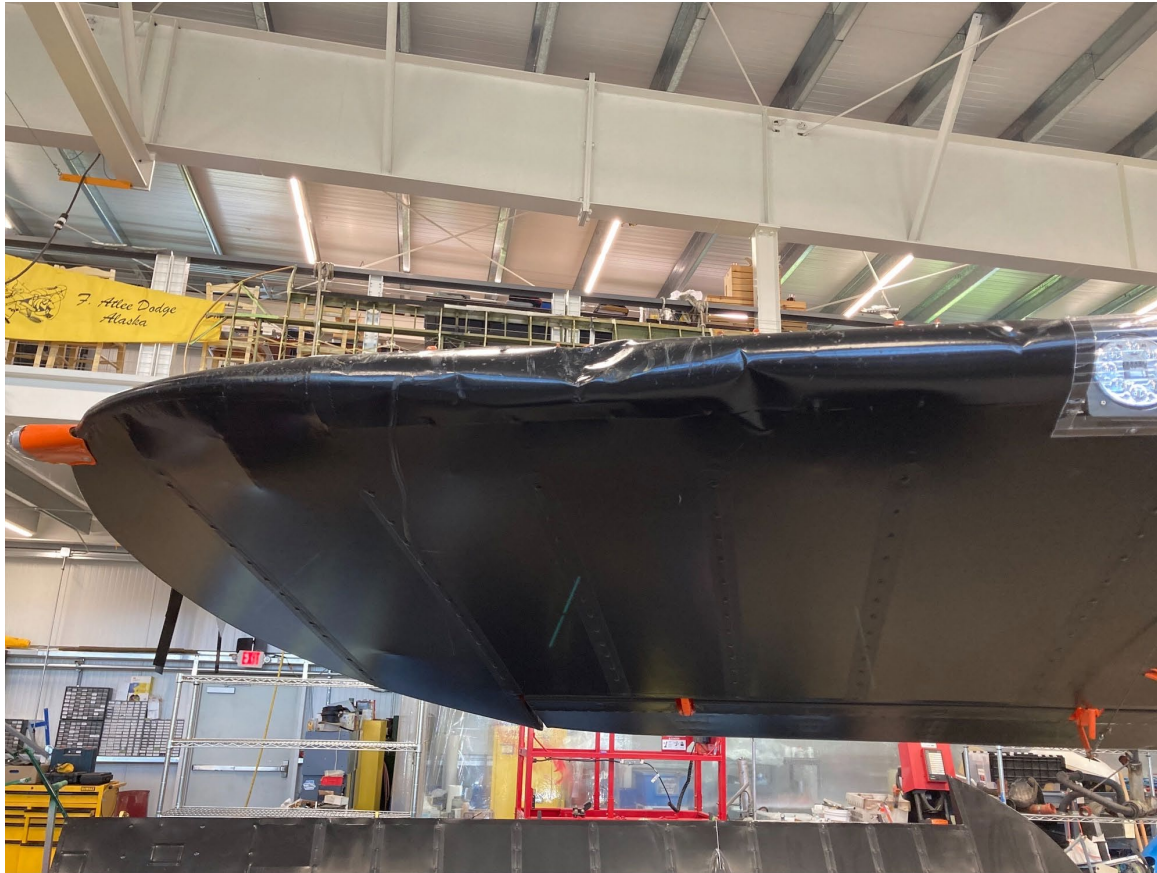
**Photograph 4 - View of right wing leading edge (Courtesy of FAA)**

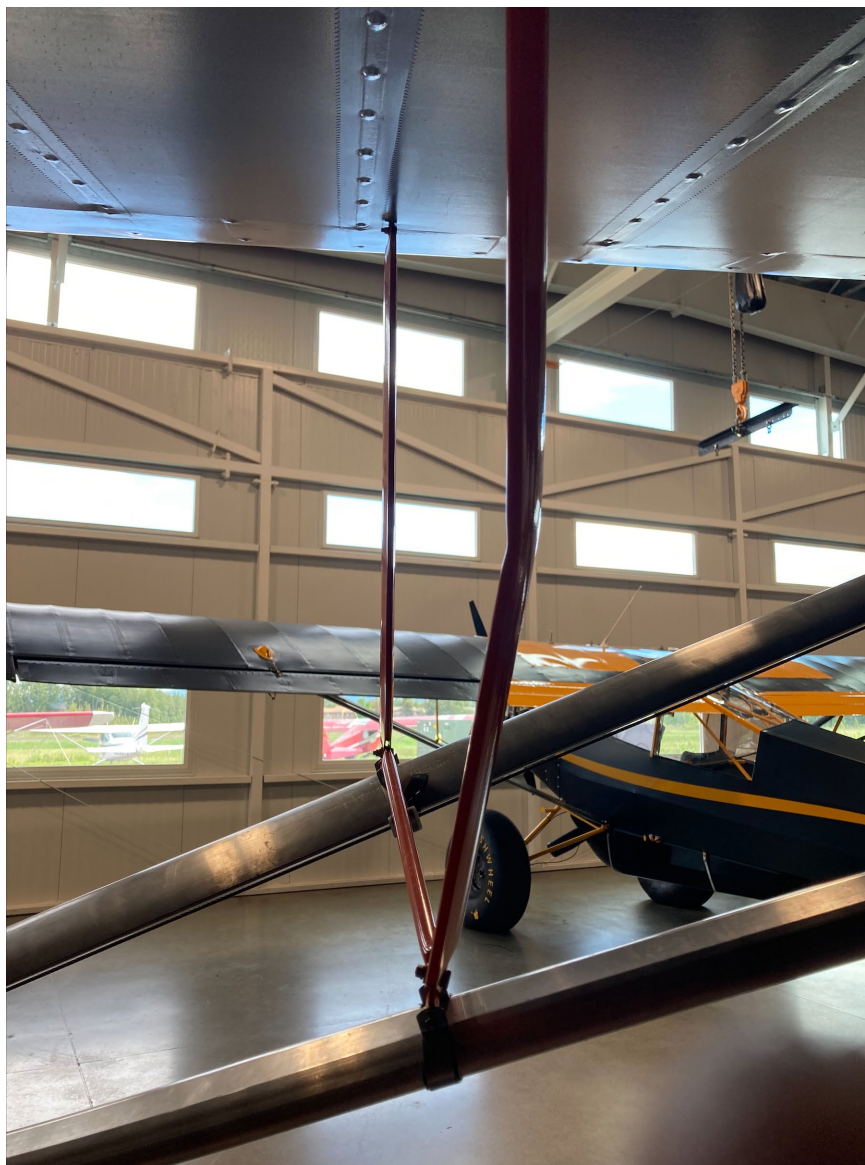
**Photograph 5 - View of right wing aft jury strut (Courtesy of FAA)**
