# National Transportation Safety Board

ANC23LA051

## **ENGINE EXAMINATION**

Location: Ninilchik, AK  
Date: July 12, 2023  
Time: 1530

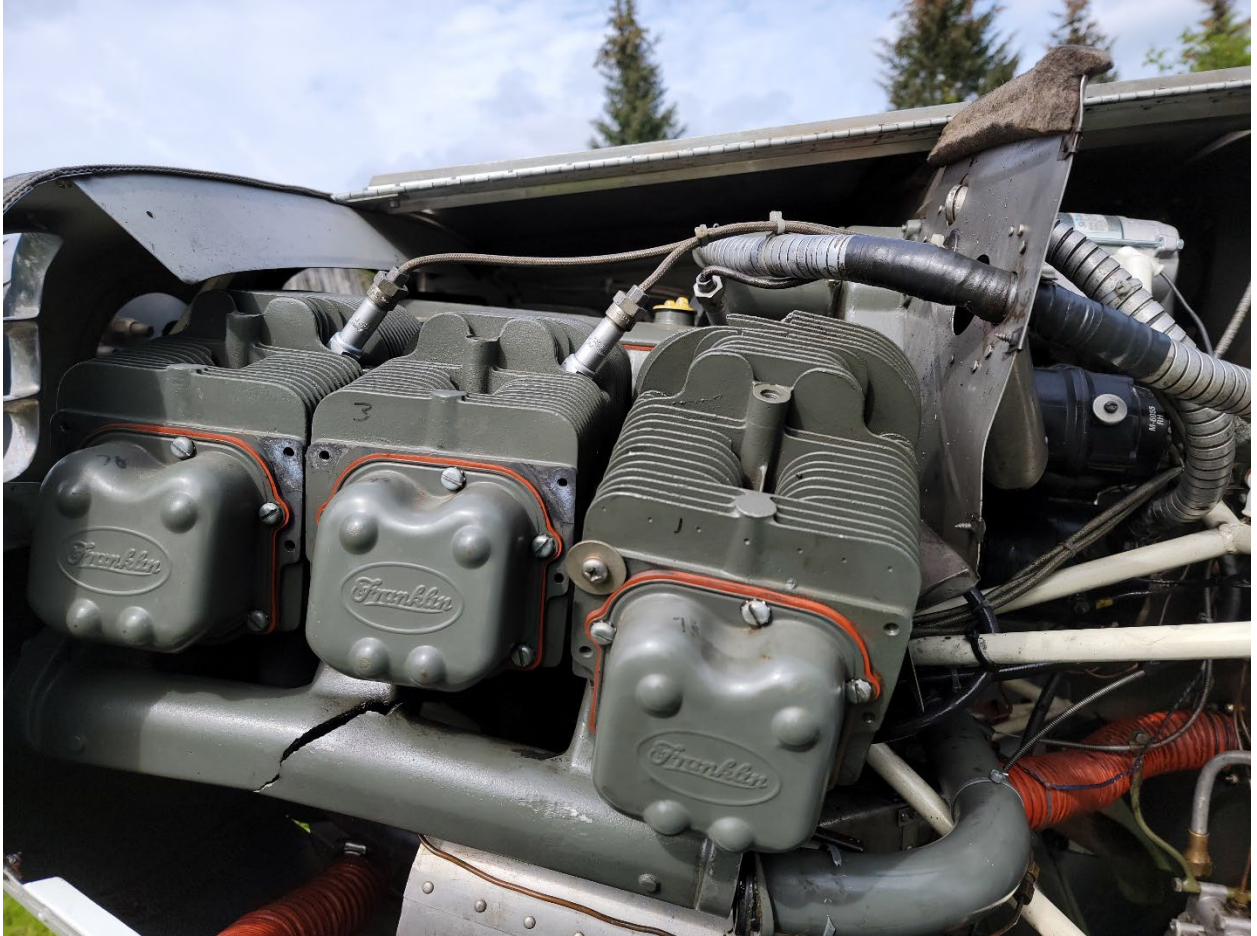
**Figure 1 View of the left side of the engine, note cylinder No. 1 partially separated.**

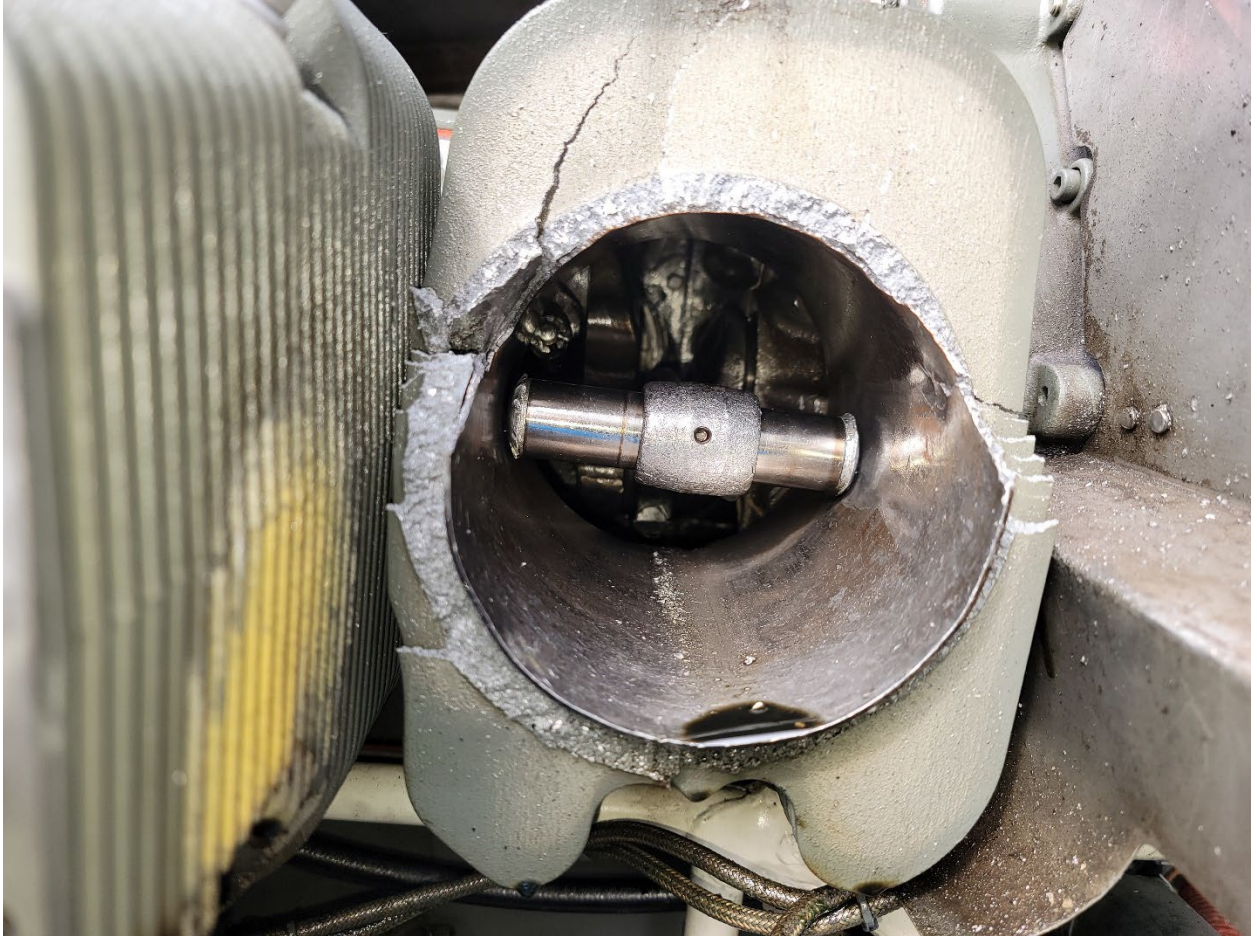
Removal of the No. 1 Cylinder. The No. 1 cylinder was completely fractured around the middle of the cylinder. It was still attached to the intake manifold and the exhaust tubes. Both the top and bottom sparkplug insert helicoils were loose from impact forces; metal fragments were present on the No. 1 spark plug. The piston rings were visible sticking out from between the two halves of the fractured cylinder. The piston and valve were not located. Only a small portion of the attachment point of the intake valve was still attached. Inside top part of the cylinder showed signs of multiple impacts.

**Figure 2 View inside the attached portion of the No. 1 cylinder.**

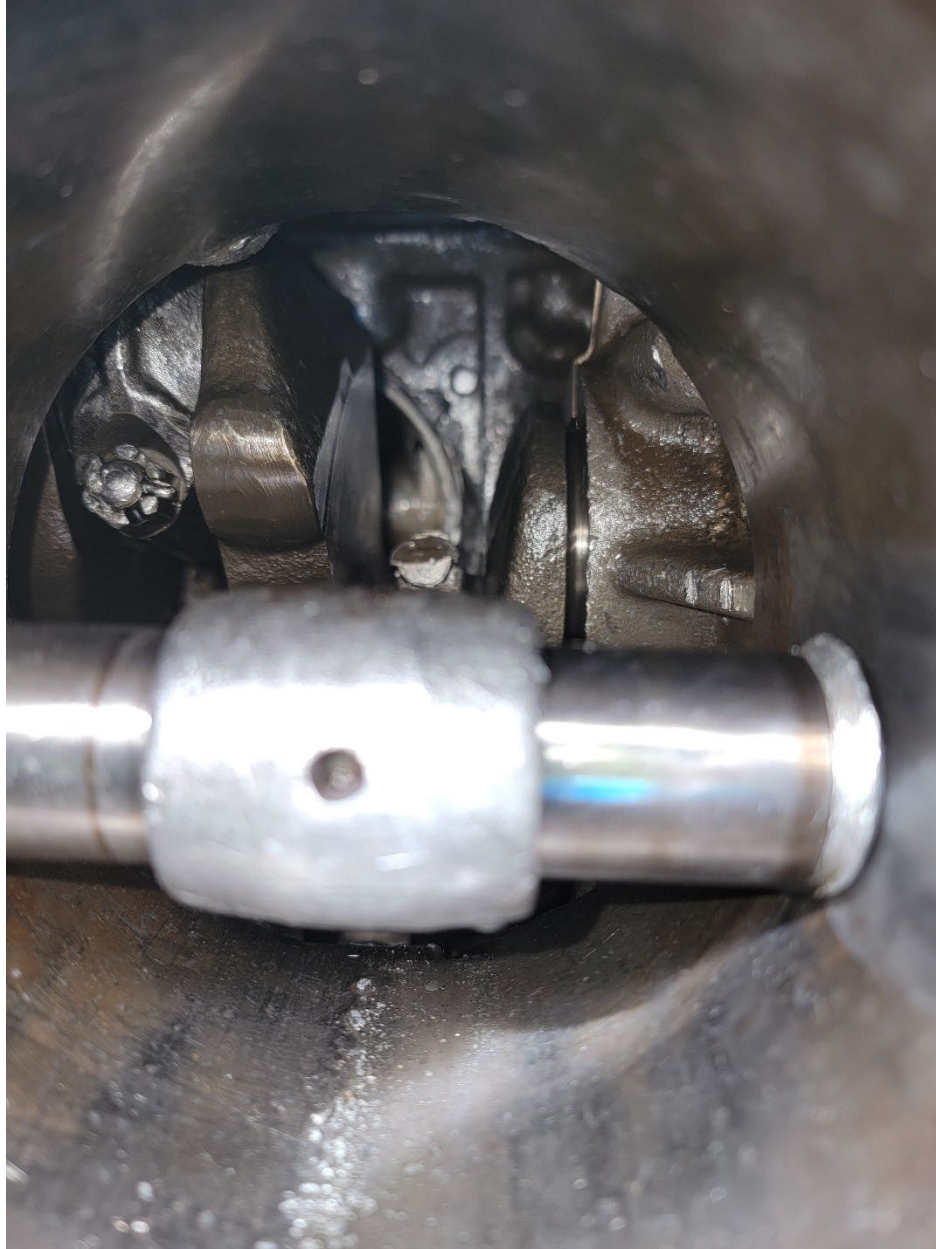
**Figure 3 View into the engine case from the No. 1 cylinder.**

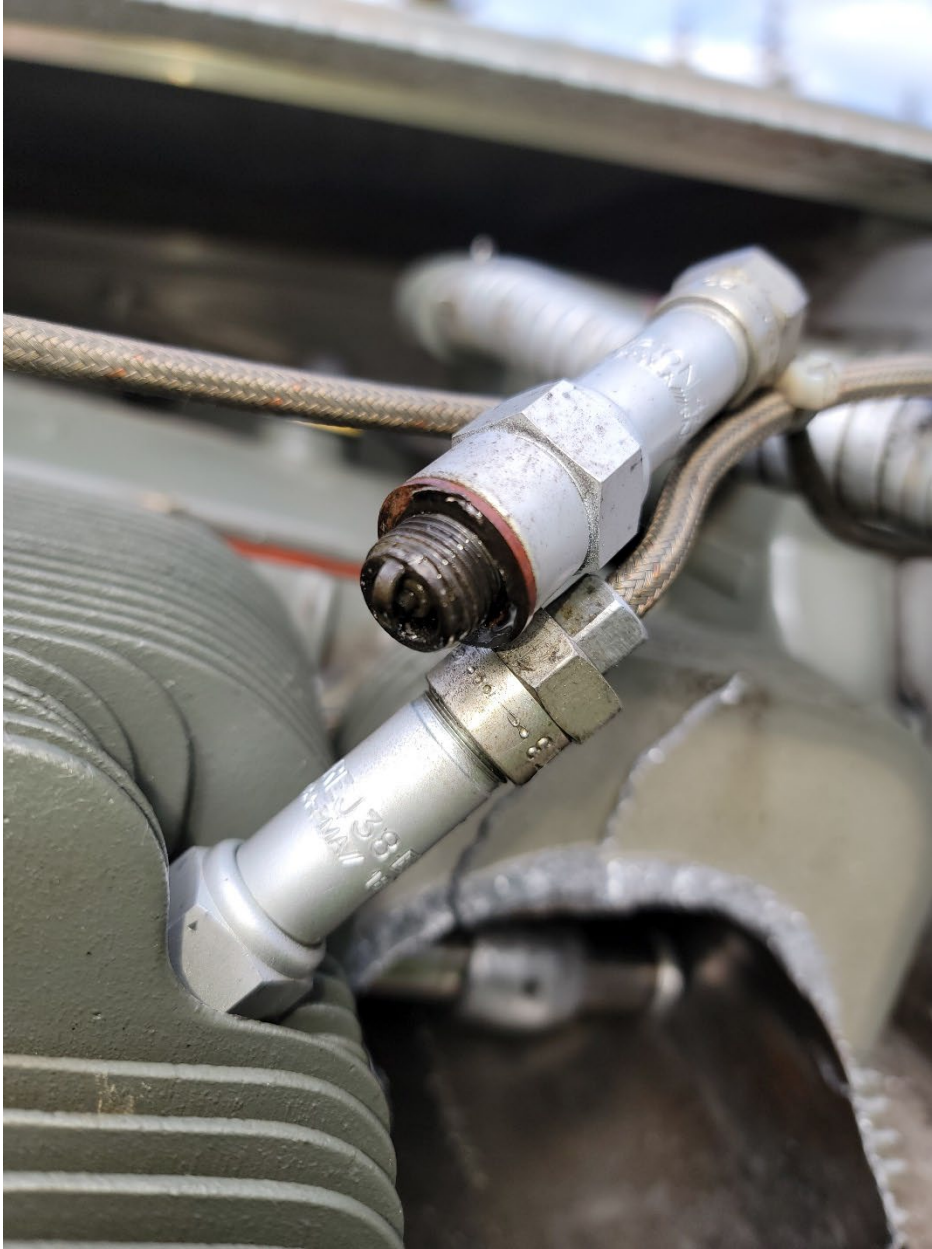
**Figure 4 No. 1 top sparkplug, the bottom sparkplug remained loosely attached to the cylinder.**

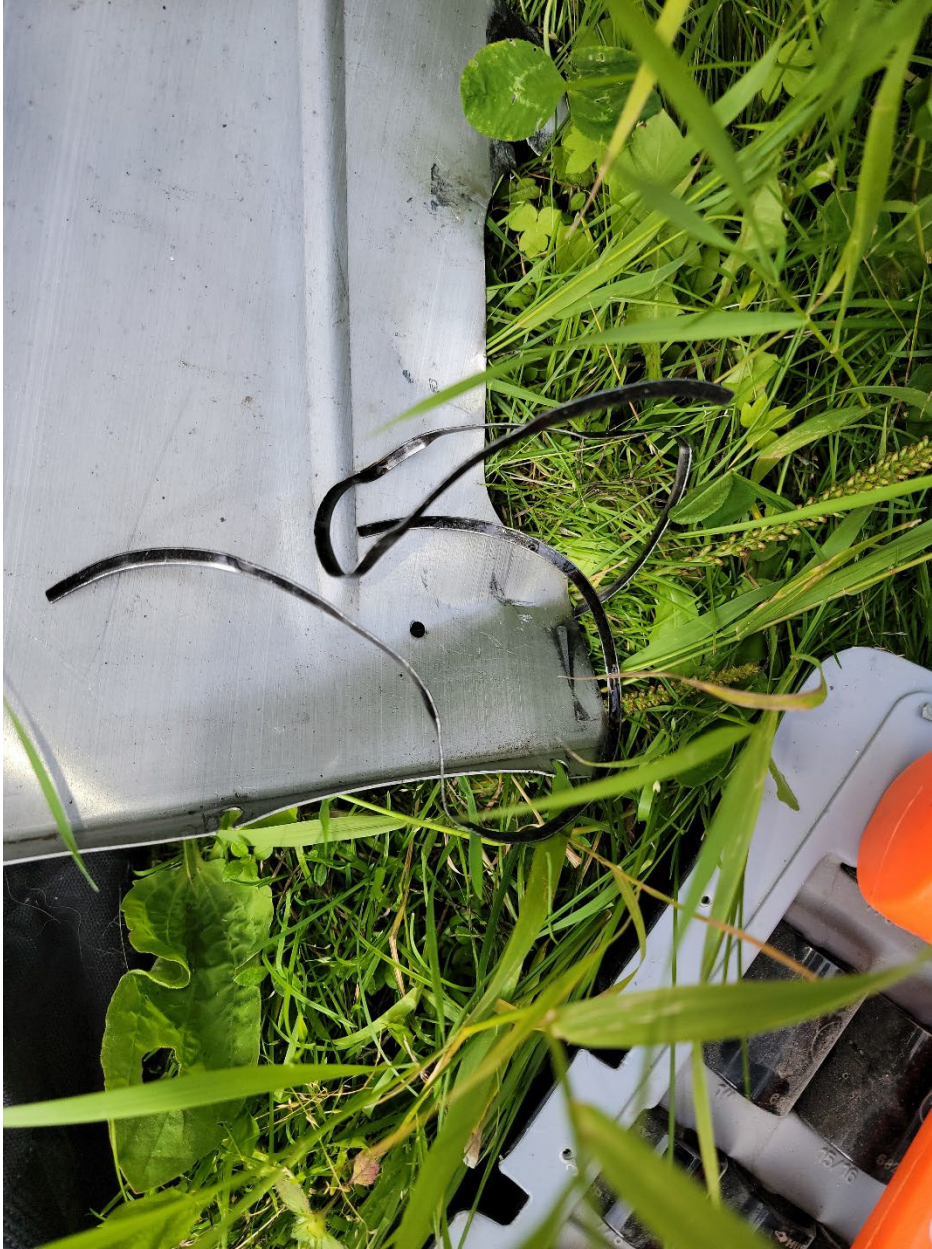
**Figure 5 View of the No. 1 cylinder piston rings after being removed from the engine.**

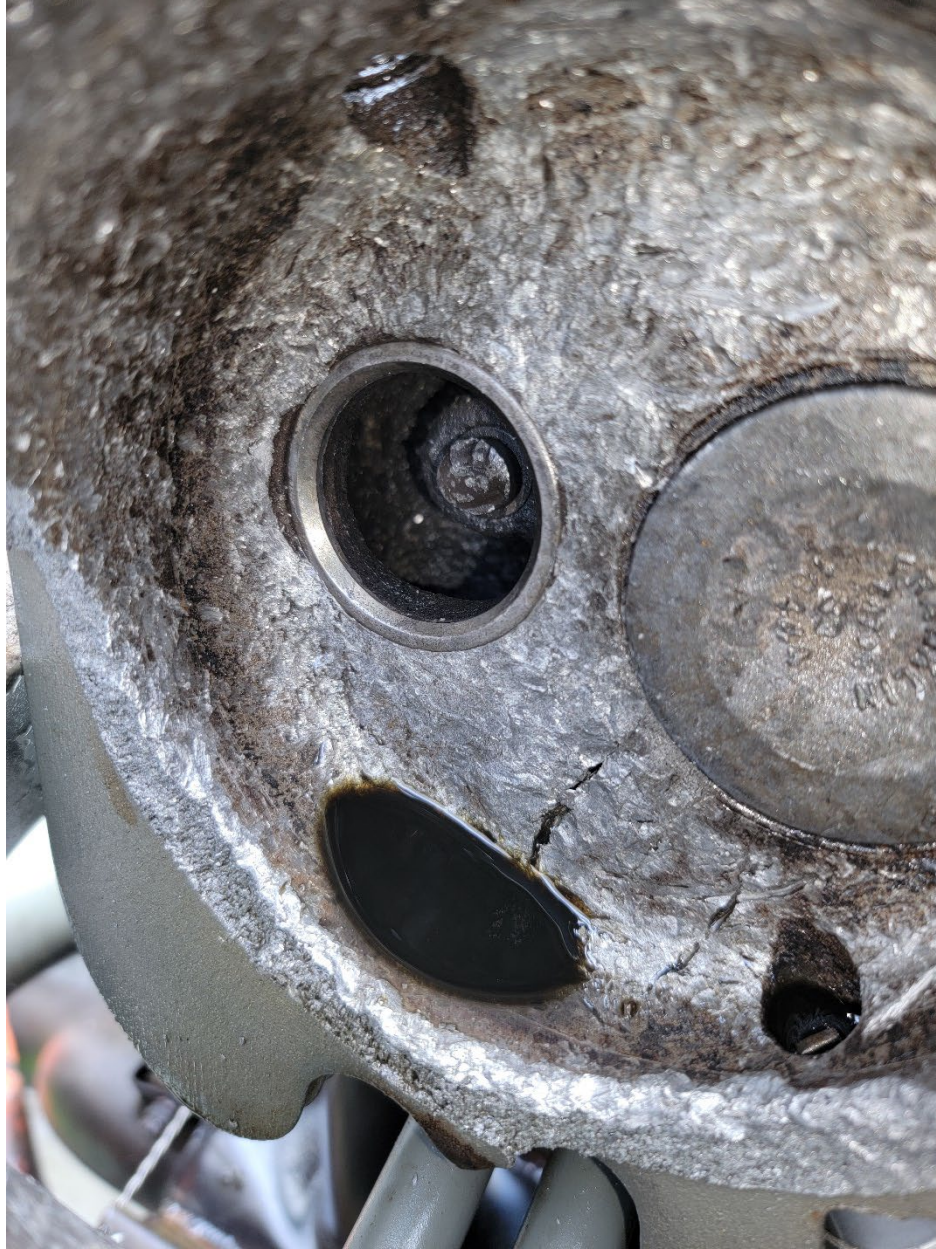
The intake valve spring was overextended, which pushed the rocker arm outward. No anomalies were noted on the rocker. The intake push tube was not bent; the exhaust push tube housing was slightly bent. The valve stem was fractured about an inch from the interior base of the valve. The valve stem shaft moved freely when pushed inward from the rocker. There was extensive damage to the valve stem surfaces. Fragments of the piston, intake valve stem head were not located.

**Figure 6 View inside the No. 1 cylinder after removal from engine, note the remaining portion of the exhaust valve stem.**
