ANC23LA051

## INVESTIGATION PHOTOGRAPHS

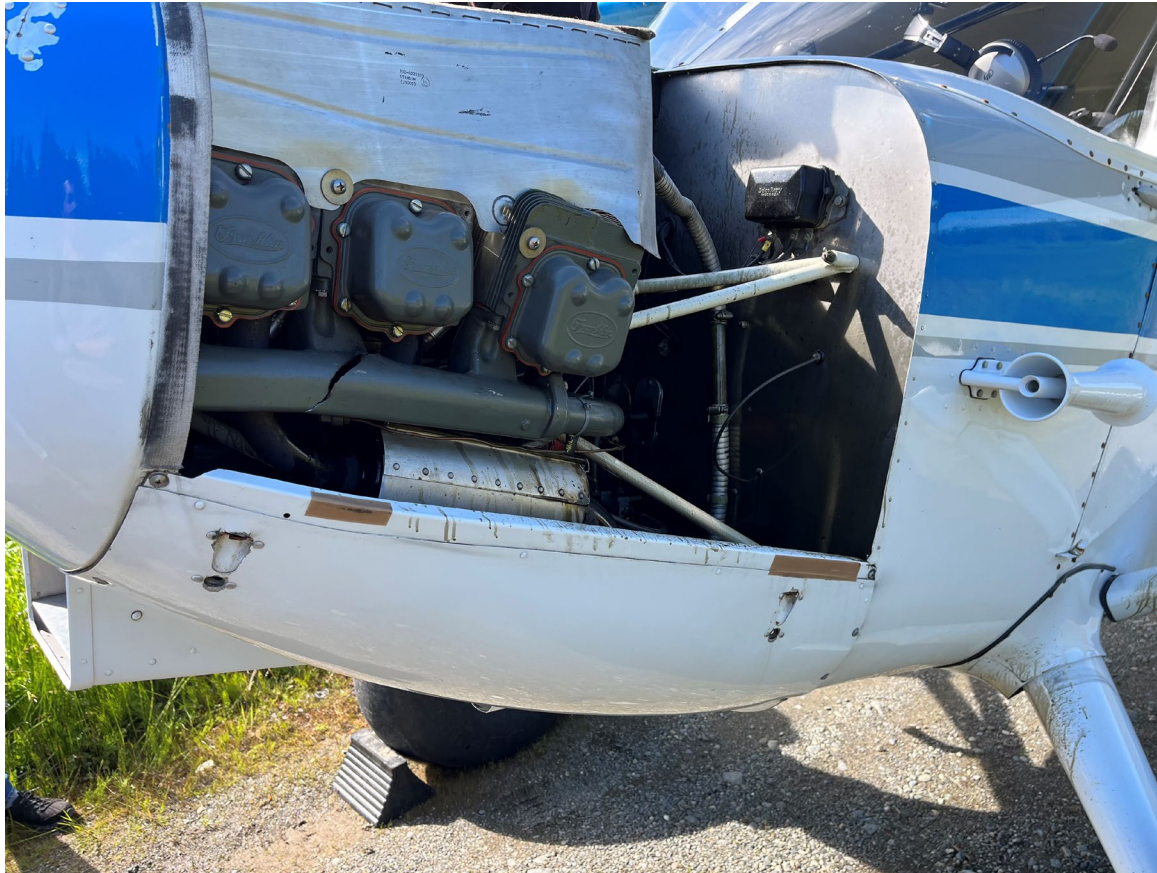
**Photograph 1 - View of left side of engine compartment. (Courtesy of FAA)**

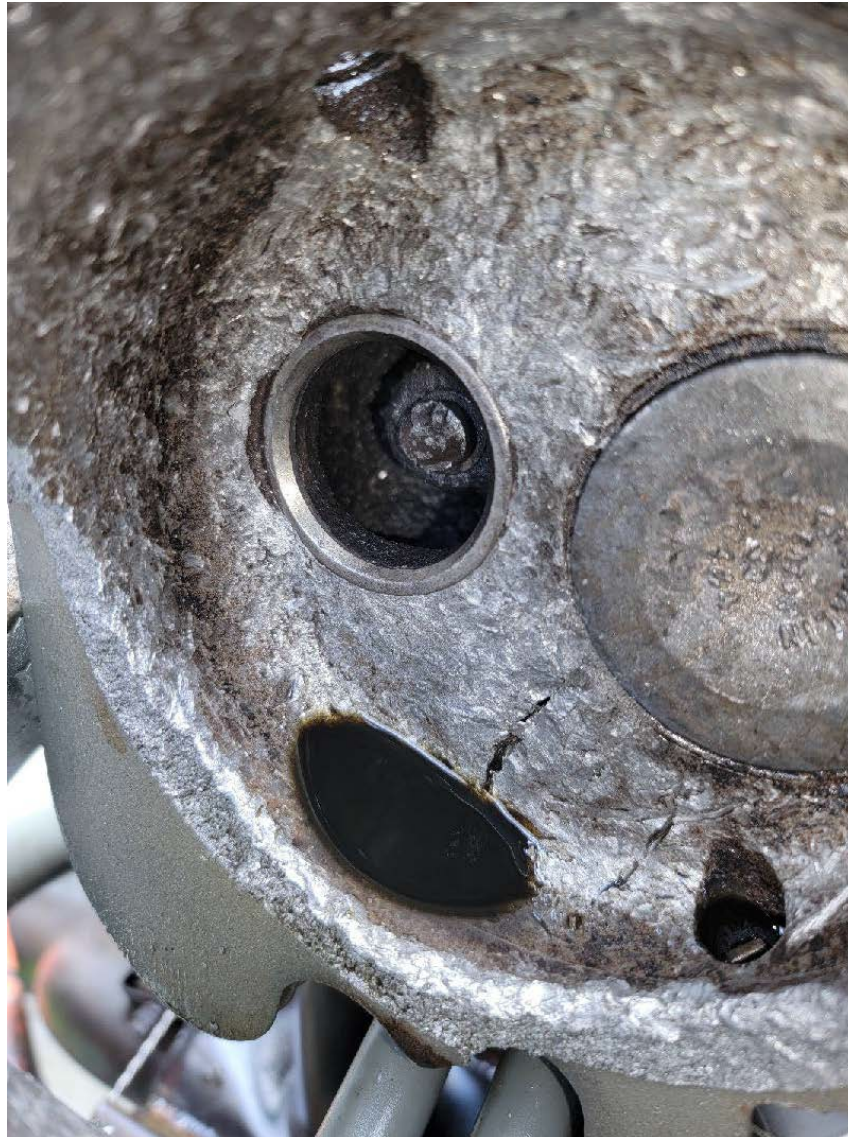
**Photograph 2** - View inside the No. 1 cylinder after removal from engine, note the remaining portion of the exhaust valve stem.
