# National Transportation Safety Board

ANC23LA053

## **ENGINE EXAMINATION**

Location: Ninilchik, AK  
Date: July 12, 2023  
Time: 1620  
Airplane: N83391

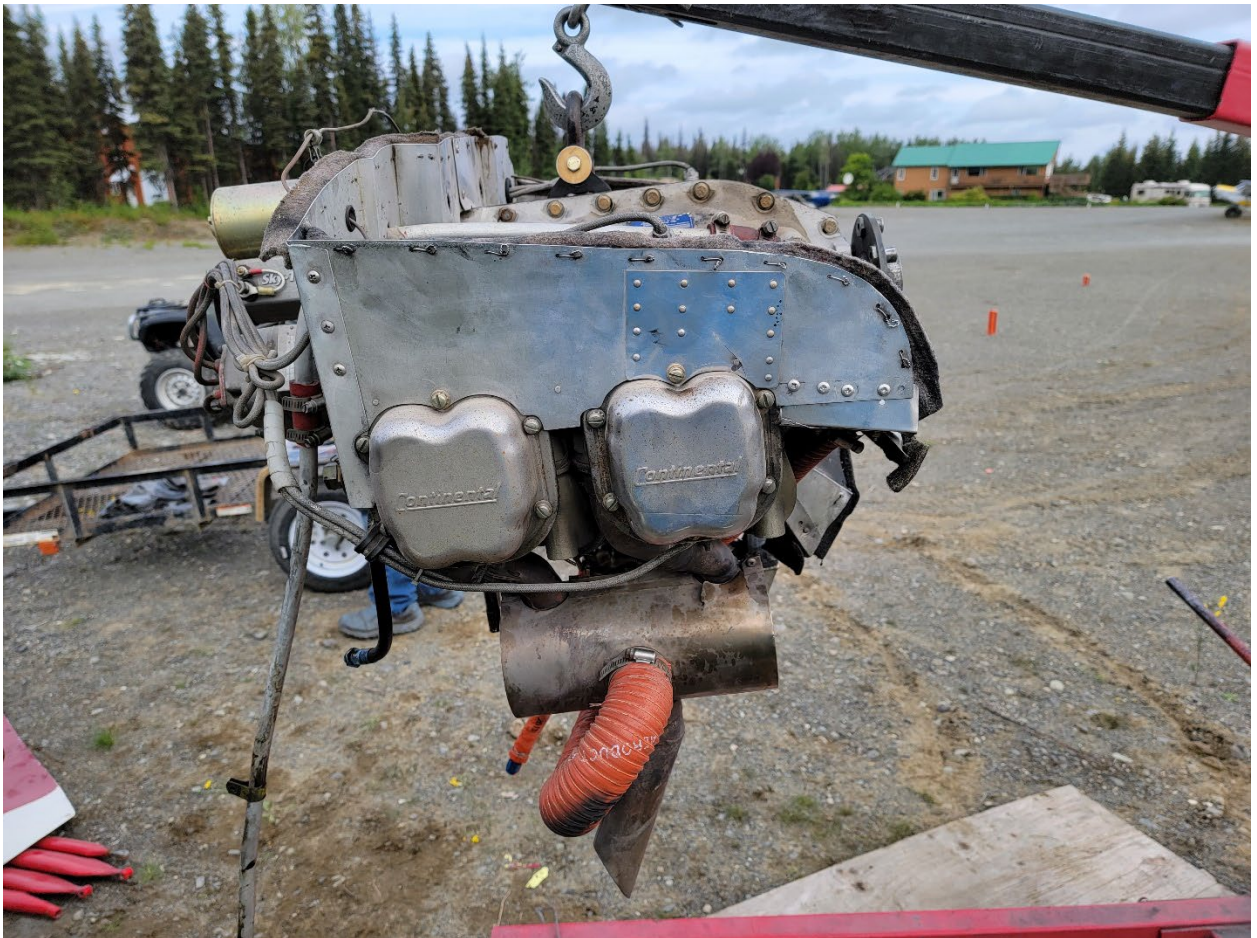
**Figure 1. Right side of engine after removal from airplane.**

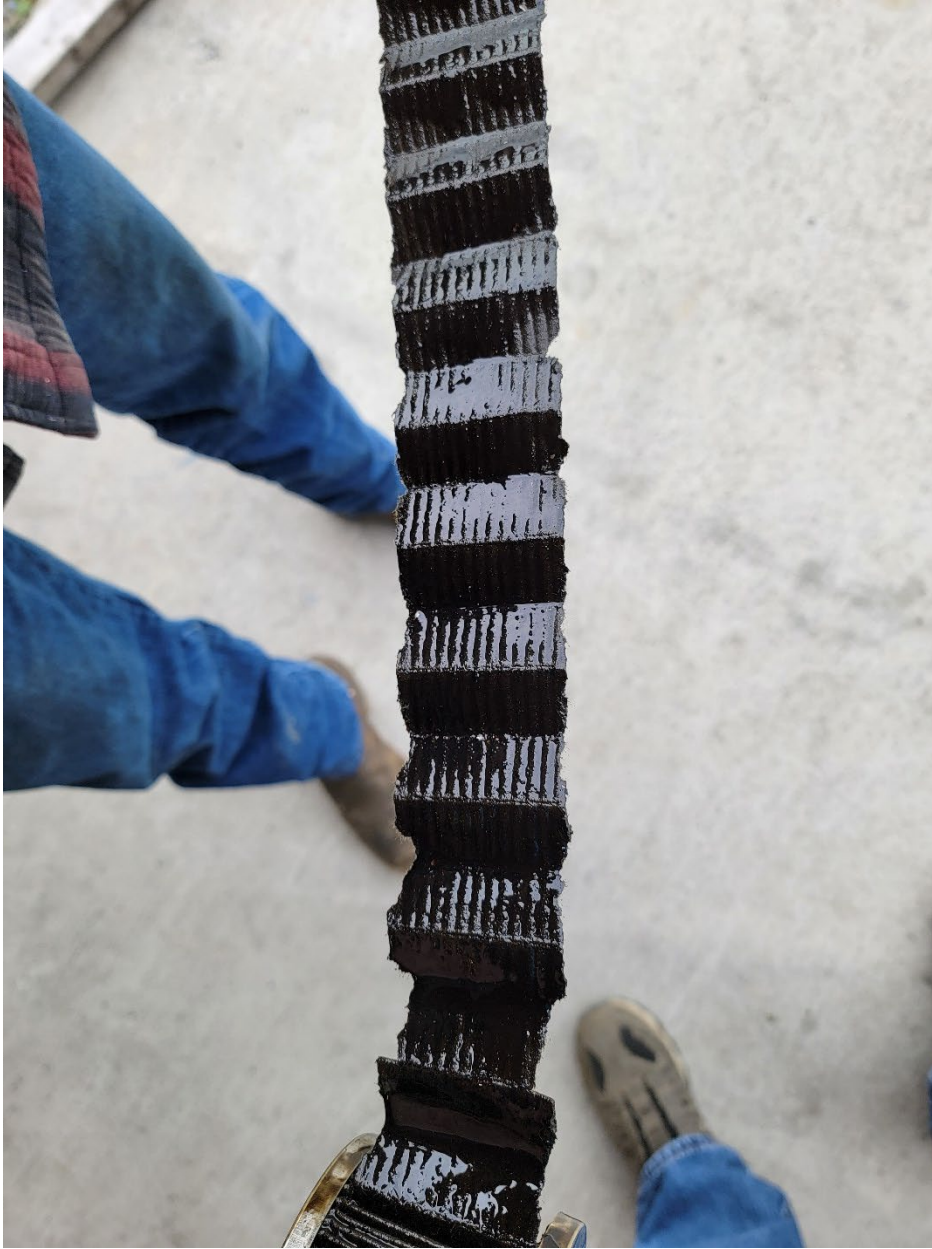
accessory case was removed from the engine (*figure 6*). All oil passages in the accessory case were clear of obstruction, Compressed air was applied to each oil passage and observed exiting out of the accessory case. The oil pump was inspected with no anomalies noted. The oil filter was removed, and the filter was examined with minor amounts of metal seen in the filter (*figure 3*). Two cylinders were removed to examine inside the engine case (*figure 8*). Fragments of a main bearing were observed on the walls inside the case (*figure 9*). The number one main bearing spun and blocked the oil supply journal to the main crank. This led to no oil being supplied to the engine's main bearings and led to the total loss of engine power.

**Figure 3. View of oil filter.**

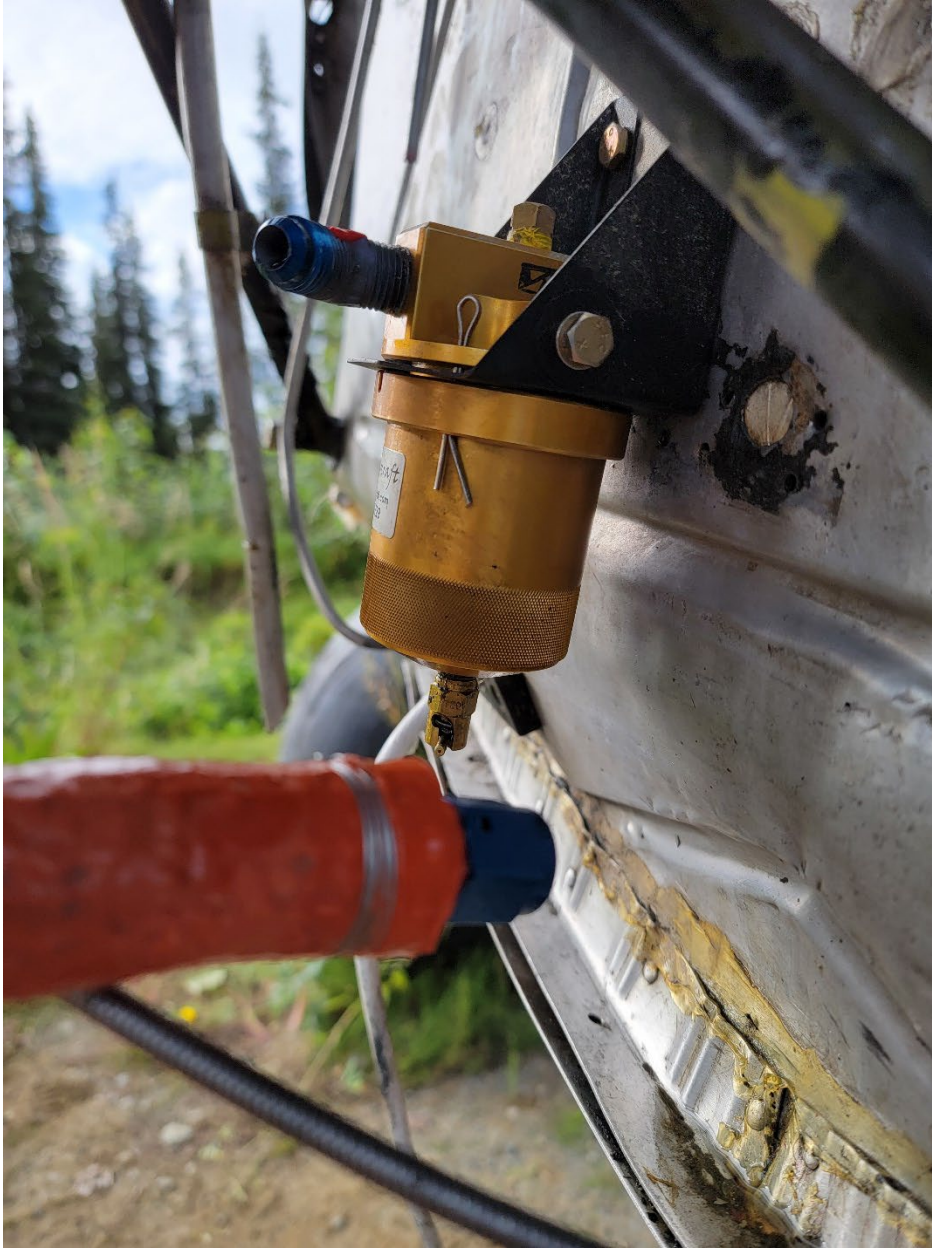
The engine oil pan was removed. The oil pan contained oil and the oil pick up tube was attached and free of obstruction (*figure 2*). The engine was removed from the airplane to remove the accessory case. Fuel was observed in the fuel line from the gascolator to the carburetor and the gascolator was full of fuel (*figure 4*). The

**Figure 4. View of gascolator.**

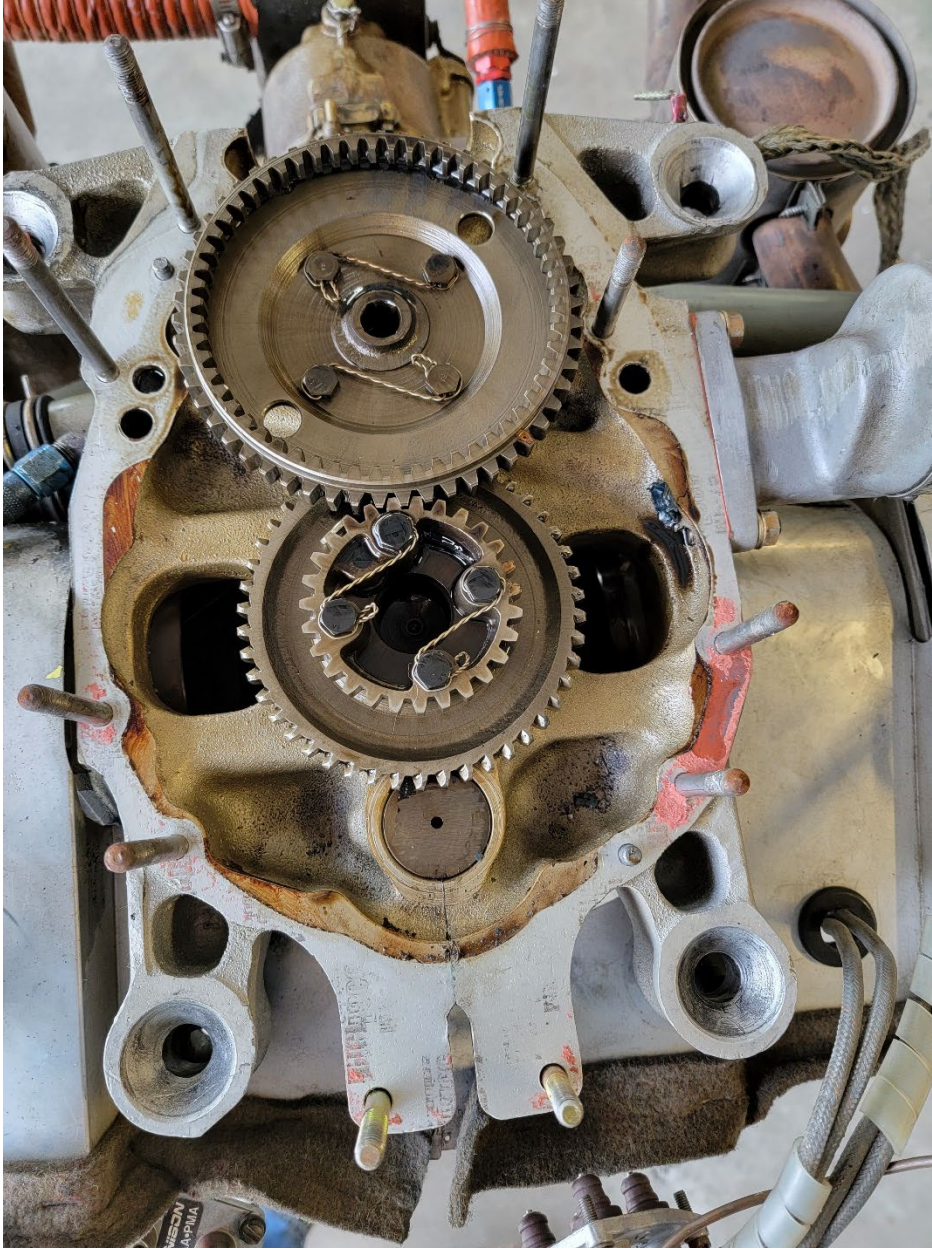
**Figure 5. View of aft of engine with the accessory case removed.**

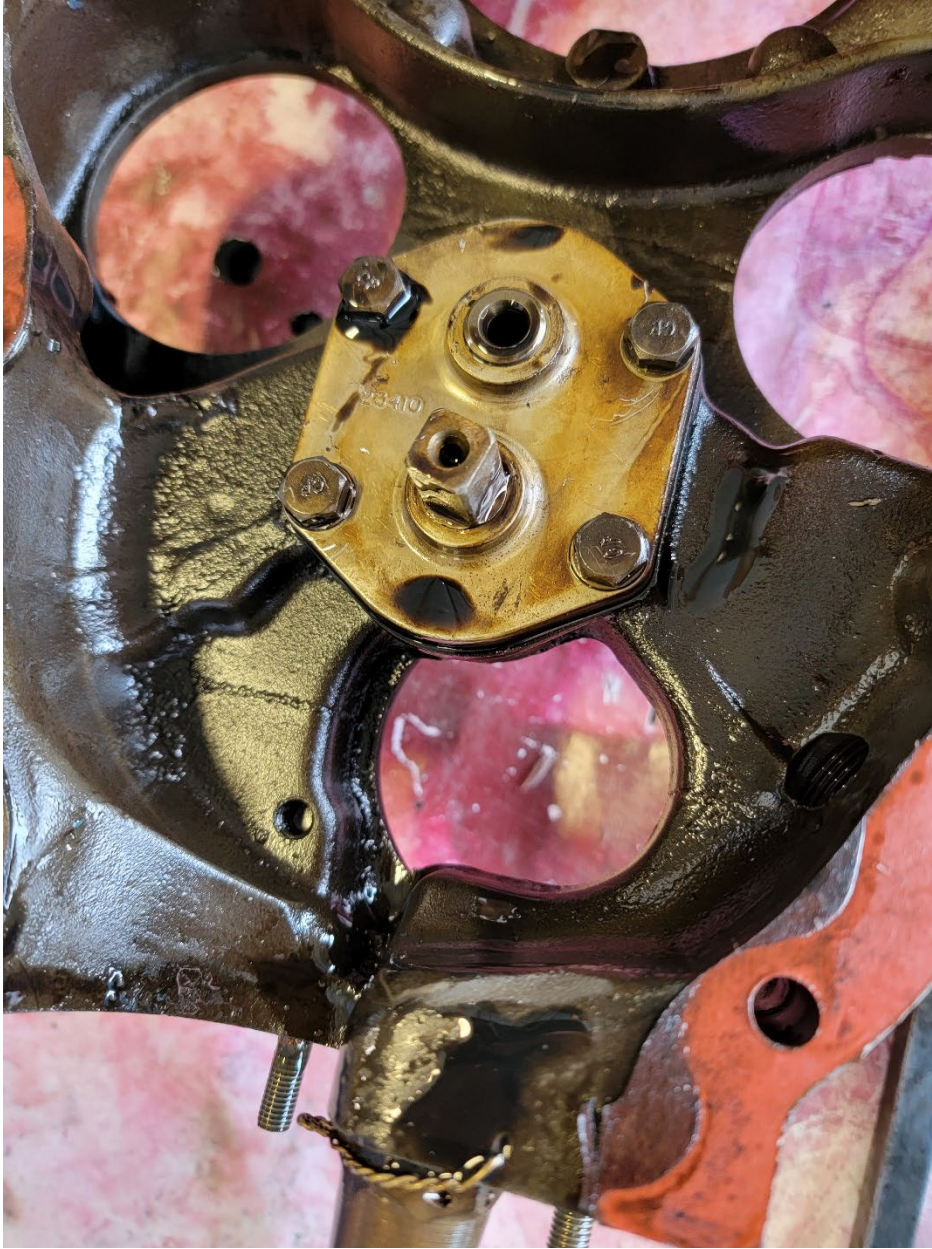
**Figure 6. View of oil pump in the accessory case.**

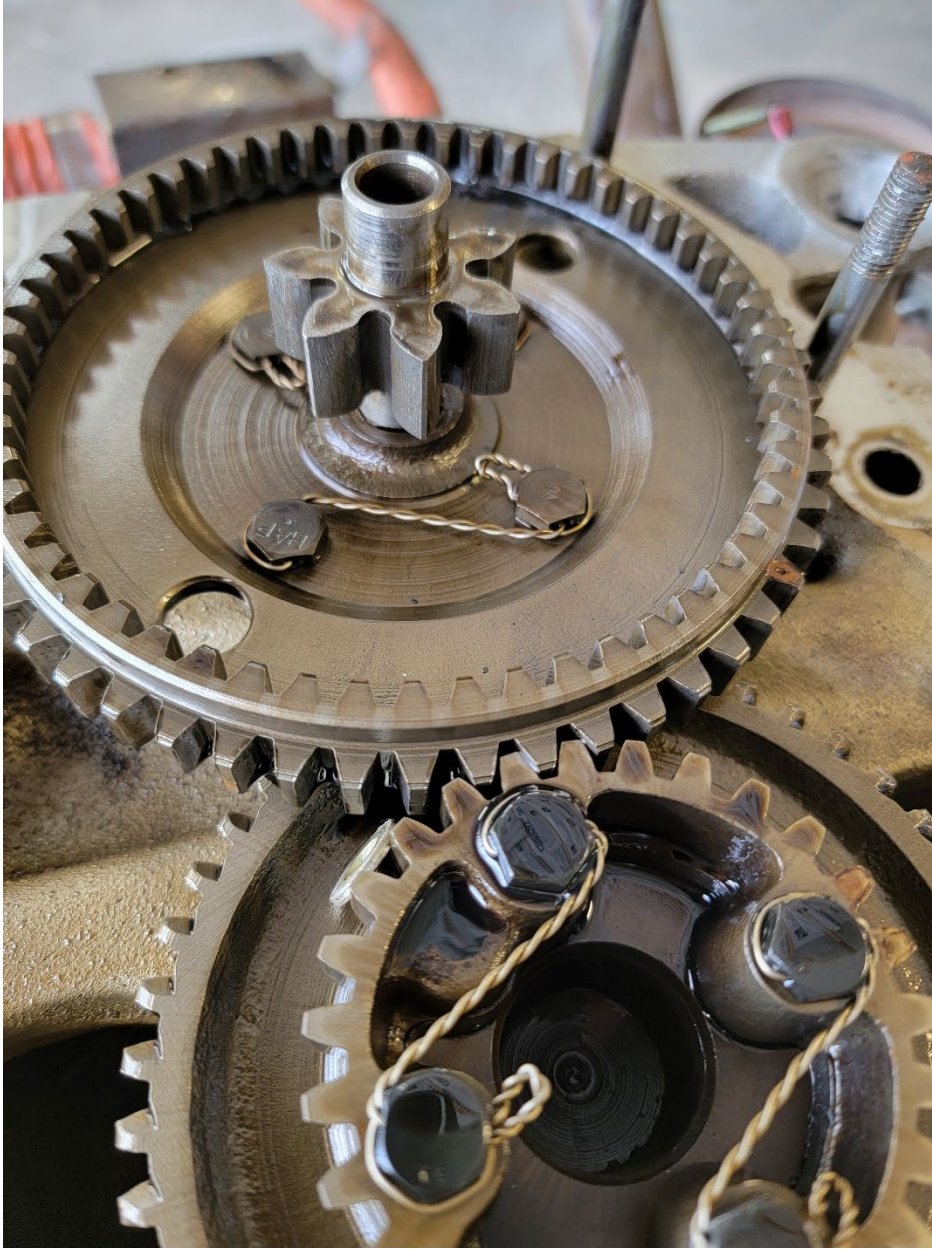
**Figure 7. View of oil pump gear.**

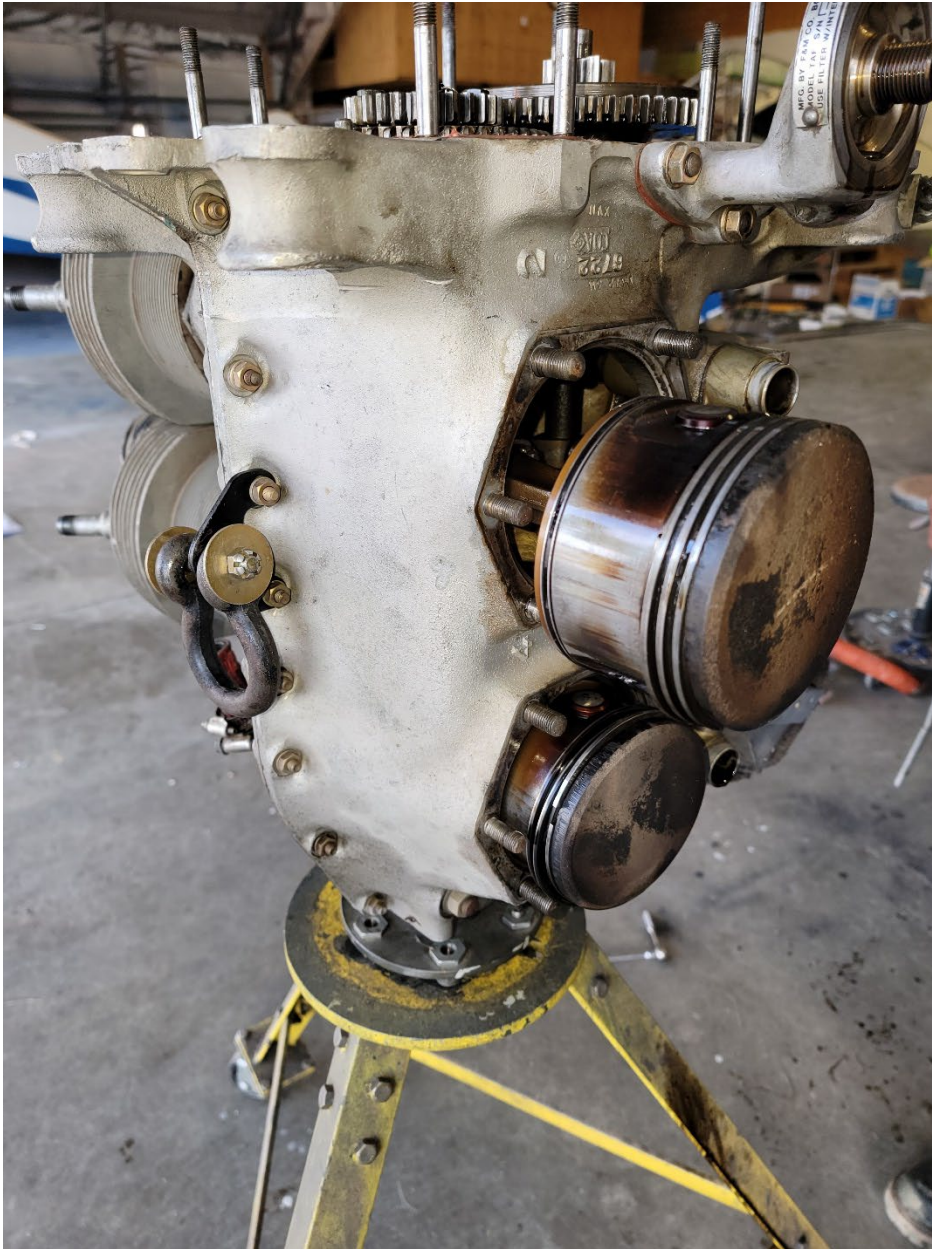
**Figure 8. View of engine with the left side cylinders removed.**

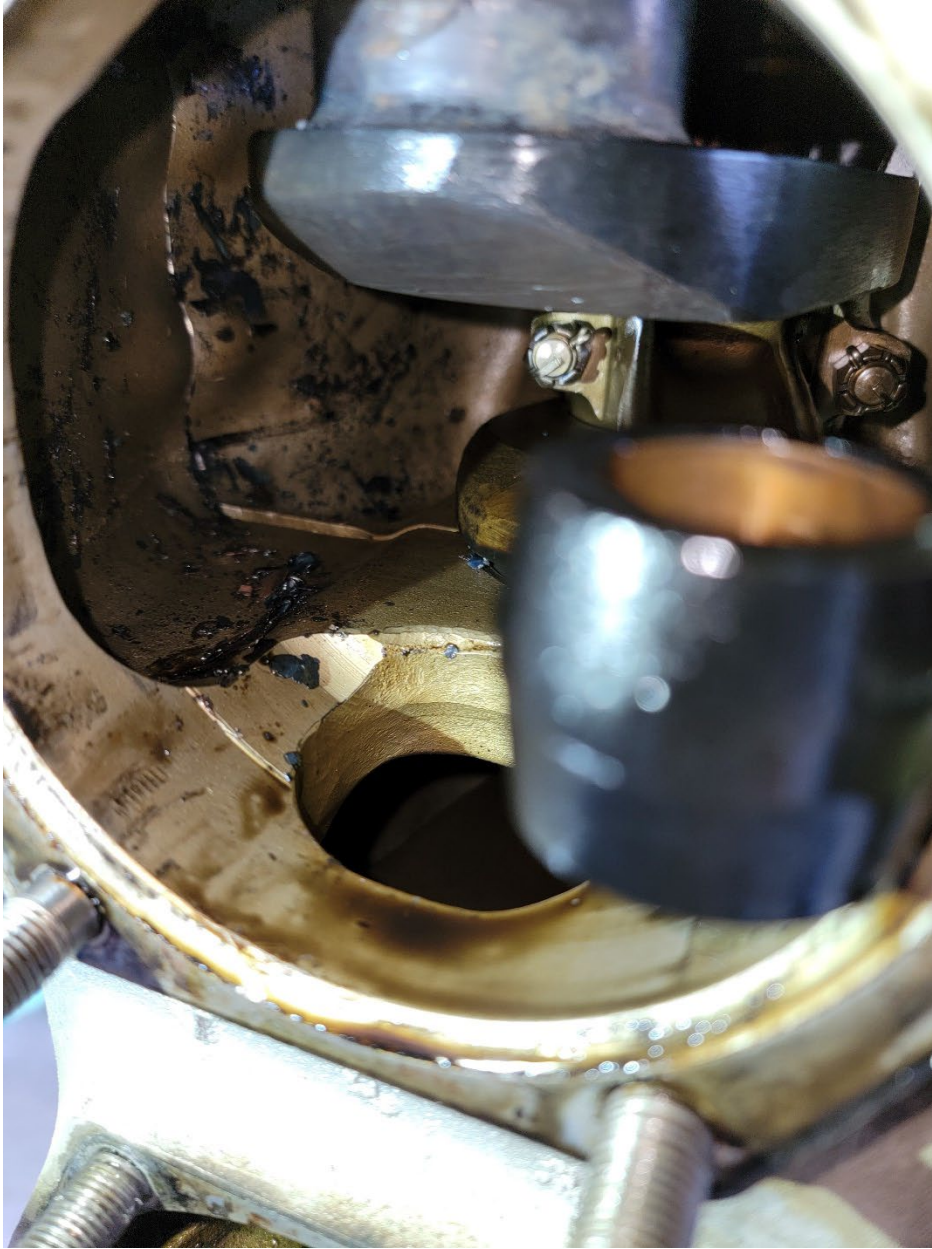
**Figure 9. View looking inside the engine case and fragments of a main bearing.**
