ANC23LA062

## INVESTIGATION PHOTOGRAPHS

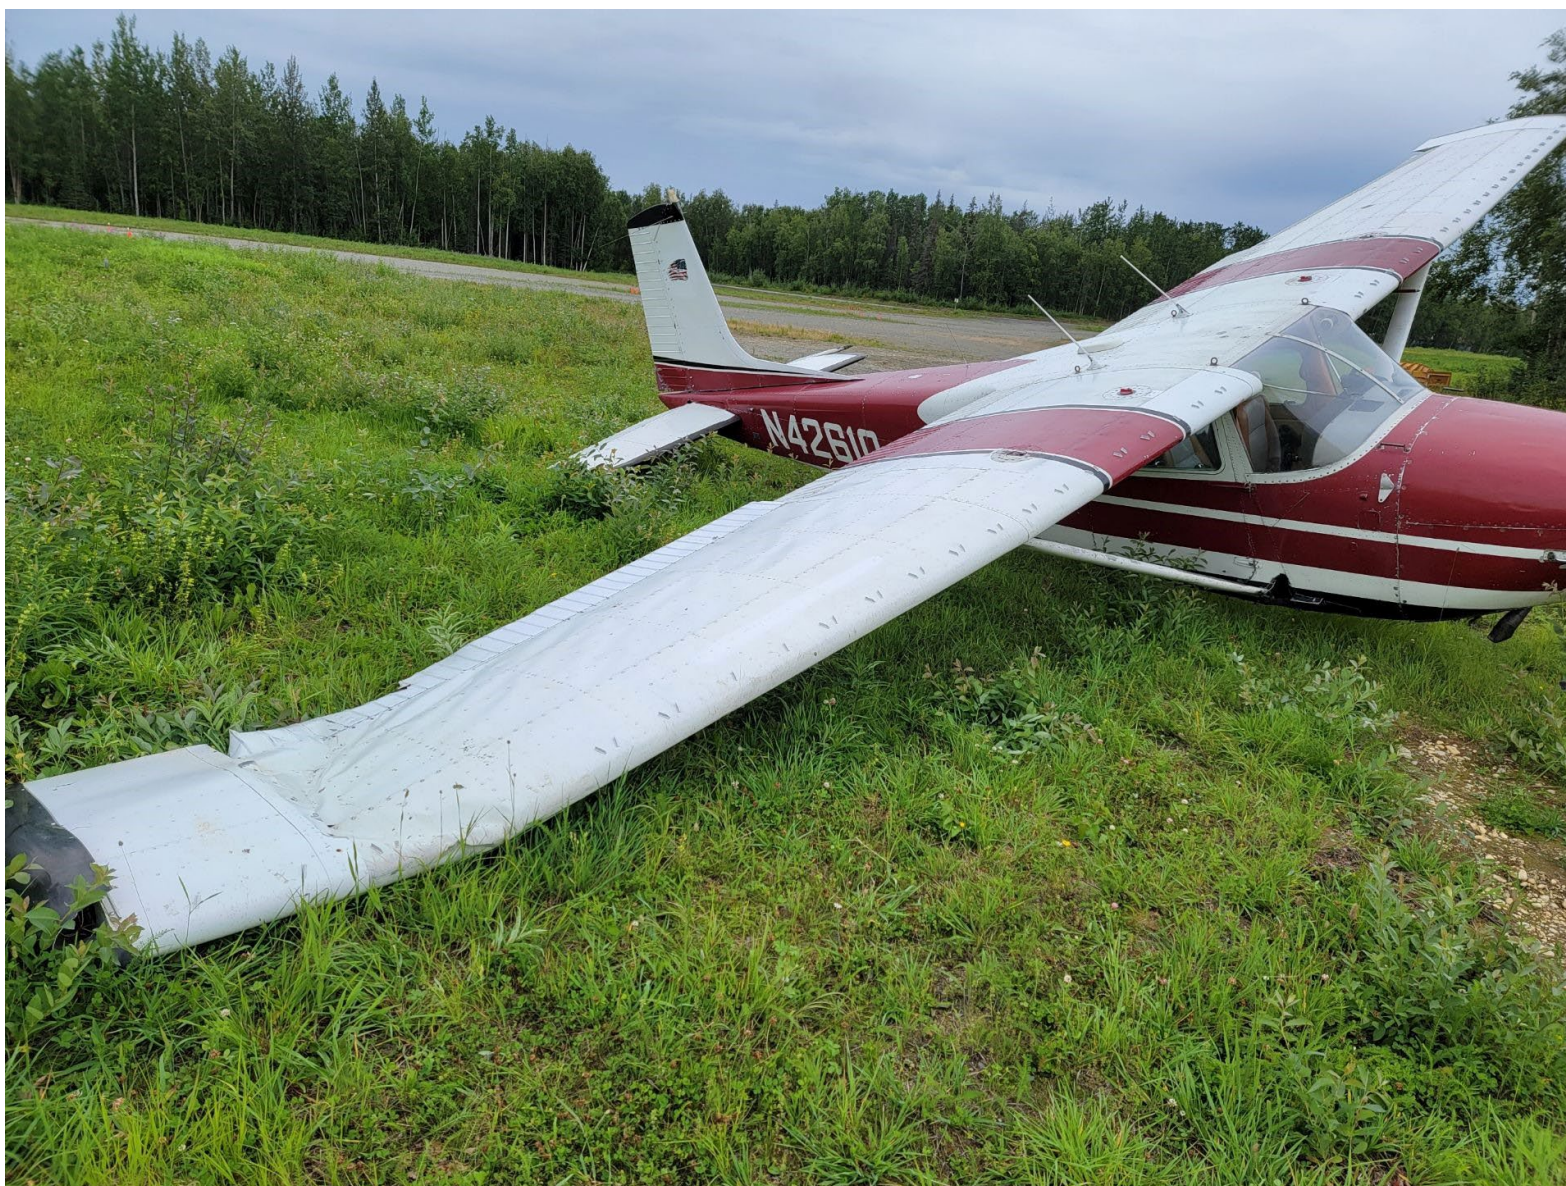
**Photograph 1 - Damaged right wing (Courtesy of NTSB Investigator)**

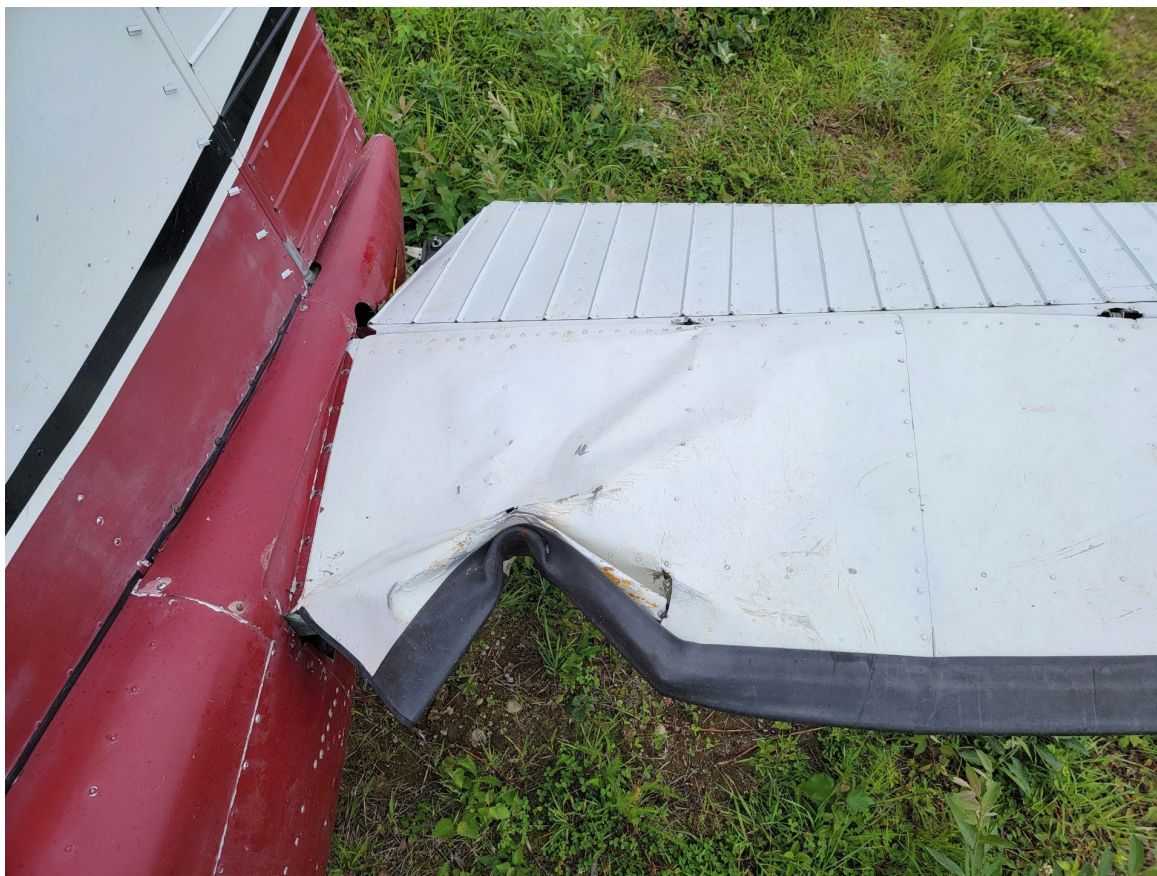
**Photograph 2 - Damaged left horizontal stabilizer (Courtesy of NTSB Investigator)**
