ANC23LA063

**INVESTIGATION PHOTOGRAPH**

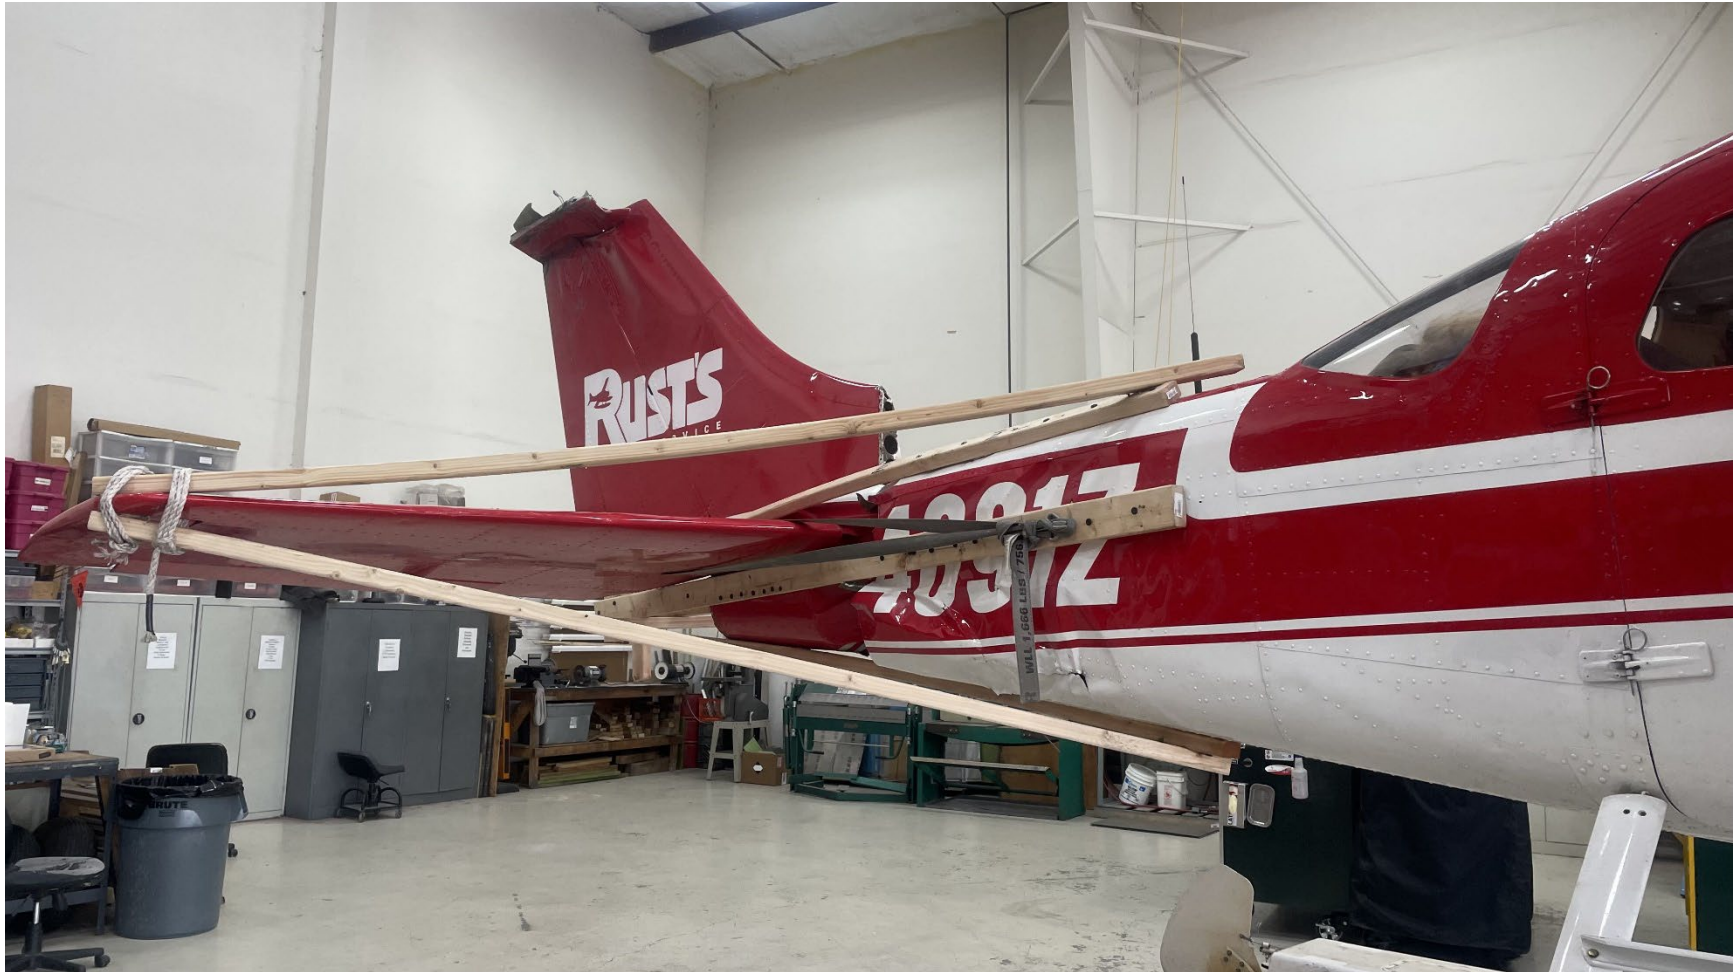
**Photograph 1 - Damaged rudder and vertical stabilizer (Courtesy of Operator)**
