ANC23LA068

## INVESTIGATION PHOTOGRAPHS

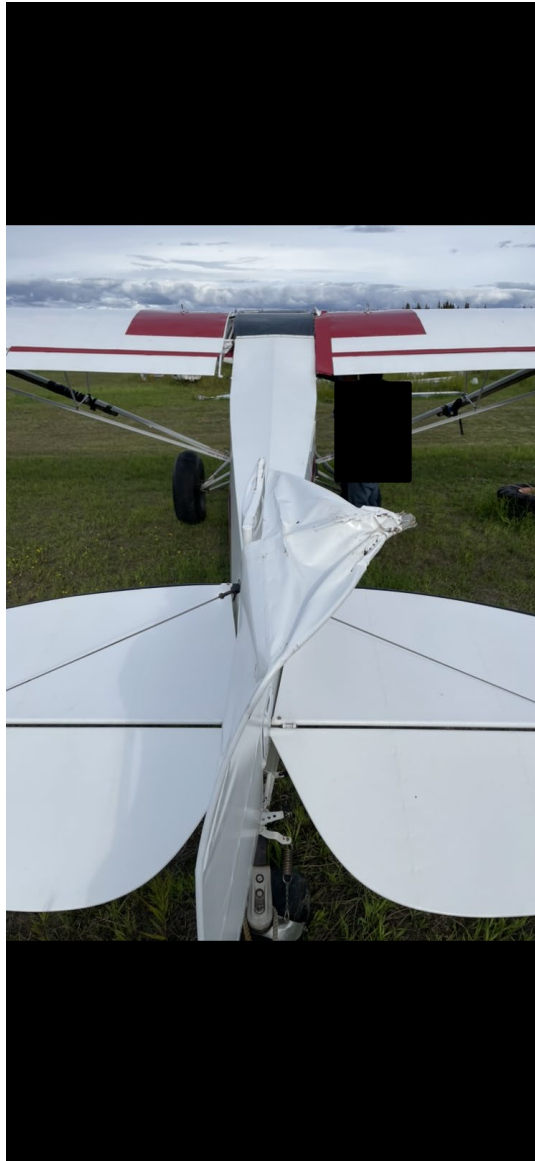
**Photograph 1 - Aft view of damage to the airplane's tail. (Courtesy of owner)**
