# National Transportation Safety Board

ANC23LA070

## ENGINE EXAMINATION

Airplane: Oliver Robert K (Kitfox) Series 6 airplane, N151RF

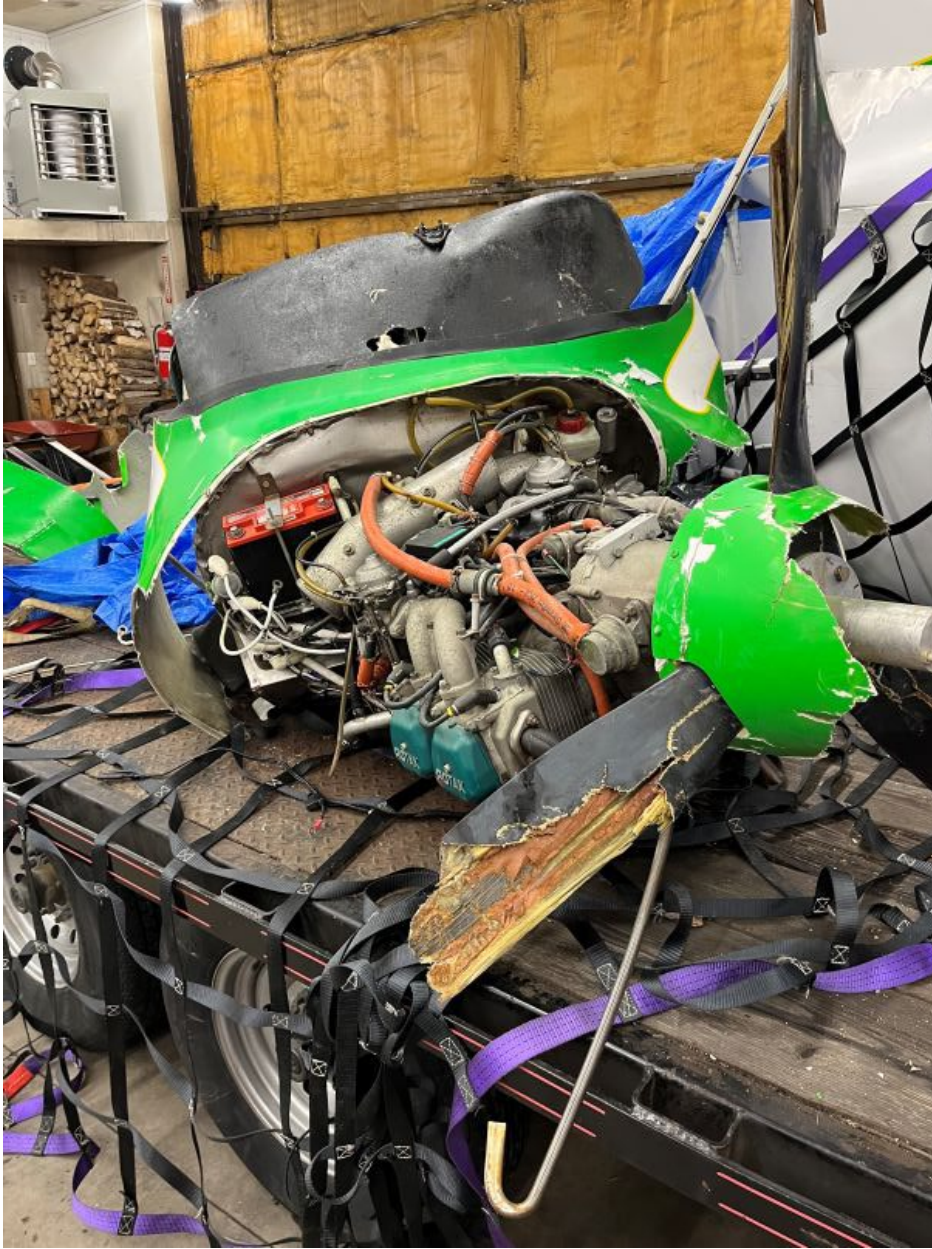
**Figure 1 View of engine before examination.**

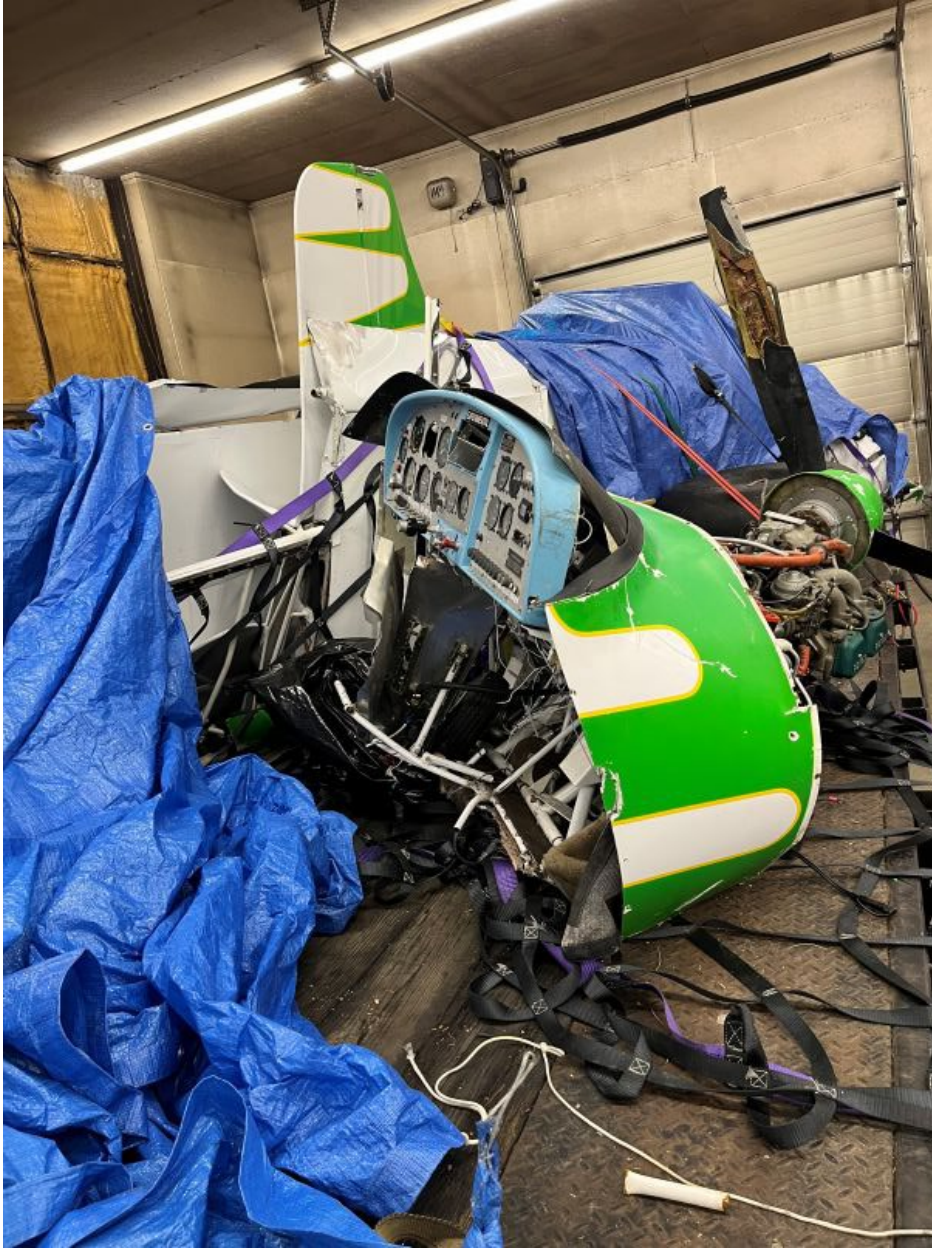
**Figure 2 Right side view of cockpit area and engine.**

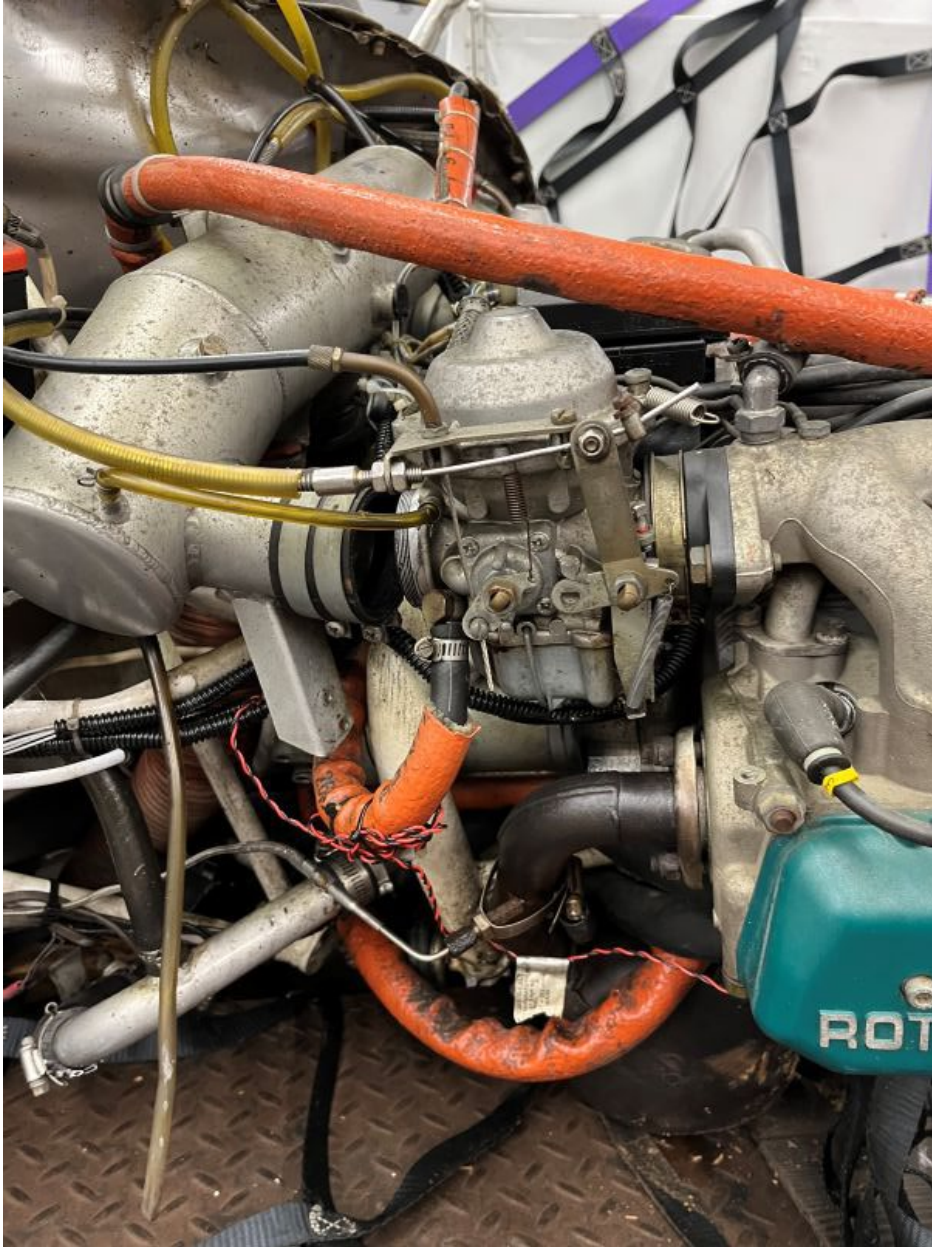
**Figure 3. Right side view of right carburetor.**

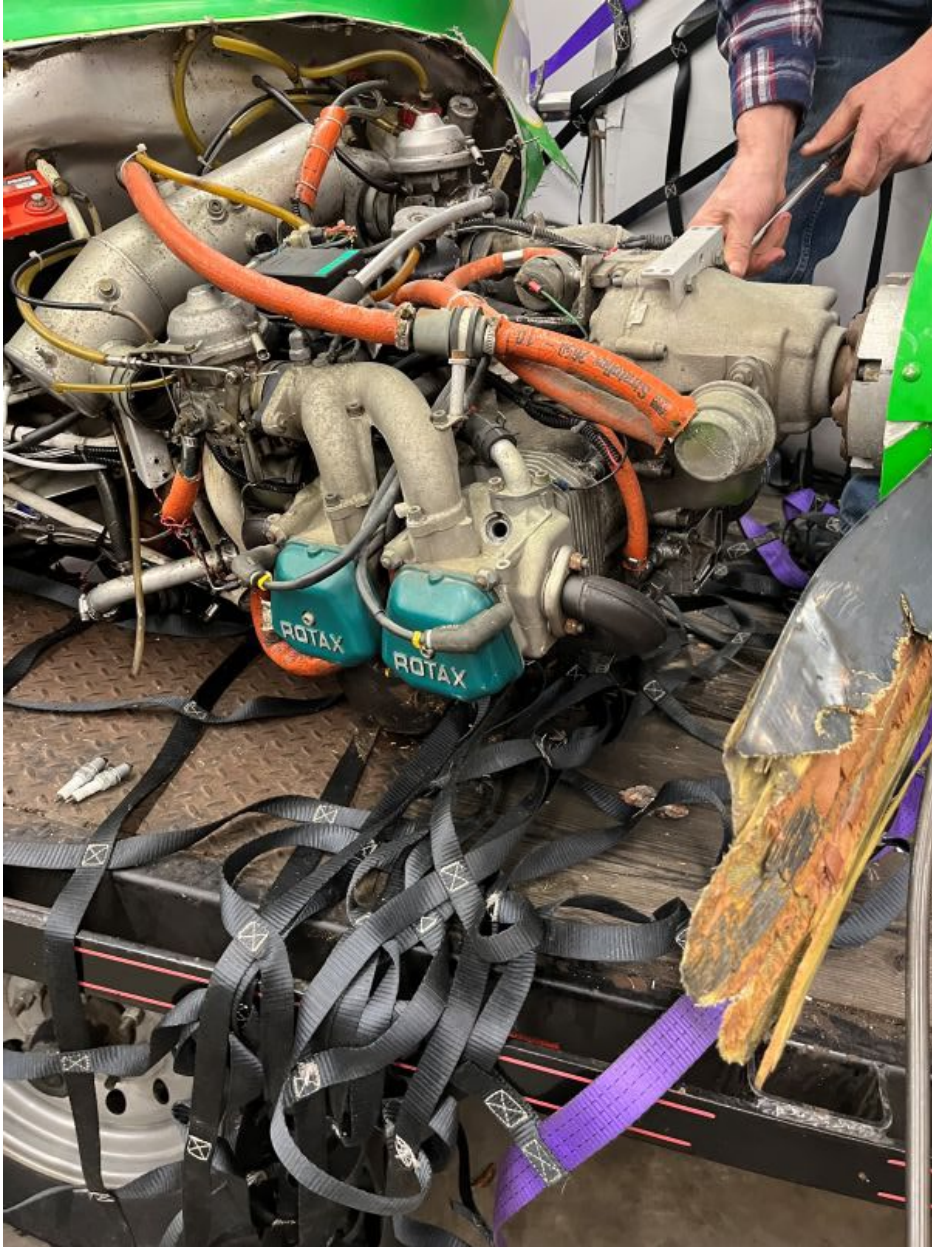
**Figure 4 View of the right side of the engine.**

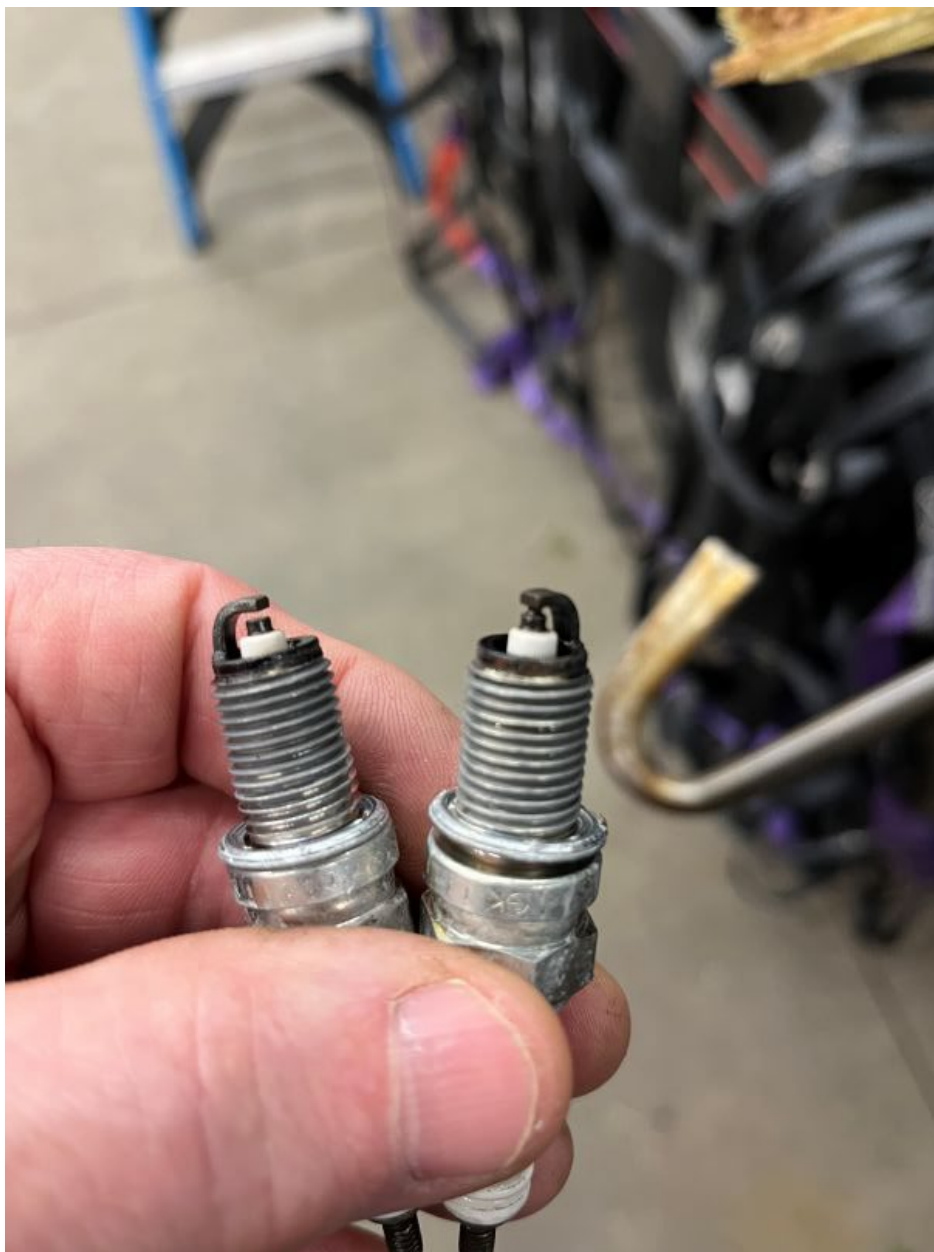
**Figure 5 View of sparkplugs from the top of the cylinder.**

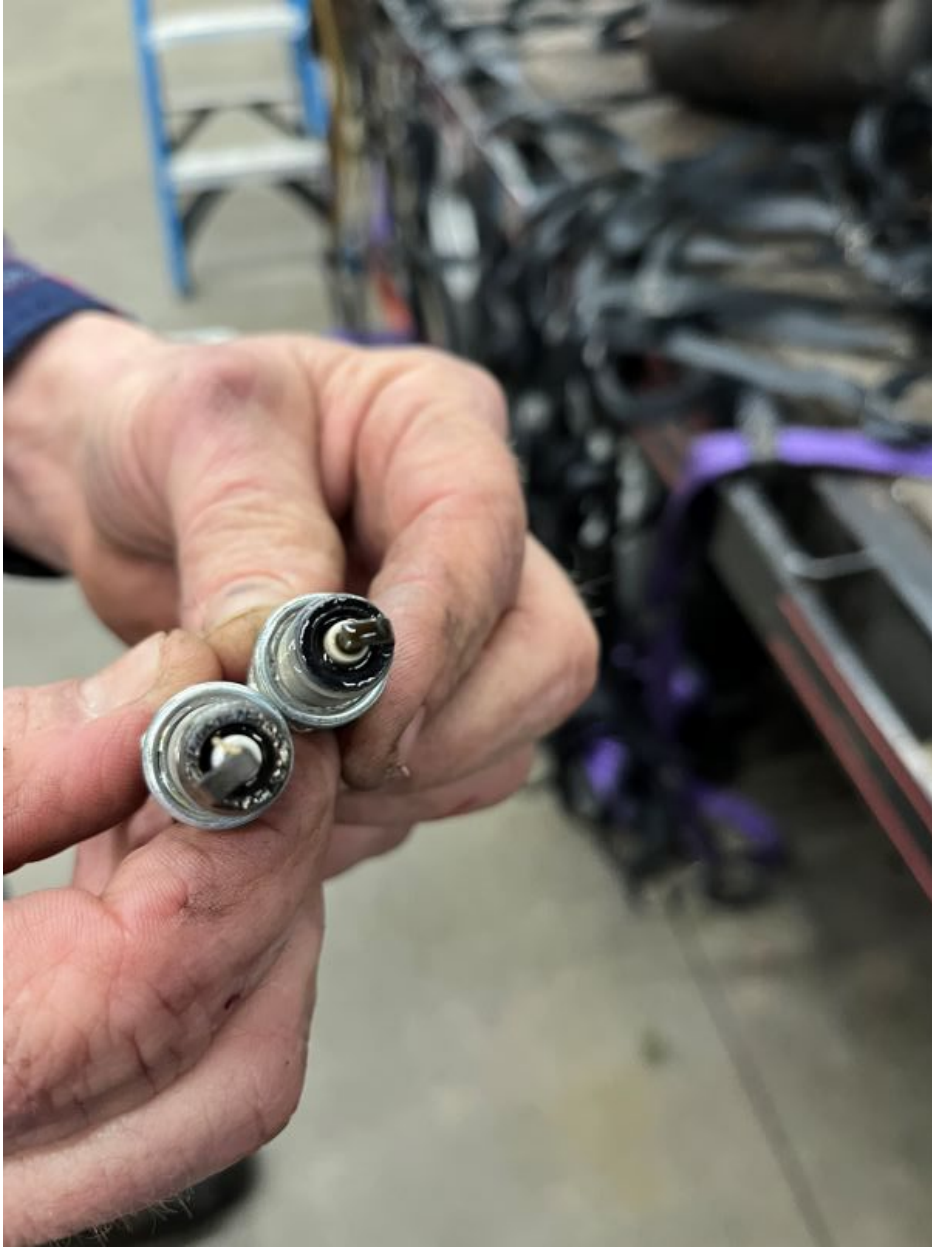
Keith checked to see if the engine had any compression. The top spark plugs were removed, being a non standard engine he didn't have a proper compression tester adaptor, so he just put his finger in the spark plug hole to see if there was any compression while rotating the prop. There was some compression for all 4 cylinders. The forward R/H cylinder built pressure and blew a large amount of oil out of the plug hole. He pulled the bottom spark plugs out and the rest of the oil drained out of the forward R/H cylinder. An estimated total, 1 cup of oil came out of the cylinder. A small amount of oil came from the back R/H cylinder. Small amounts of water drained from the two L/H cylinders. The plugs were examined and looked normal except the lower plugs installed in the two R/H cylinder that had oil in them.

**Figure 6 View of sparkplugs from the bottom of the cylinder.**
