# National Transportation Safety Board

ANC23LA078

## ENGINE EXAMINATION

Location: Nenana, AK  
Date: September 16, 2023  
Time: 1600 Local  
Airplane: N907W Murphy Moose SR3500

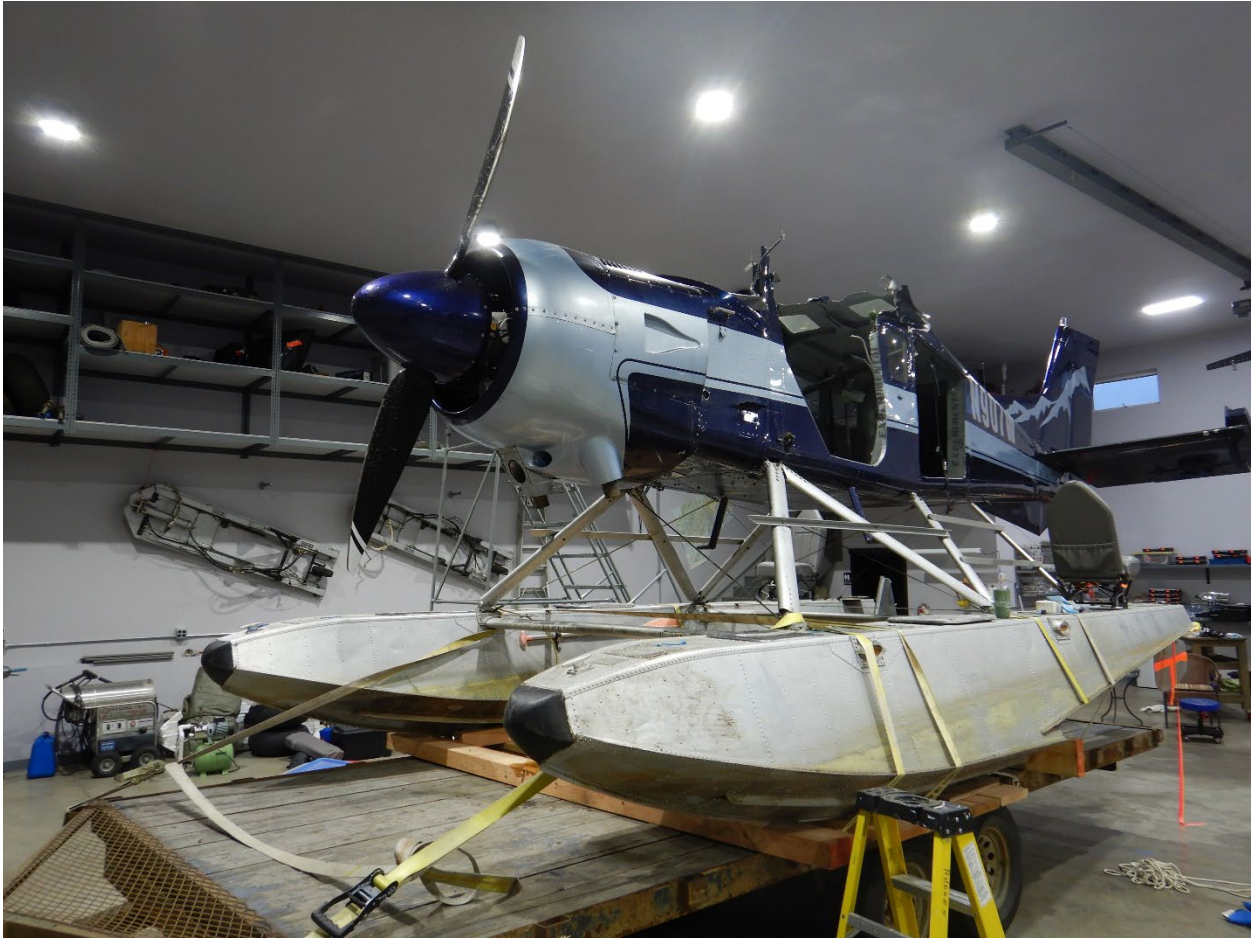
Pilot reported that enroute in a float equipped airplane, he noticed a slight rise in engine gas temperature (EGT) with a slight decrease in fuel consumption. The engine was operating normally but at a slight reduction in power output. Engine power then began to surge with a rapid decrease in power. The pilot made a left turn into the wind and towards a large lake to make an emergency landing. About 200 ft above ground level (AGL) the engine loss total power. There was not sufficient altitude to make a landing to the lake and the pilot made a forced landing to the tundra. About 75 ft after the airplane touched down, it nosed over and sustained substantial damage to the fuselage and wings.

**Figure 1 Accident airplane after recovery.**

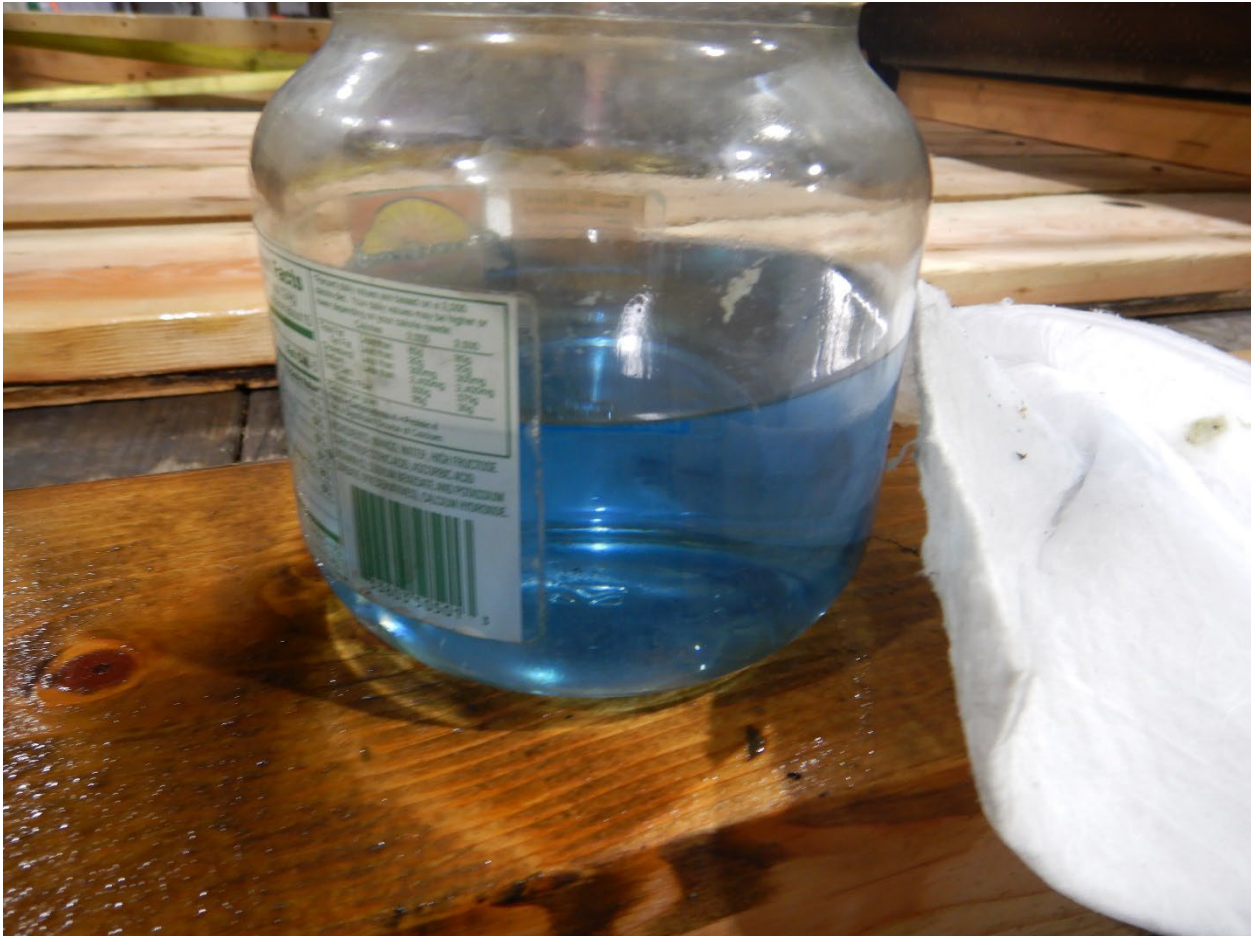
The airplane was equipped with a Steve's Gascolator. The gascolator was full of blue colored fuel (*figure 2*). Fuel was found in all fuel lines from the gascolator to the fuel control attached to the engine. The fuel was collected, and no signs of water or foreign debris was observed.

**Figure 2. Fuel recovered from the airplane's fuel lines.**

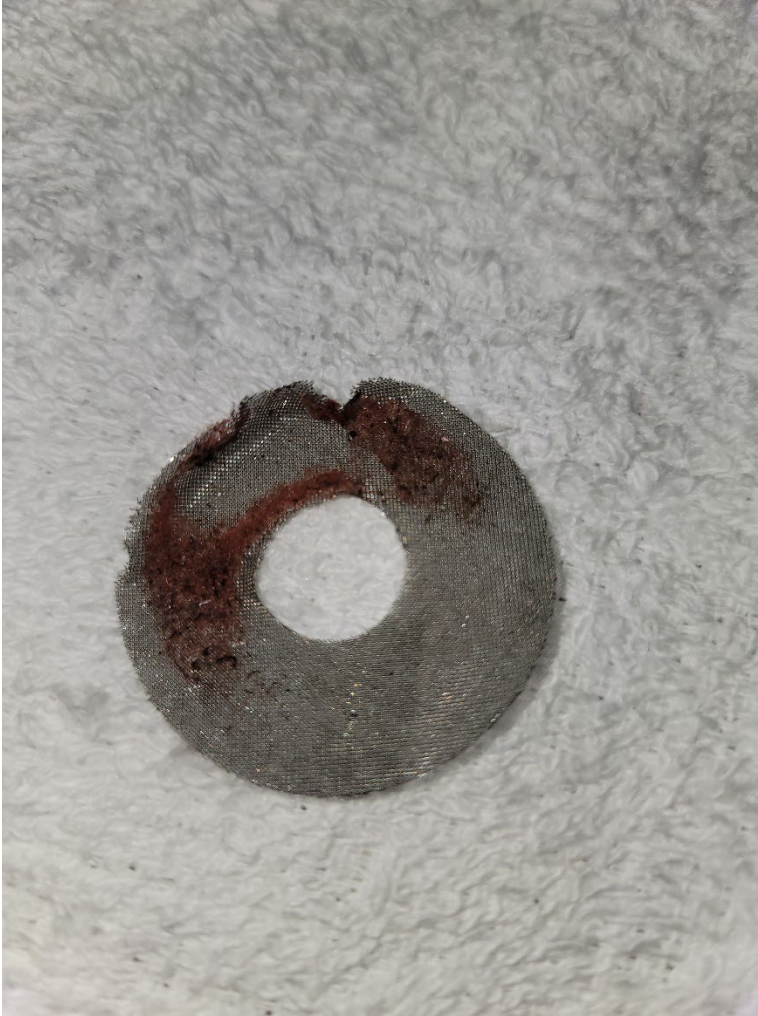
The gascolator screen was removed and inspected (*figure 3*). The screen had been cleaned about 20 flight hours prior. The screen contained some reddish nonmetallic contaminants.

**Figure 3. Gascolator screen from accident airplane.**

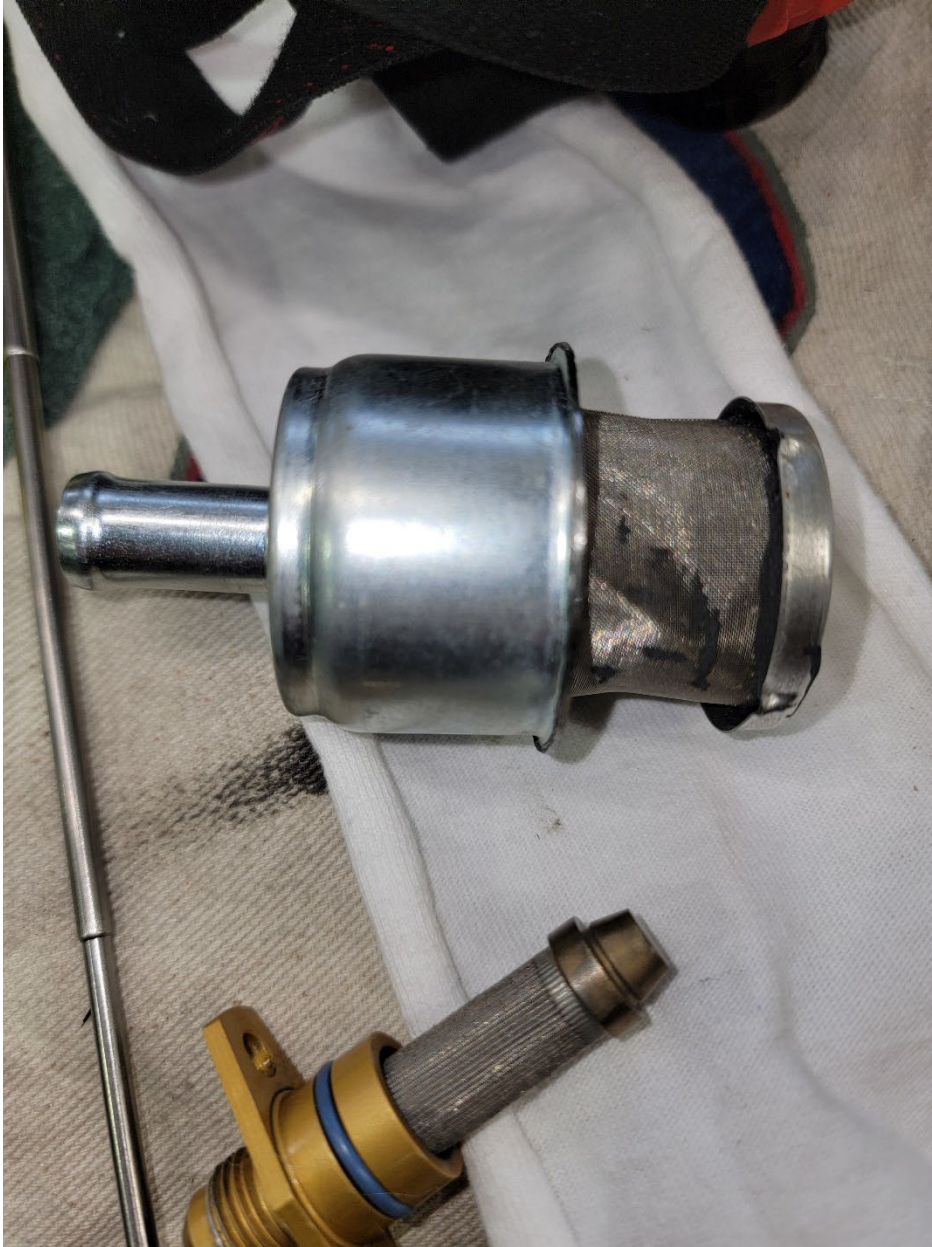
5). The filter 533248/091611K2 contained a metal 149-micron filter. The filter was examined with no observed contaminants (*figure 6*).

**Figure 6. Metal filter screen used when transferring fuel from the Swiss fuel bags into the airplane's fuel tanks.**

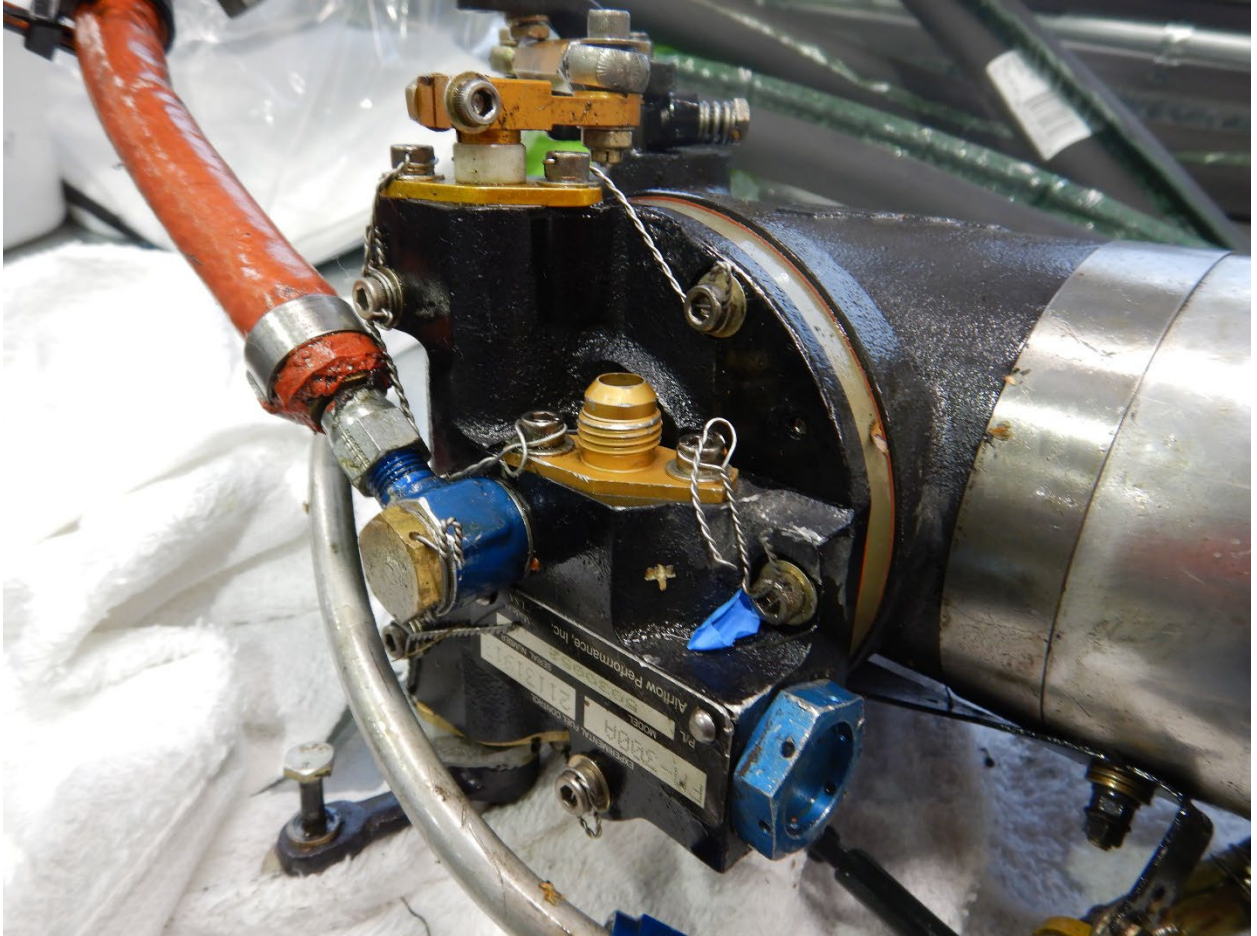
The engine Fuel Control was removed from the engine (*figure 8*). Air was blown into the fuel control, and it was very difficult to move air through the fuel inlet. We removed the inlet fuel screen from the engine Fuel Control. Light from a flashlight was shined along the filter and no light could be observed inside the filter (*figure 9*). Fine nonmetallic fibers could be seen in the filter. The inlet fuel filter is a 74-micron filter. The owner was unaware of the requirements to inspect and clean the fuel control inlet filter. The filter had been in operation for about 12 to 13 years.

**Figure 8. Engine fuel control.**

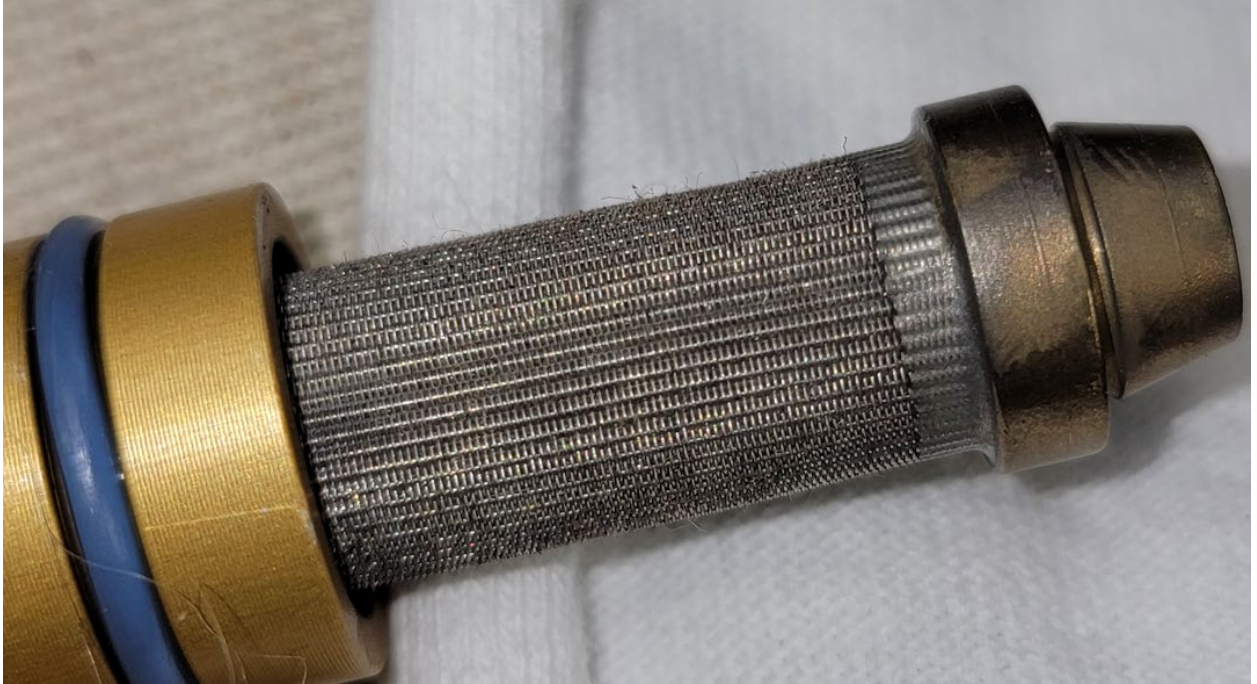
**Figure 9. Inlet fuel screen from the engine fuel control.**

An examination of the engine revealed the fuel inlet screen into the fuel control unit was plugged and prevented fuel from entering the engine.

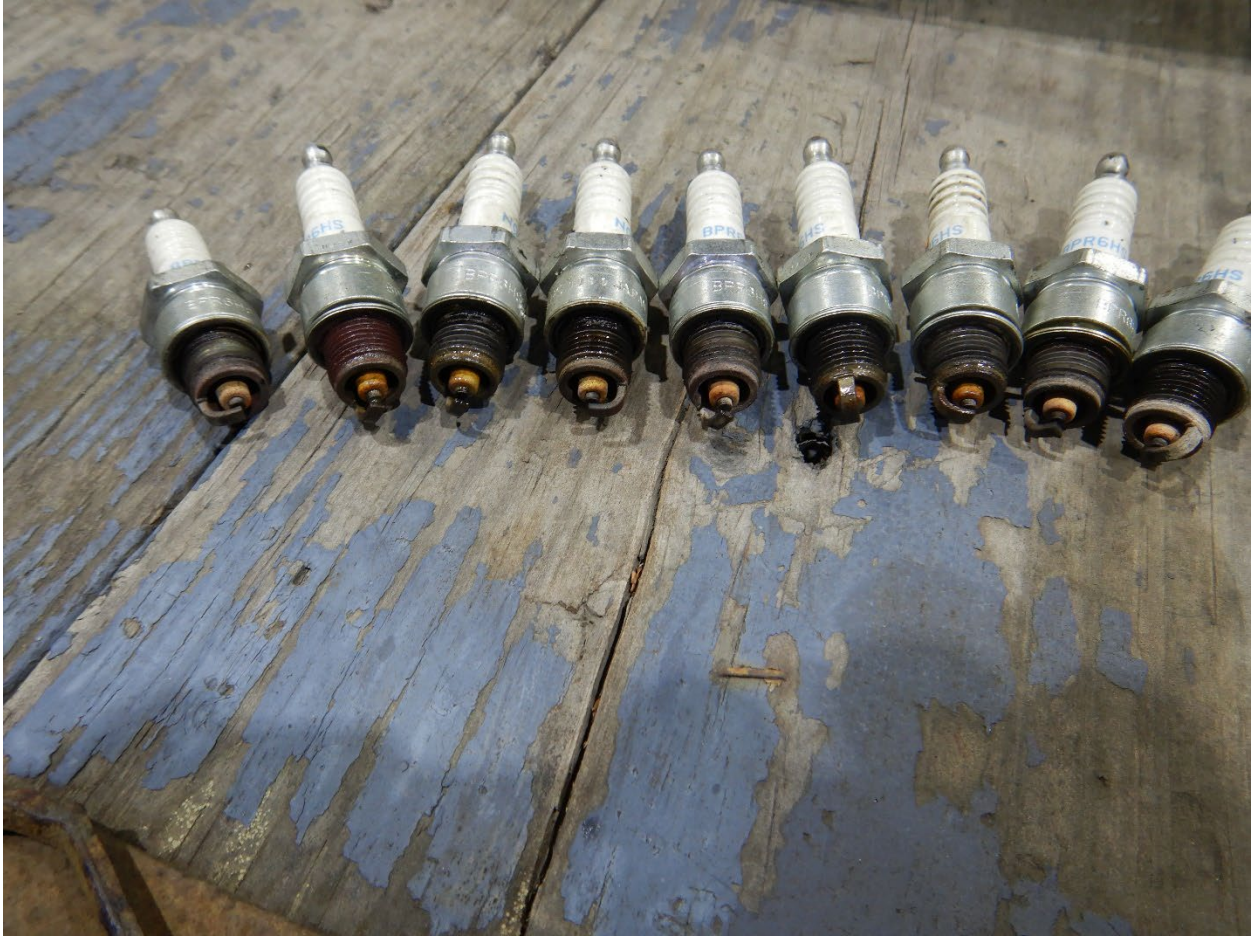
The engine rotated easily by hand with the sparkplugs removed. No unusual noise or feel were observed when rotating the engine. Strong thumb compressions were observed in all cylinders. All sparkplugs were undamaged with normal electrodes (*figure 11*).

**Figure 11. Sparkplugs removed from the engine.**
