ANC23LA078

## INVESTIGATION PHOTOGRAPHS

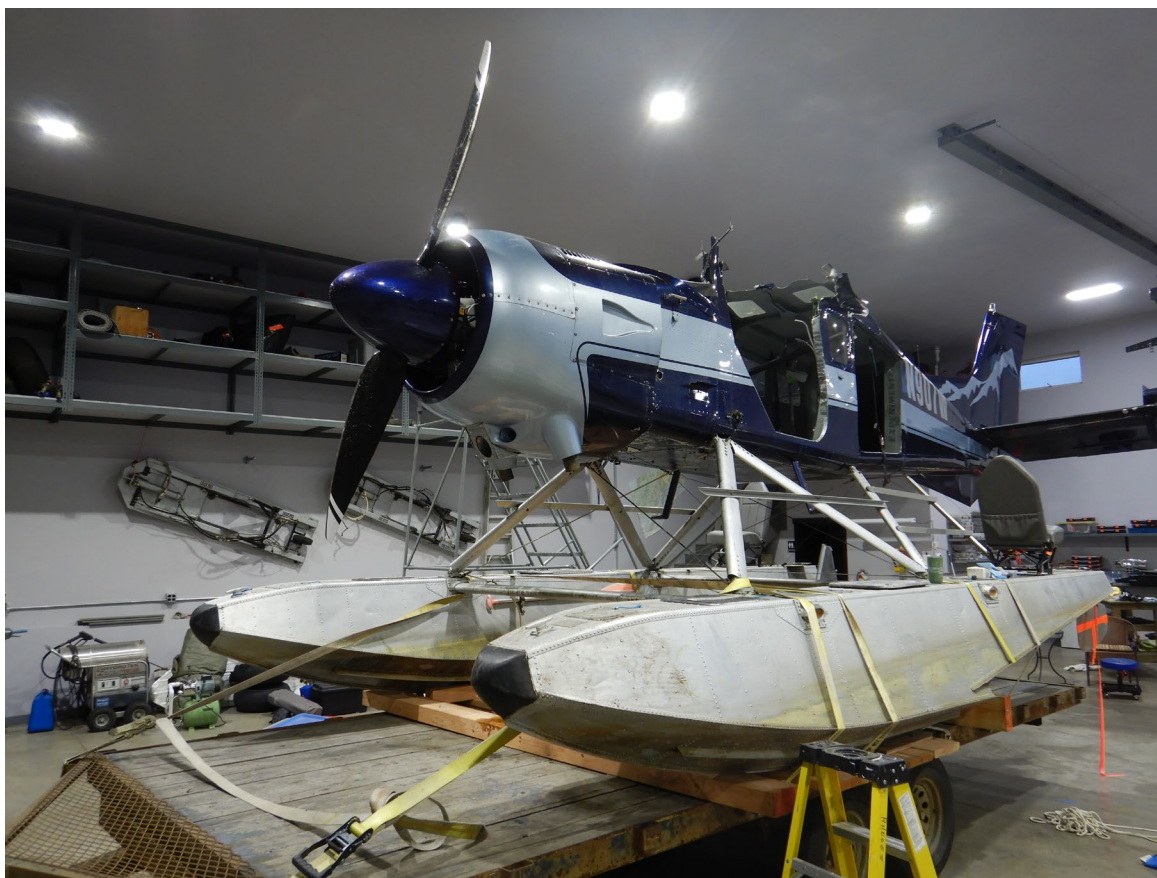
**Photograph 1 - Accident airplane after recovery (Courtesy of NTSB)**

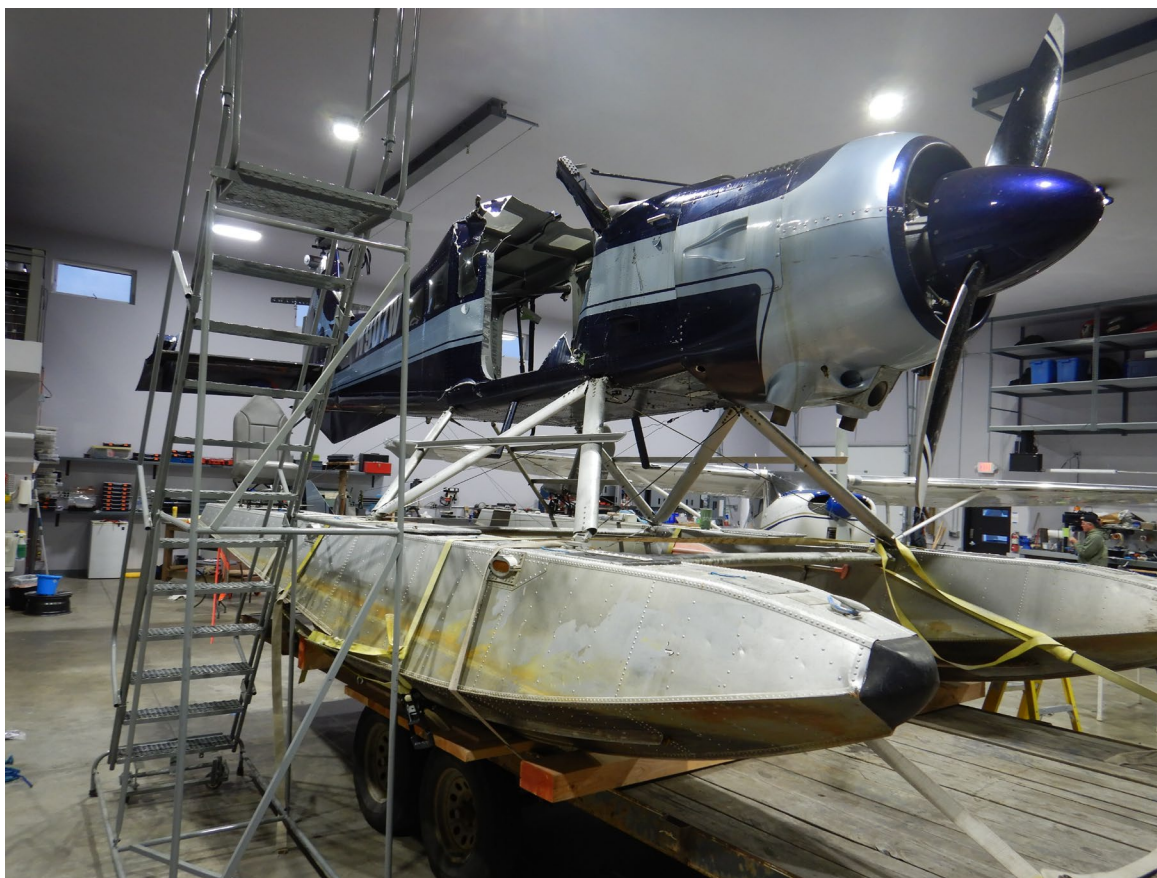
**Photograph 2 - Accident airplane after recovery (Courtesy of NTSB)**

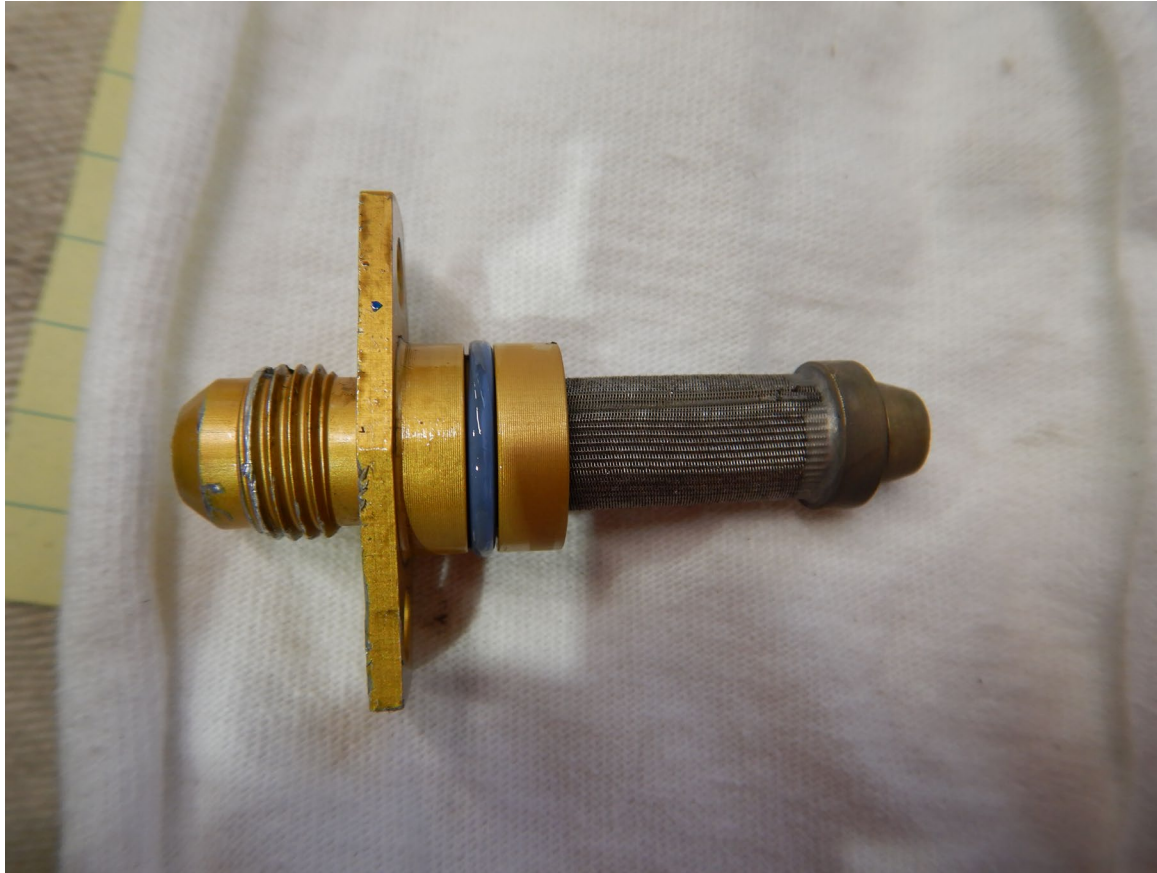
**Photograph 3 - Fuel control inlet filter (Courtesy of NTSB)**
